REHABILITATION OF THE CENTRAL MACHU PICCHU HYDROELECTRIC PLANT

**CONSTRUCTION OF GALLERIES
CONNECTING THE POWERHOUSE TO THE
TAILRACE TUNNEL**

OCTOBER 1, 2013

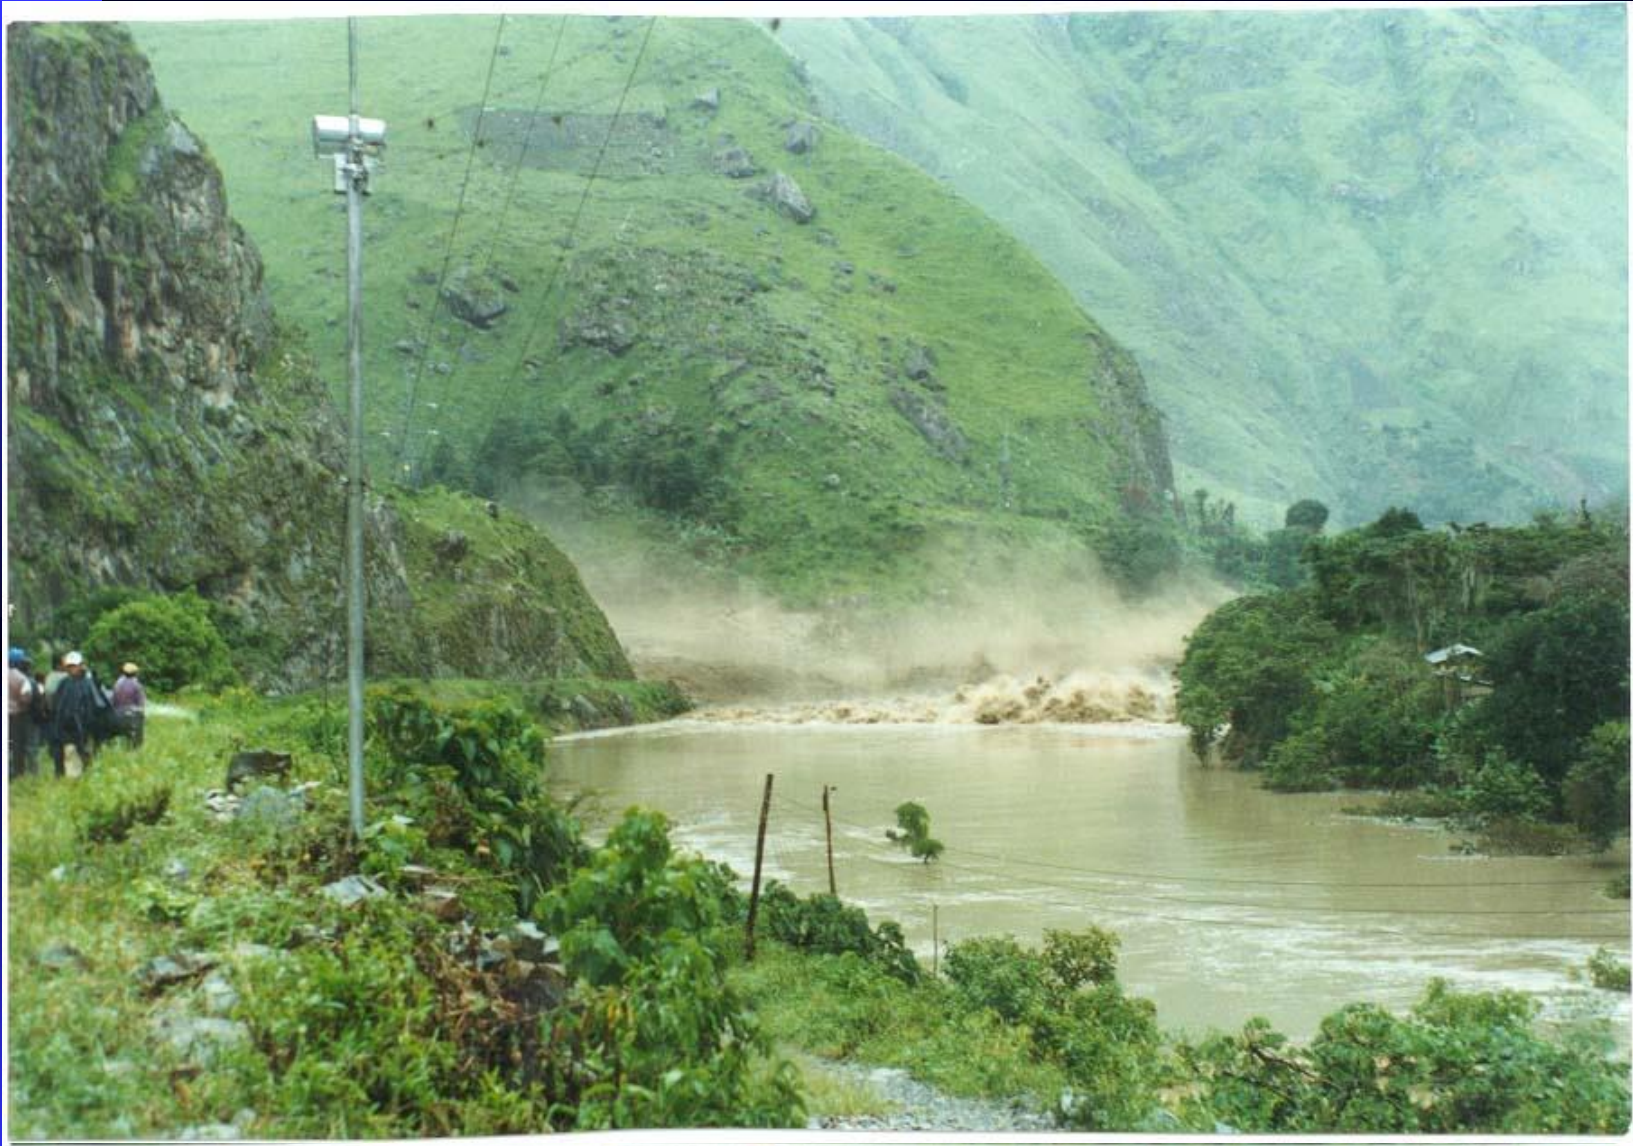
**SLIDE ARRIVING AT THE CONFLUENCE WITH THE
VILCANOTA RIVER**

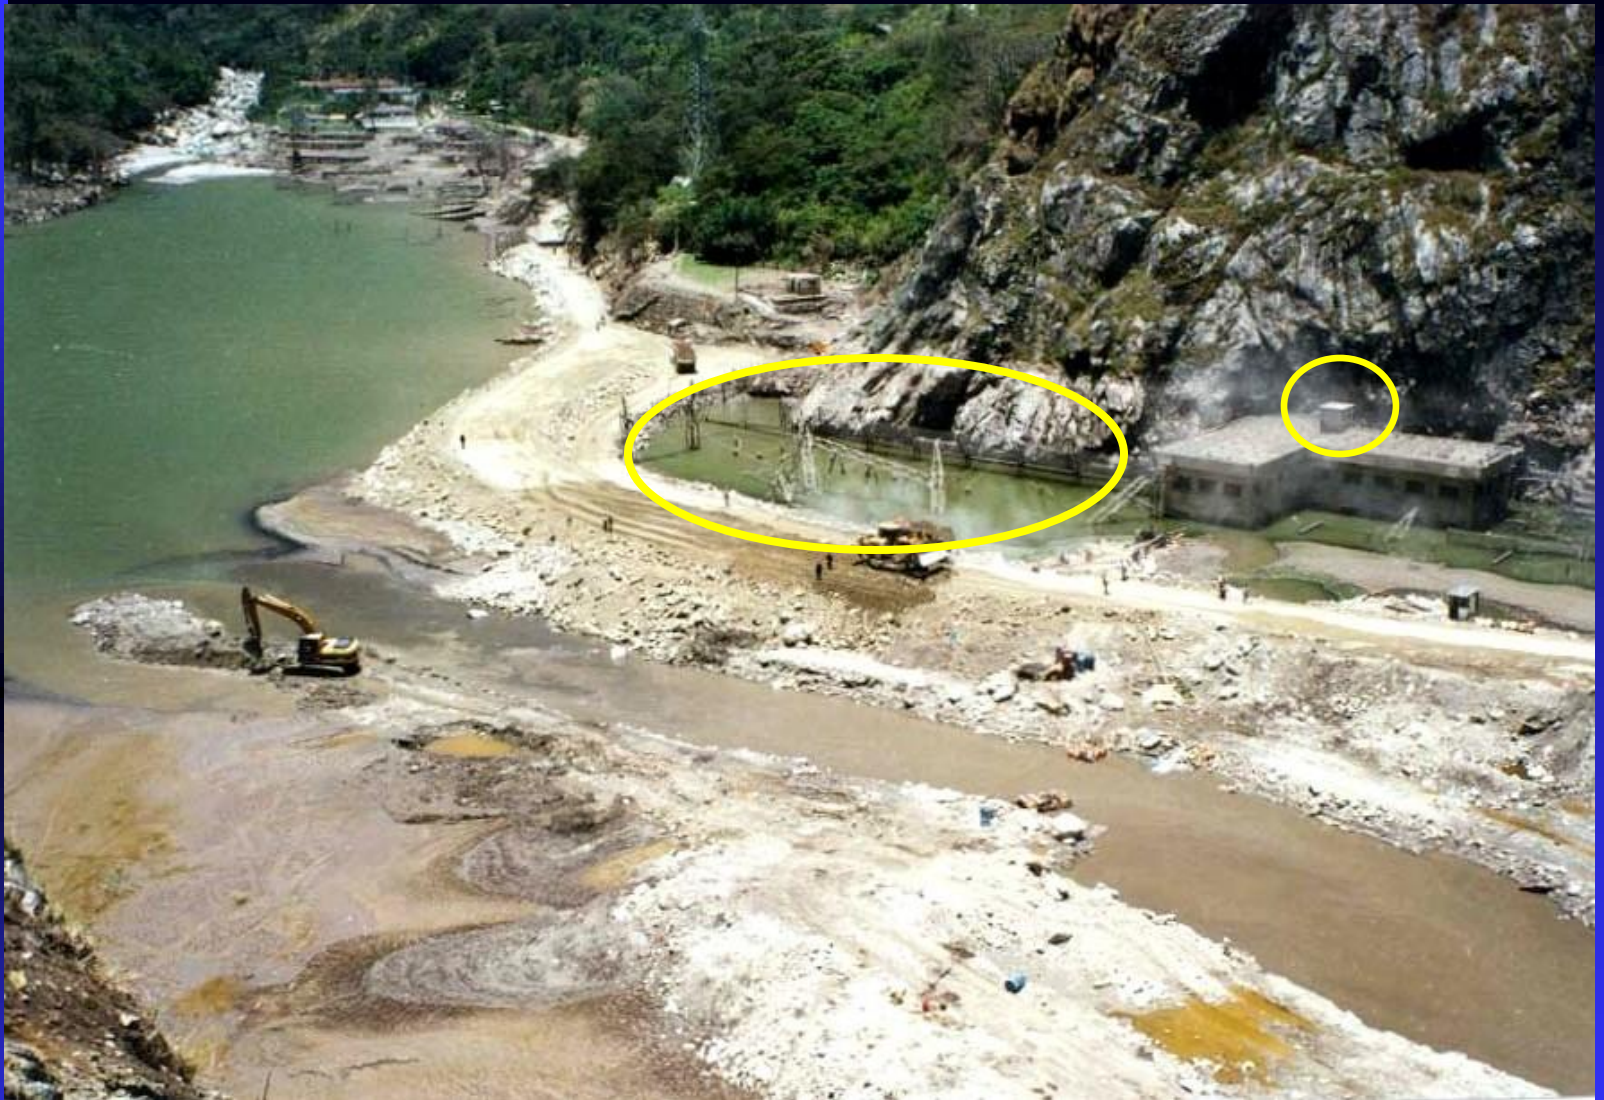
OPENING OF A DISCHARGE CHANNEL TO FACILITATE DRAINAGE

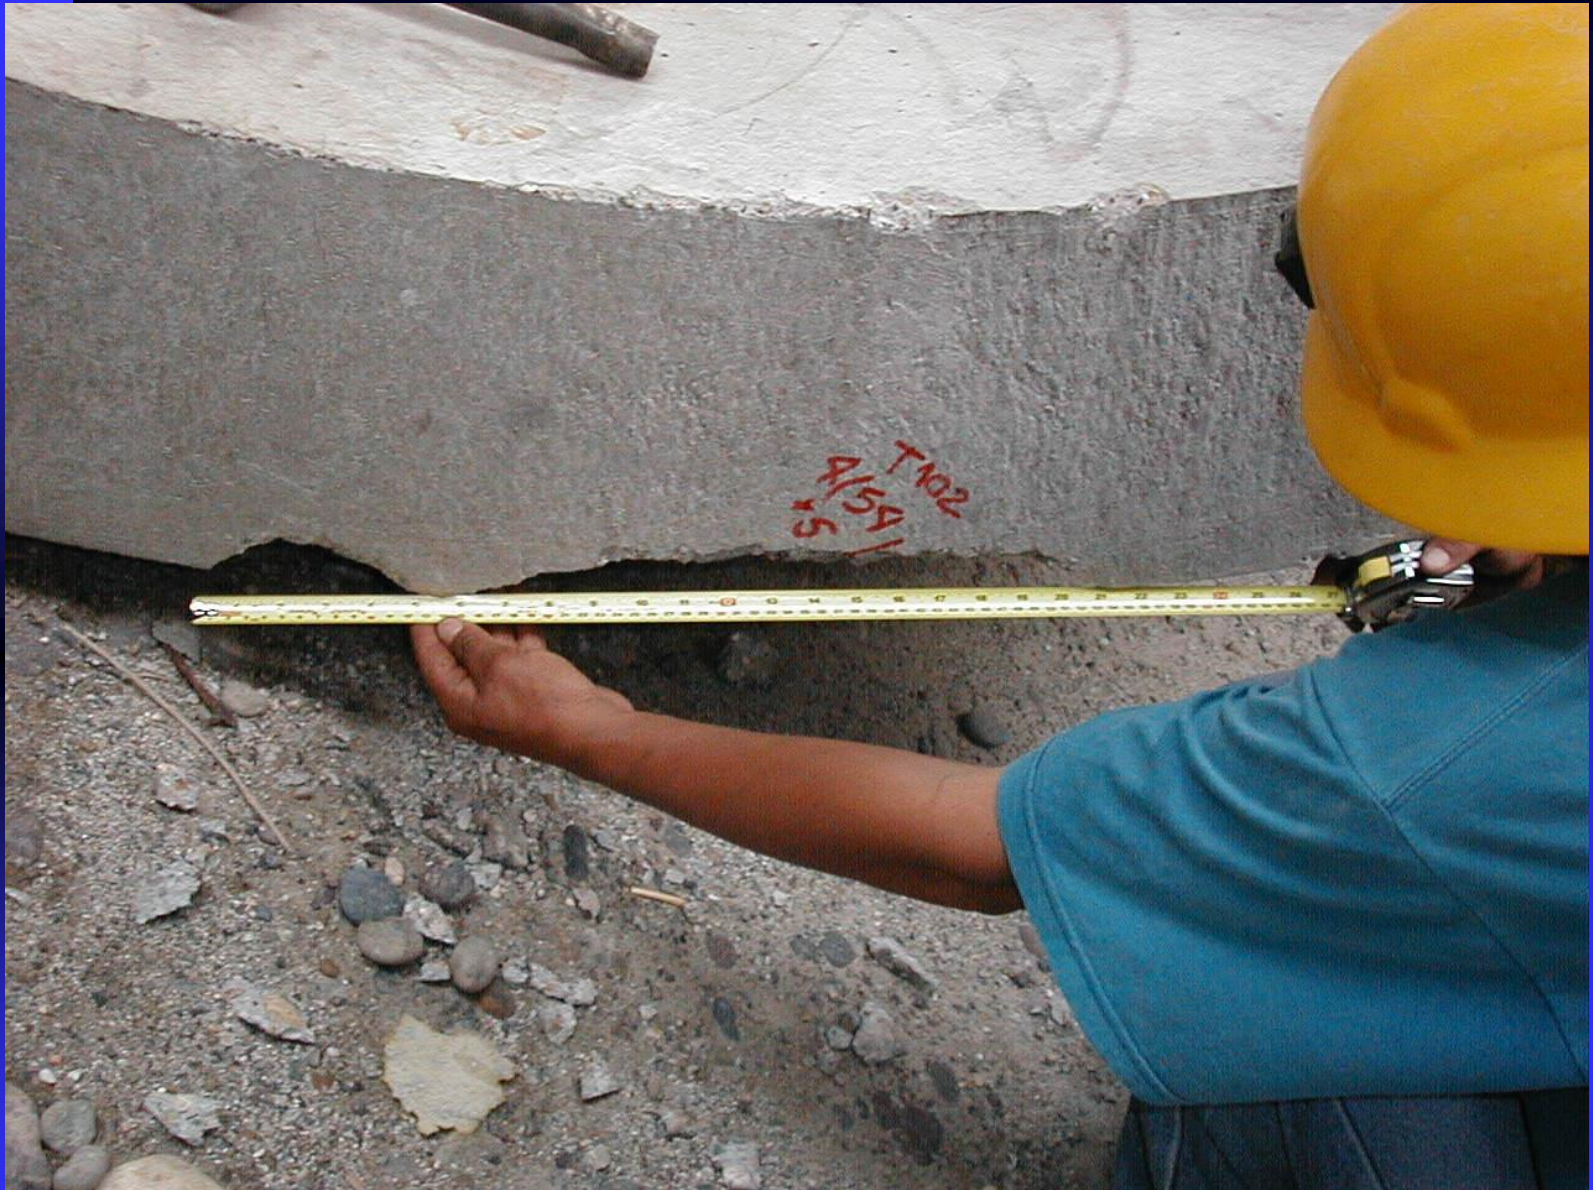
- Pipes showed many minor defects during transport by boat, truck, train and intermediate handlings.
- 9 a total of 134 pipes were unrecoverable.
- Most of the pipes were repaired using mortar epoxy under the supervision of experts.
- Repairs were tested with simple tension tests and inspected with ultrasound.

DAMAGE TO THE PIPES

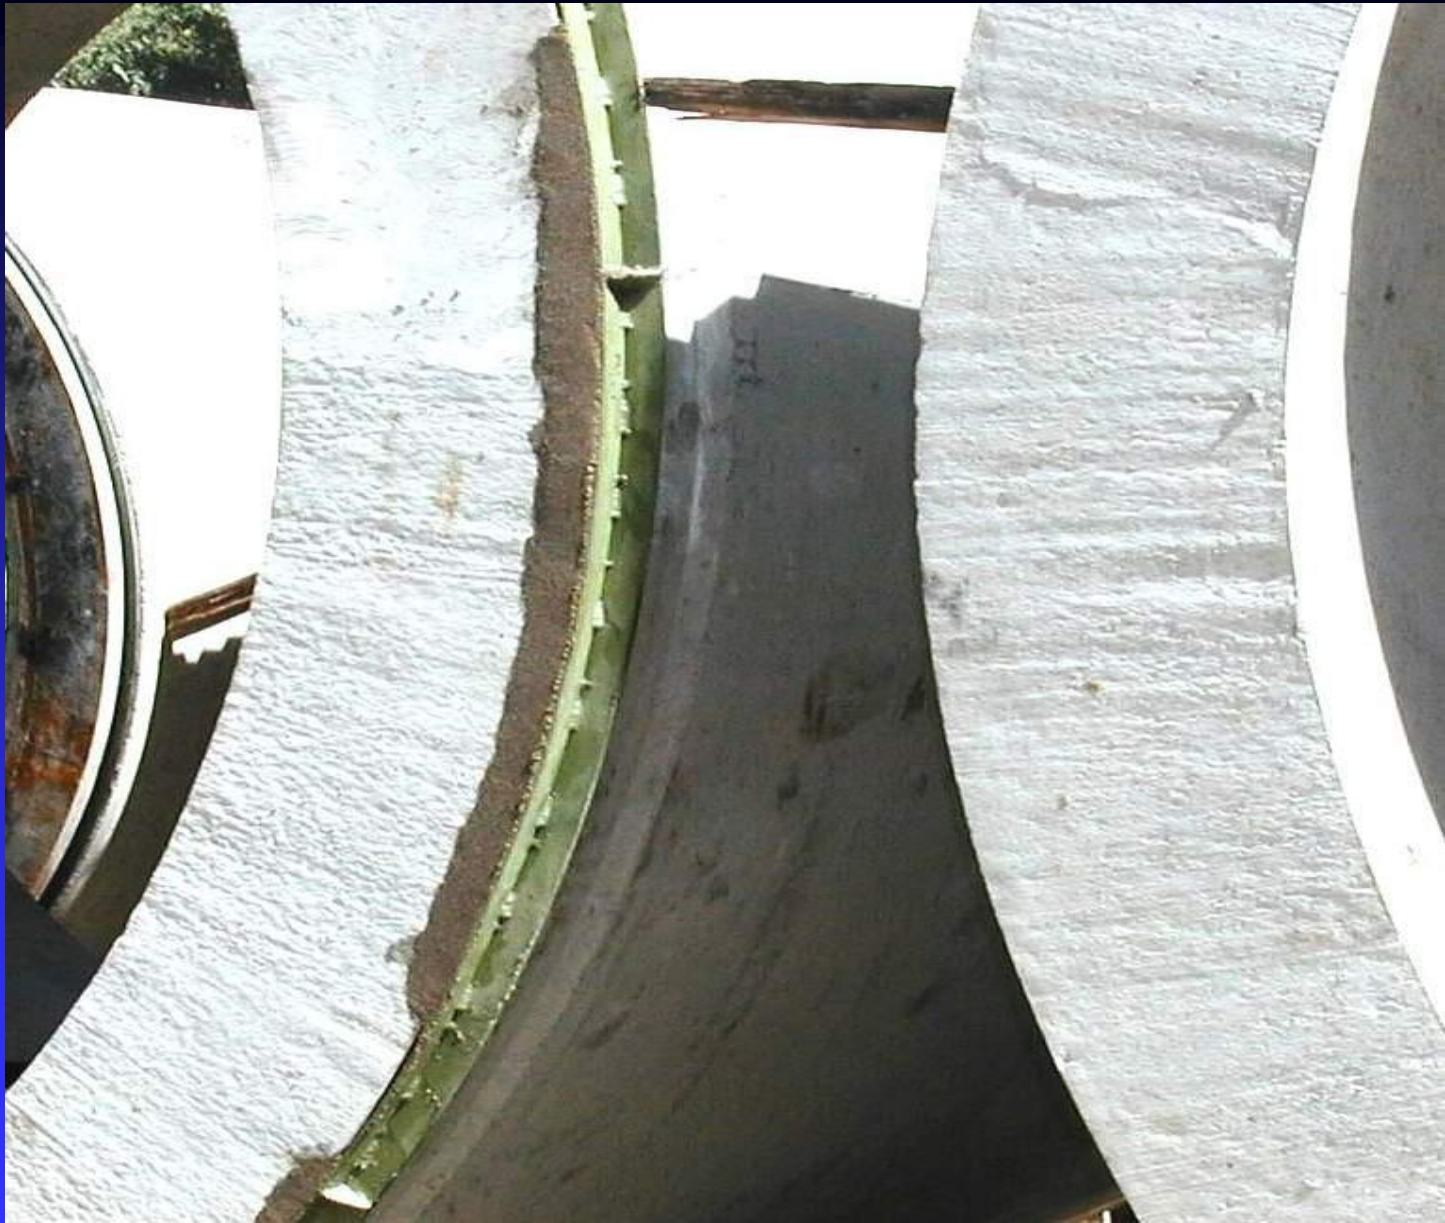
REPAIR WITH EPOXY MORTAR

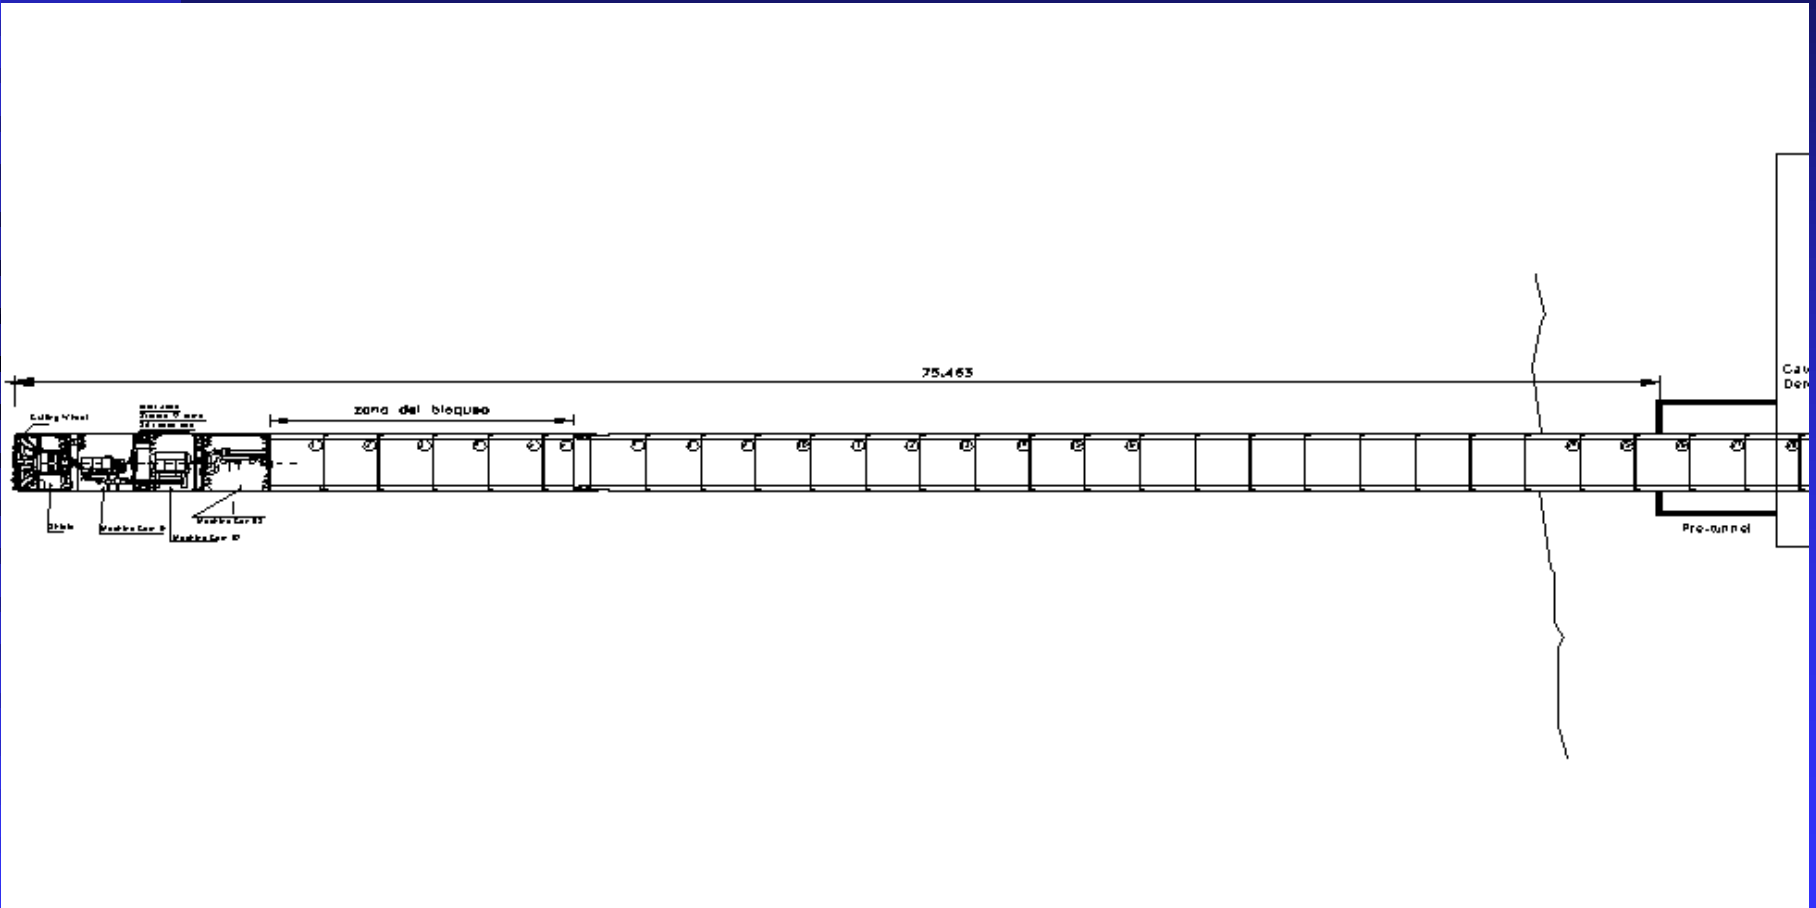
- **The advance in Tunnel #1 suddenly stopped after approx. 60 meters from the cavern on the right bank.**
- **The blockage was limited to 5 pipes behind the machine, between the inter-jack and the machine.**
- **Blocking lasted over 60 days, all efforts by using the normal means available on the site could not move the section of the pipe and the trapped machine.**

THE LOCATION OF THE BLOCKED SHIELD GRAPHIC SCHEME

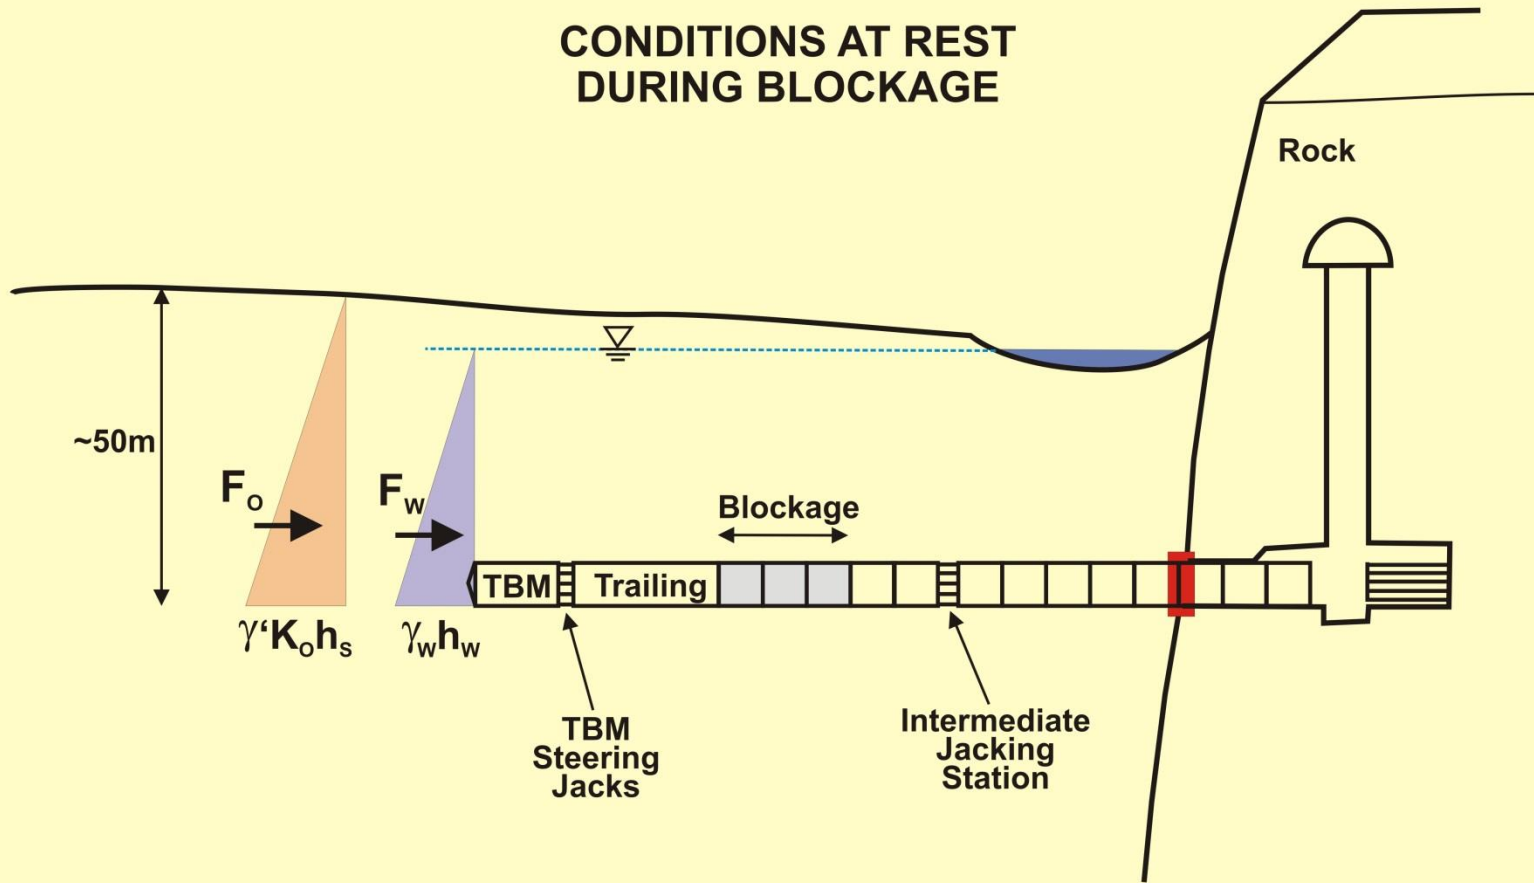
CONDITIONS AT REST DURING BLOCKAGE

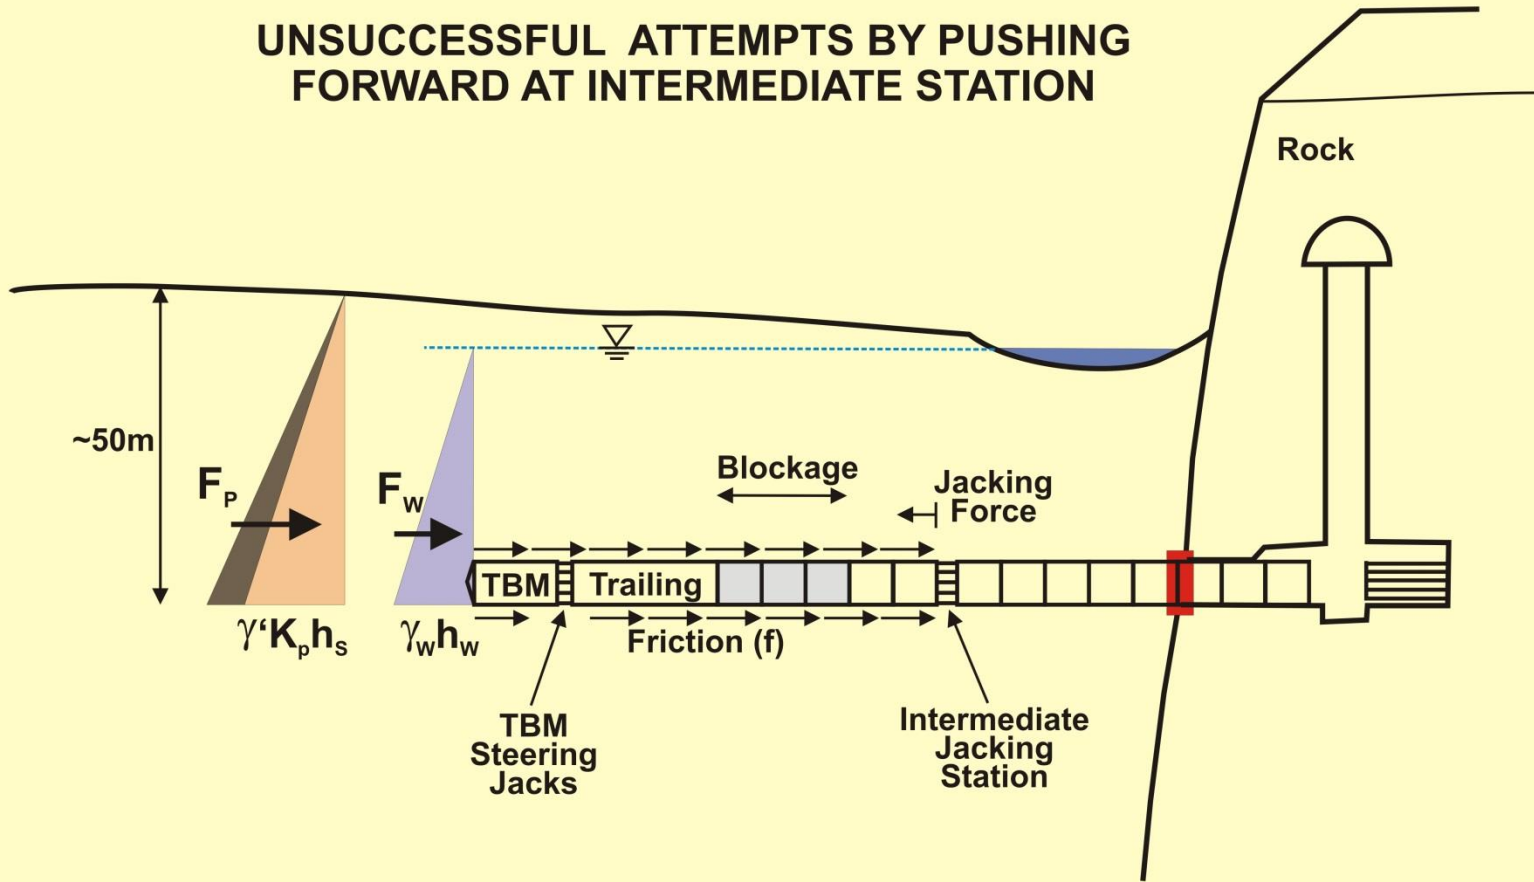
UNSUCCESSFUL ATTEMPTS BY PUSHING FORWARD AT INTERMEDIATE STATION

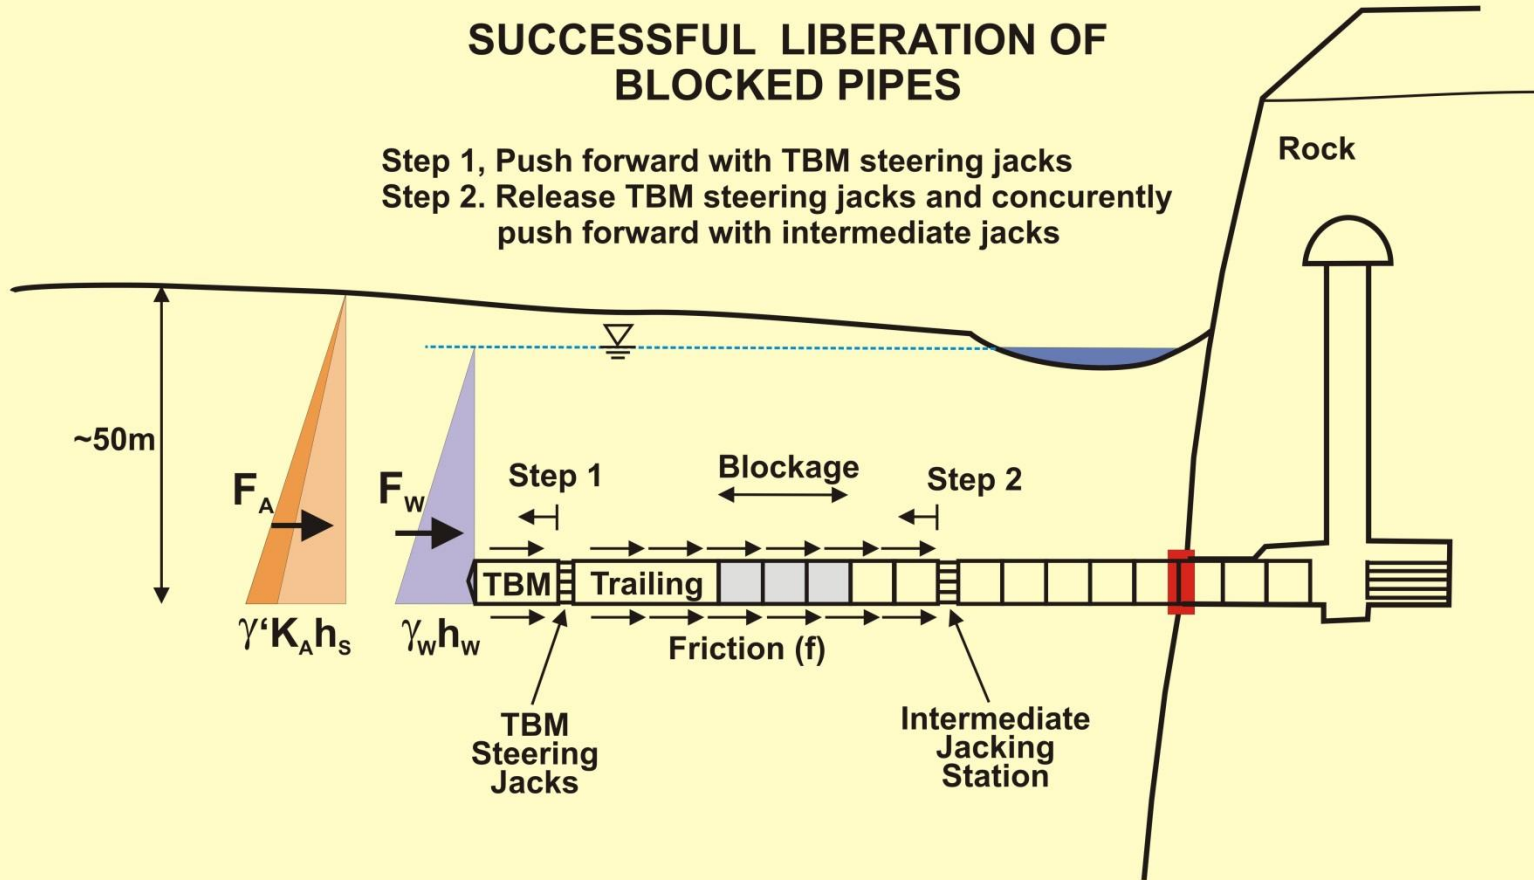
SUCCESSFUL LIBERATION OF BLOCKED PIPES

Step 1, Push forward with TBM steering jacks
Step 2. Release TBM steering jacks and concurrently
push forward with intermediate jacks

- The combined efforts of improvement of the bentonite slurry (Mr. Lyon), and the assistance of Mr. Abbott's Jason Co., helped release the machine.
- The tunnel was finally completed on 17 November, having been started in late August.

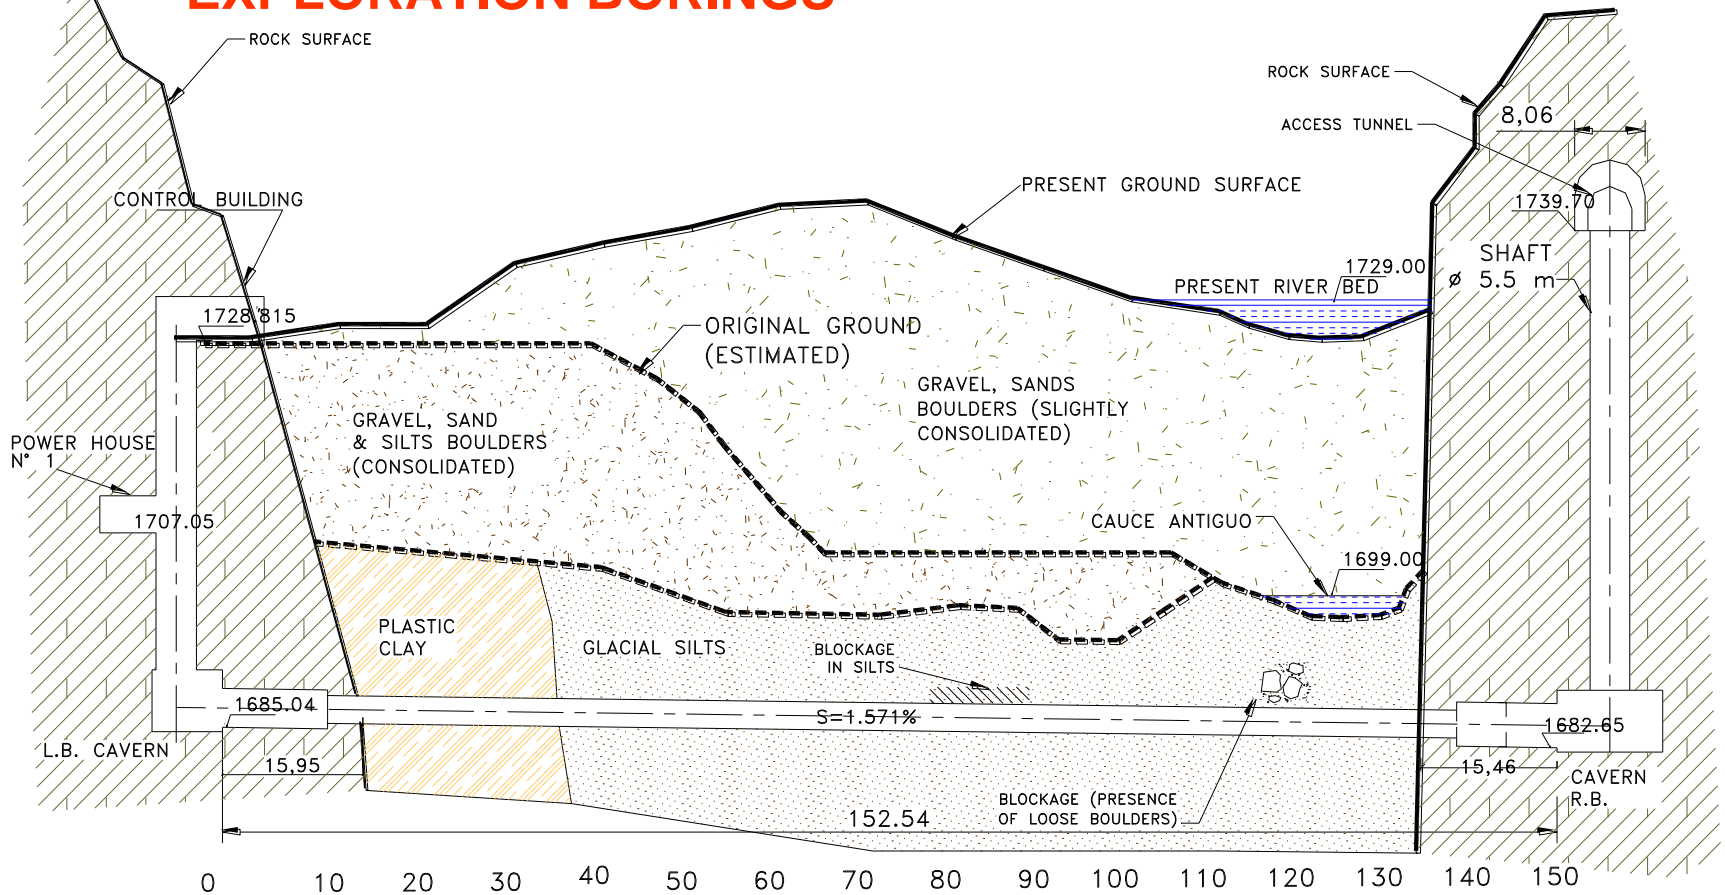
- **Findings from the exploratory program include:**
 - ◆ **The soil mass consists of fine, flowing and unstable glacial sediments.**
 - ◆ **The material behaves as a liquified sand as the shield advanced, flowing like a dense, viscos fluid.**
 - ◆ **The mass adheres very strongly on the porous surface of the concrete.**
 - ◆ **The friction force of this material exceeded the total available thrust force.**

THE GEOLOGIC SITUATION AFTER THE DEVELOPMENT OF EXPLORATION BORINGS

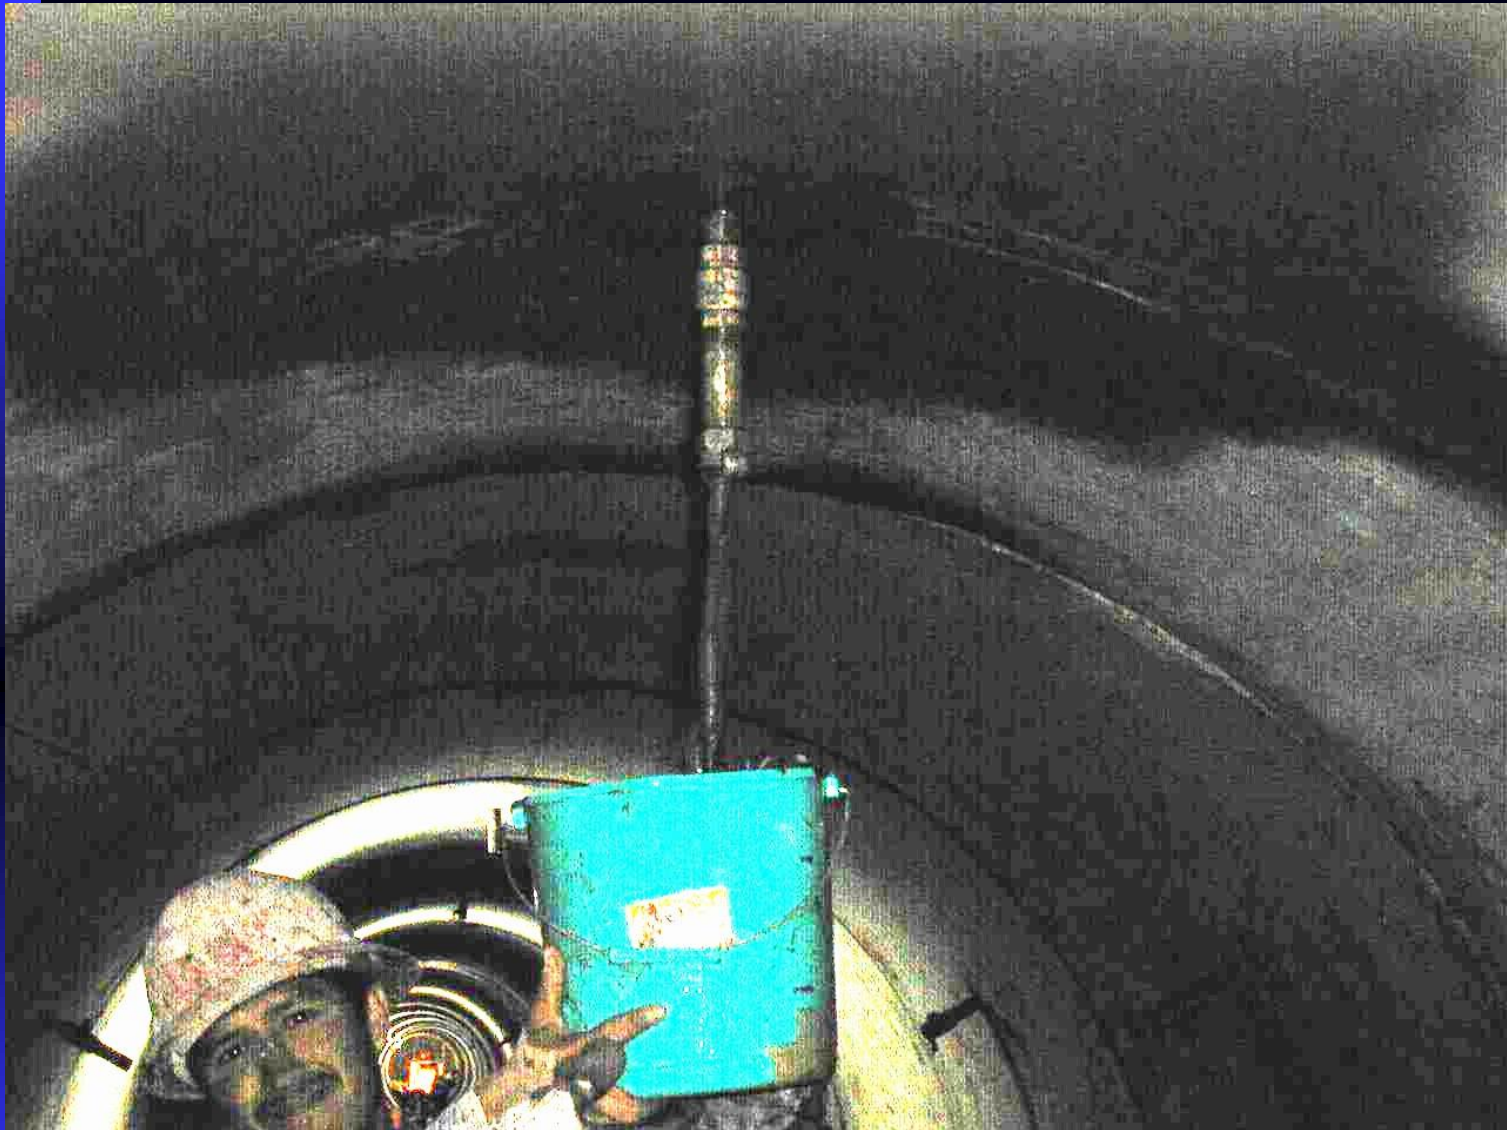
LIQUIFIED SILT FLOWING THROUGH THE INJECTION PORTS

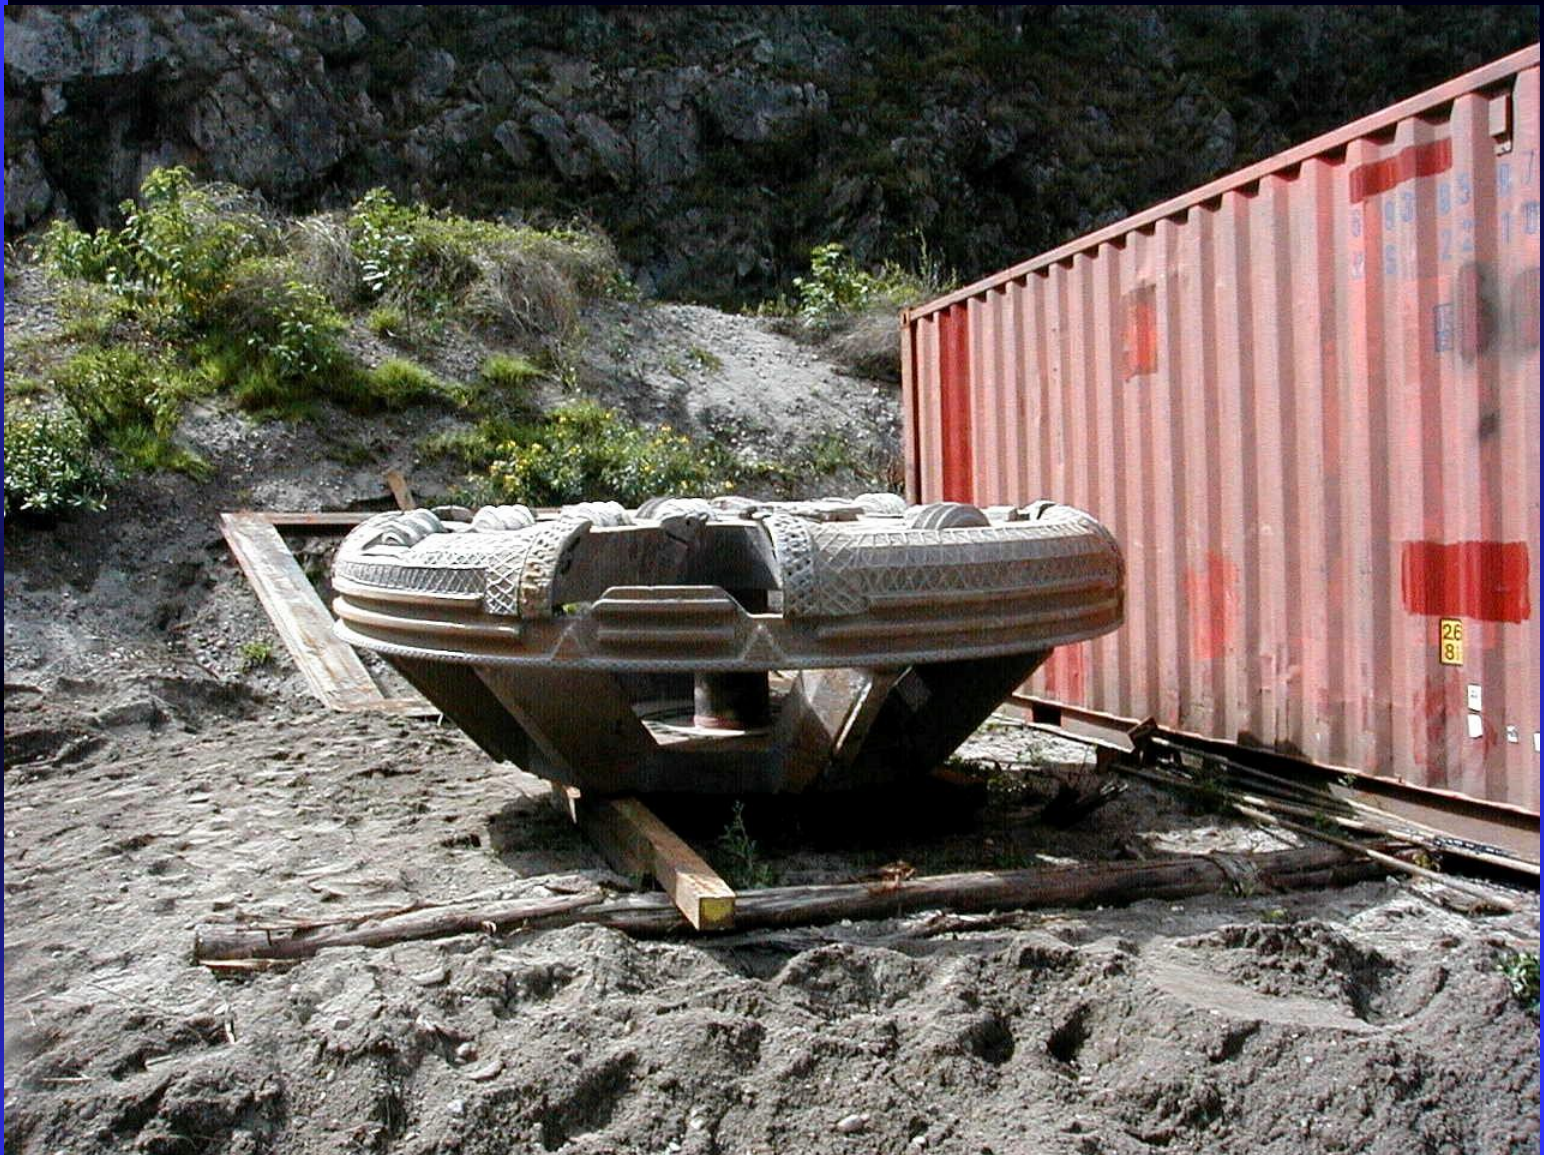
AFTER THE INCREASE IN DIAMETER CUTTING HEAD

- **The following mitigating measures were adopted:**
 - ◆ **Install three injection ports in all pipes.**
 - ◆ **Coating of the pipes with waterproof and durable coating.**
 - ◆ **Increase the diameter of the cutting head by 1 inch.**
 - ◆ **Improve the force available in the station's main thrust.**

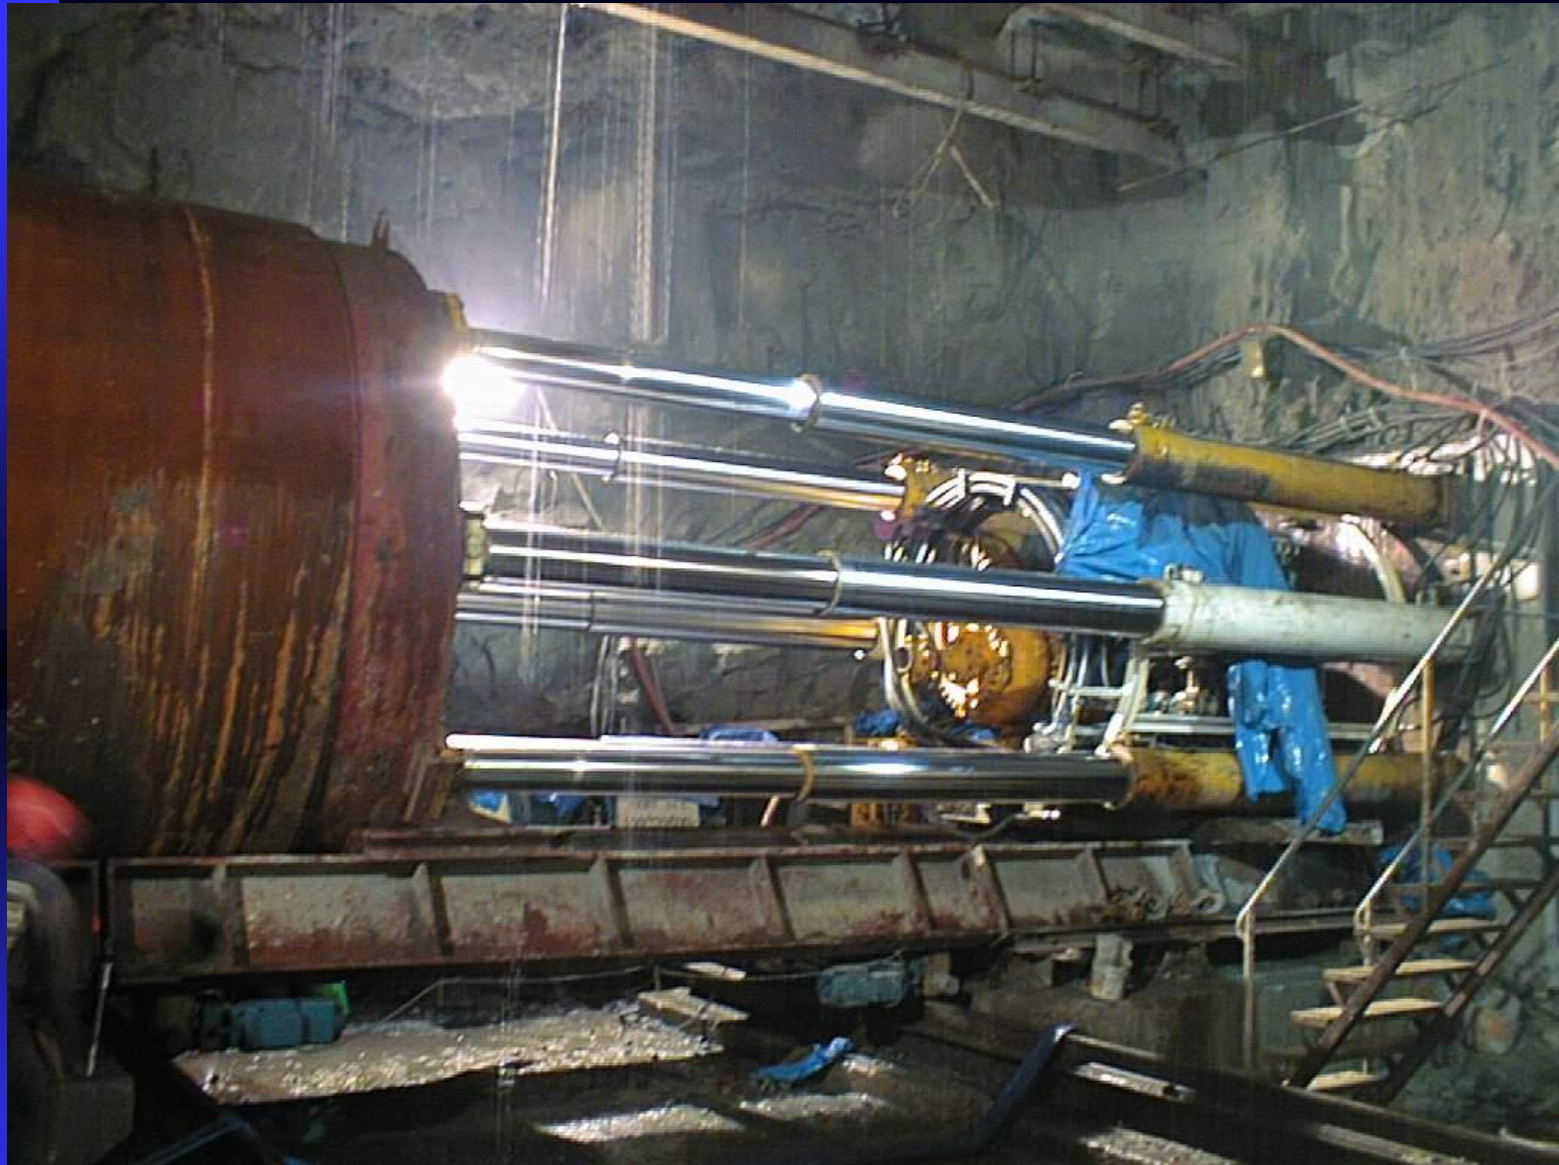
IMPROVEMENT OF THE MAIN STATION OF THRUST
