# **Geosynthetic Reinforced MSE Wall Failures and Their Remediation**

**Bob and George Koerner  
Geosynthetic Institute**

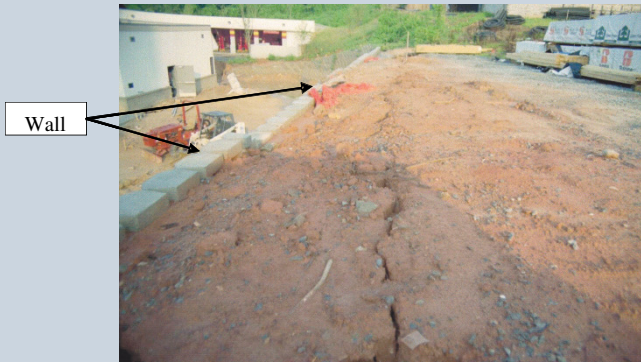
Tension Crack

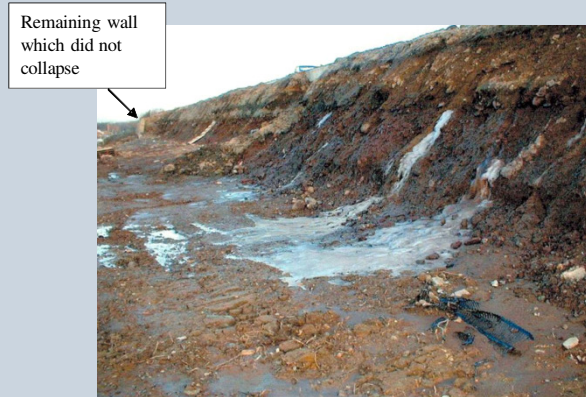
Ret. Zone Water

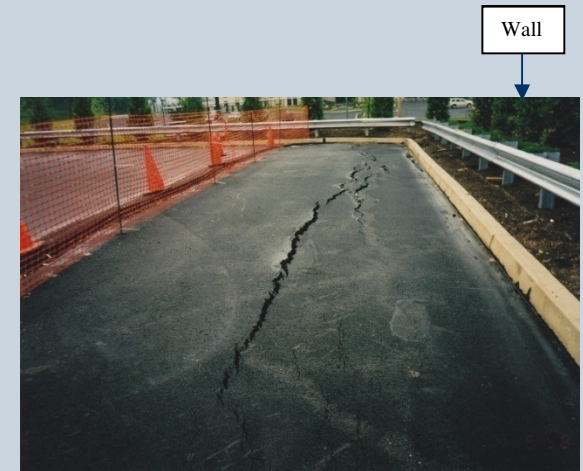
Tension Crack

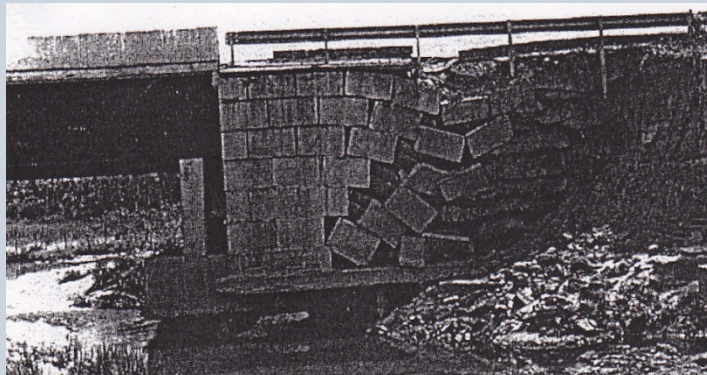
Adjacent Stream Washout

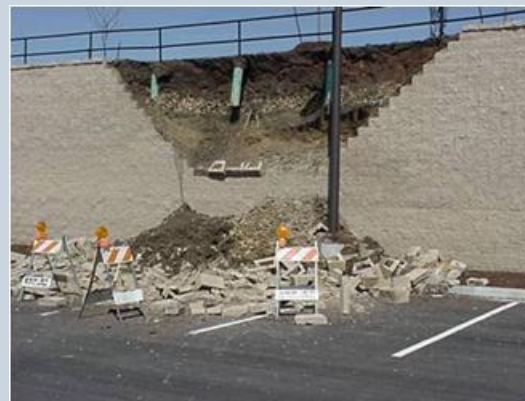
Tension Crack Behind

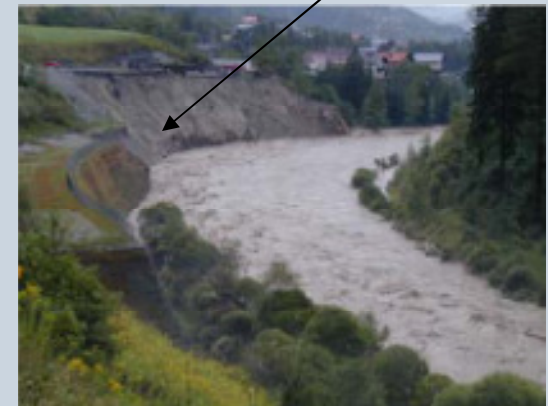
Adjacent River Flood

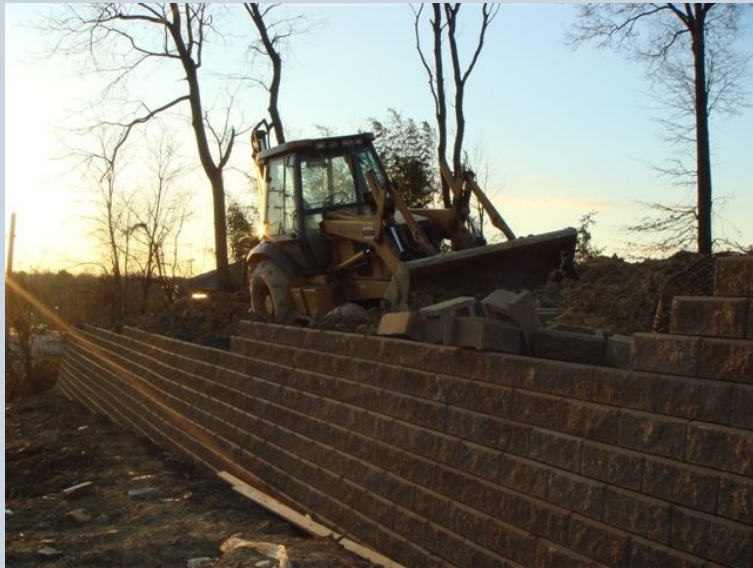
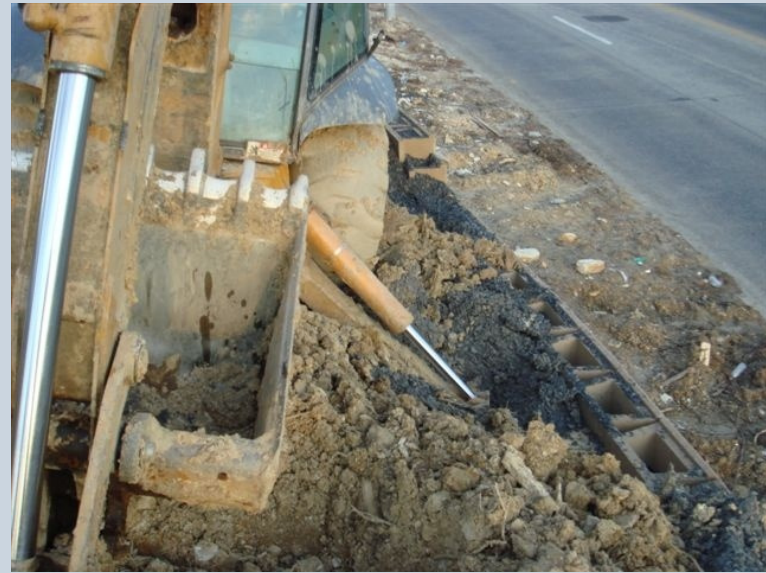
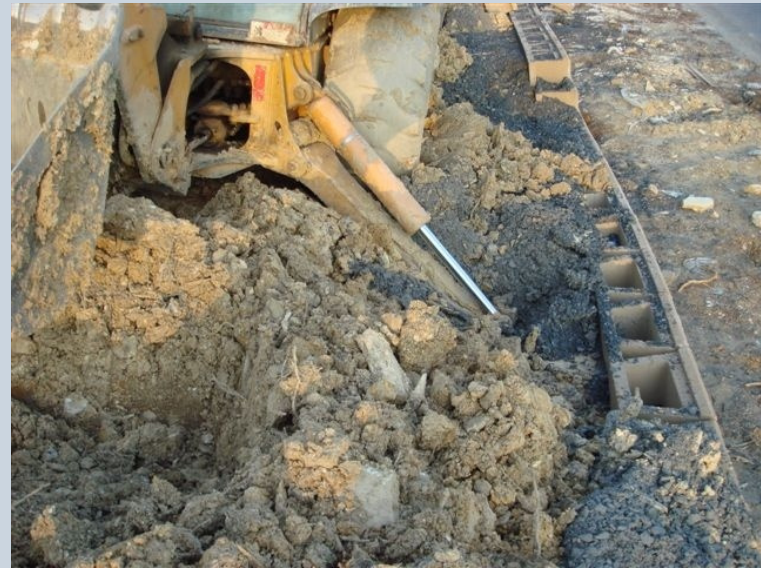
If no one watches, this is what you get; Photos by A. Filshill

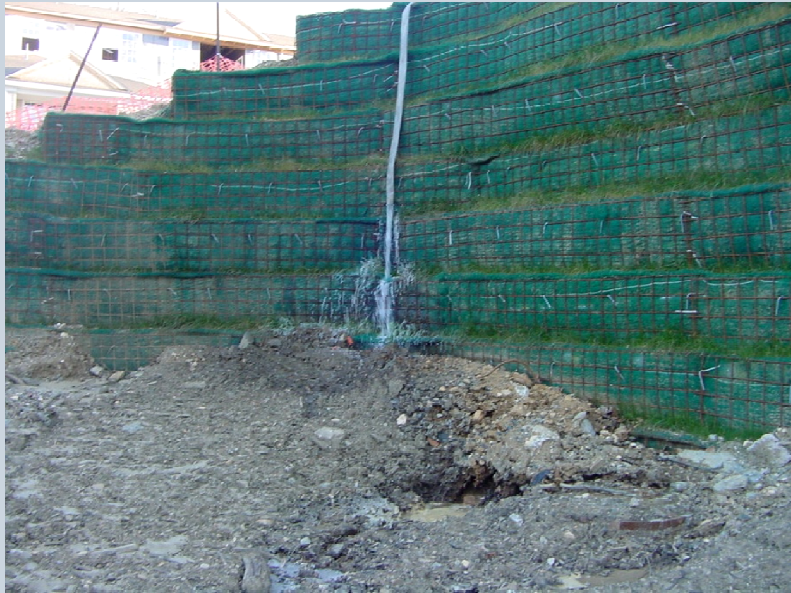
This redirection of surface water flow also avoids this from occurring.....  
(compl. A. Filshill)

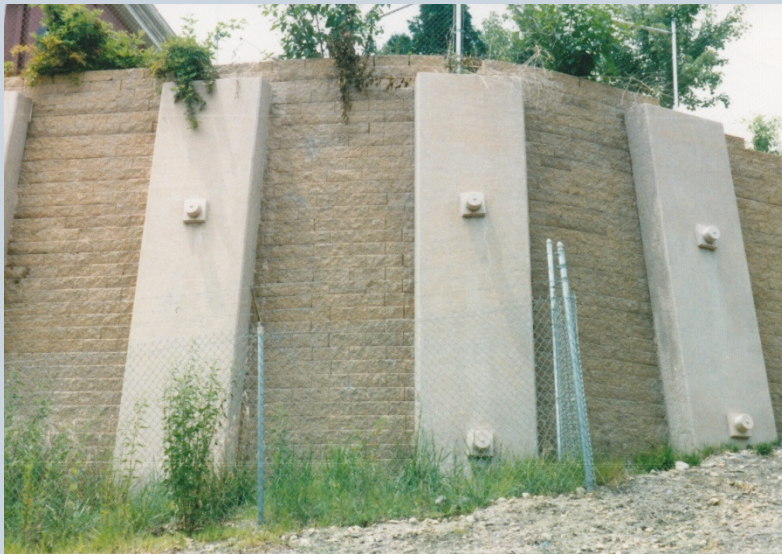
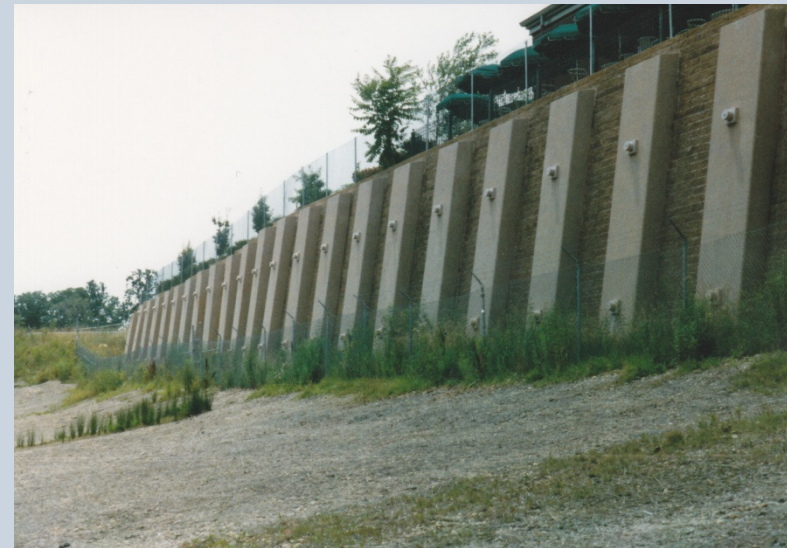
# Wall Remediation Using Ground Anchors and Reinforced Concrete Pilasters

- 9.1 m high masonry block wall
- bulged in lower and central sections within six months of construction
- ML-CL backfill soil, poorly compacted
- remediated by using ground anchor tendons attached to massive concrete pilasters

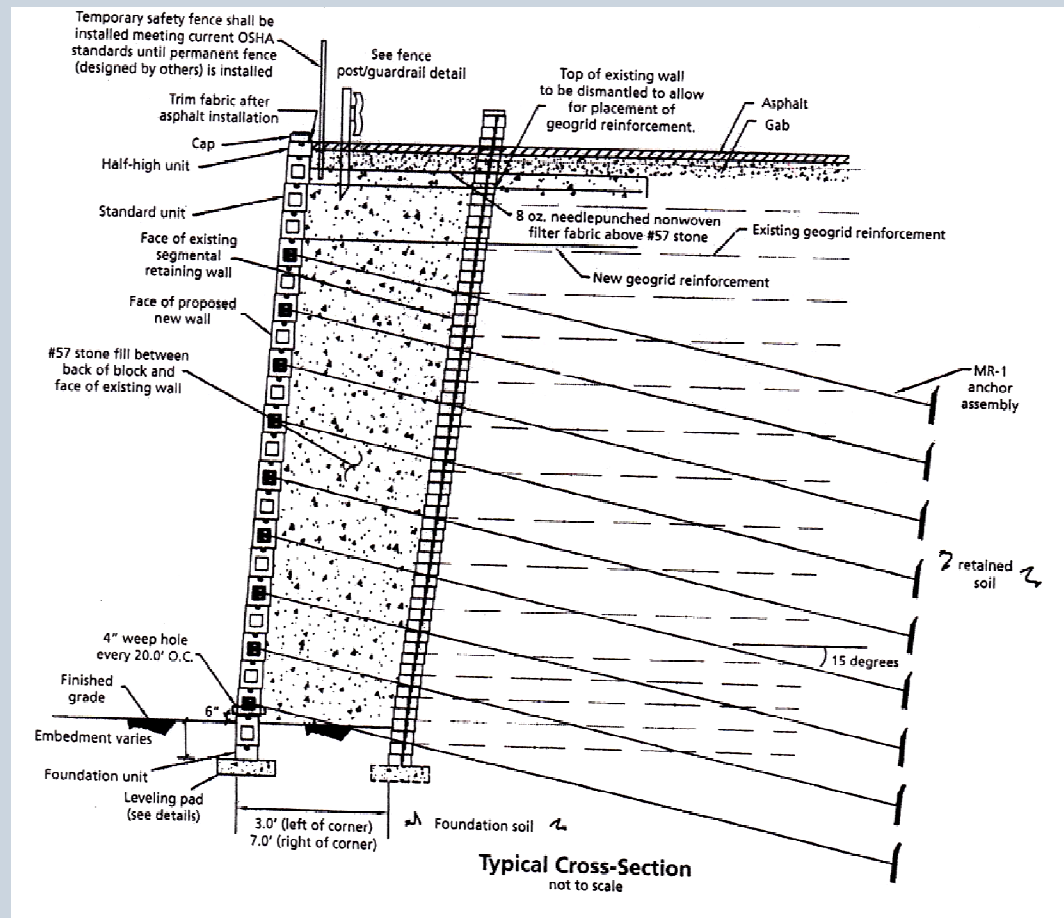
# Typical Cross-Section of Original Wall and its Newly Constructed Support Wall (after, Paulson, GFR, 2002)

- 9.1 m high masonry block wall
- small section collapsed after two years
- section rebuilt and entire wall stabilized
- ML-SP backfill soil, poorly compacted
- geogrids were laid out incorrectly
- rainfall triggered instability
- ground anchor (type?) tendons tied to H-beams within new facing

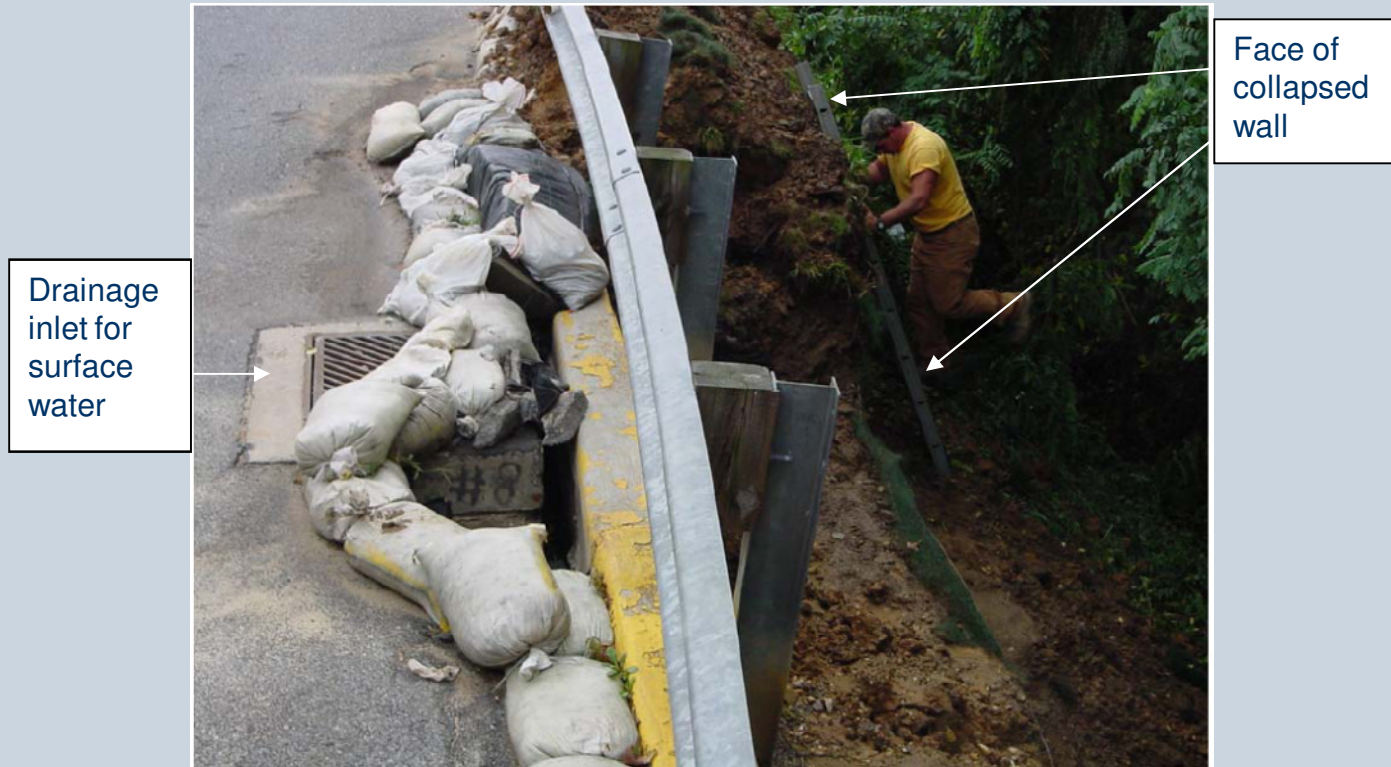
# Drainage Inlet (Catch Basin) Located in the Reinforced Soil Zone of Collapsed Wall

- 4.6 m high masonry block wall
- partial collapse after eight years
- ML-CL backfill soil; poorly compacted
- internal water from leaking catch basins
- remediated using gabions with duckbill anchors at end of driven tendons

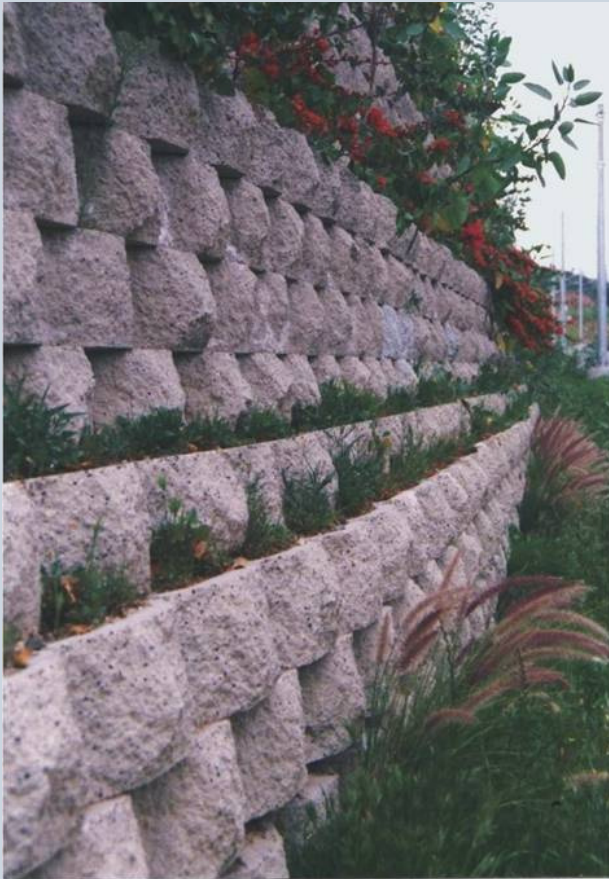
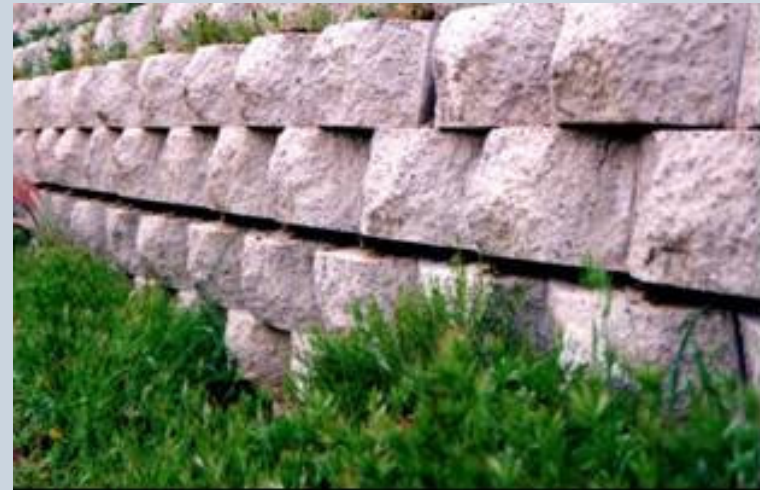
# Evidence of Horizontal Sliding Wall Sections

- 4.6 m high masonry block wall
- deformed after two years
- bulging first; then horizontal sliding
- cause attributed to rainfall events
- stabilized using grouted soil nails and reinforced shotcrete at face

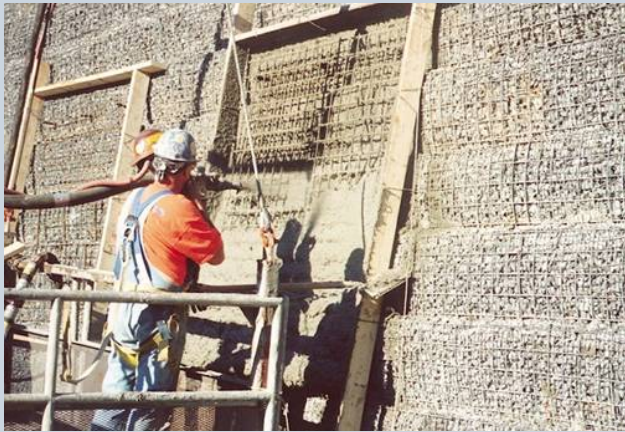
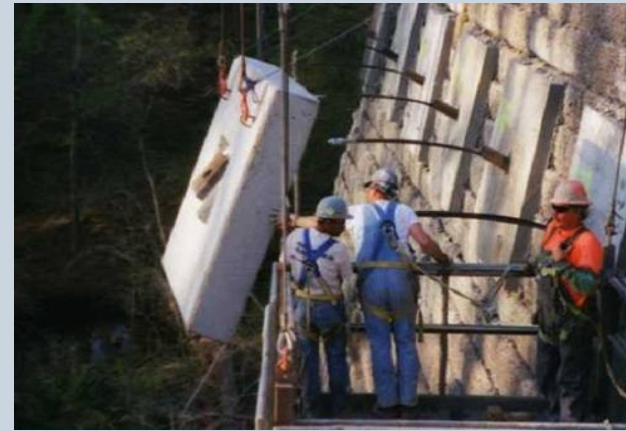
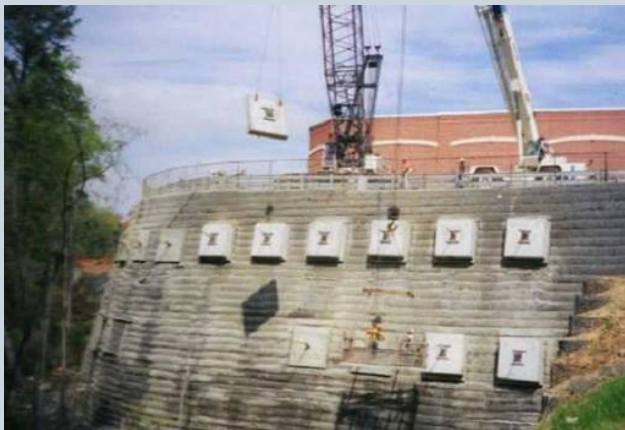
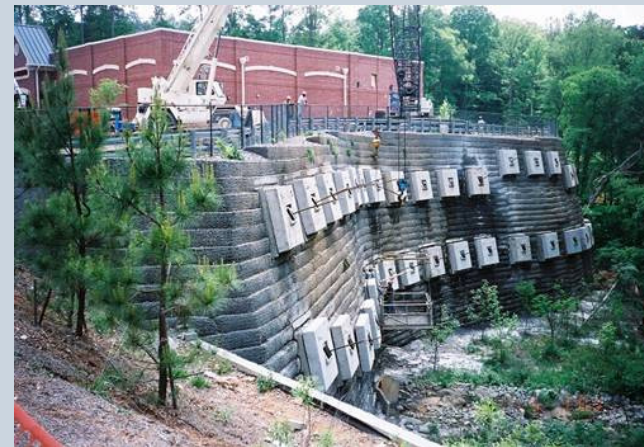
# Remediation Scheme Used to Stabilize Deforming WWM/GG Wall

- 16.5 m high masonry block wall
- >>150 mm deformation after two years
- internal water pressure from drainage system located within reinforced zone
- deformations correlated to rainfall events
- grouted soil nails against concrete panels
- complex and costly wall stabilization

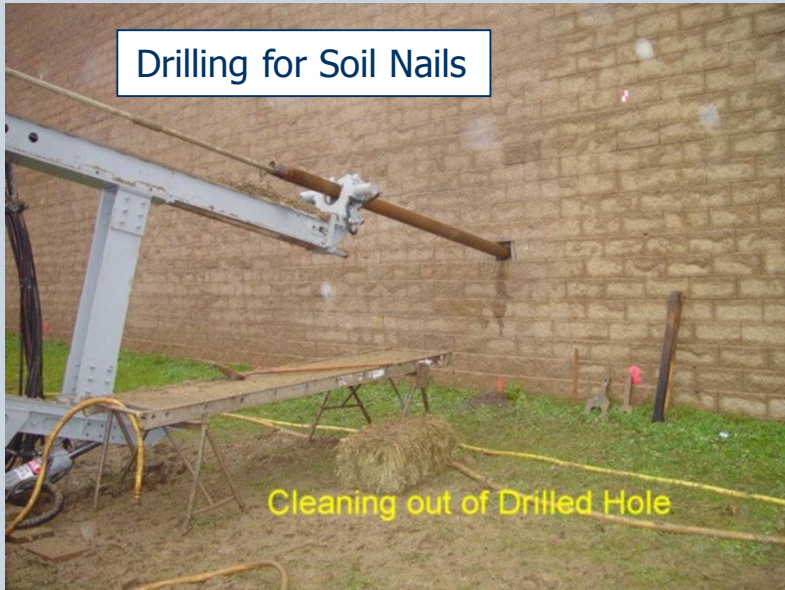
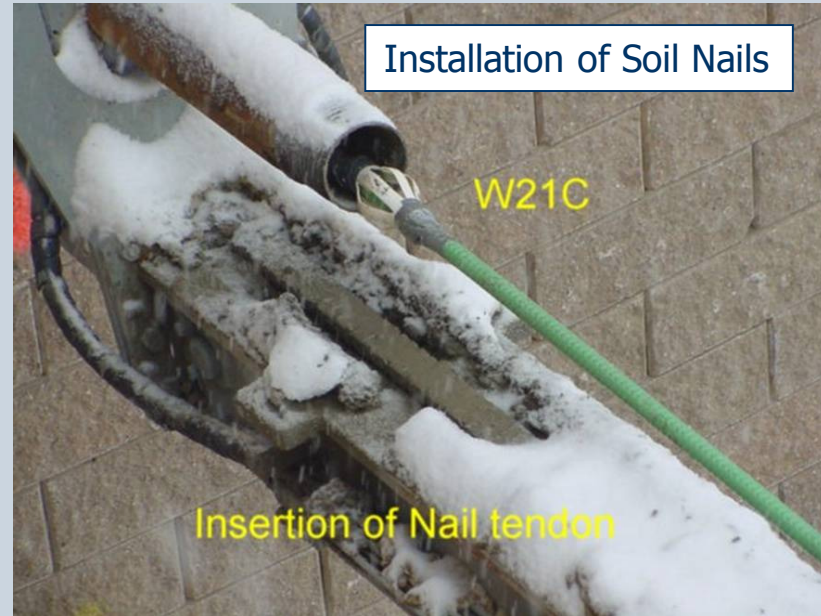
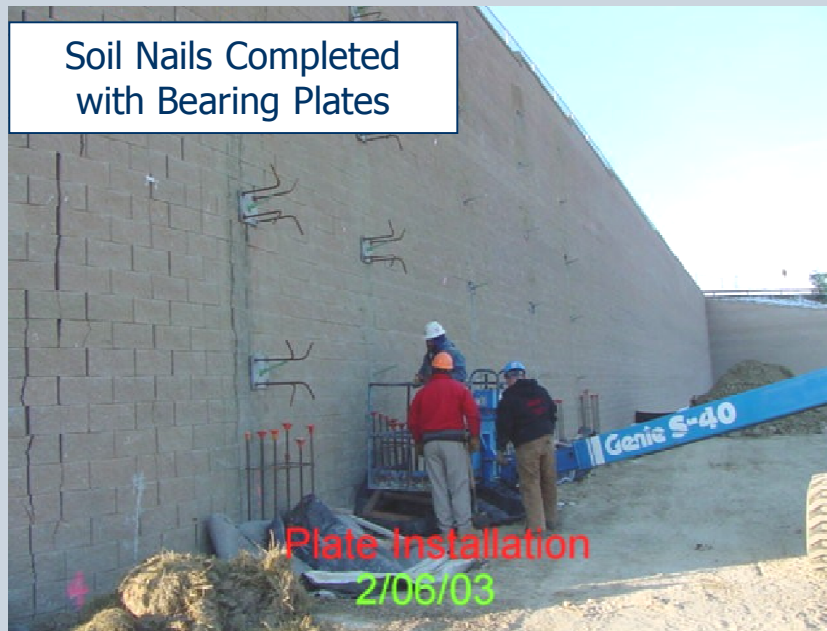
- 11.6 m high masonry block wall
- deformed after 18-months service
- blocks were constantly wet
- ML backfill soil; moderate compaction
- homogeneous HDPE geogrid reinforcement
- tension cracks behind reinforcement
- grouted soil nails attached to concrete pilasters

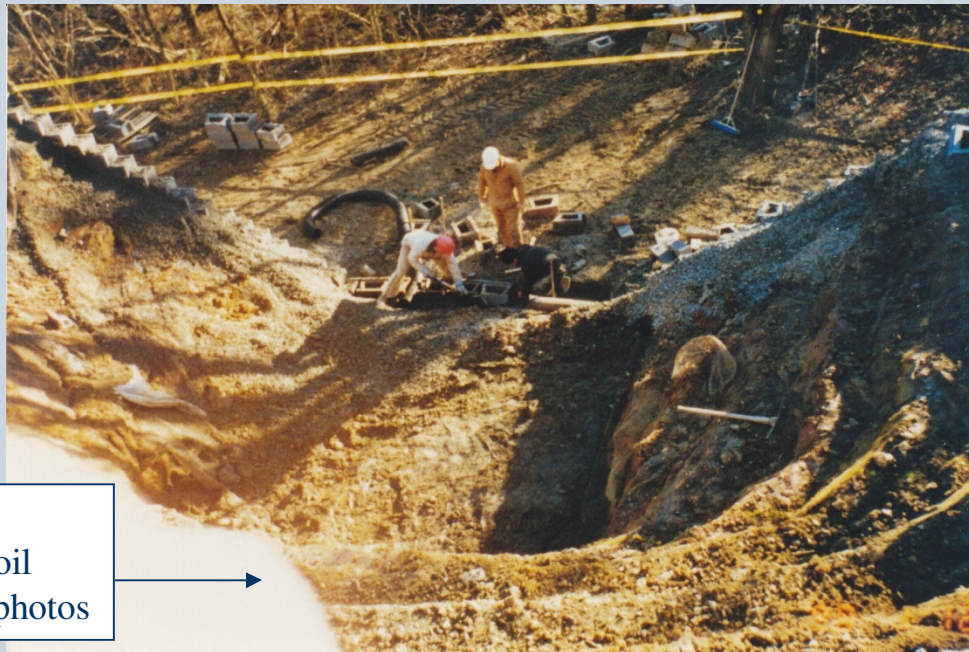
# Collapsed Wall Rebuild with Shotcreted Retained Soil Zone for Stability

- rebuild is usually using sandy gravel backfill soils with good compaction
- concern is over steep backslope stability, i.e., workers' safety and OSHA
- this wall had internal drainage problems

shotcrete  
retained soil  
(see next photos)
