Failures of Helical Pile and Helical Anchor Projects and Associated Lessons Learned

Howard A. Perko, Ph.D., PE
Magnum Geo-Solutions, LLC

Abstract

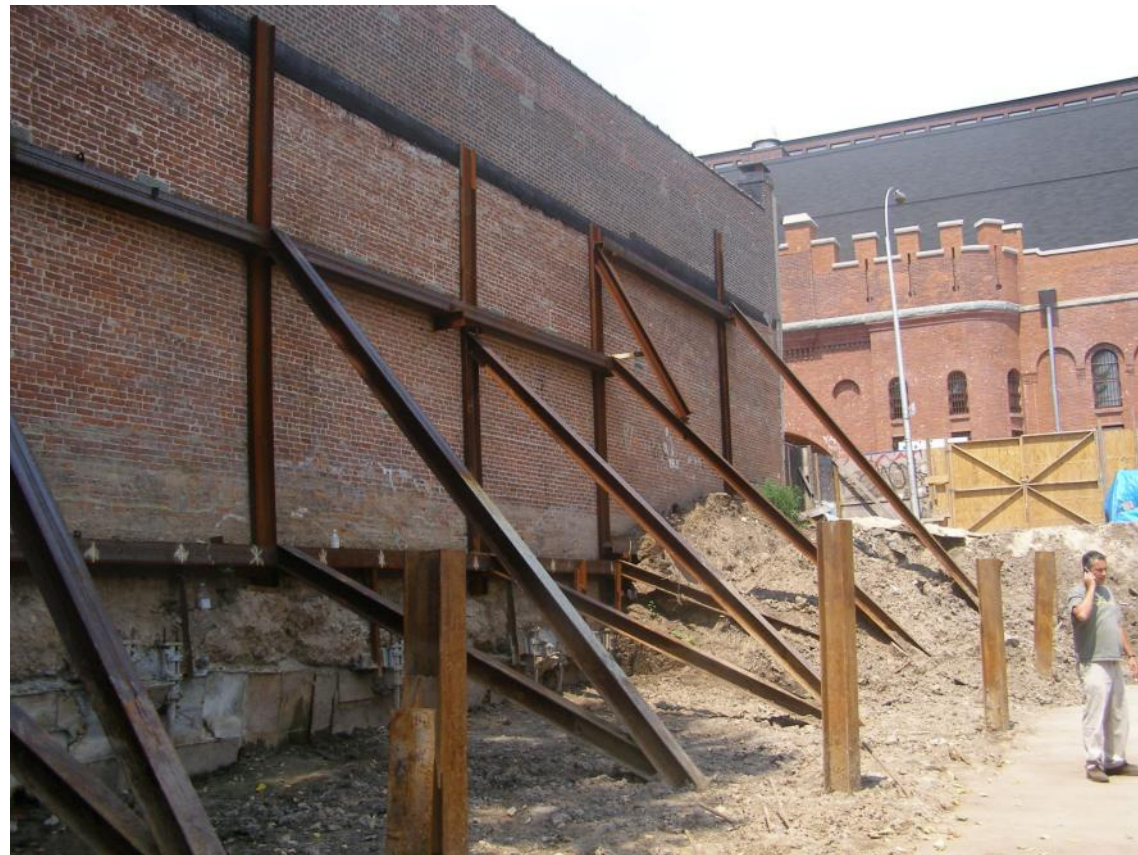
- Helical piles were installed to reduce settlement during conventional concrete underpinning
- Footing rotated, piles buckled, and building settled severely
- Photo shows supplemental raker bracing system installed with deadmen after settlement

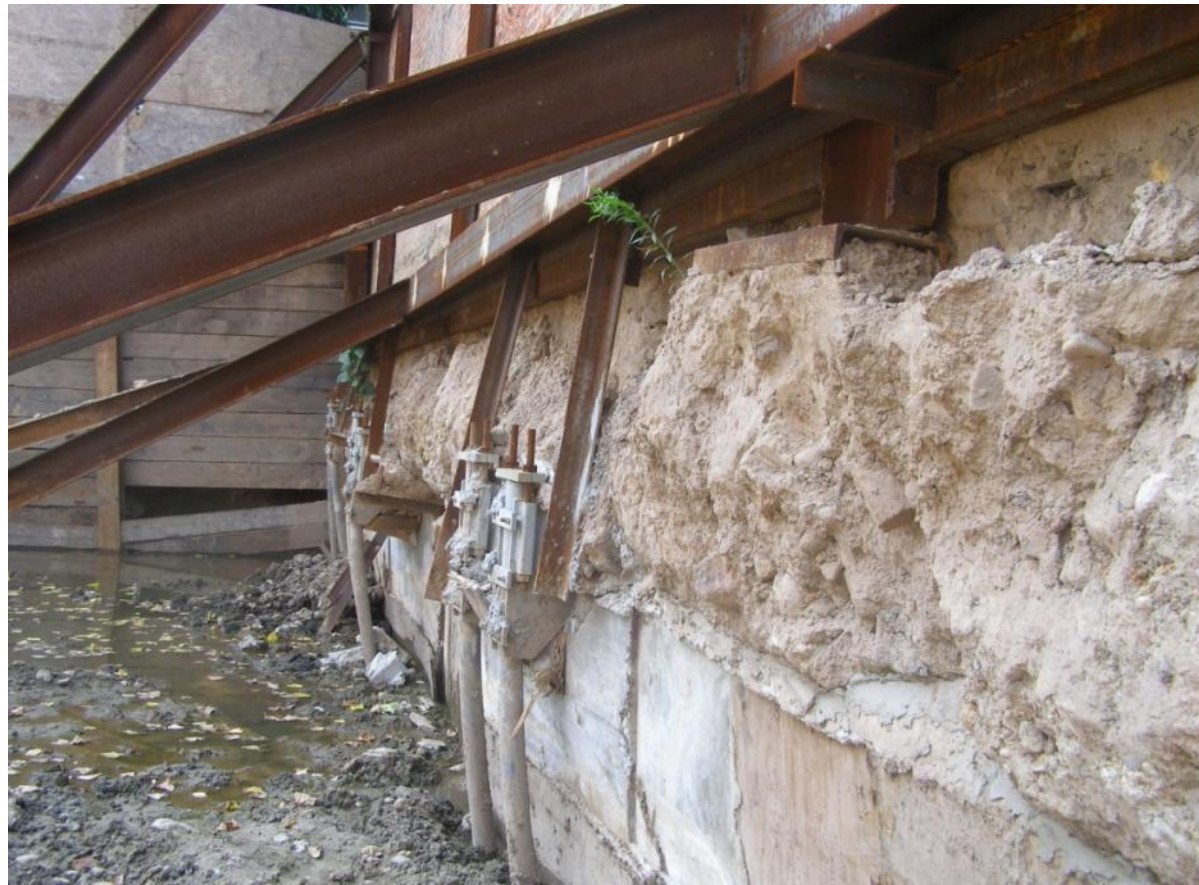
- Photo shows buckled pile and bracket system
- Helical piles were 1-3/4" square shaft with reinforcing sleeves
- All piles were installed along the outside of the building
- This and a similar failure were catalysts to a nearly 2 yr moratorium on helical piles in NYC

Potential Cause of Failure

- Failed to follow existing code provisions regarding stability and bracing of the tops of piles

Per IBC2006: 1807.2.4 Pile or Pier Stability (Similar Section in NYC BC)

- All piles shall be braced for lateral stability
- Three or more piles per cap is considered braced
- Piles staggered under a wall are considered braced
- Otherwise provide engineered means of lateral bracing

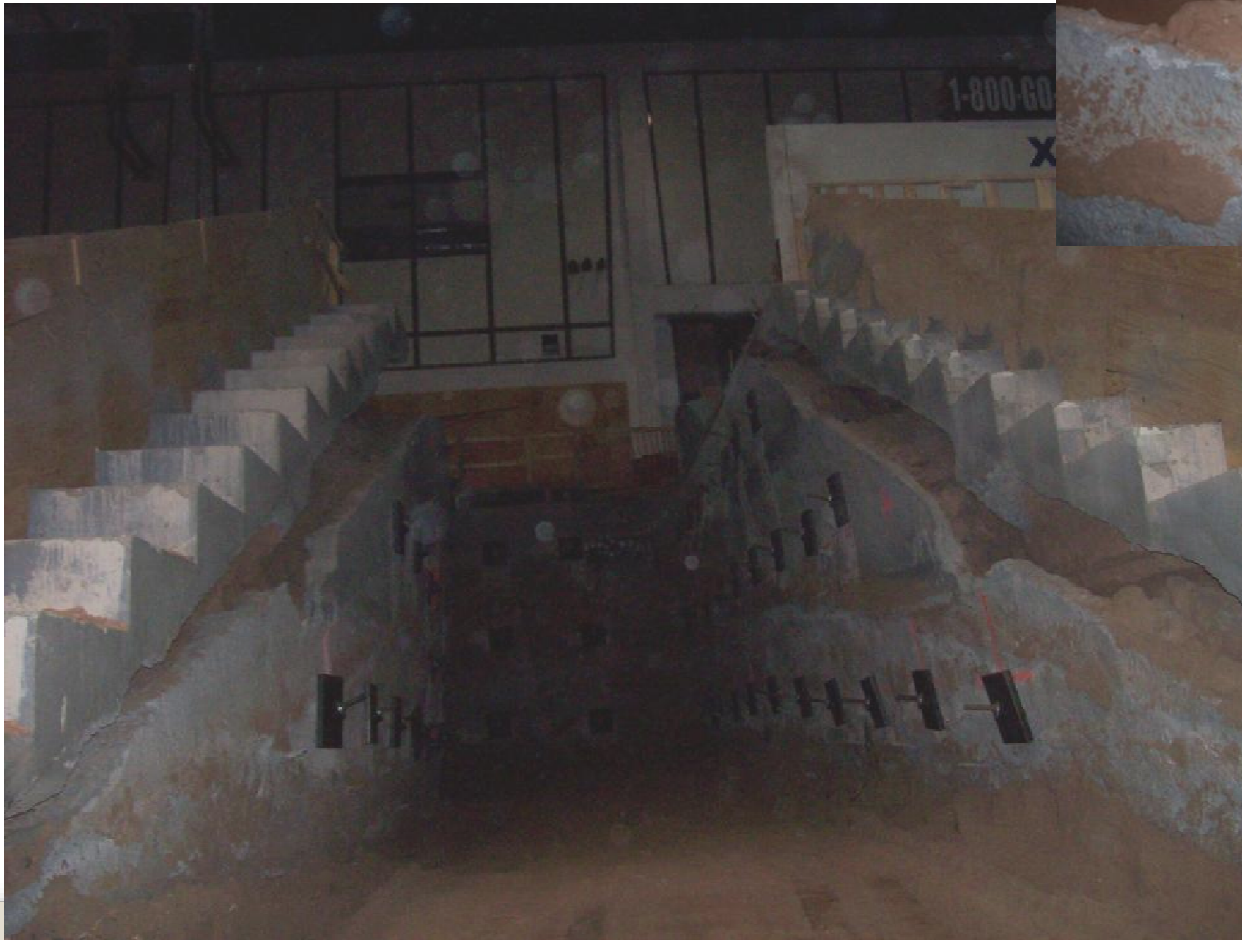
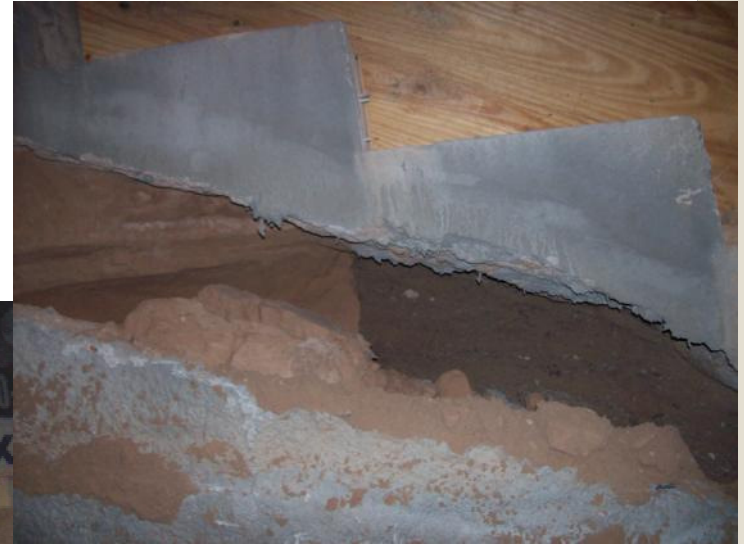
- 3 rows of helical soil nails
- Approximately 15-foot cut between bleachers
- Reportedly a progressive failure

Potential Causes of Failure

- Misunderstanding between anchored wall and soil nail wall
- Bearing capacity failure
- Improper reinforcing steel

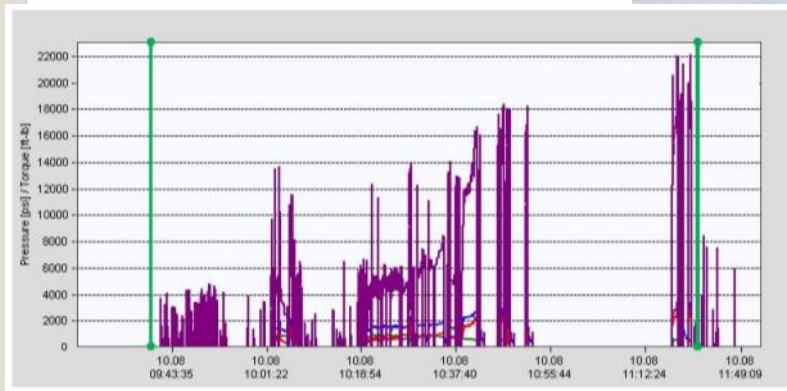
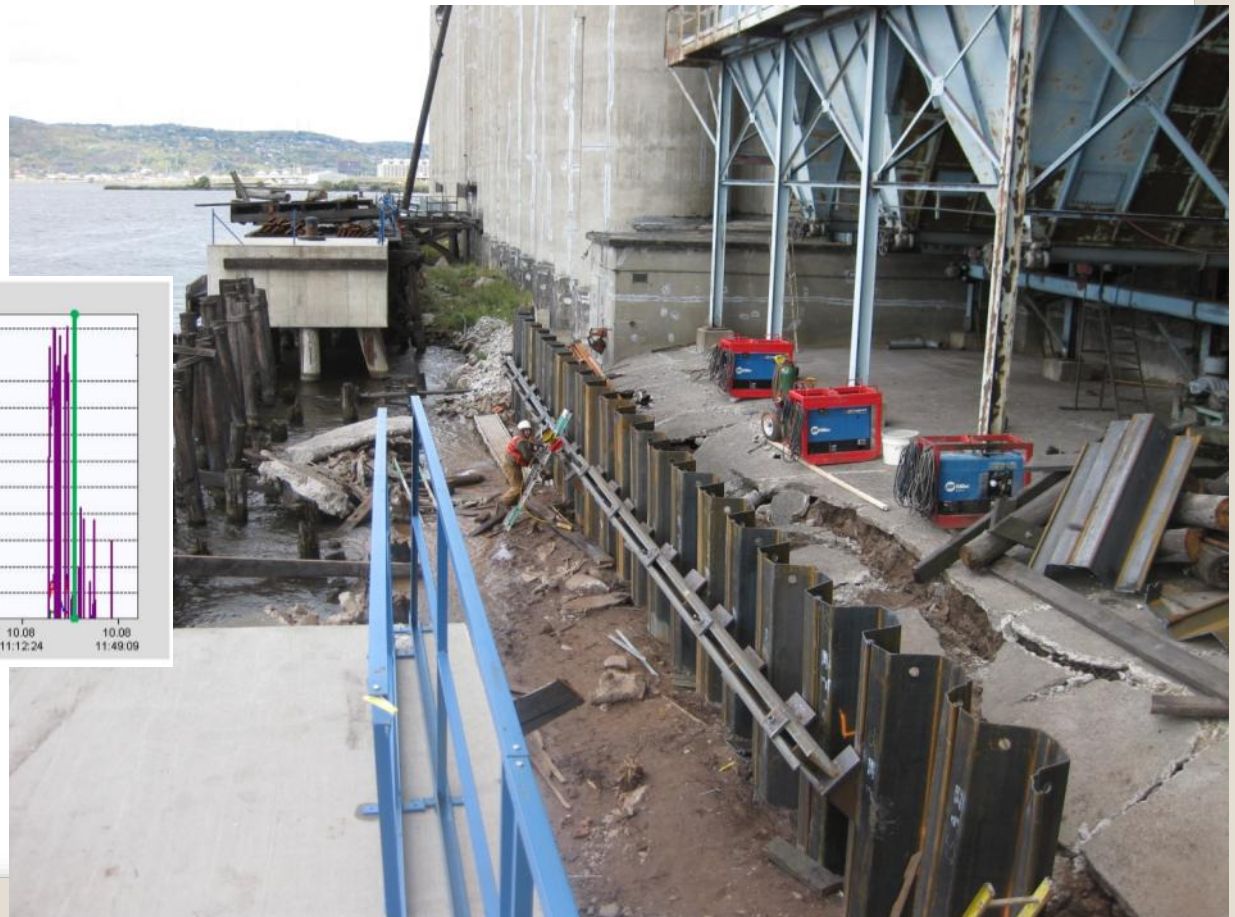
- 1 row of approximately 35' long helical tie-backs
- Continuous torque readings during installation
- Approximately 15-foot cut to removed failed timber crib wall
- All 18 helical anchors failed proof test
- Supplemental anchors based on same design methods, installed by same crew using different torque motor passed proof tests

Potential Cause of Failure

- Flawed torque motor calibration

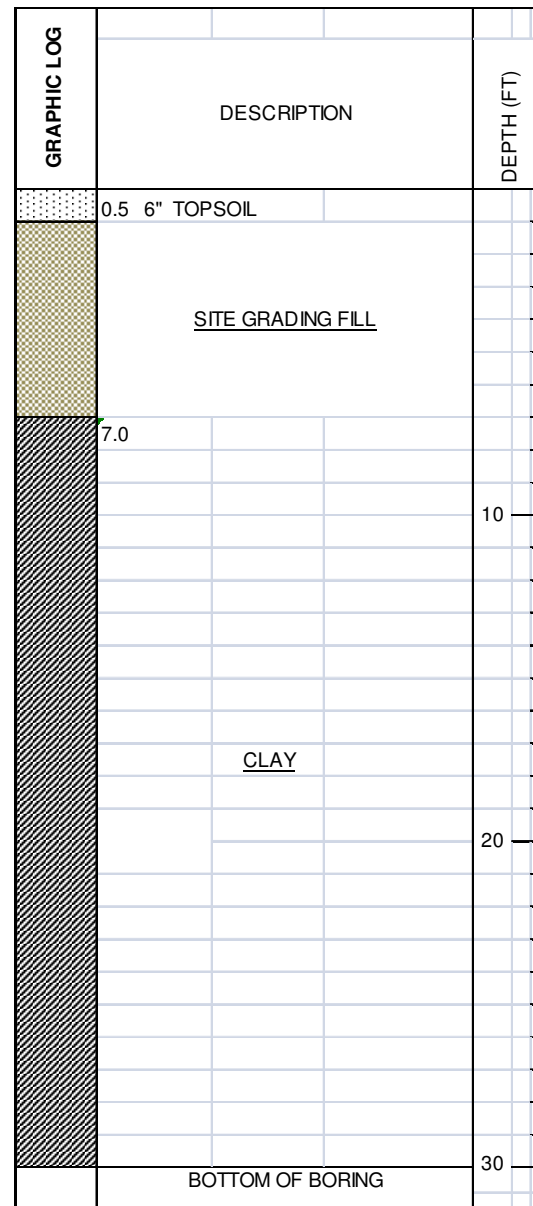
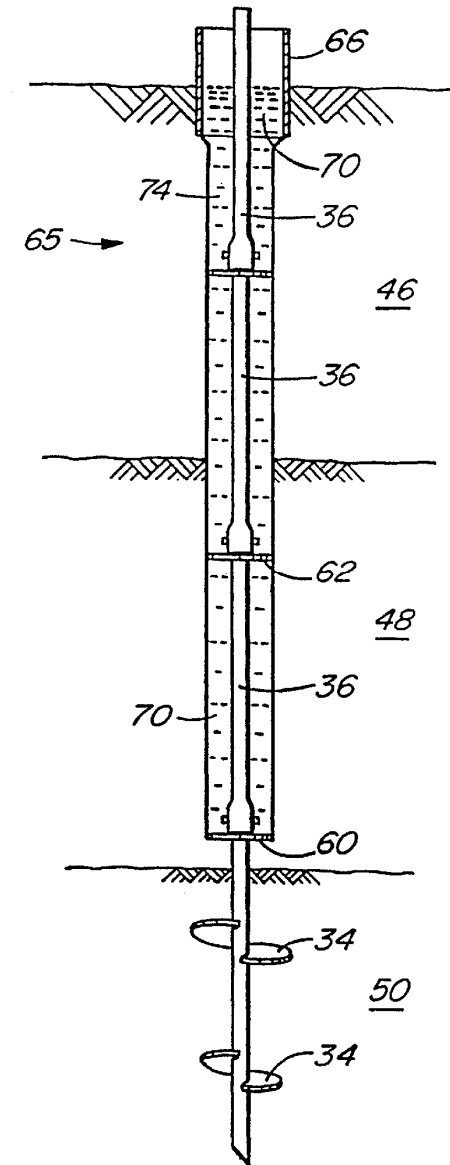
- Grouted pull-down piles
- Houses settled several inches
- Approximately 7-feet of site grading fill
- Piles bottomed in soft clay, grouted full depth

Potential Cause of Failure

- Down-drag of site grading fill on grouted pile

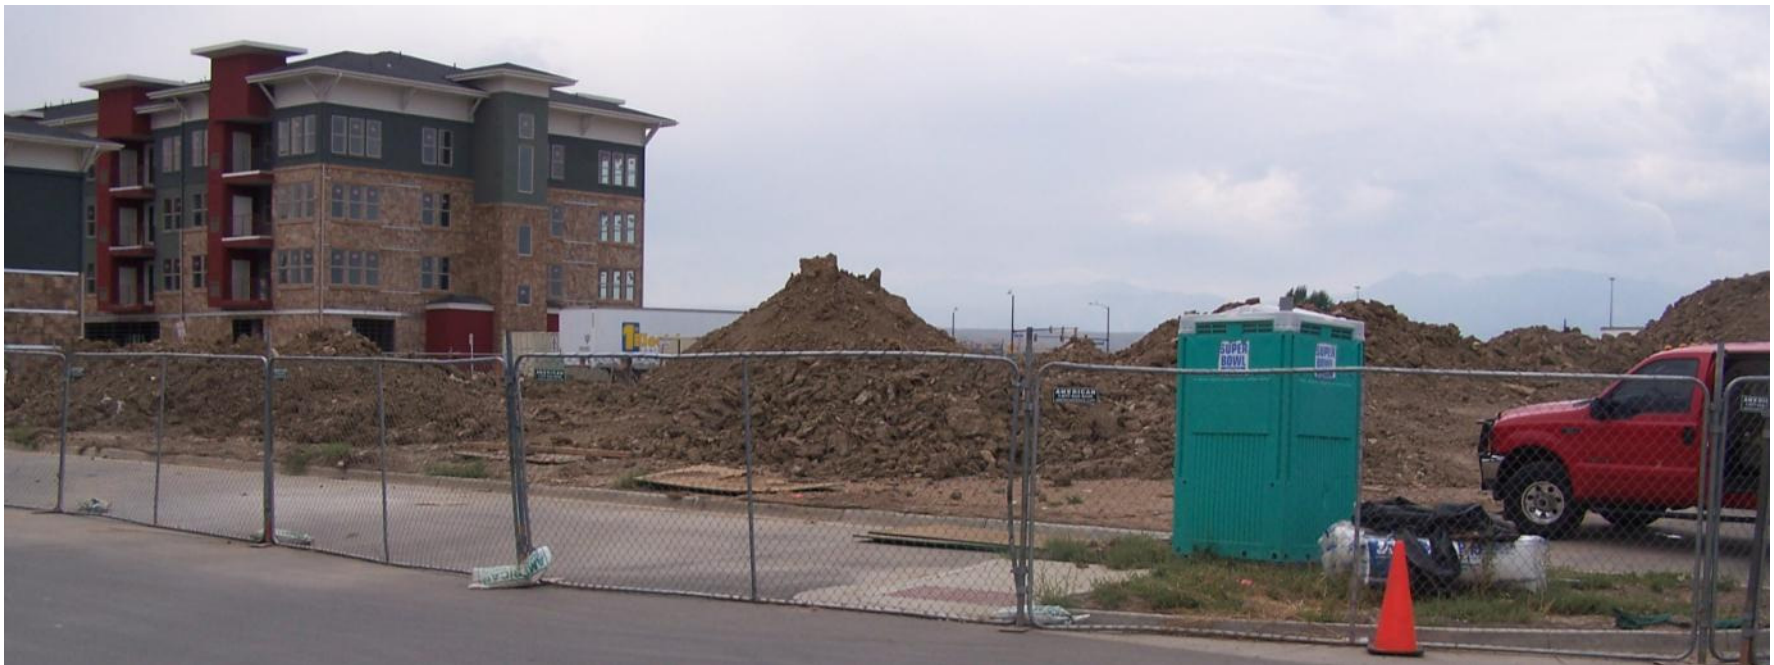
- Approximately 140 helical piles installed to support several 5-story apartment buildings
- Design load of helical piles= 45 to 65 tons
- Immediately after construction, several of the buildings exhibited settlement on the order of 4"
- Three of the buildings had to be demolished and re-built. The others were repaired by underpinning.

Potential Causes of Failure

- Non-conforming helix invalidates capacity to torque readings
- Insufficient bearing area; relied on torque alone and did not check theoretical bearing capacity
- Over-reliance on load tests

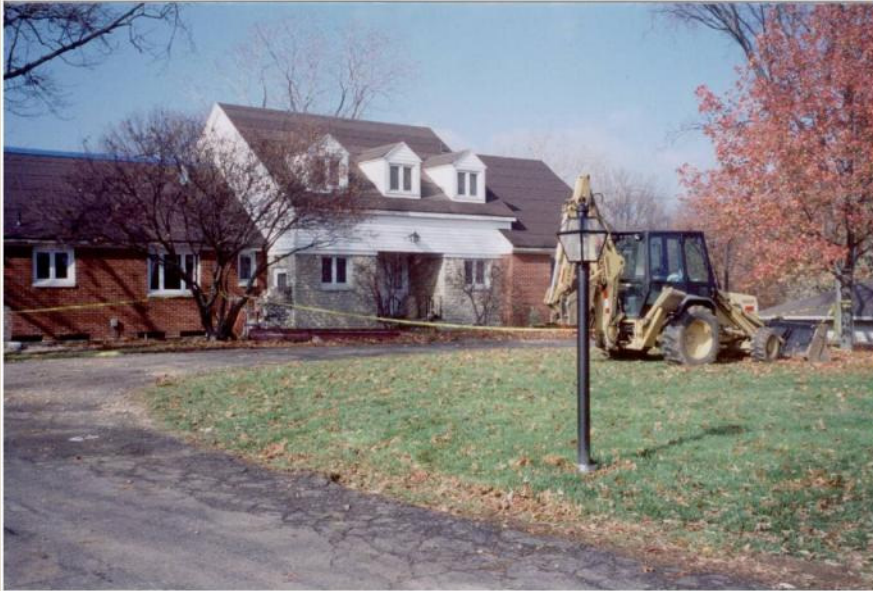
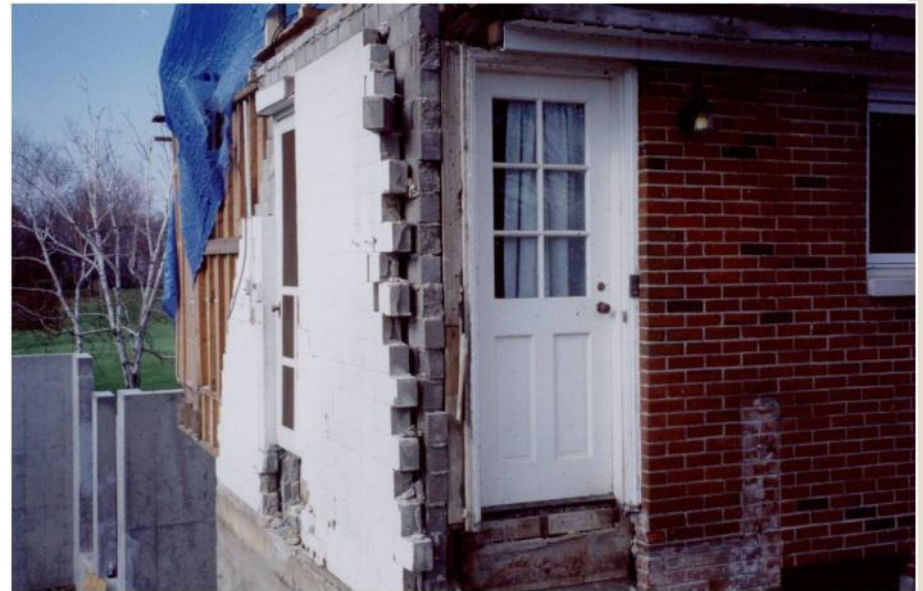
- An addition was being constructed on the back of this home
- The existing back wall experienced settlement
- A foundation repair contractor was called out to install several piles along the back wall

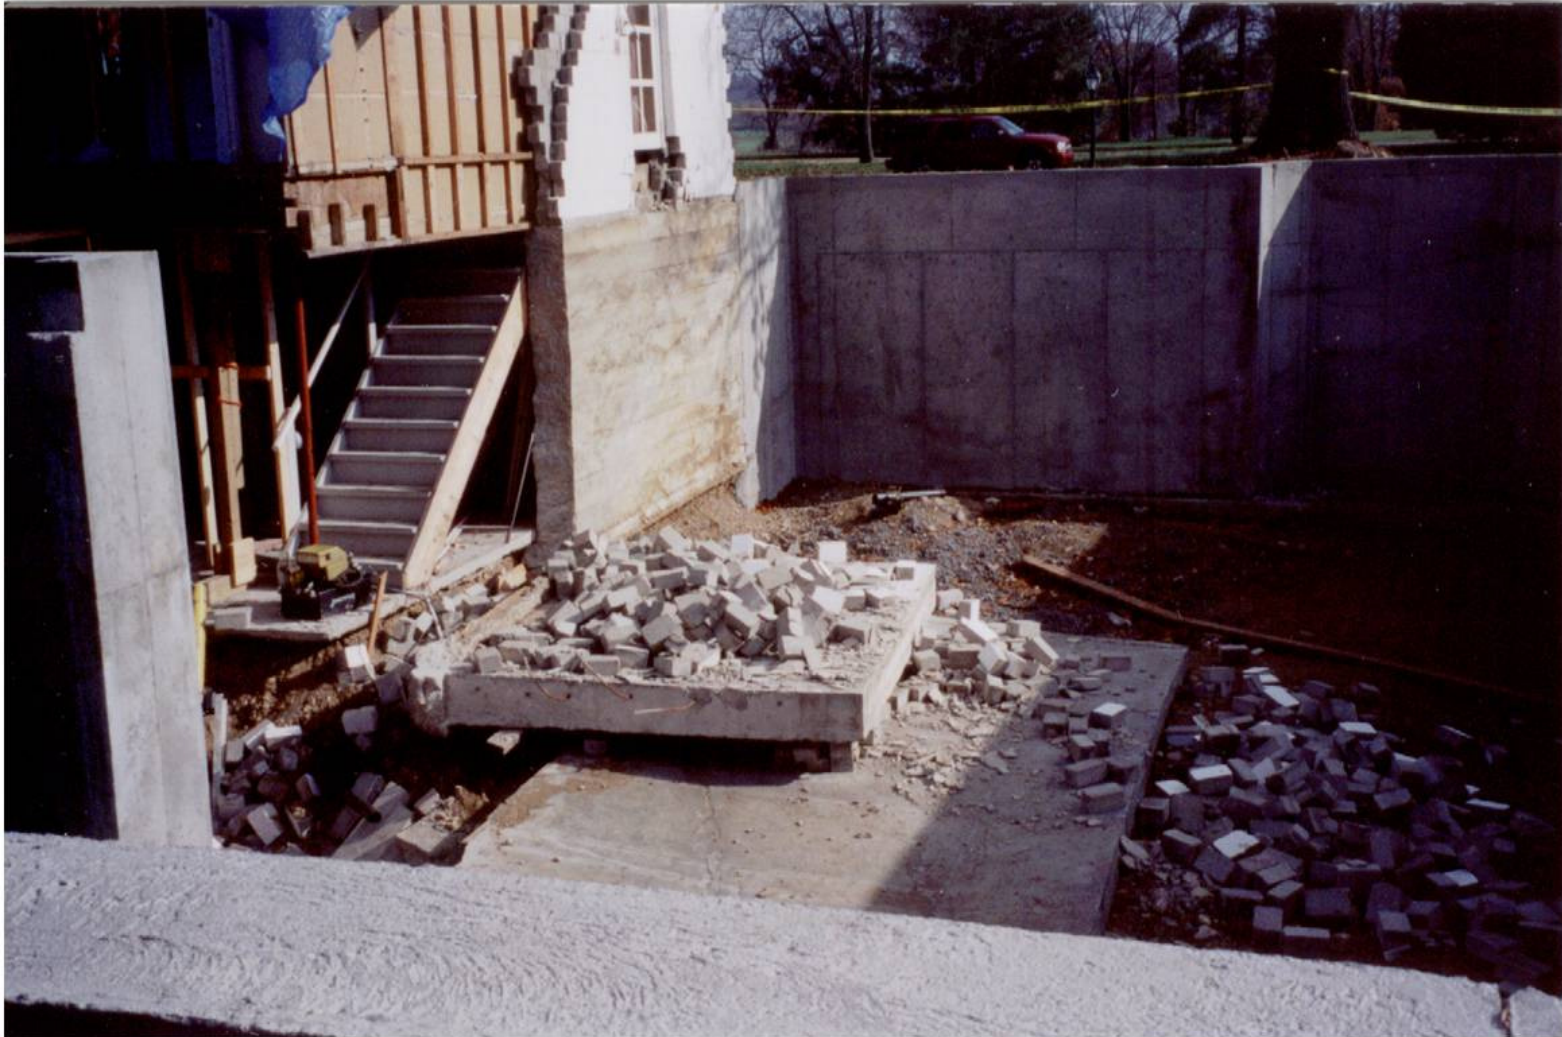
- During installation of piers, the wall suddenly collapsed, tragically killing one of the workers.
