Schnabel
ENGINEERING

Emergency Repairs to the Jefferson Memorial Seawall

Dr. Jesús Gómez, P.E., D.GE

Geo Virginia 2012. Williamsburg, Virginia

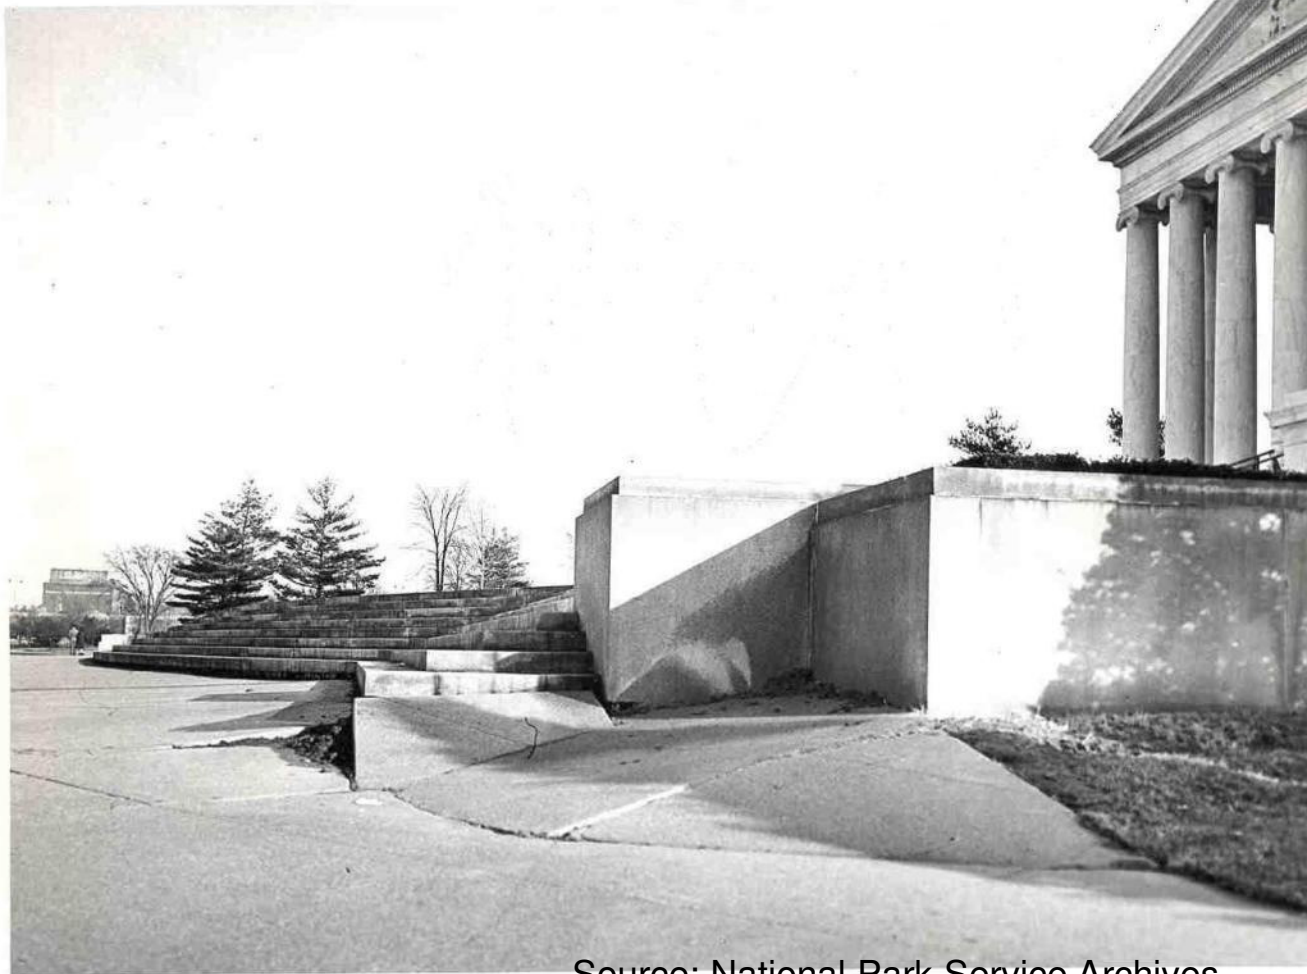
- By the 1960s, North Plaza had settled over 3 ft in places
- Perimeter walls sagged significantly
- Steps showed northward movement and structural damage
- Seawall settled but much less than North Plaza
- Memorial building not affected

- Study commissioned (Storch Report)
 - Reconstruction of North Plaza on piles
 - Buttressing of the steps
 - Repositioning of perimeter walls
 - No repair to seawall
 - Valuable information
- Repairs implemented by 1971

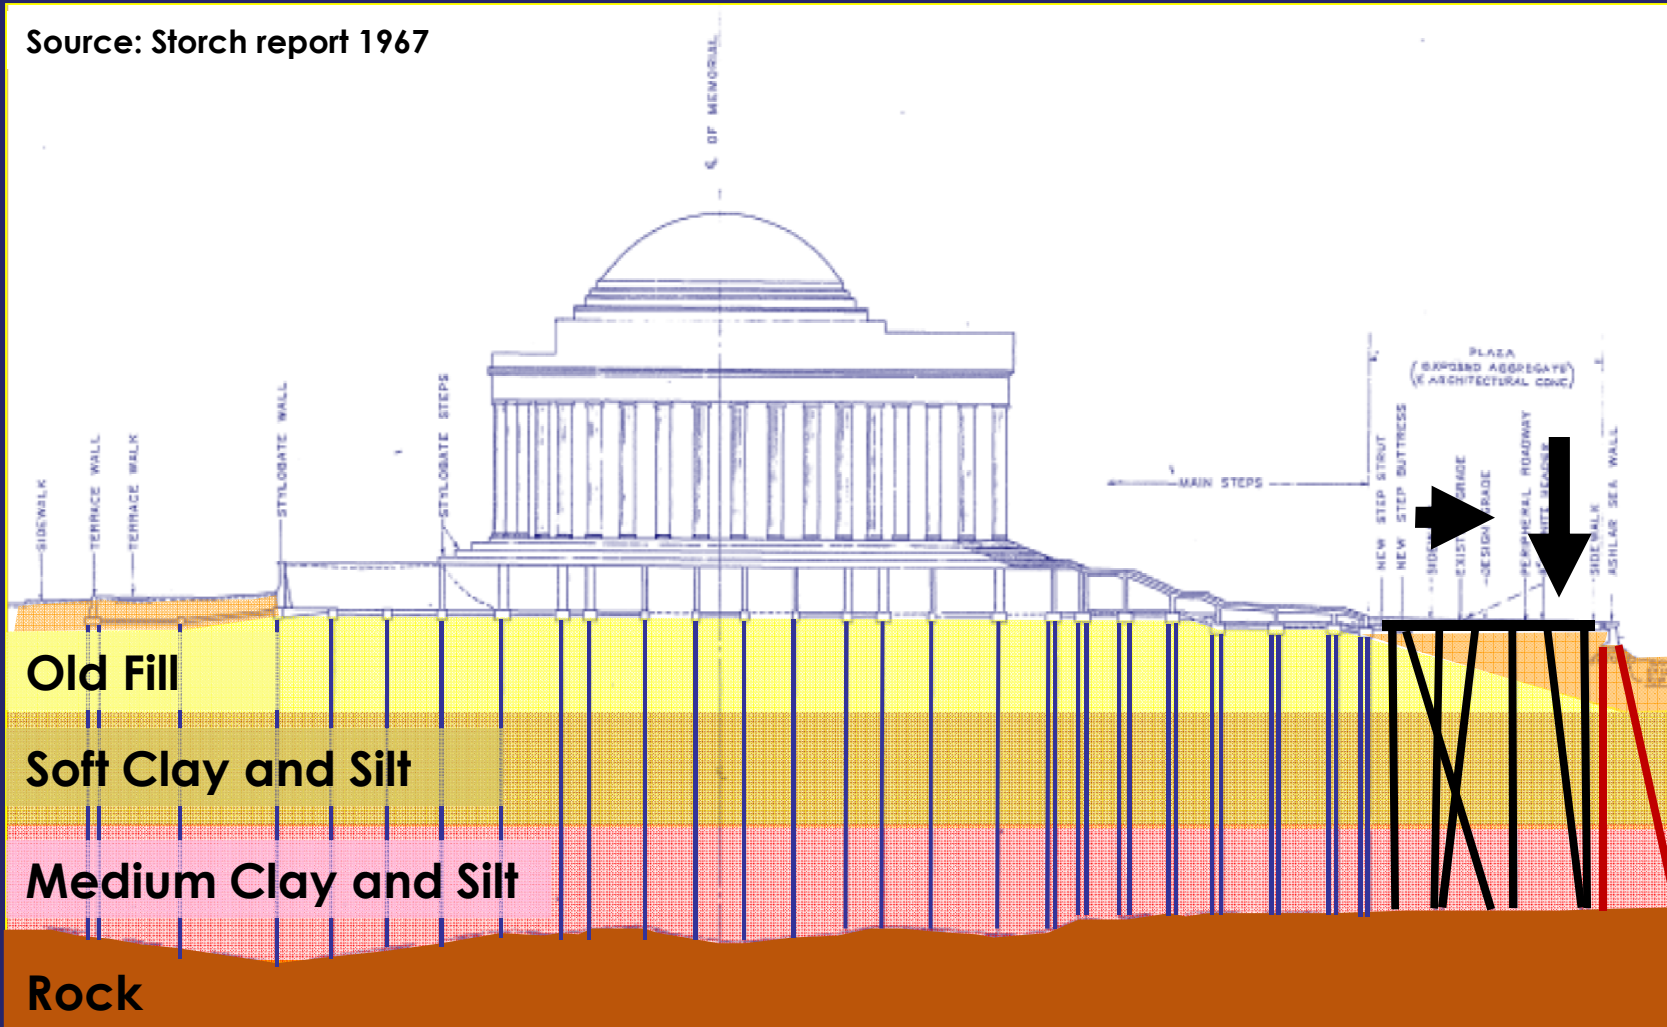
Source: Storch report 1967

Old Fill

Soft Clay and Silt

Medium Clay and Silt

Rock

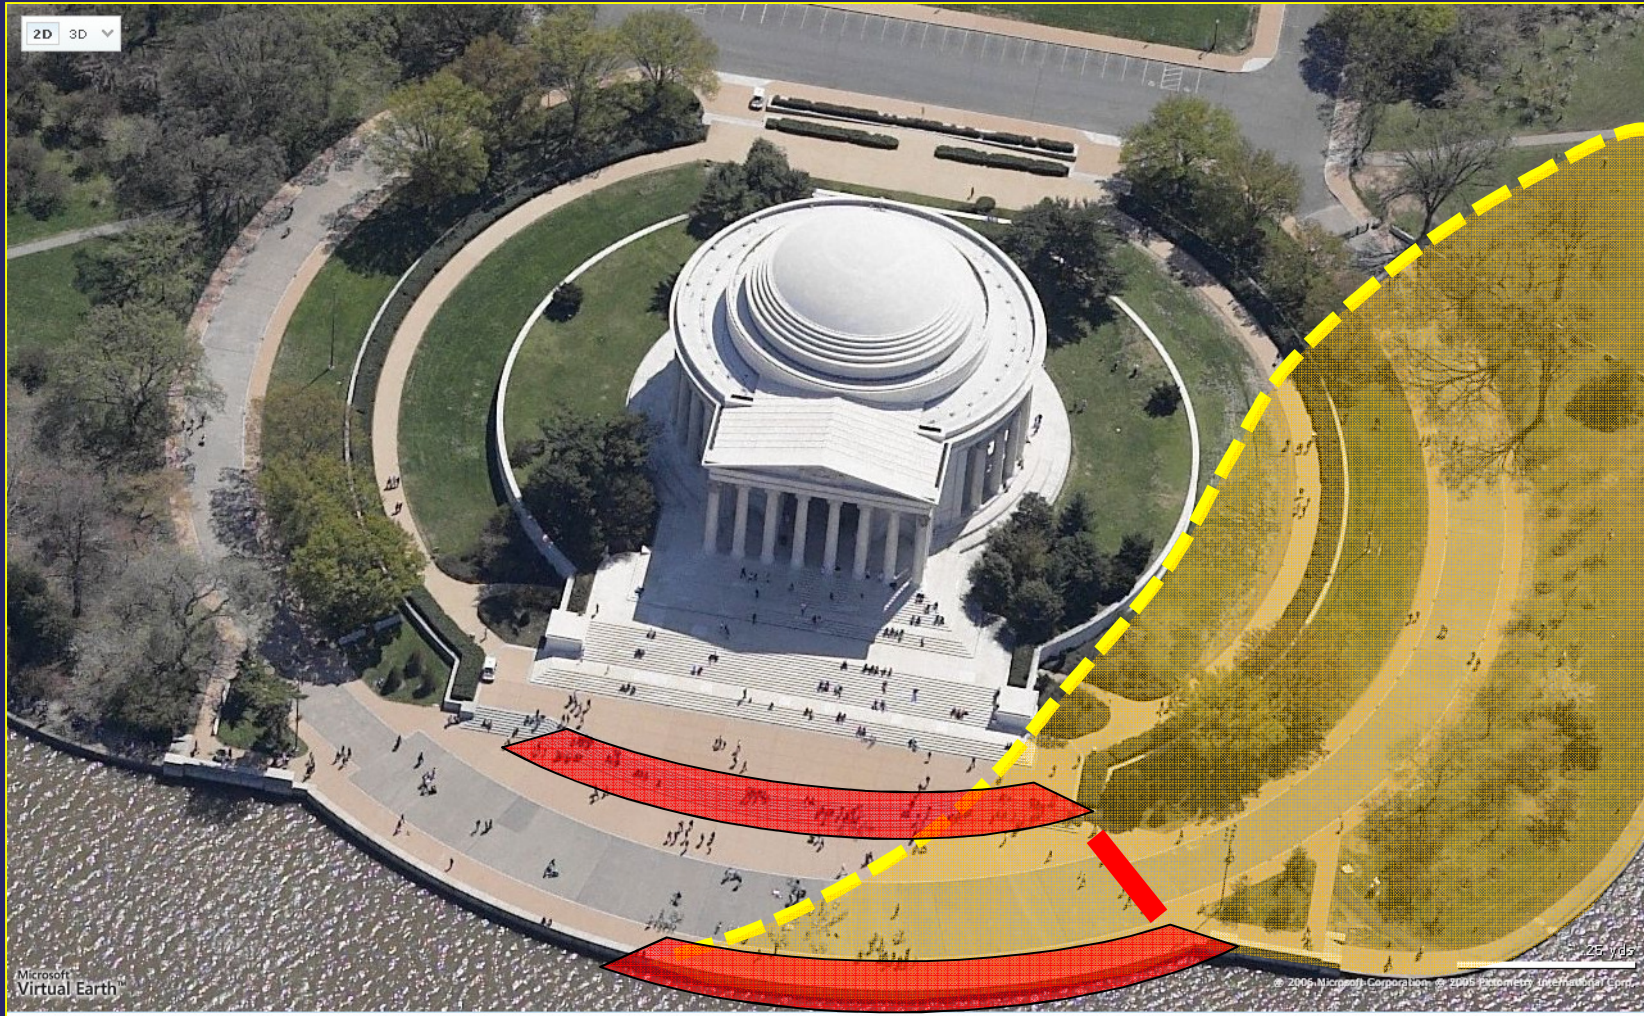
- 2005-2006
 - “Sudden” noticeable seawall settlement
 - North Plaza pulling away from Steps
- October 2006, NPS commissions investigation of movements

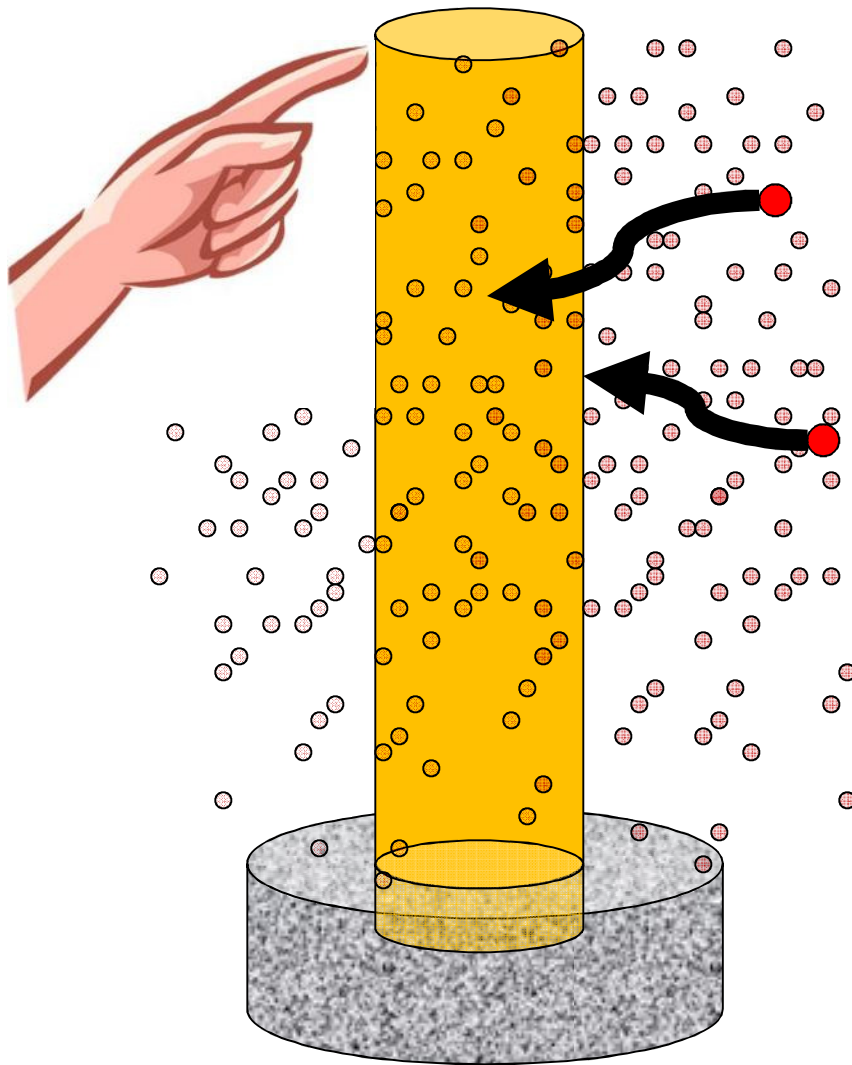
Lateral analyses of caisson and piles

- Apply soil movement profile
- Apply given displacement at top
- Determine shear at top
- For piles consider batter

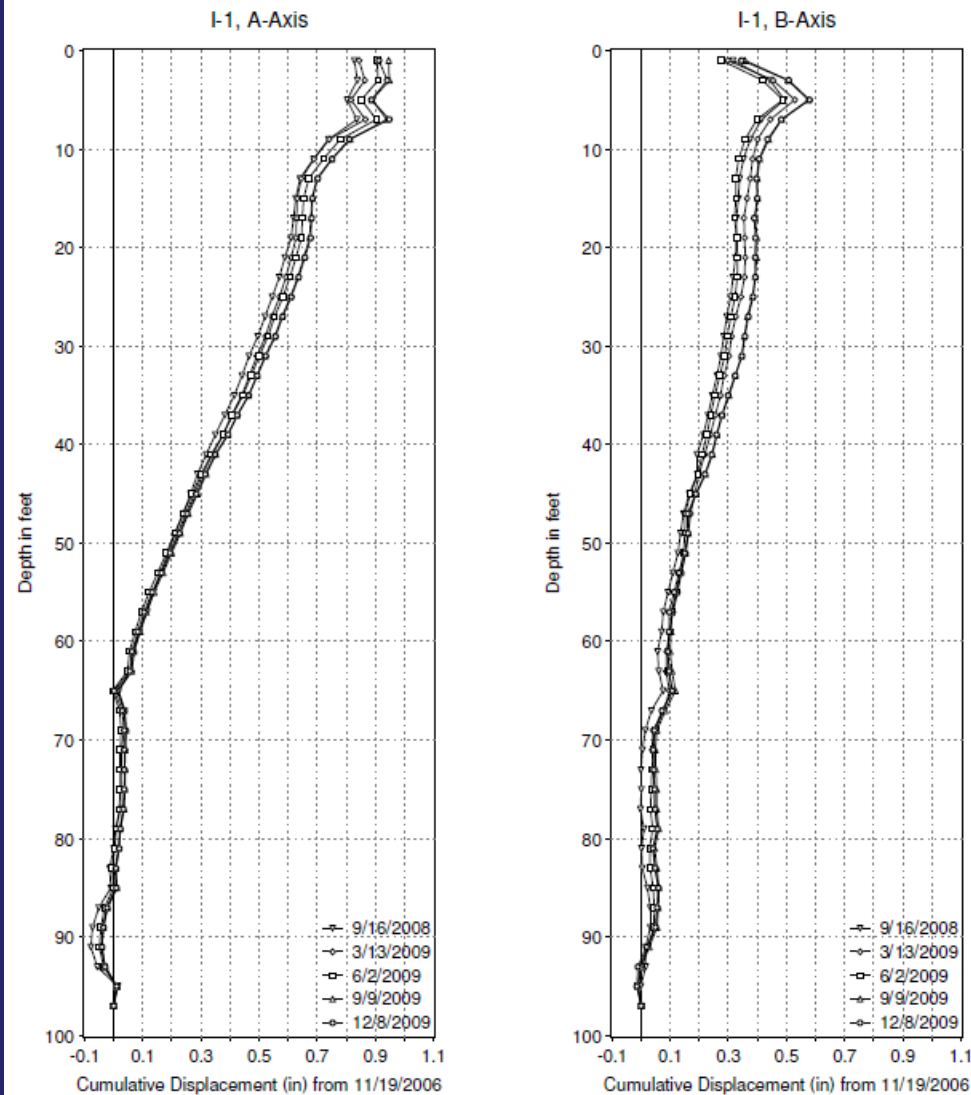
Soil movement profile

- Scaled from inclinometers
- Maximum displacement at top
- Zero at about 65 ft
- Used settlement/lateral displacement ratio from Plaxis

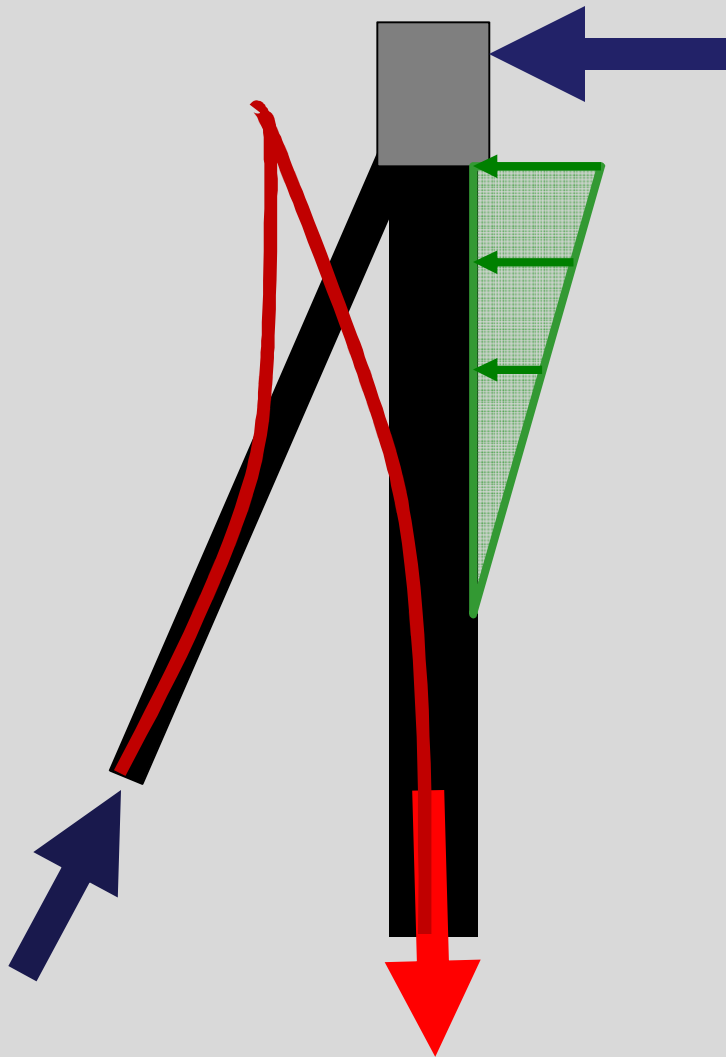
- Iterative process
- Determine existing Plaza shear from Lpile analysis for various soil and head displacements
- Guess caisson and pipe pile sizes
- Use Lpile to determine shear forces, bending etc for zero head displacement
- Design caisson and piles
- Run structural analyses using framework or similar and determine head displacement
- Run next iteration
