Series of mistakes leading to the collapse of a small dam in Colombia.

Jaime Suarez-Diaz Msc, PE
Distinguished Professor
Universidad Industrial de Santander, Colombia.

GEOVIRGINIA 2018

Lessons Learned in Geotechnical Engineering

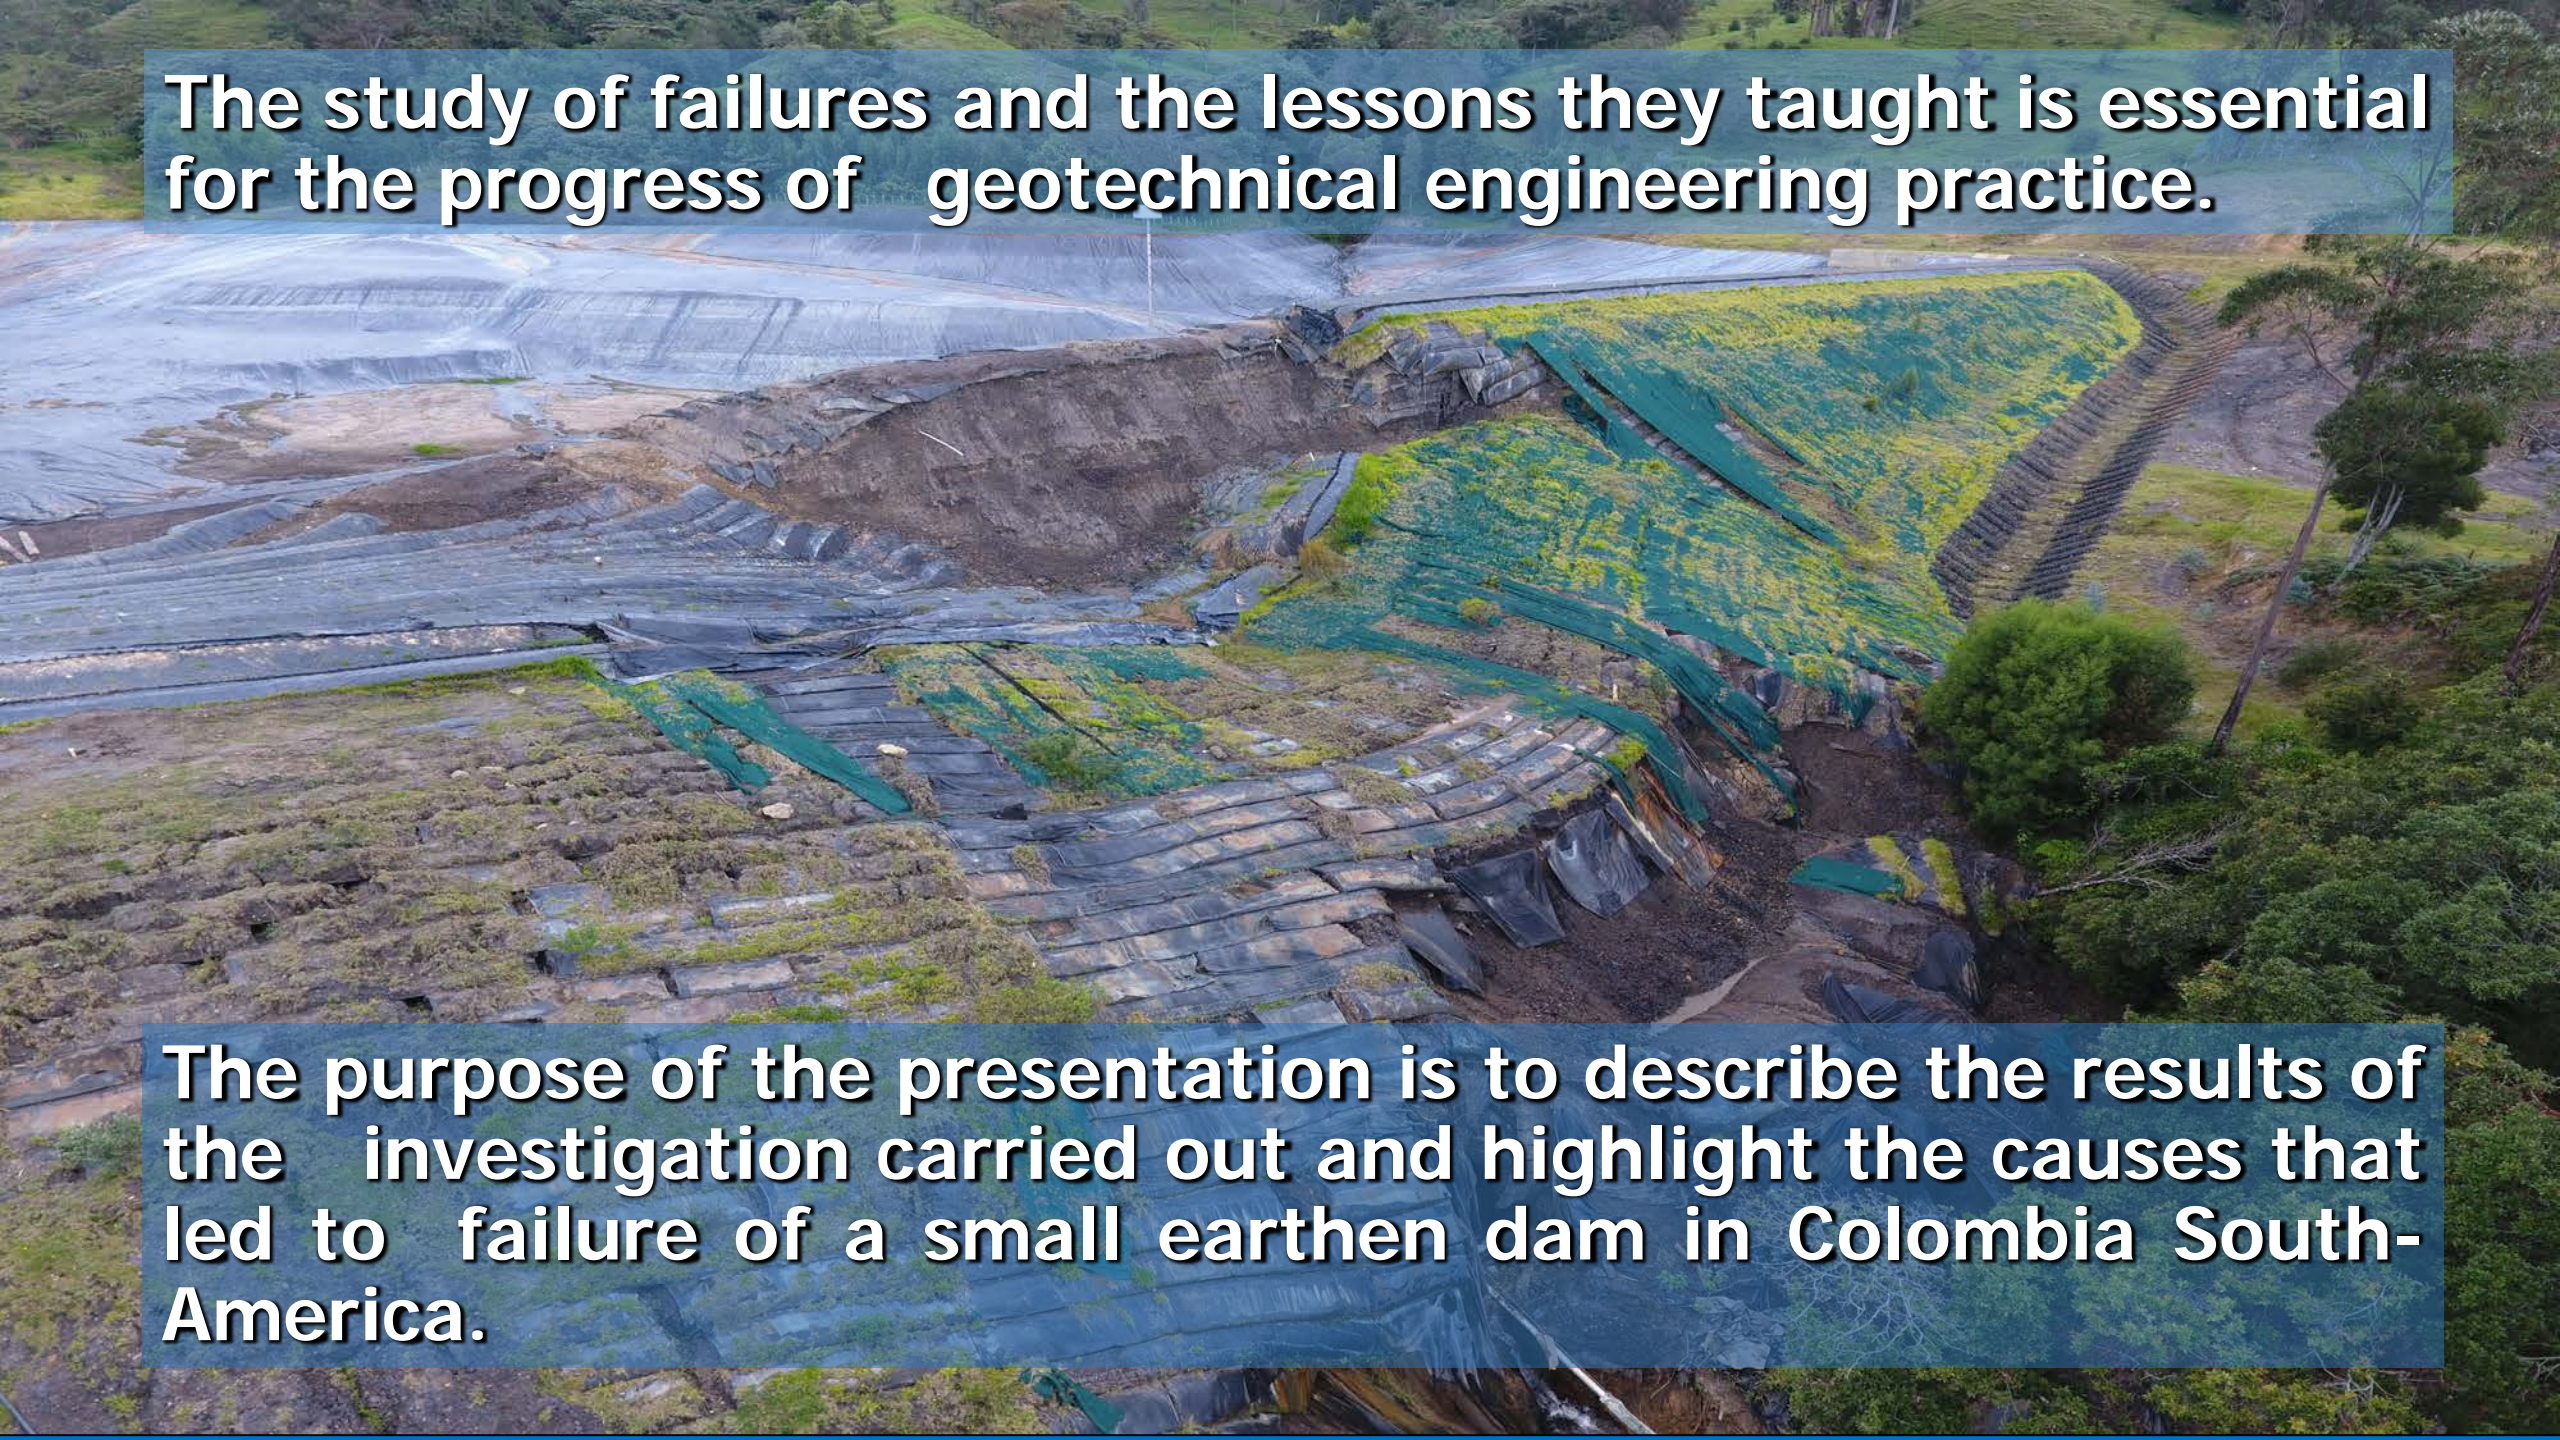
**The dam failed 7th June 2016
two weeks after filling up the reservoir.**

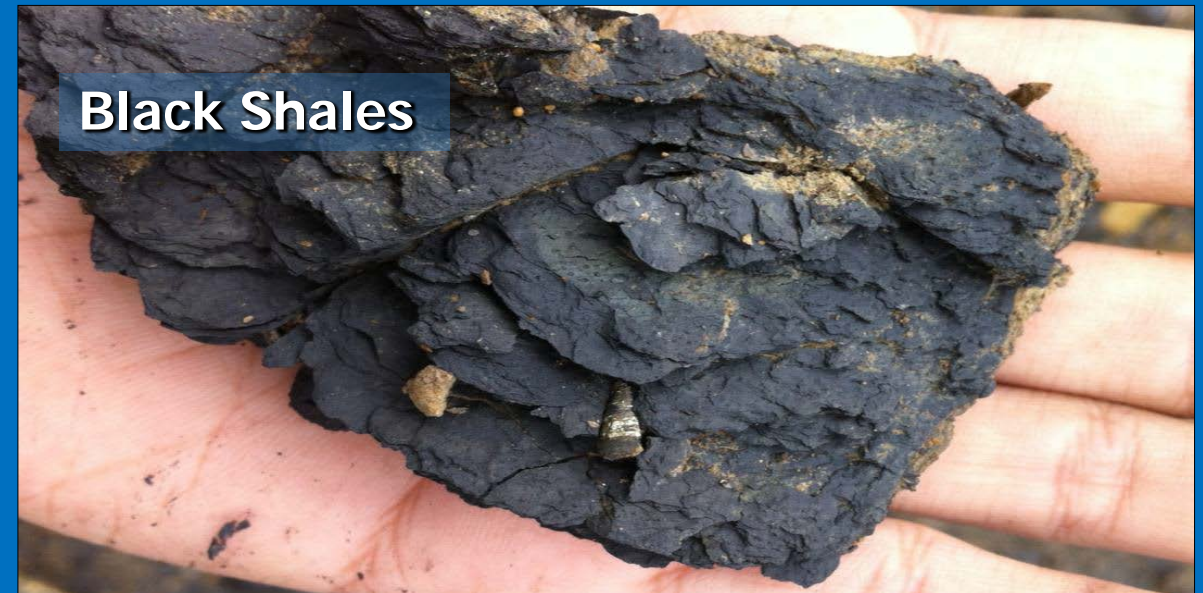
The Tablazo formation is known for the karstic behavior of the limestone rocks, but the surface rocks were shales, residual soils and some colluvial deposits.

Geologists did not identify the presence of limestones.

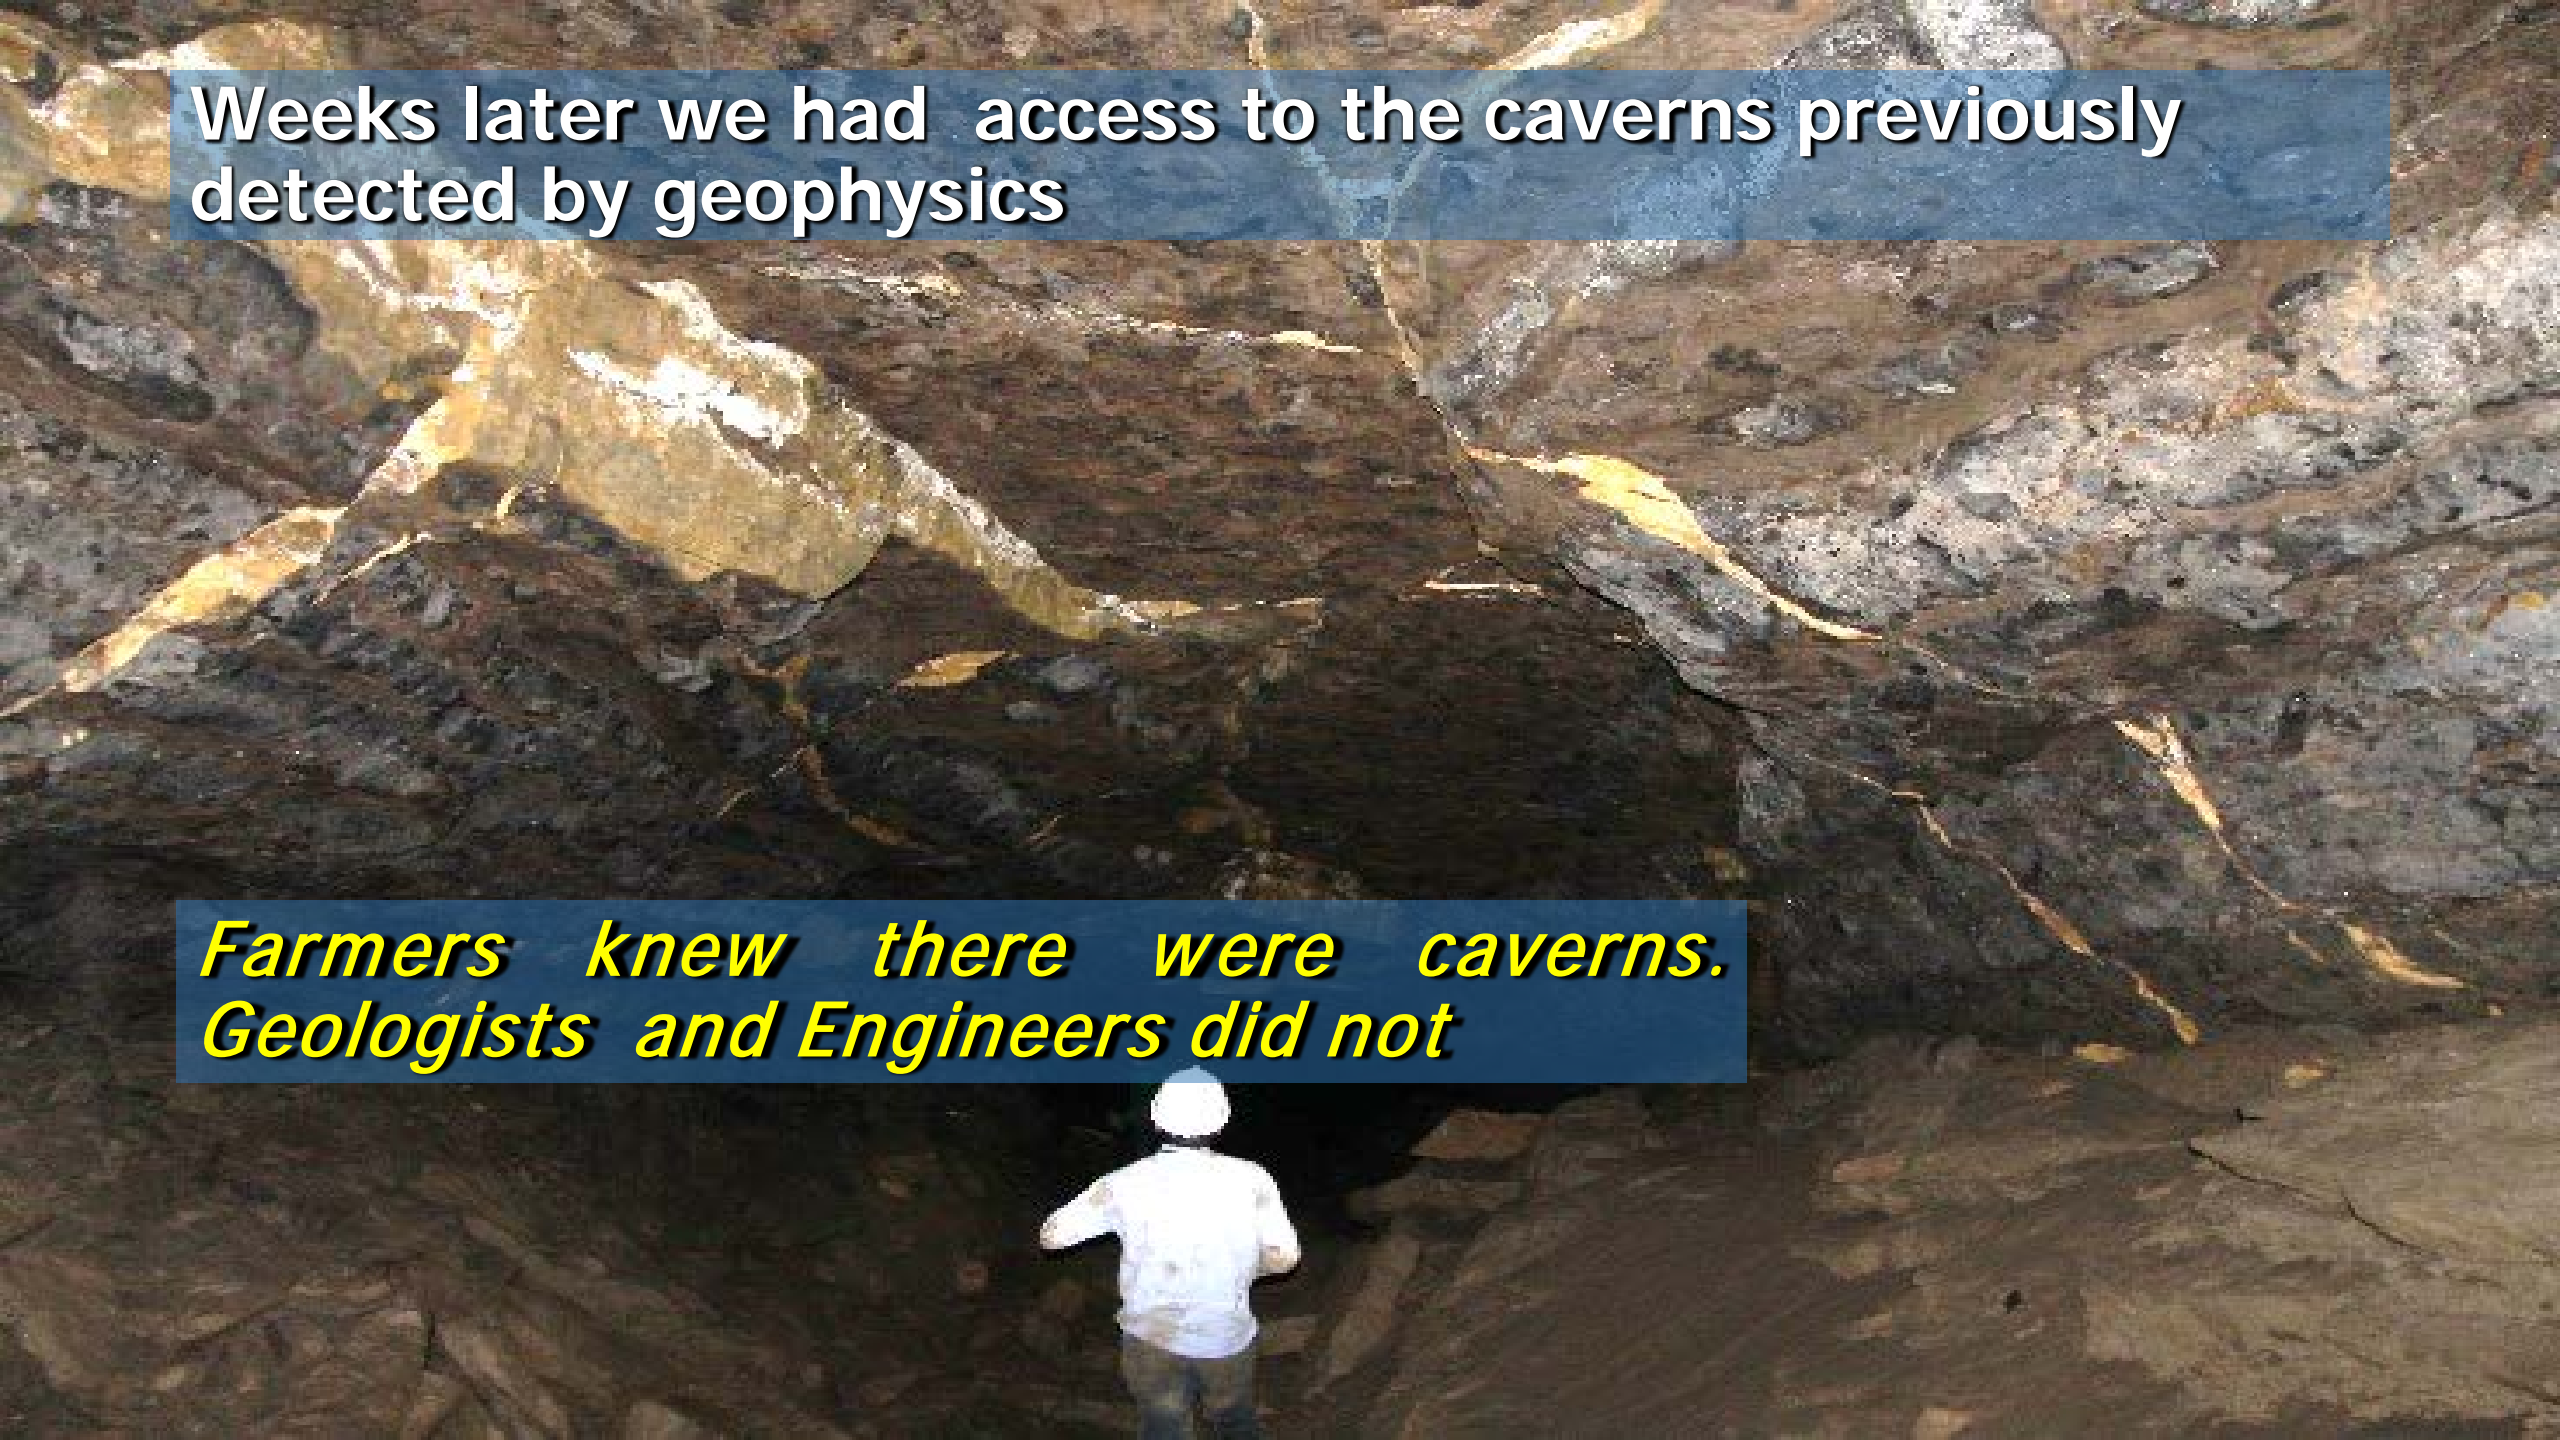
Weeks later we had access to the caverns previously detected by geophysics

Caverns did not have a direct influence on the failure of the dam, but in the long term, to have caverns 20 meters below the reservoir, was a great problem.

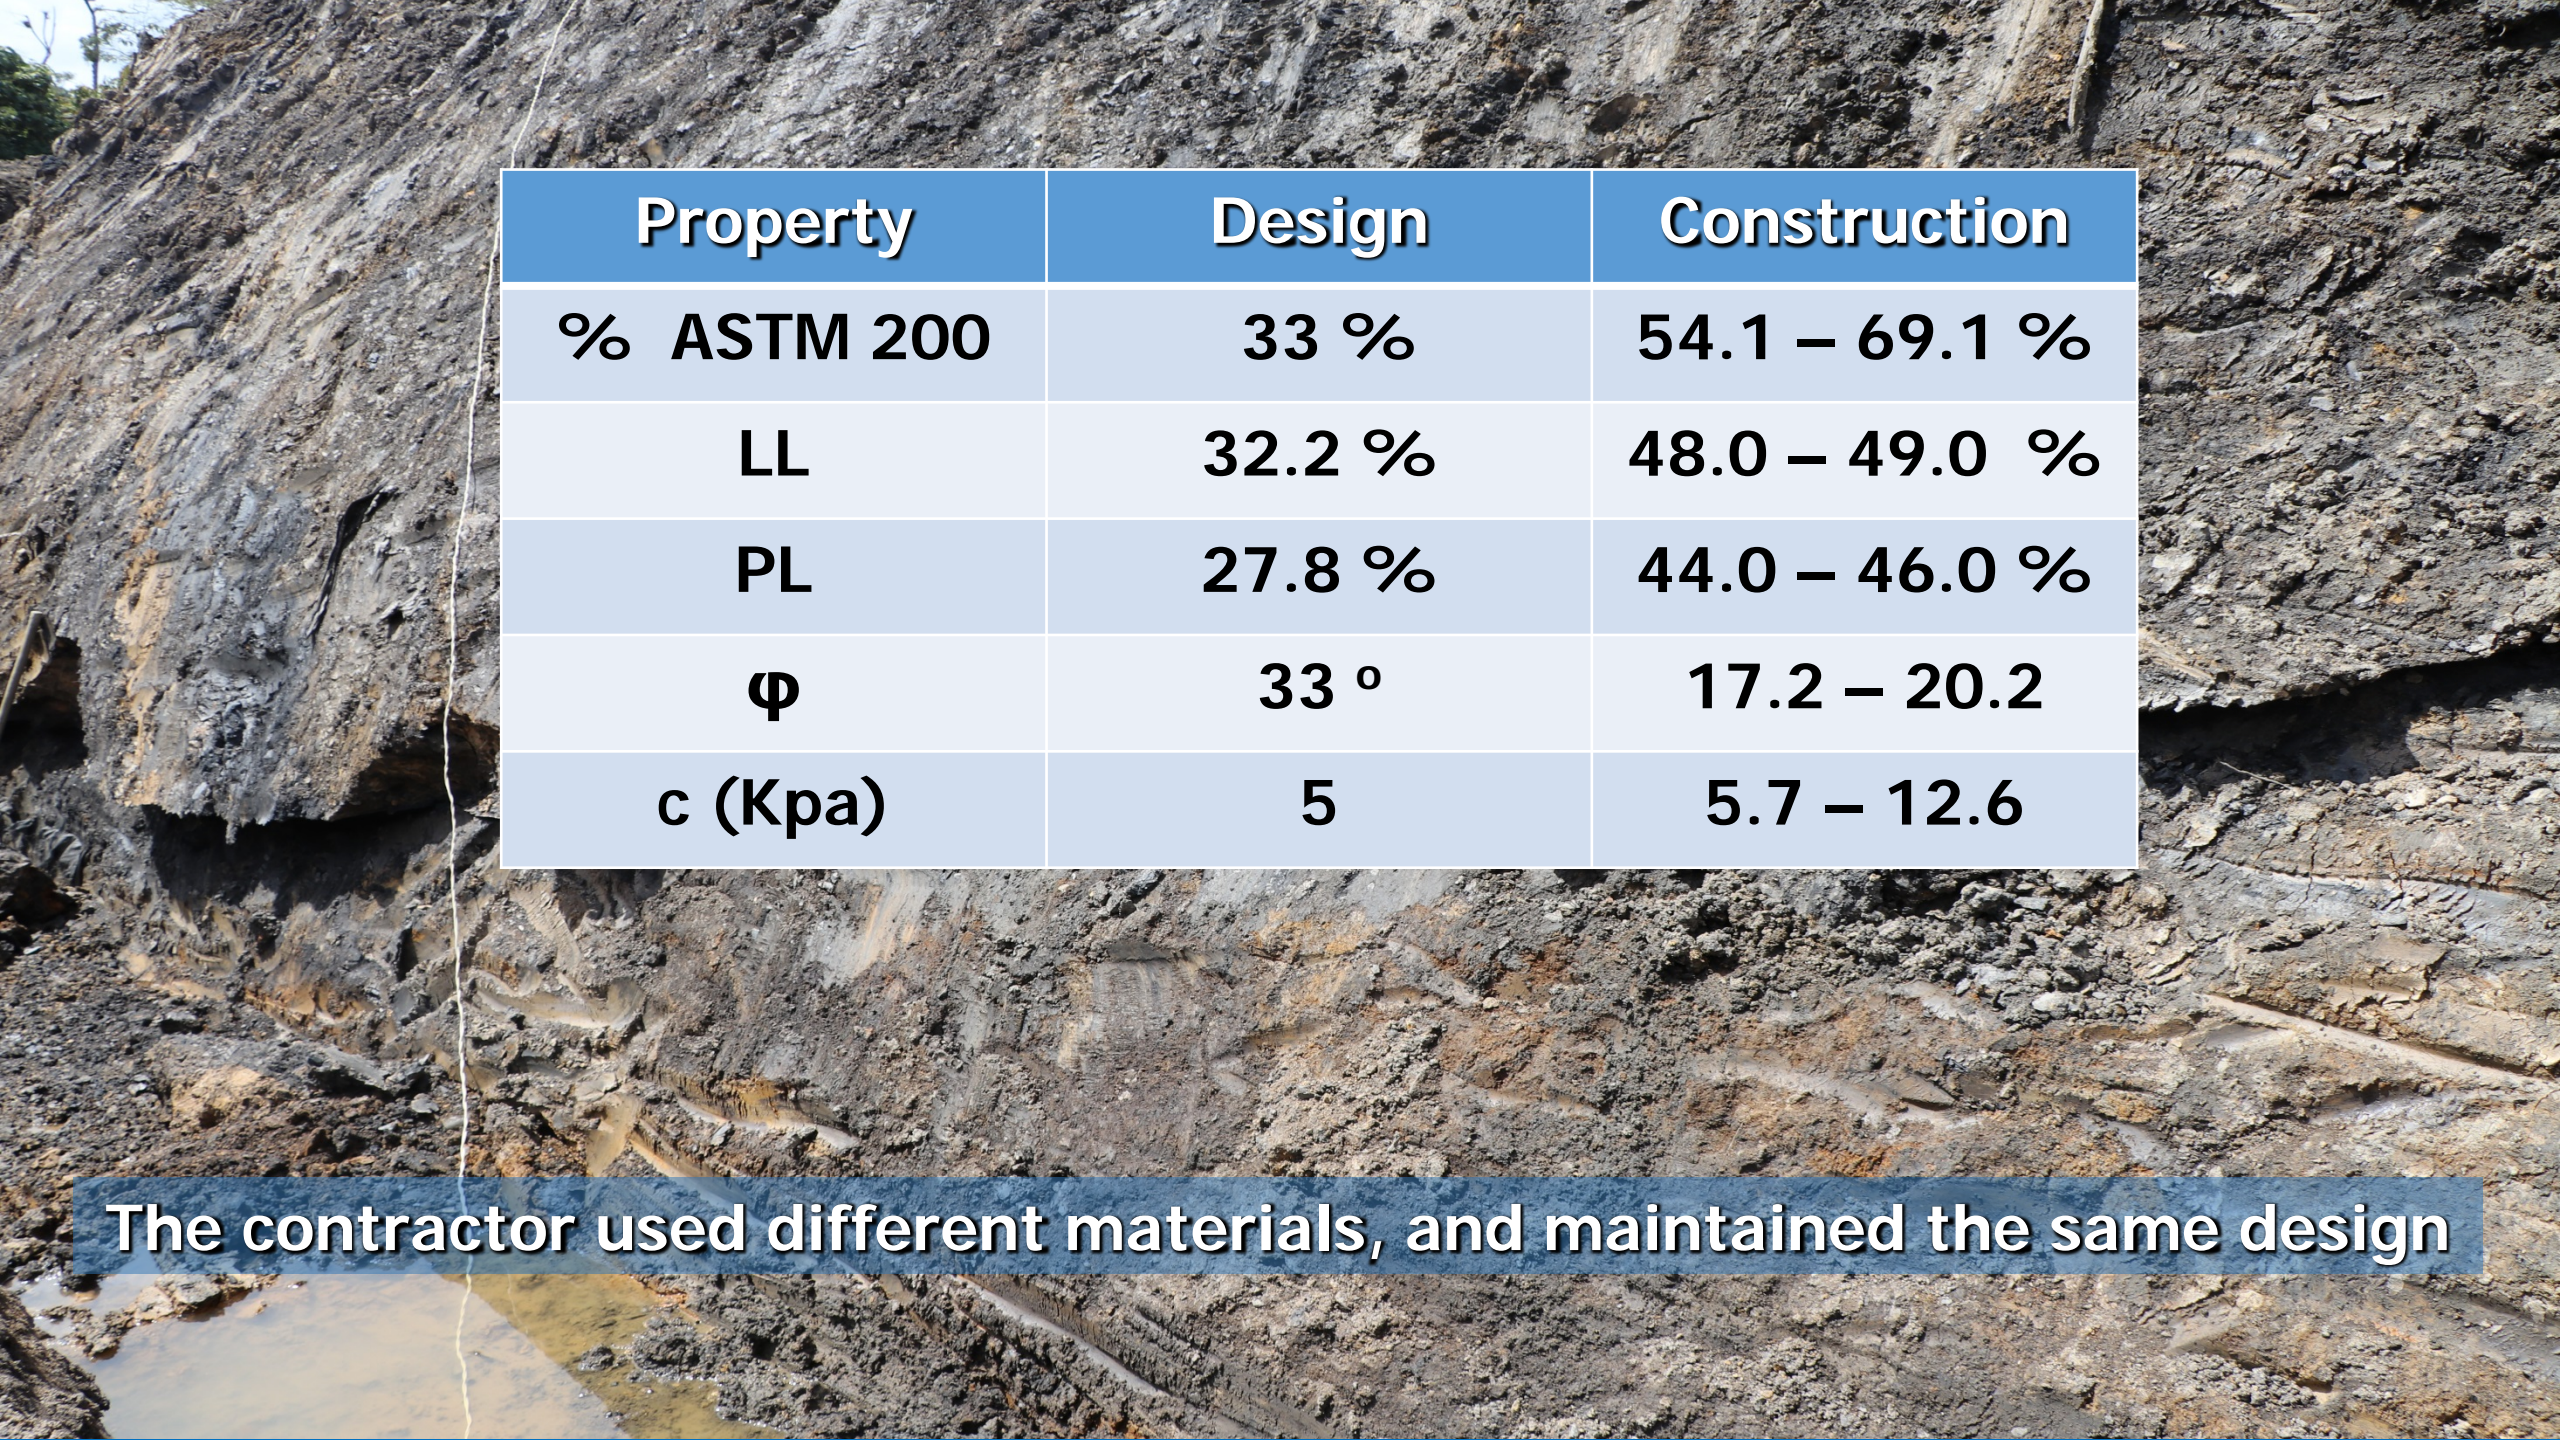
The design specified sandy clay, but for economic reasons the contractor changed it to somewhat more plastic clay. There was not enough specified material near the site. They finally used material from the excavation of the reservoir

The contractor used different materials, and maintained the same design

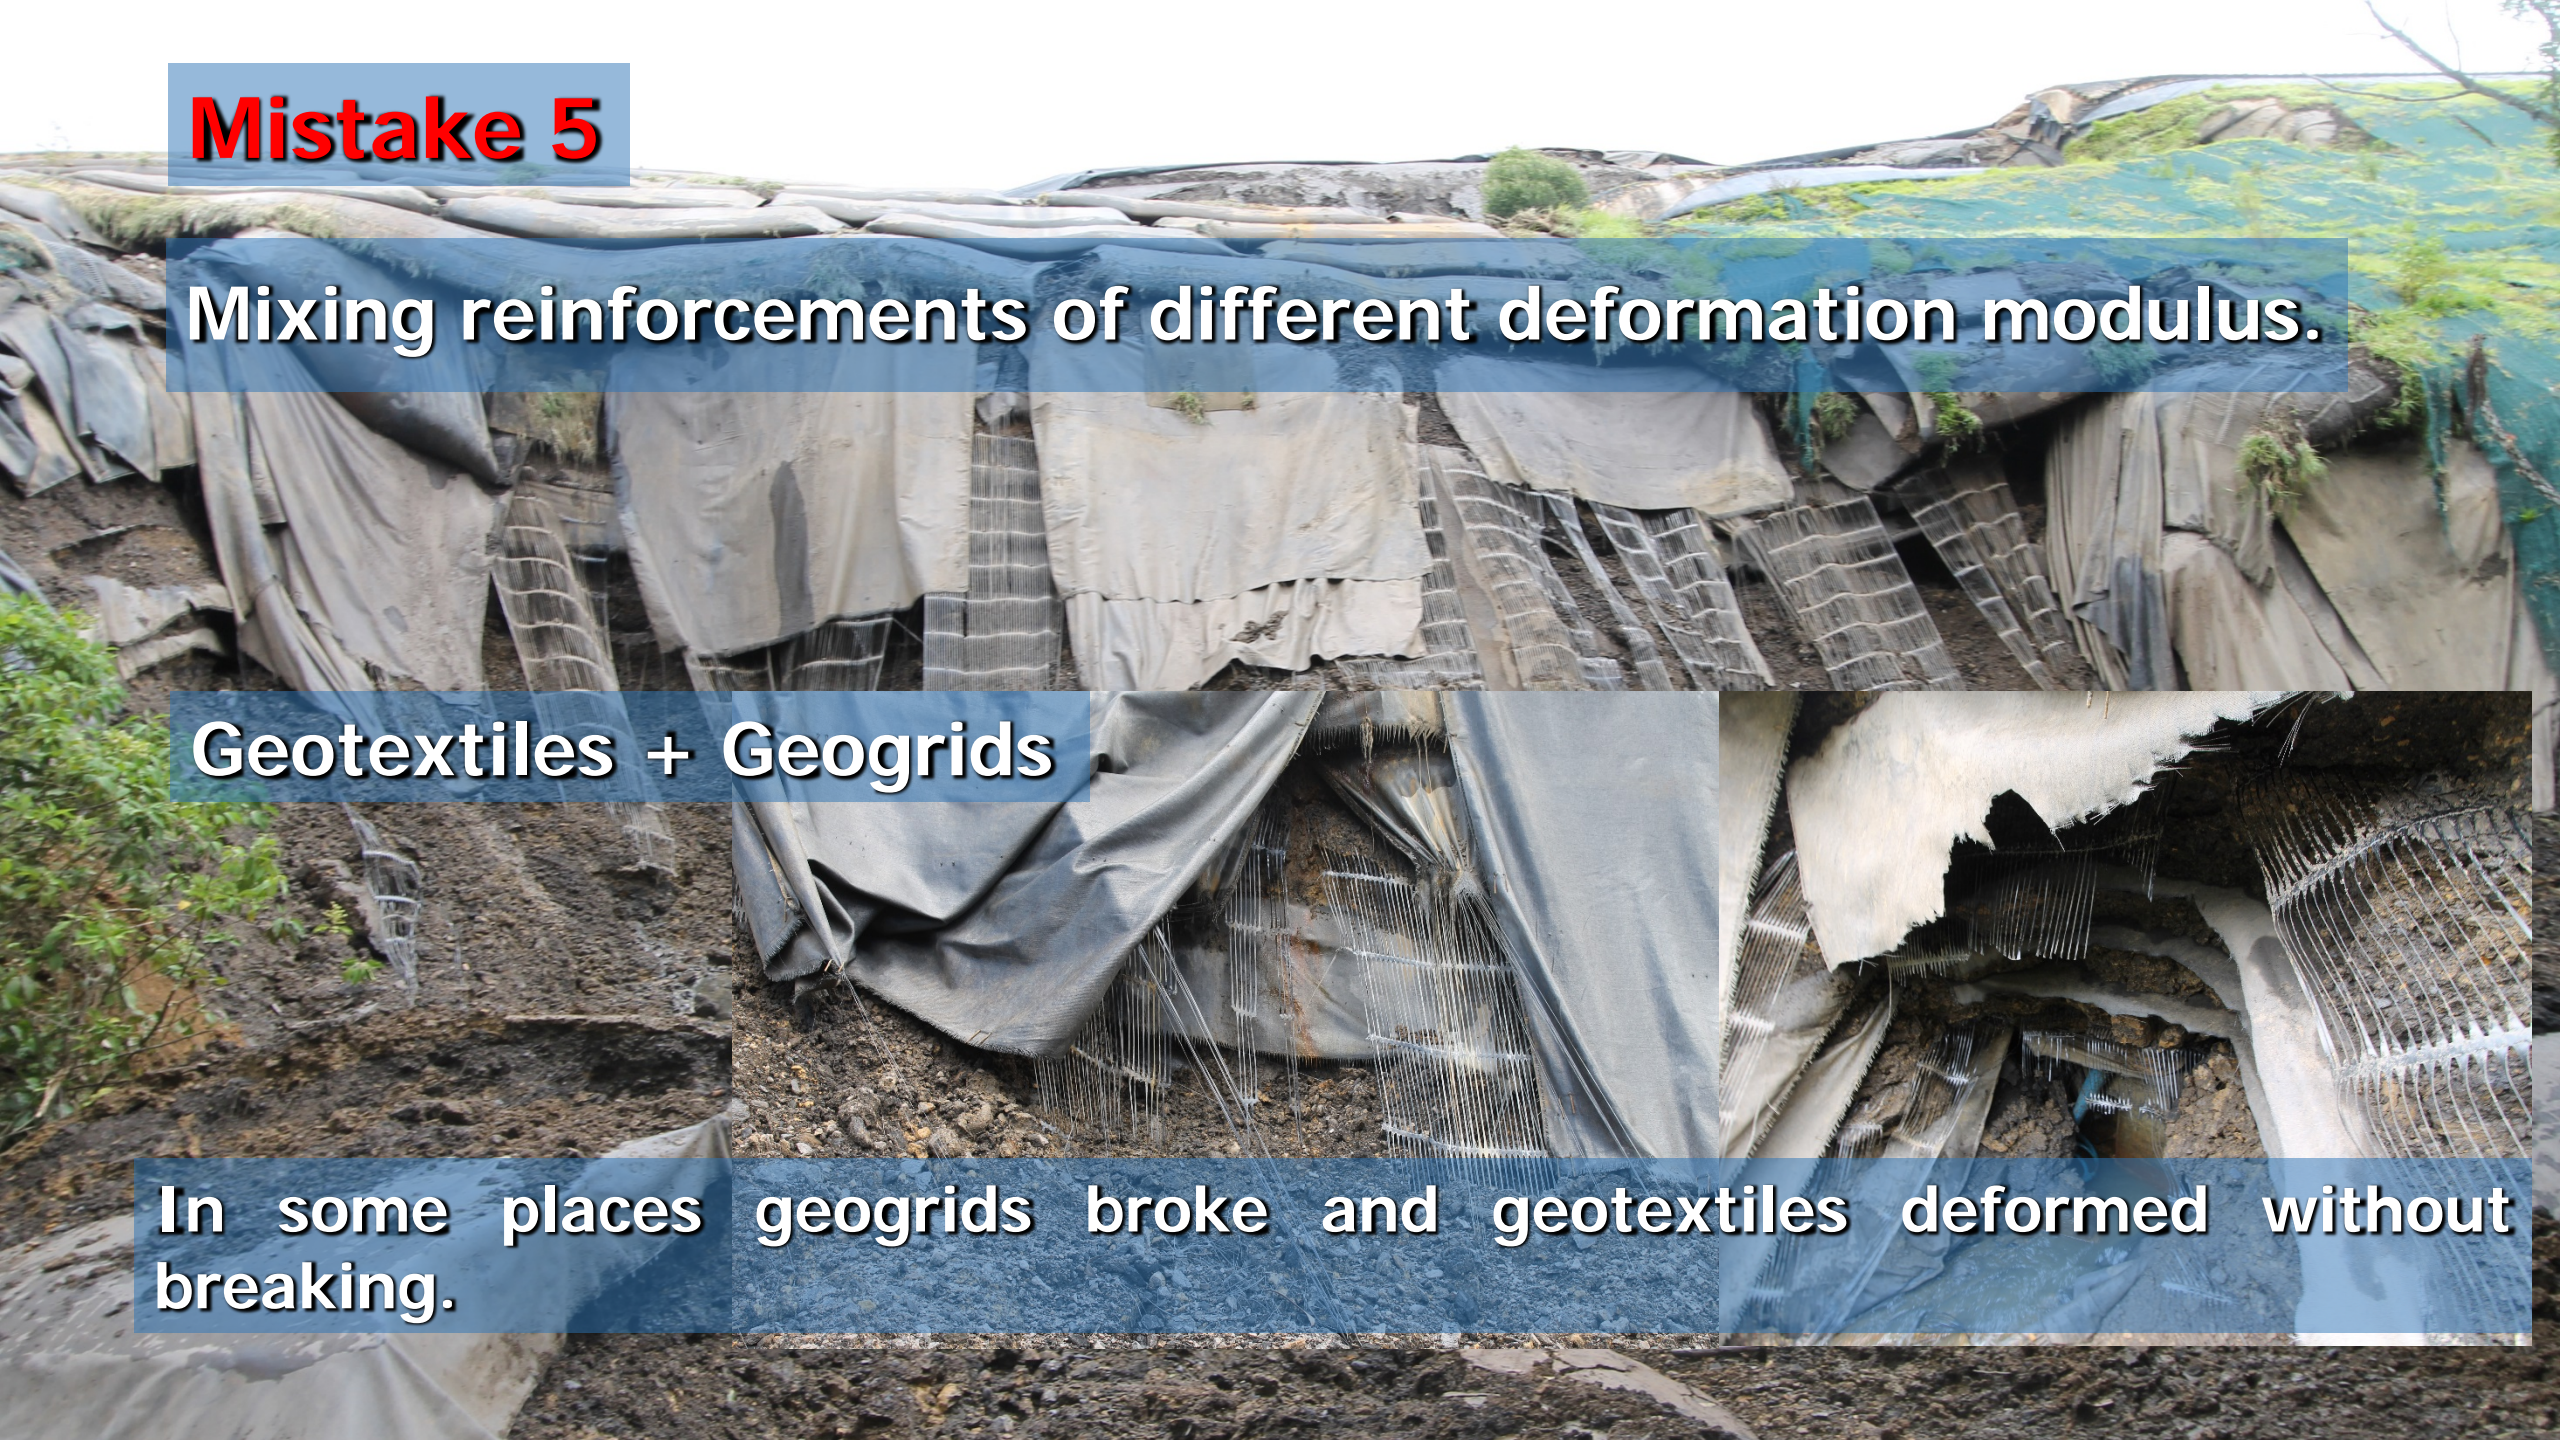
In some places geogrids broke and geotextiles deformed without breaking.

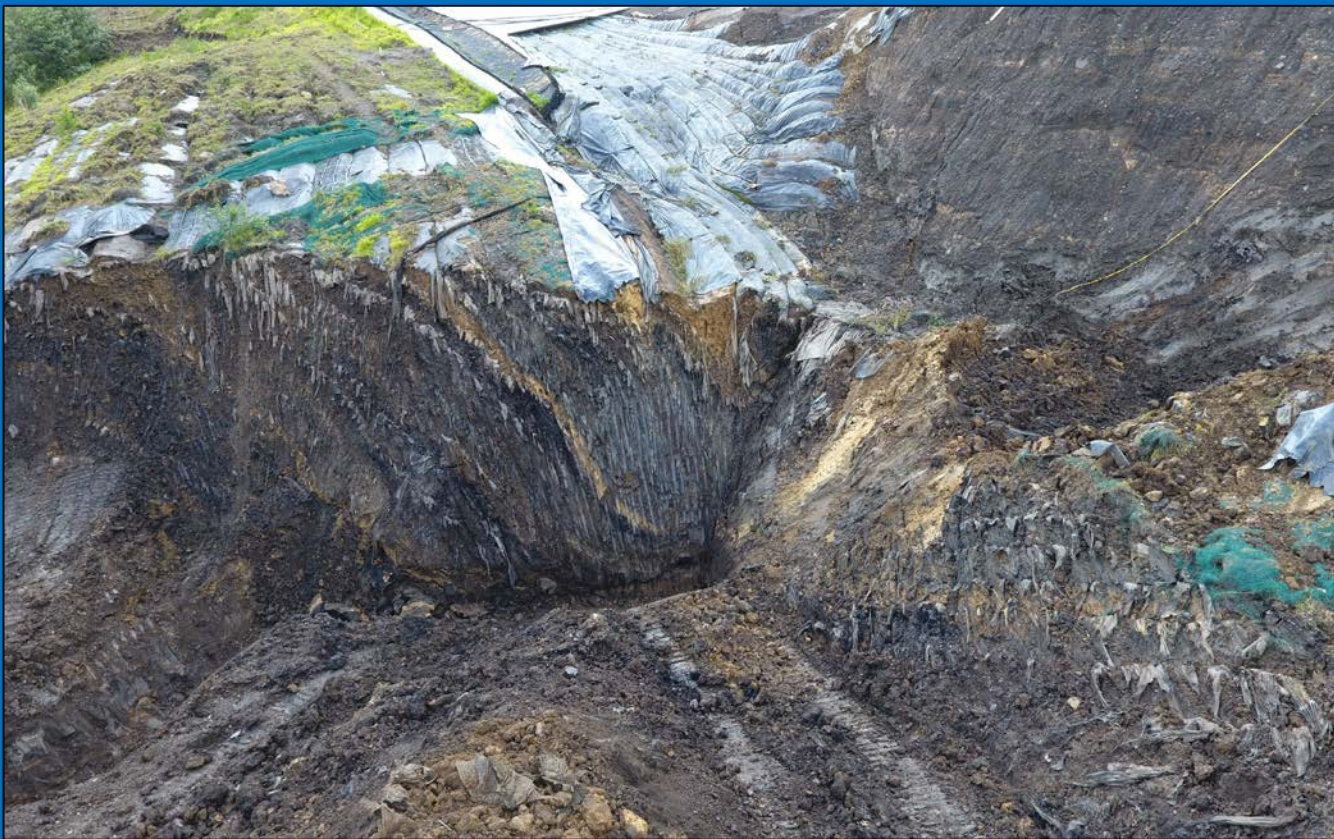
Length of reinforcements was not enough to control deep slope failure

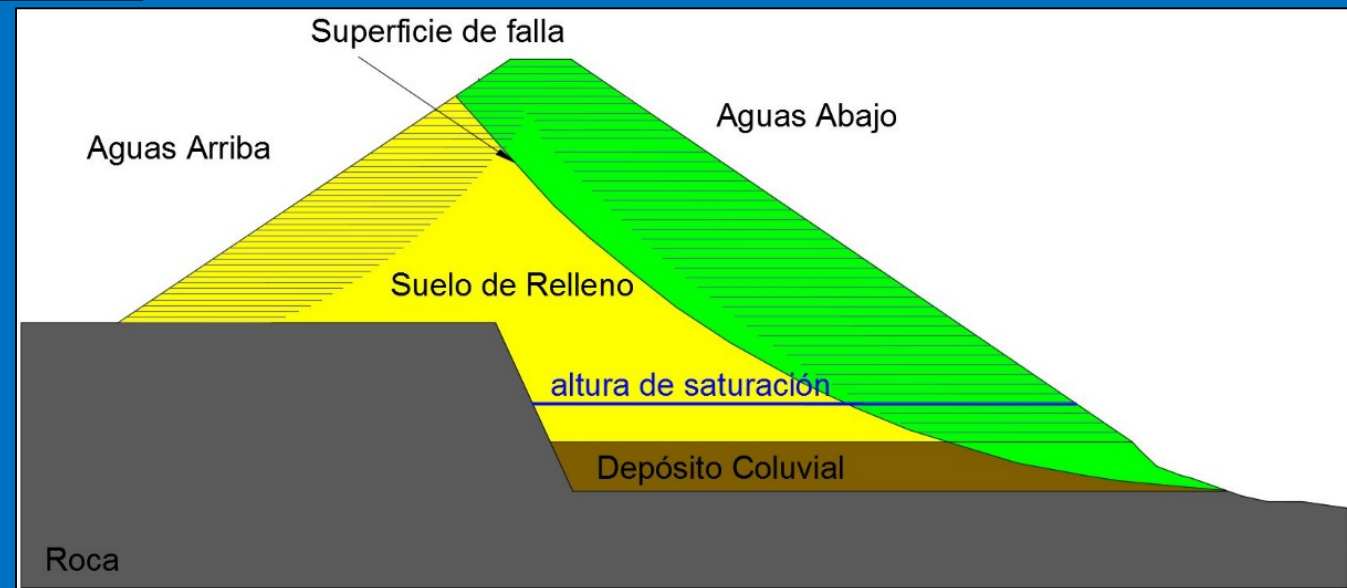
Actual failure occurred behind the reinforcement

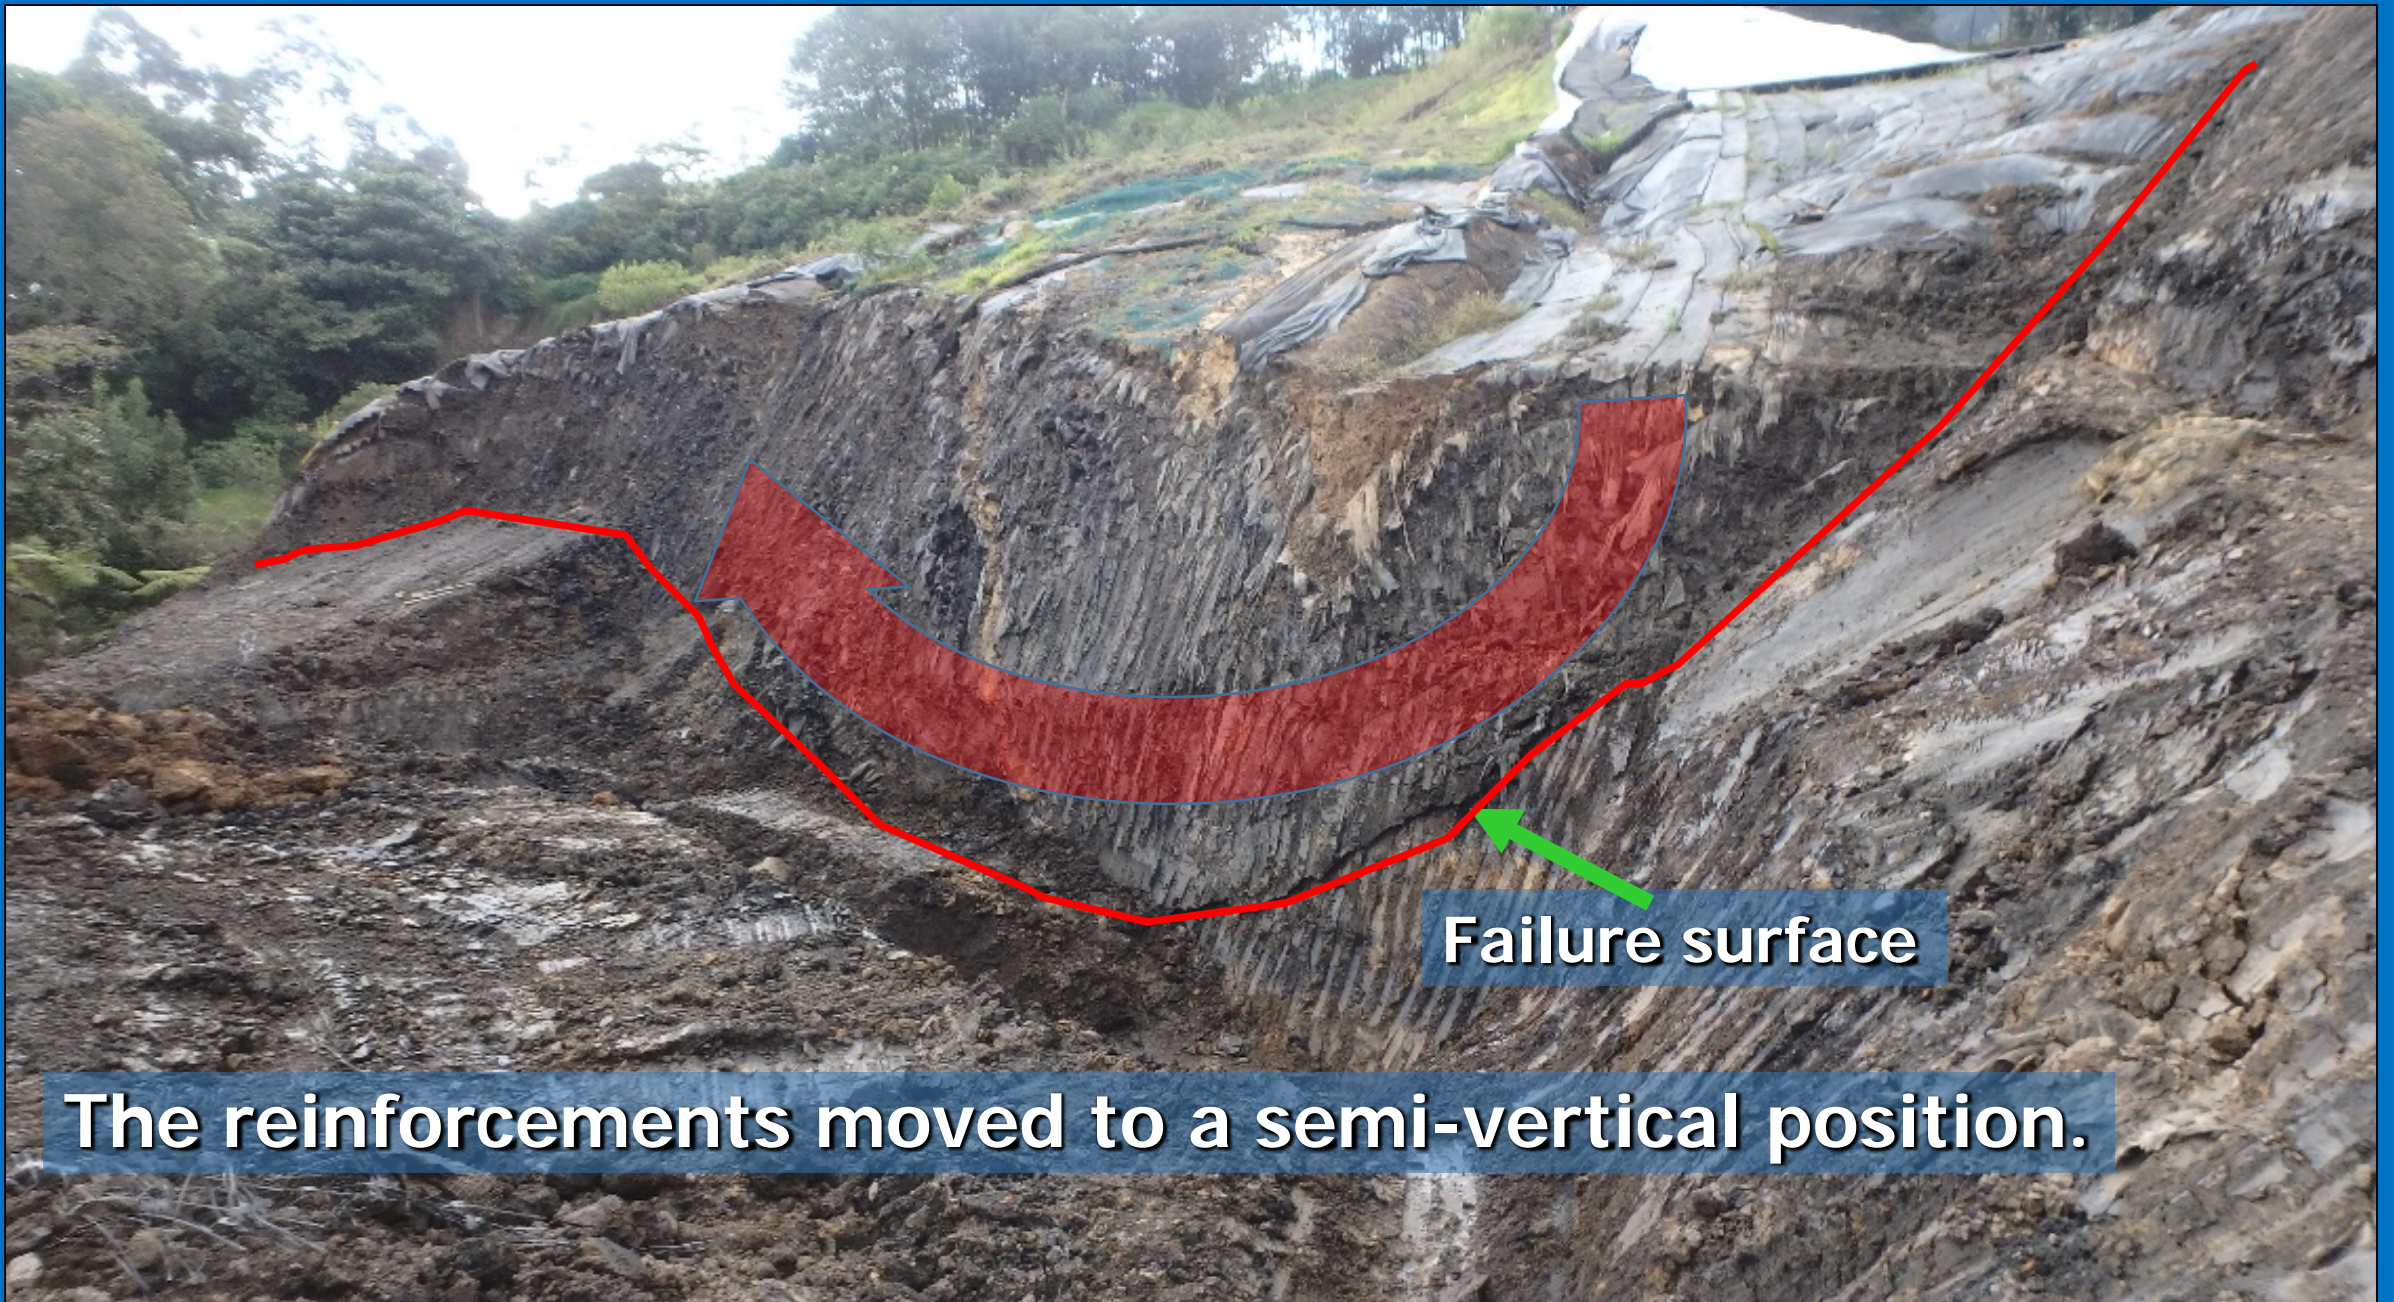
Failure surface

The reinforcements moved to a semi-vertical position.

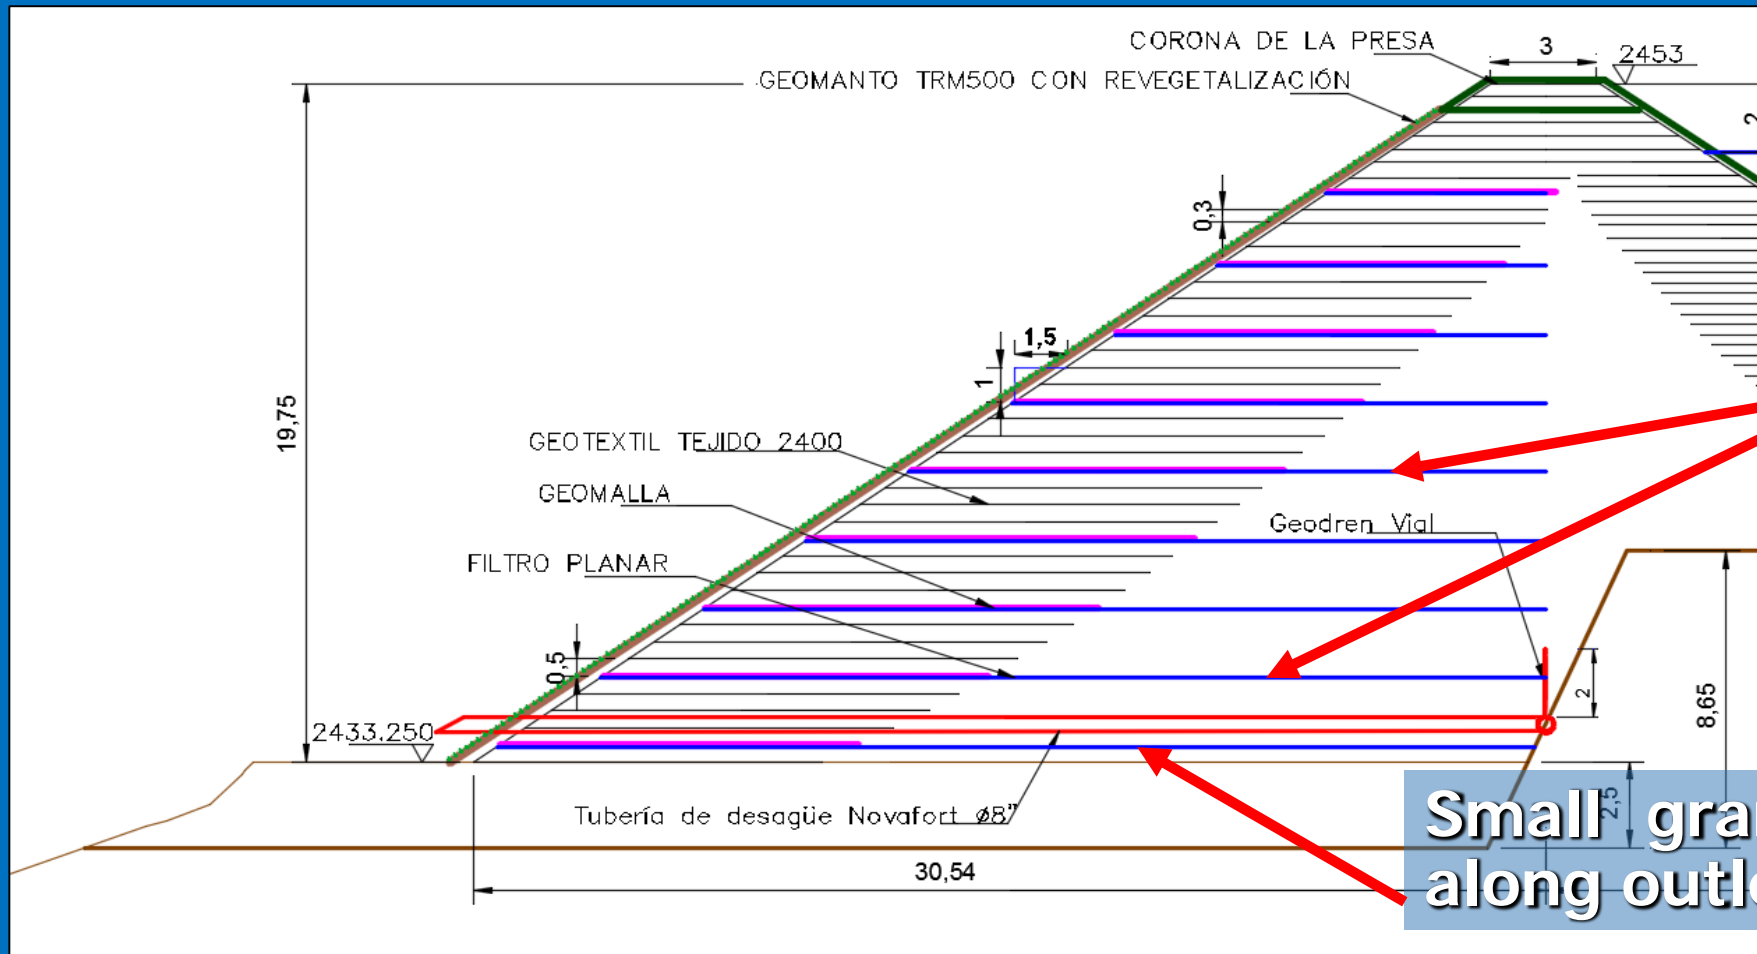
Geosynthetic drains

Small granular drains along outlet conduit

Most drains were Geo-synthetic drains
They did not have enough capacity to manage the water filtrations.
