Series of mistakes leading to the collapse of a small dam in Colombia.

Jaime Suarez-Diaz Msc, PE
Distinguished Professor
Universidad Industrial de Santander, Colombia.

GEOVIRGINIA 2018

Lessons Learned in Geotechnical Engineering

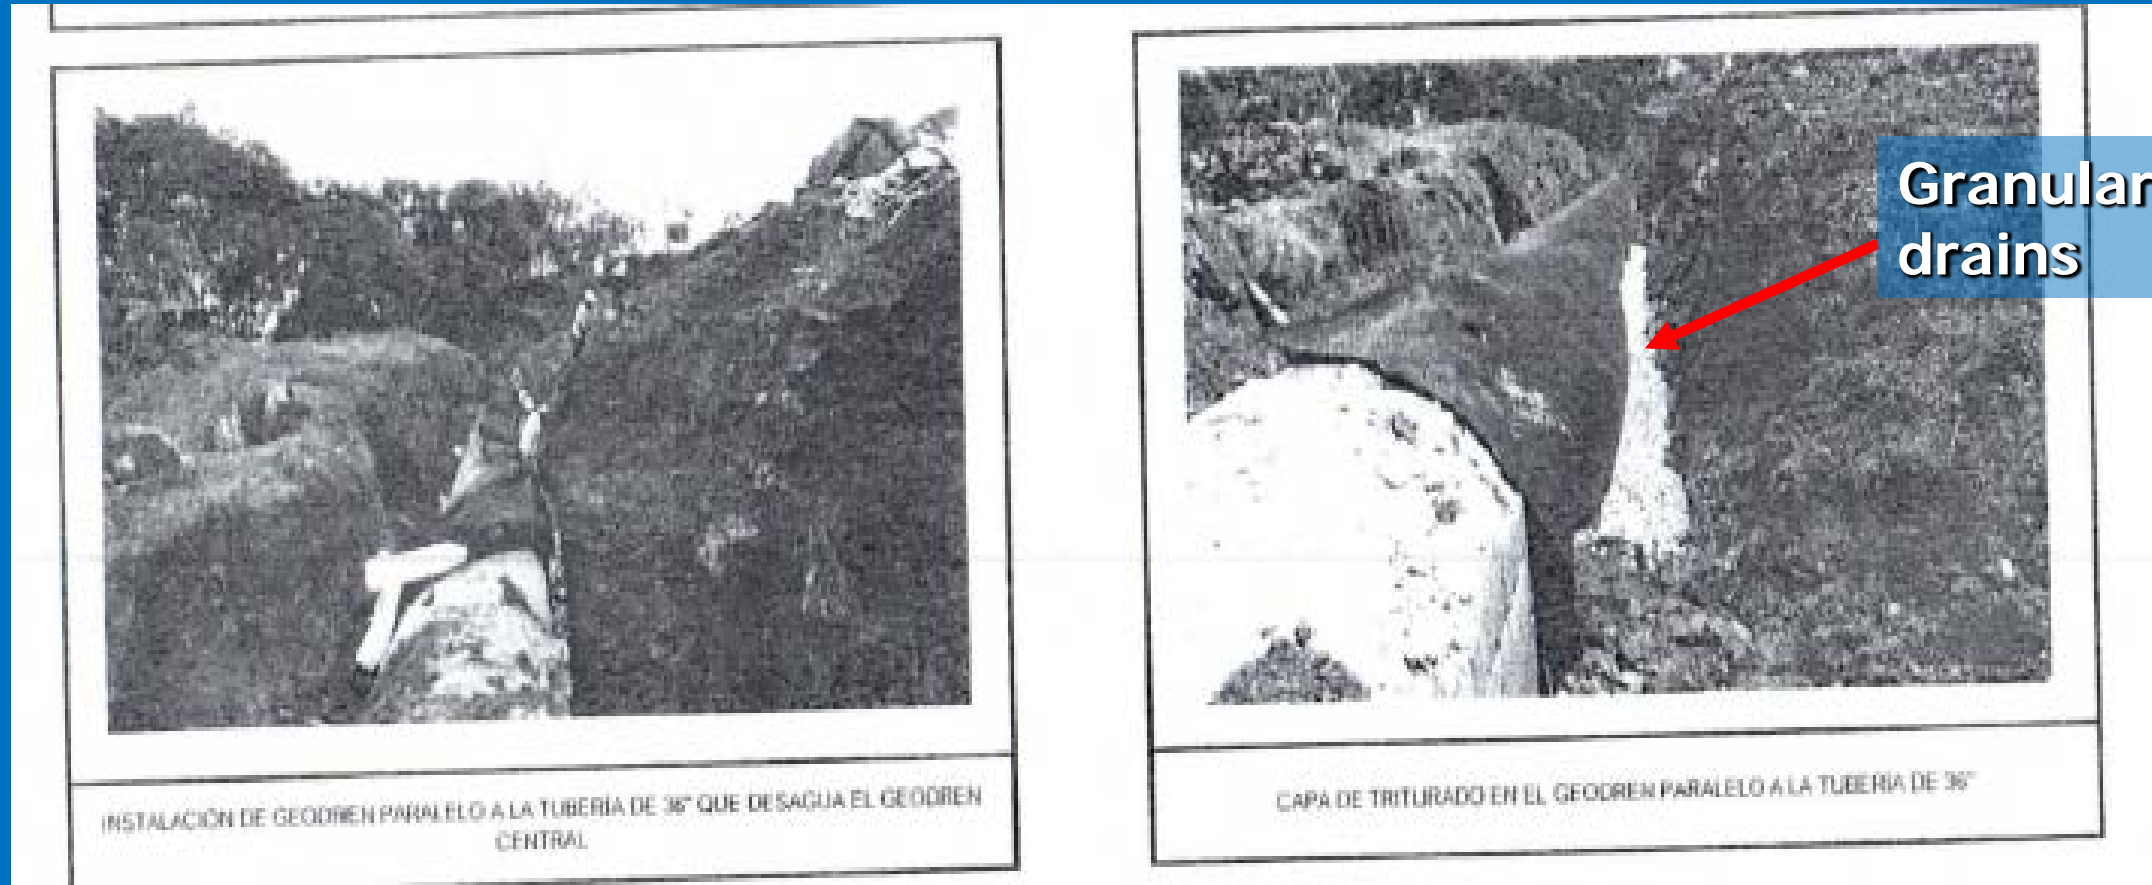
The contractor built small gravel trench drains along the reinforced concrete conduit.

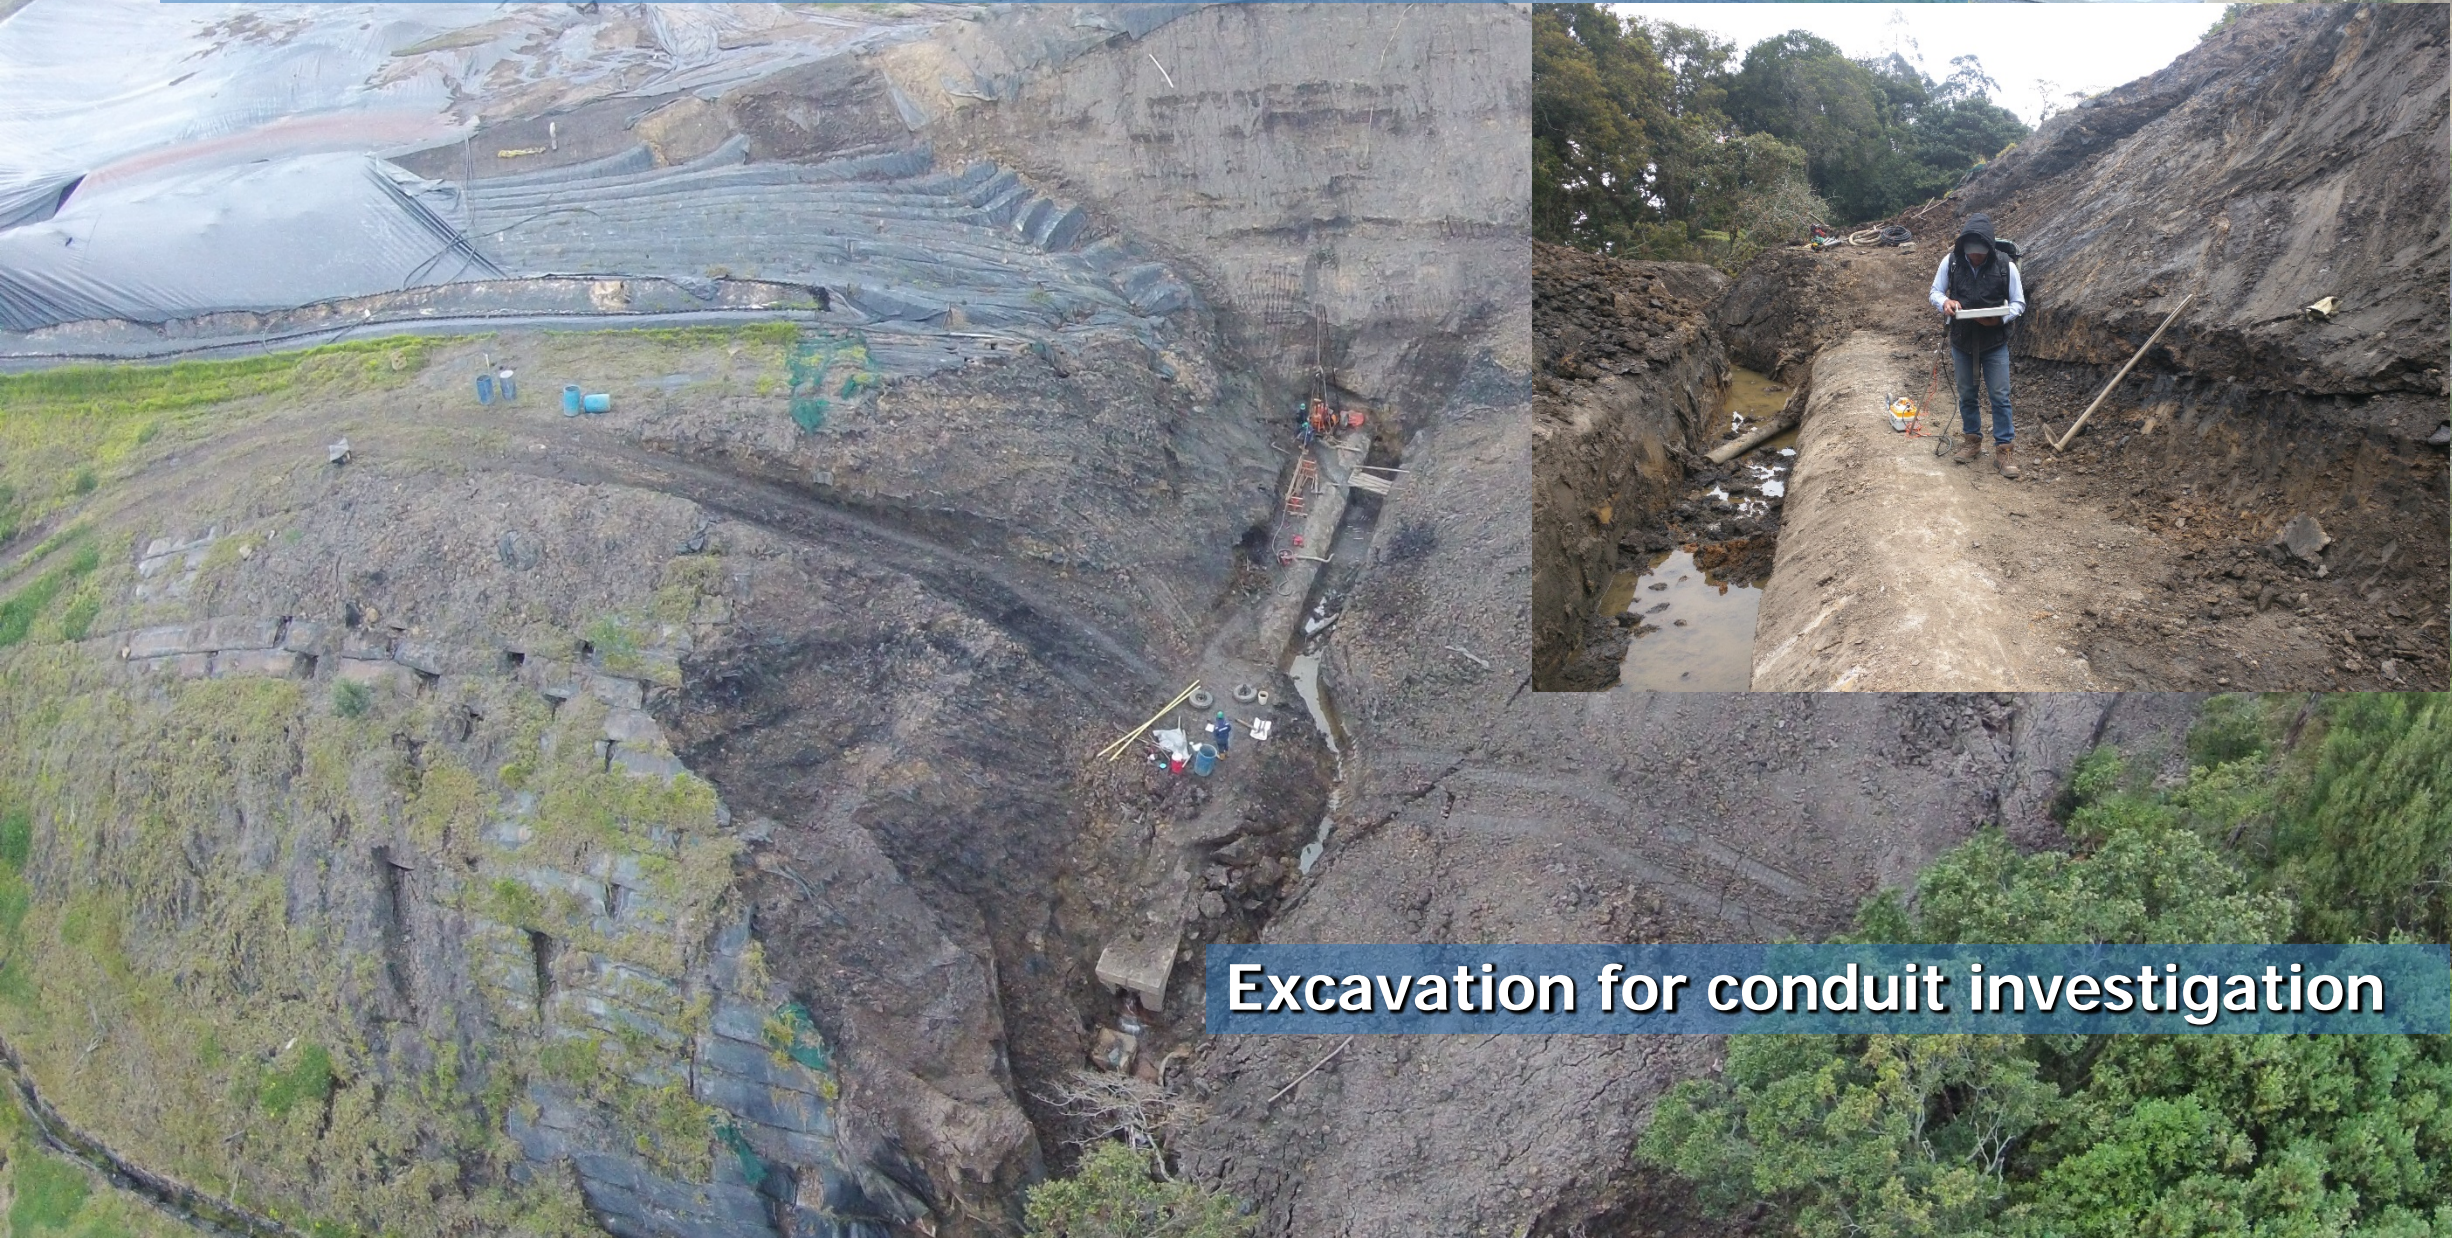
Excavation for conduit investigation

The behavior of the conduit was investigated

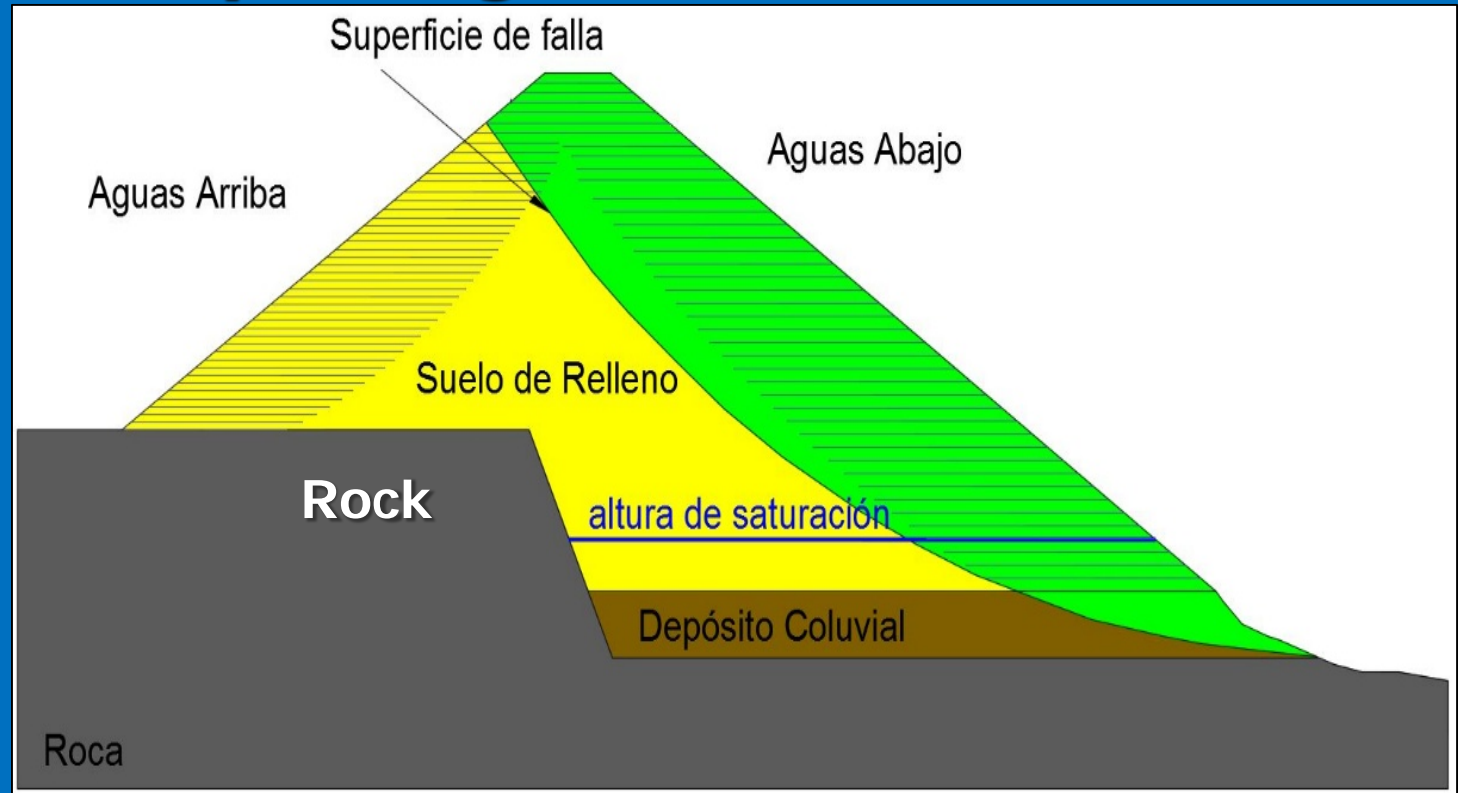
The dam foundation and the conduit was partially on rock and soil. This produced non-uniform settlements of the dam and the conduit.

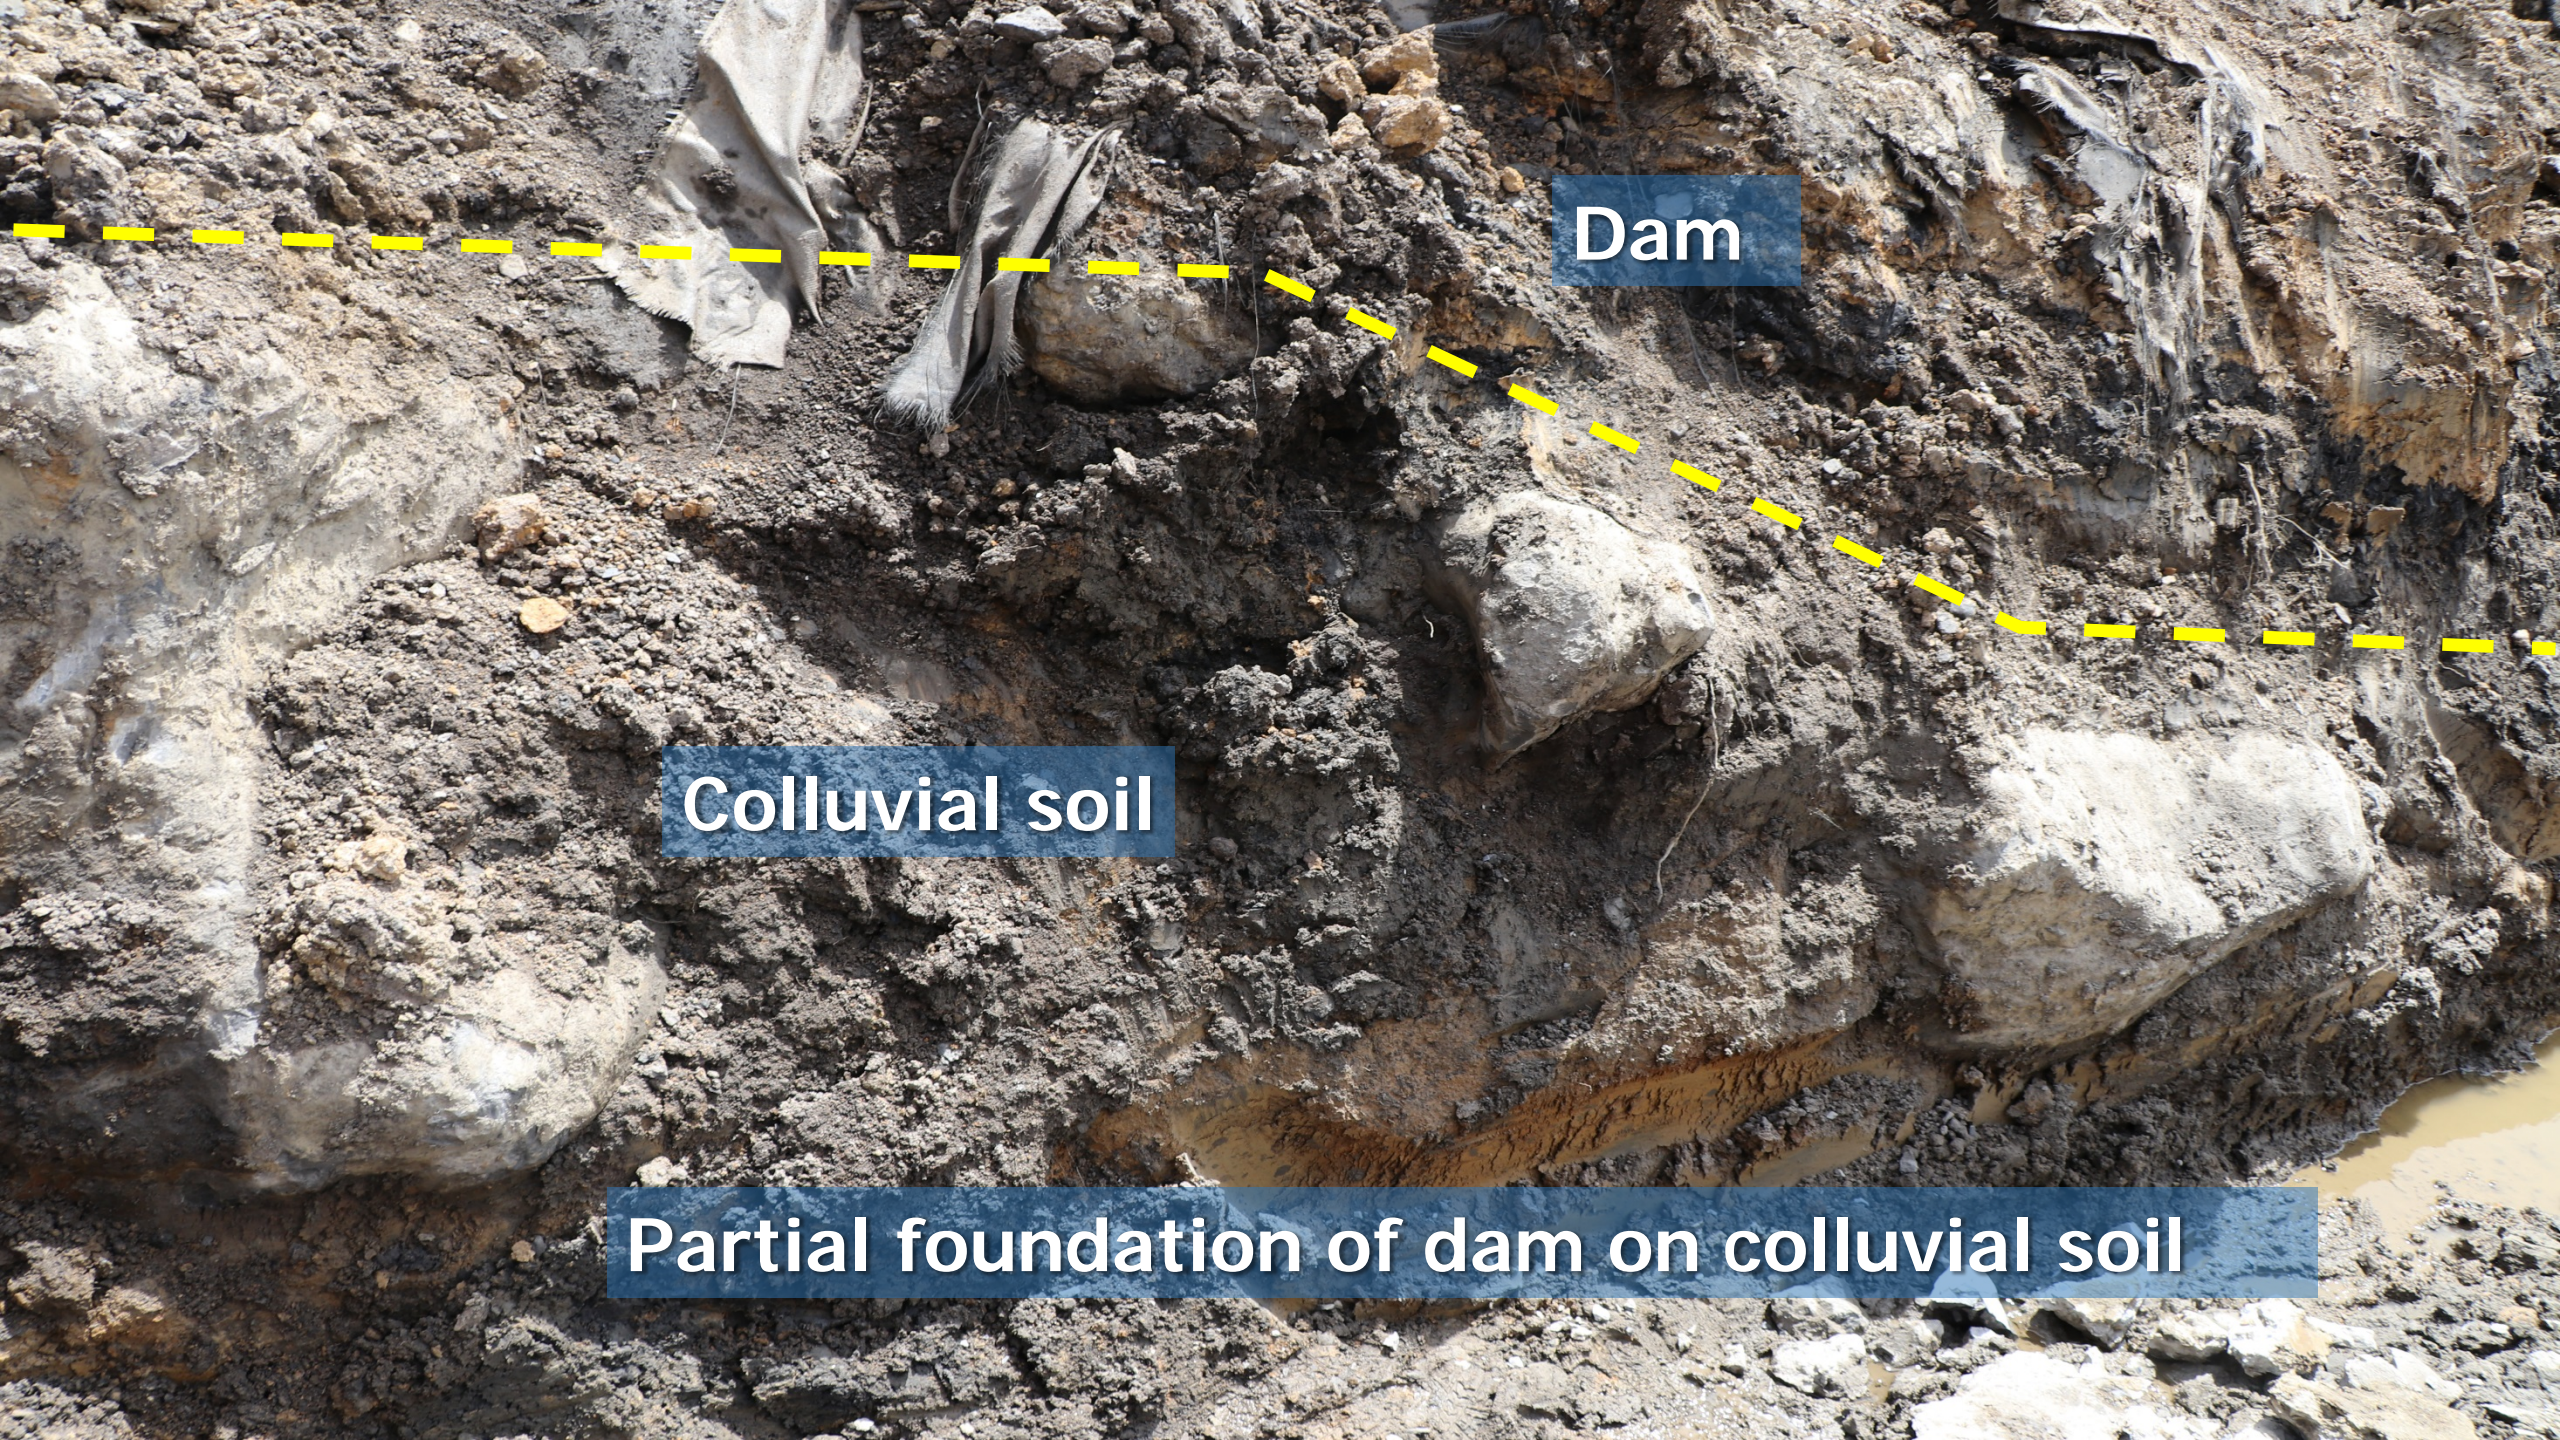
Partial foundation of dam on colluvial soil

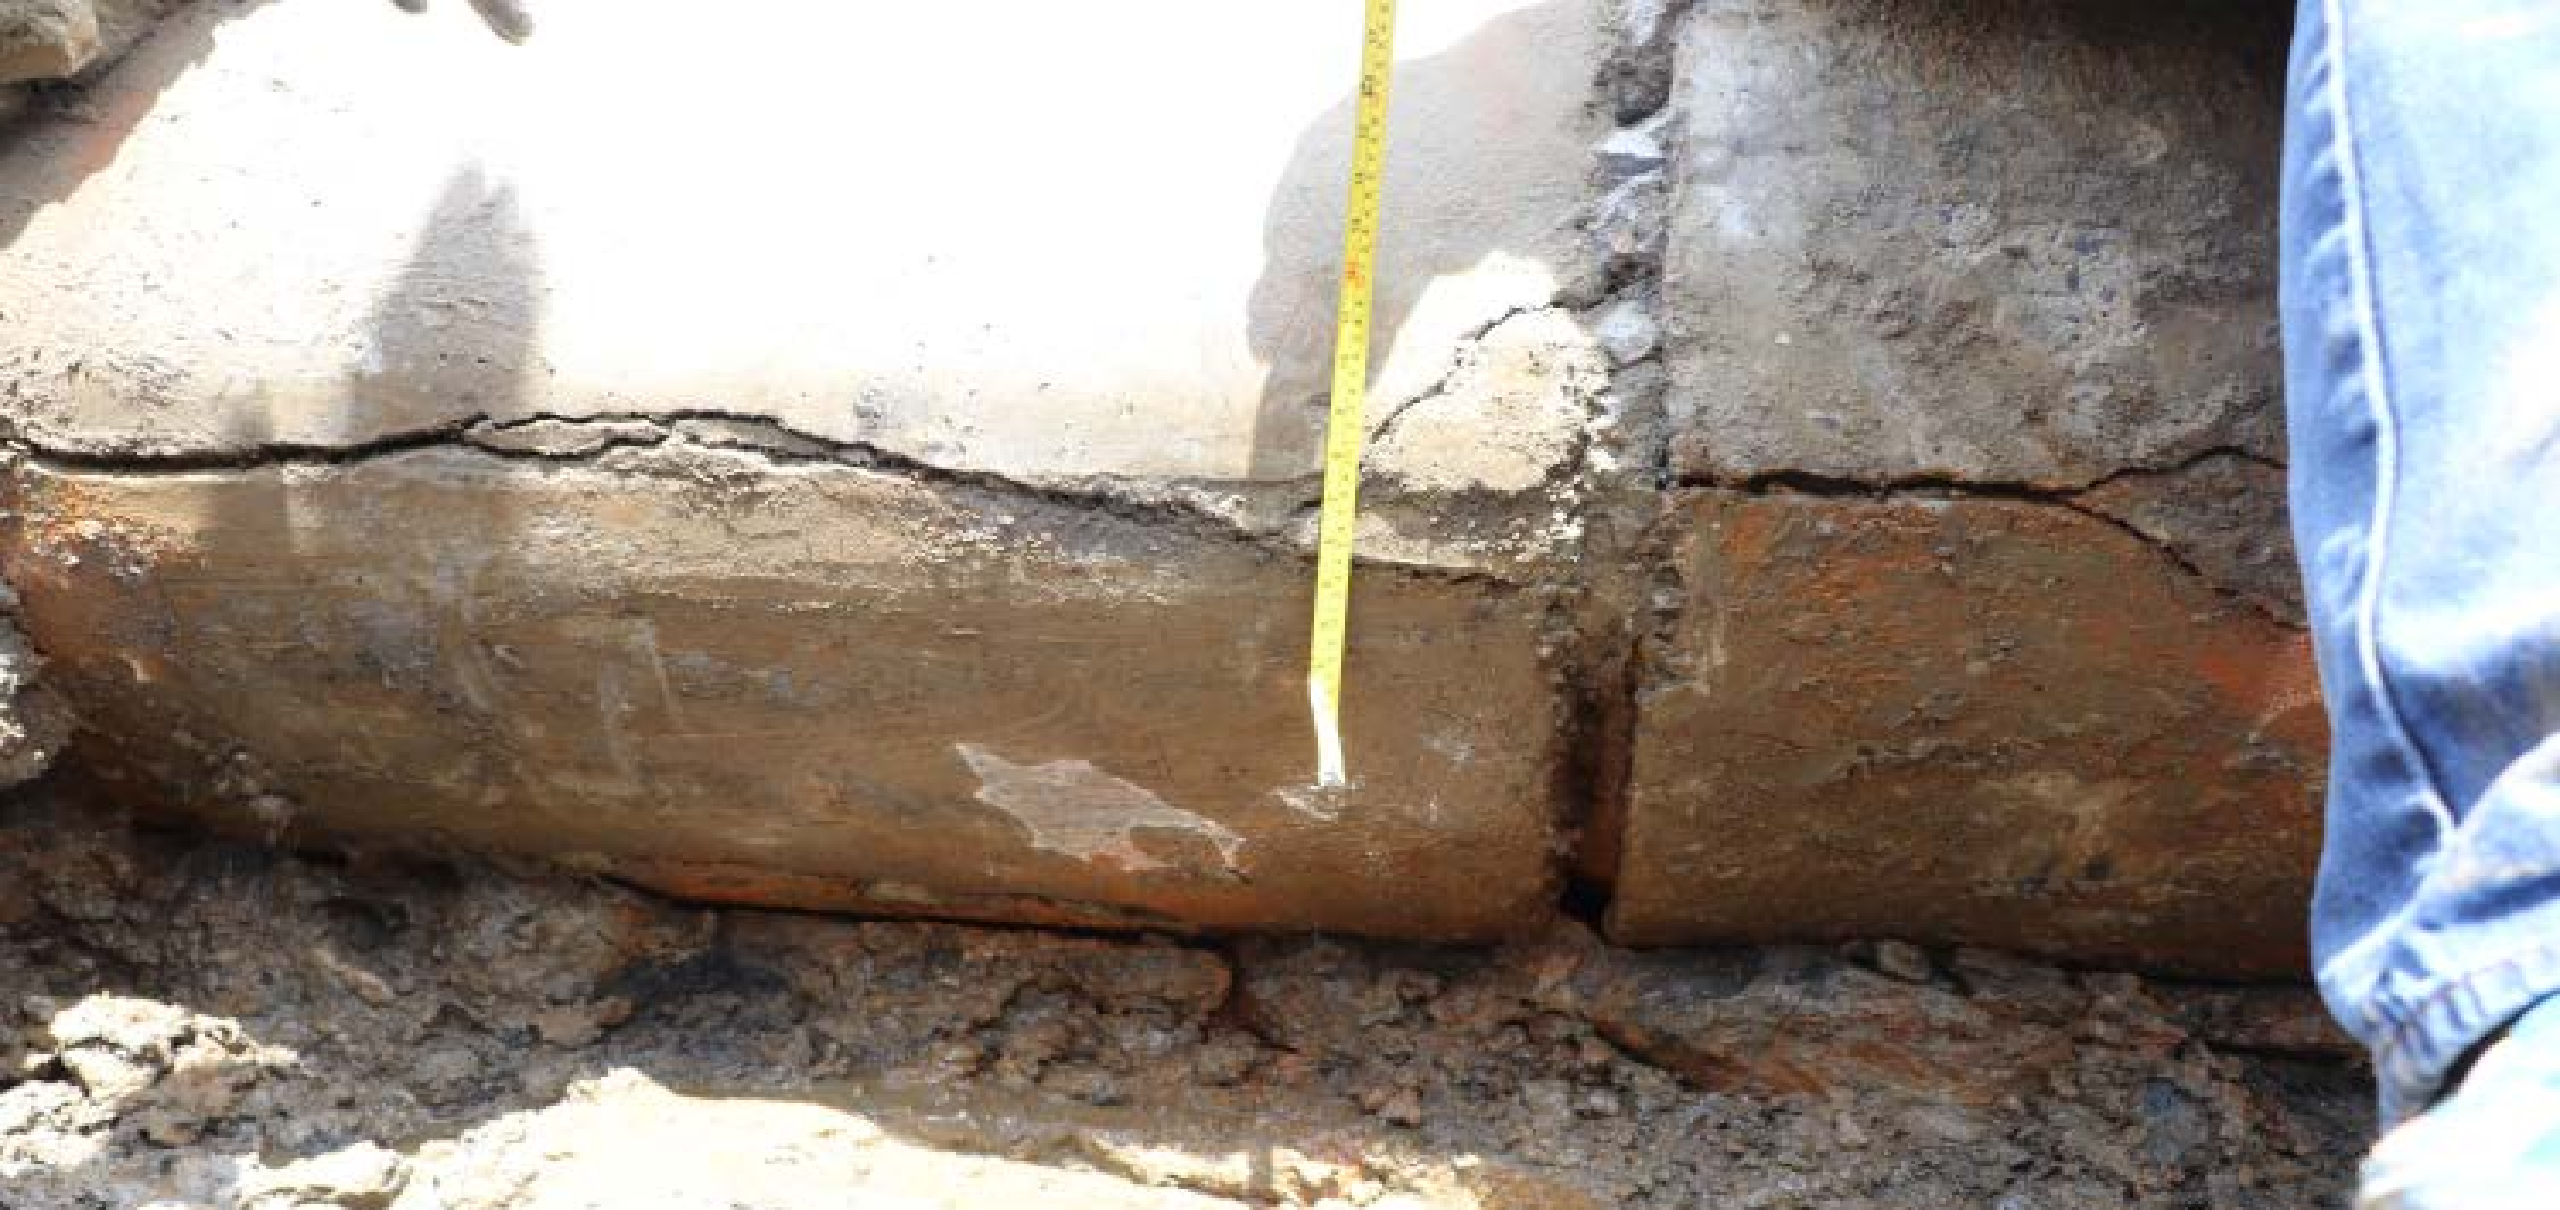
During construction the conduit broke due to non-uniform settlements

Reinforced concrete conduit affected by non-uniform settlements

Cracks on the conduit

Solution implemented by the contractor:

The contractor introduced an additional smaller metallic conduit with fluid concrete between the two tubes

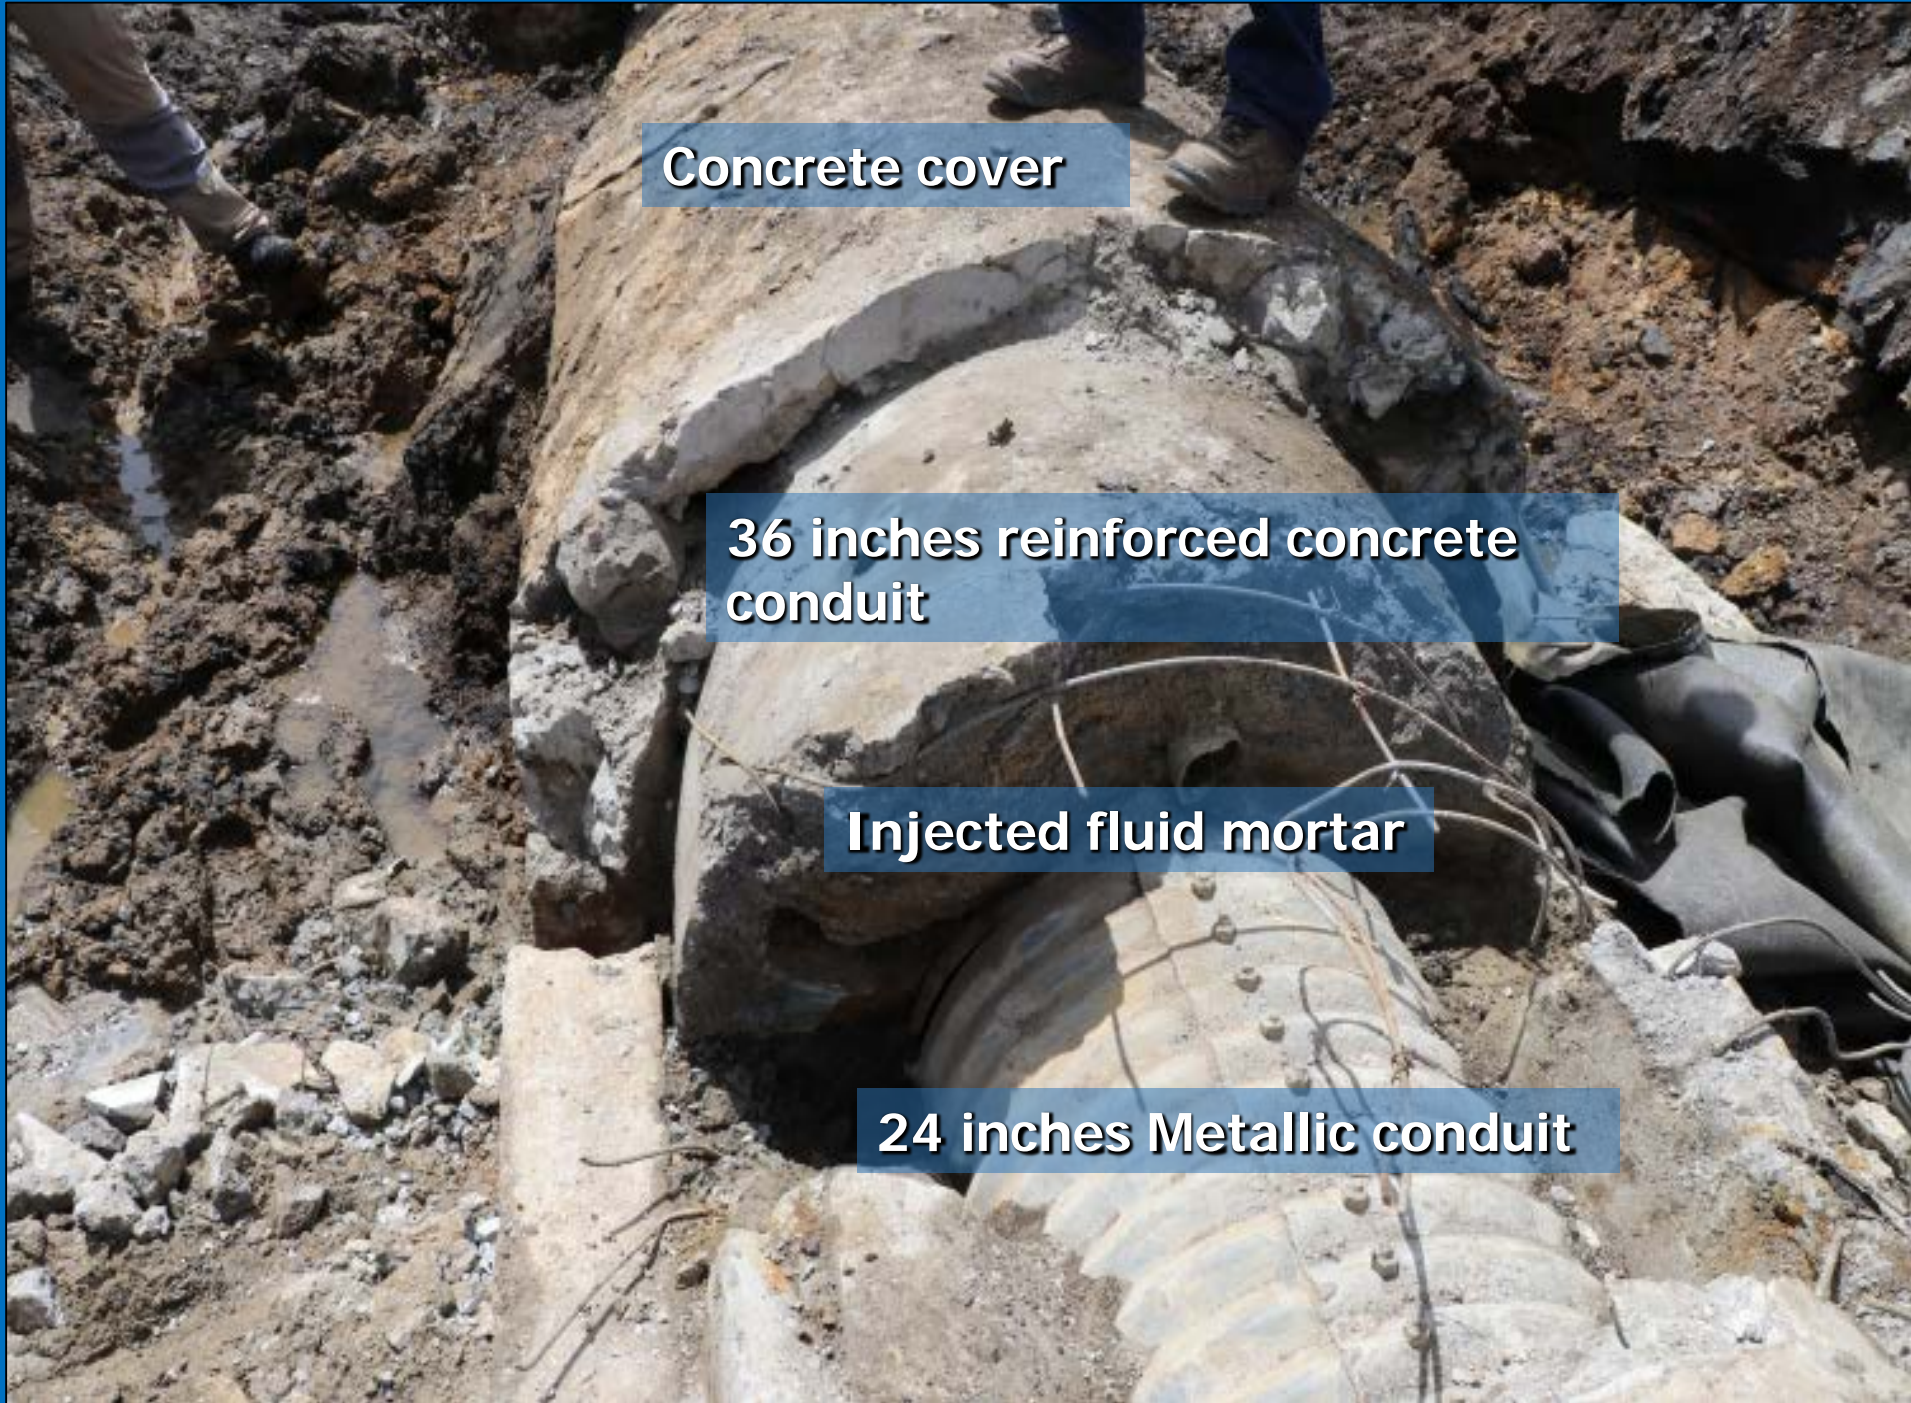
Concrete cover

36 inches reinforced concrete conduit

Injected fluid mortar

24 inches Metallic conduit

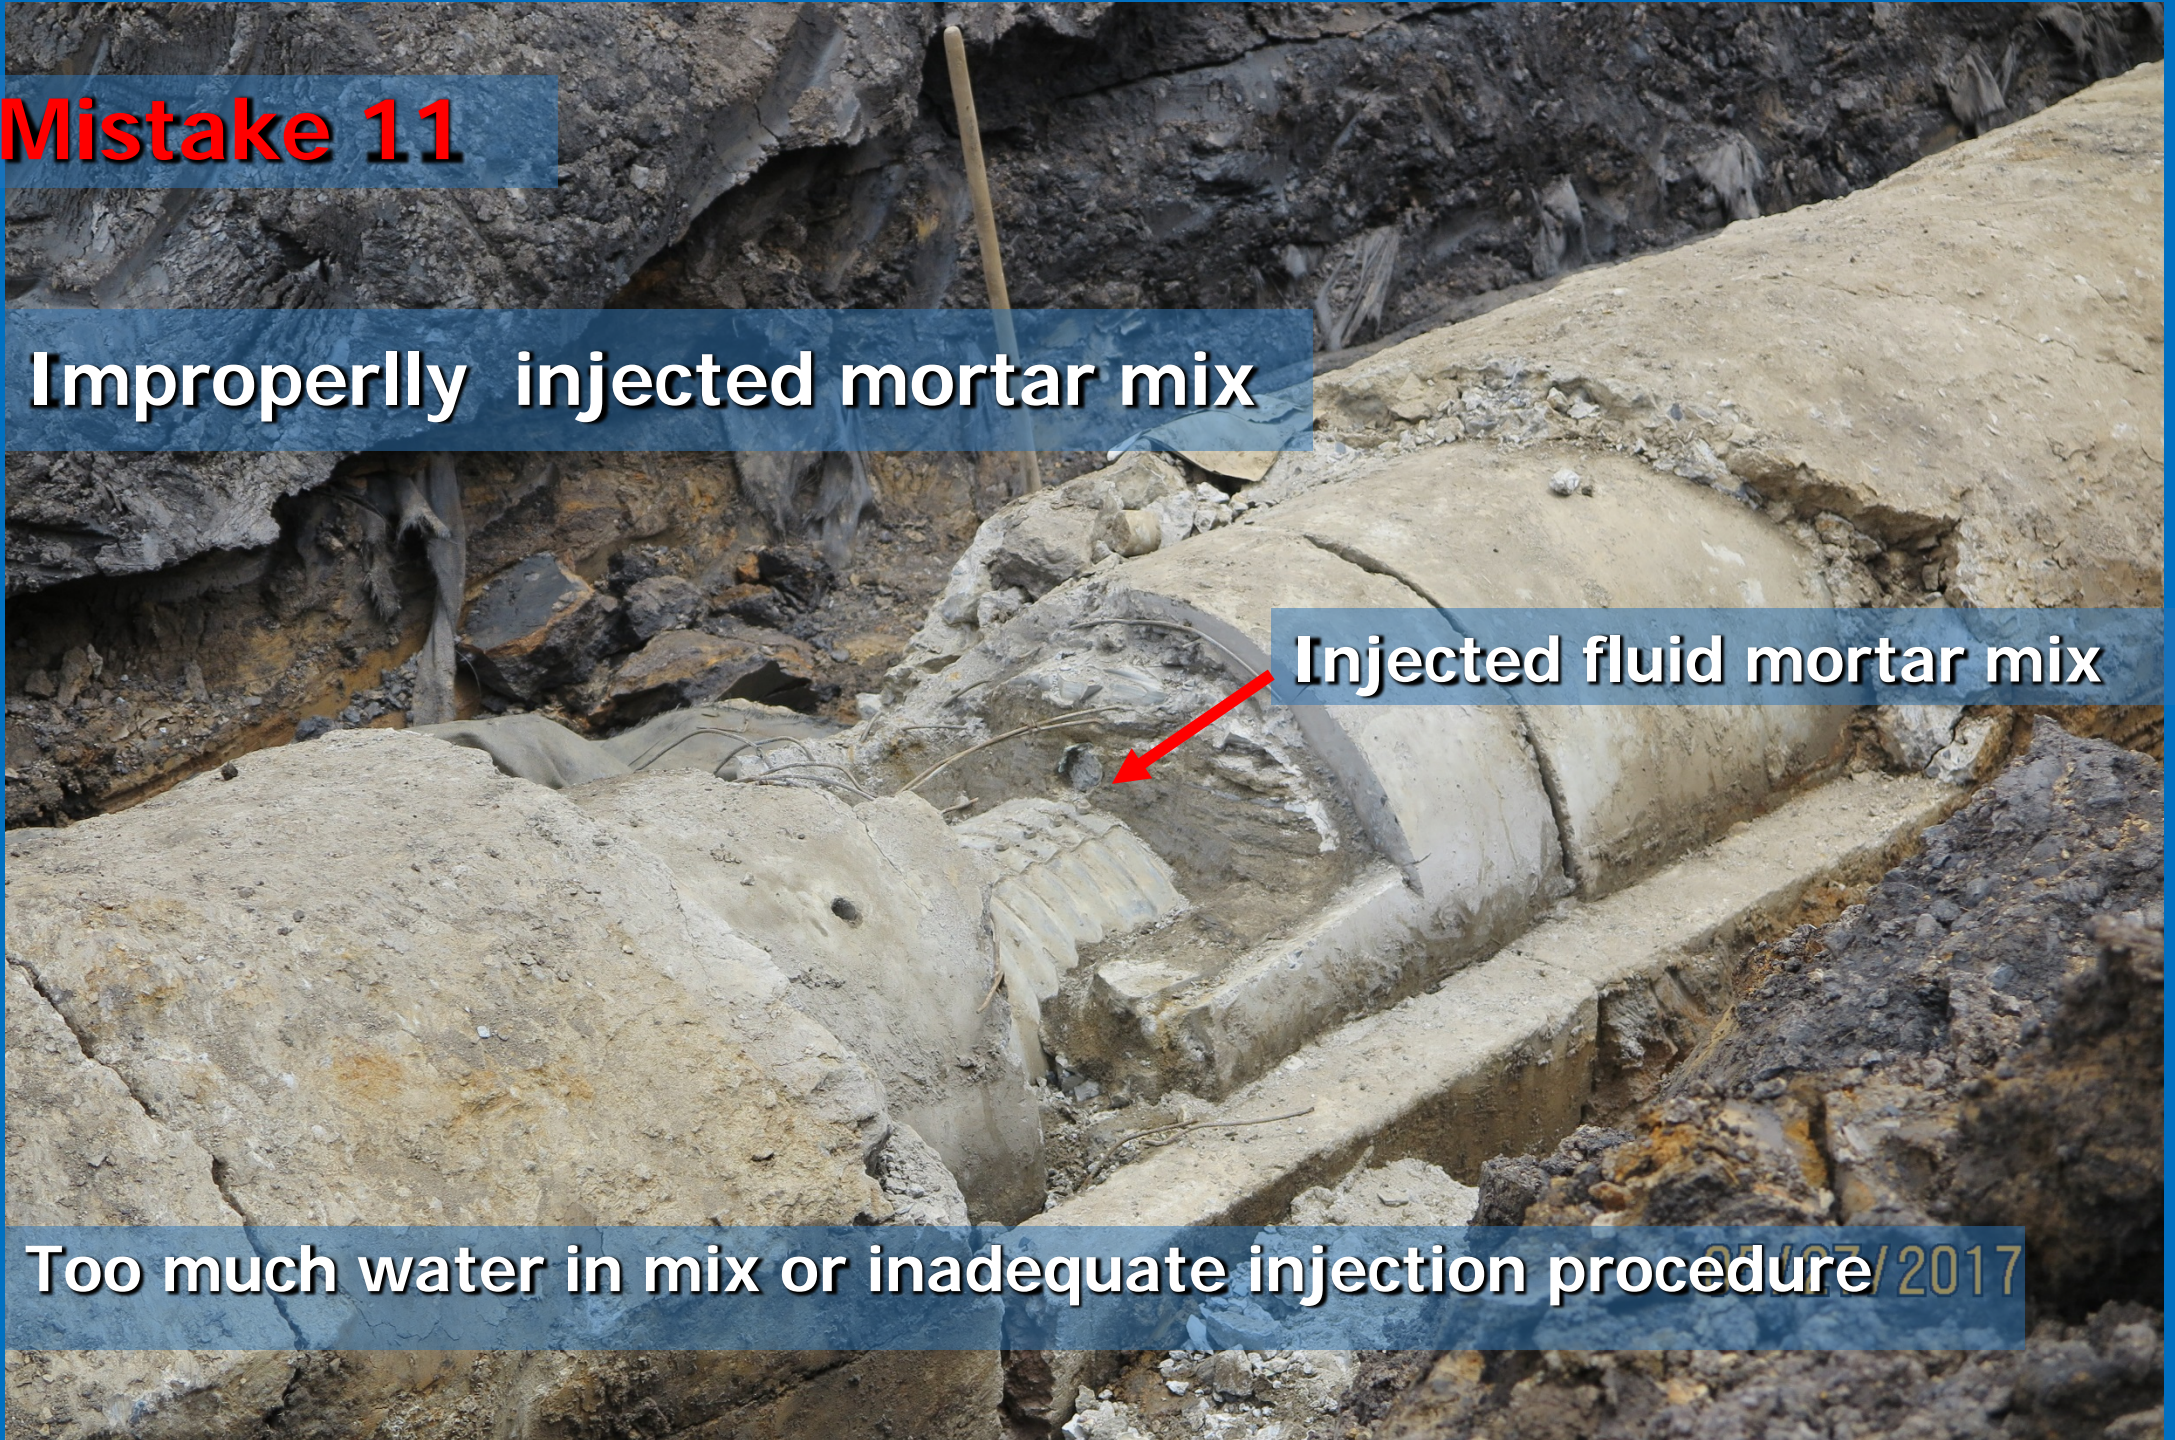
Too much water in mix or inadequate injection procedure

There was sedimentation in the fluid concrete and the solution did not work.

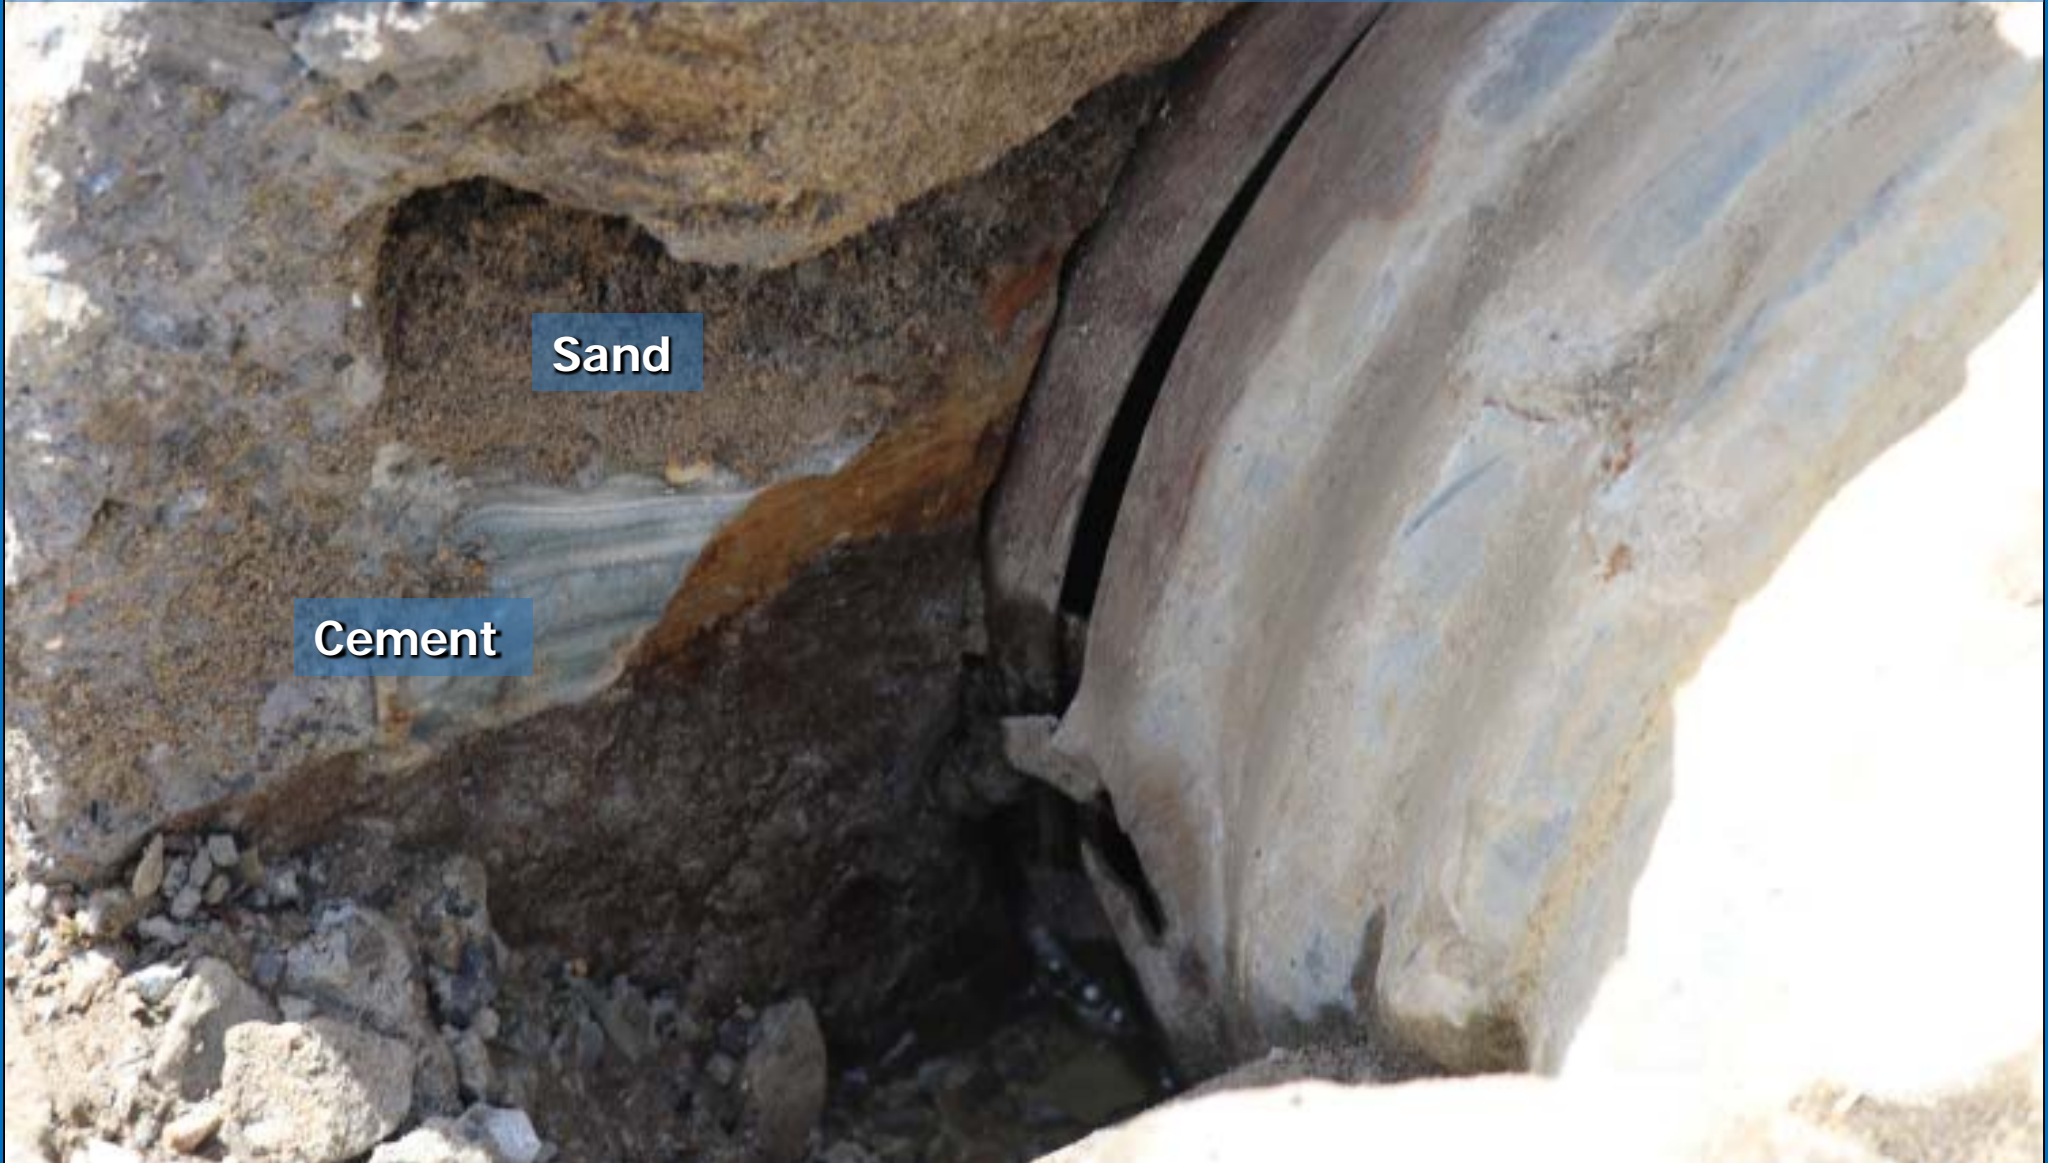
Sedimentation of fluid mortar
