Series of mistakes leading to the collapse of a small dam in Colombia.

Jaime Suarez-Diaz Msc, PE
Distinguished Professor
Universidad Industrial de Santander, Colombia.

GEOVIRGINIA 2018

Lessons Learned in Geotechnical Engineering

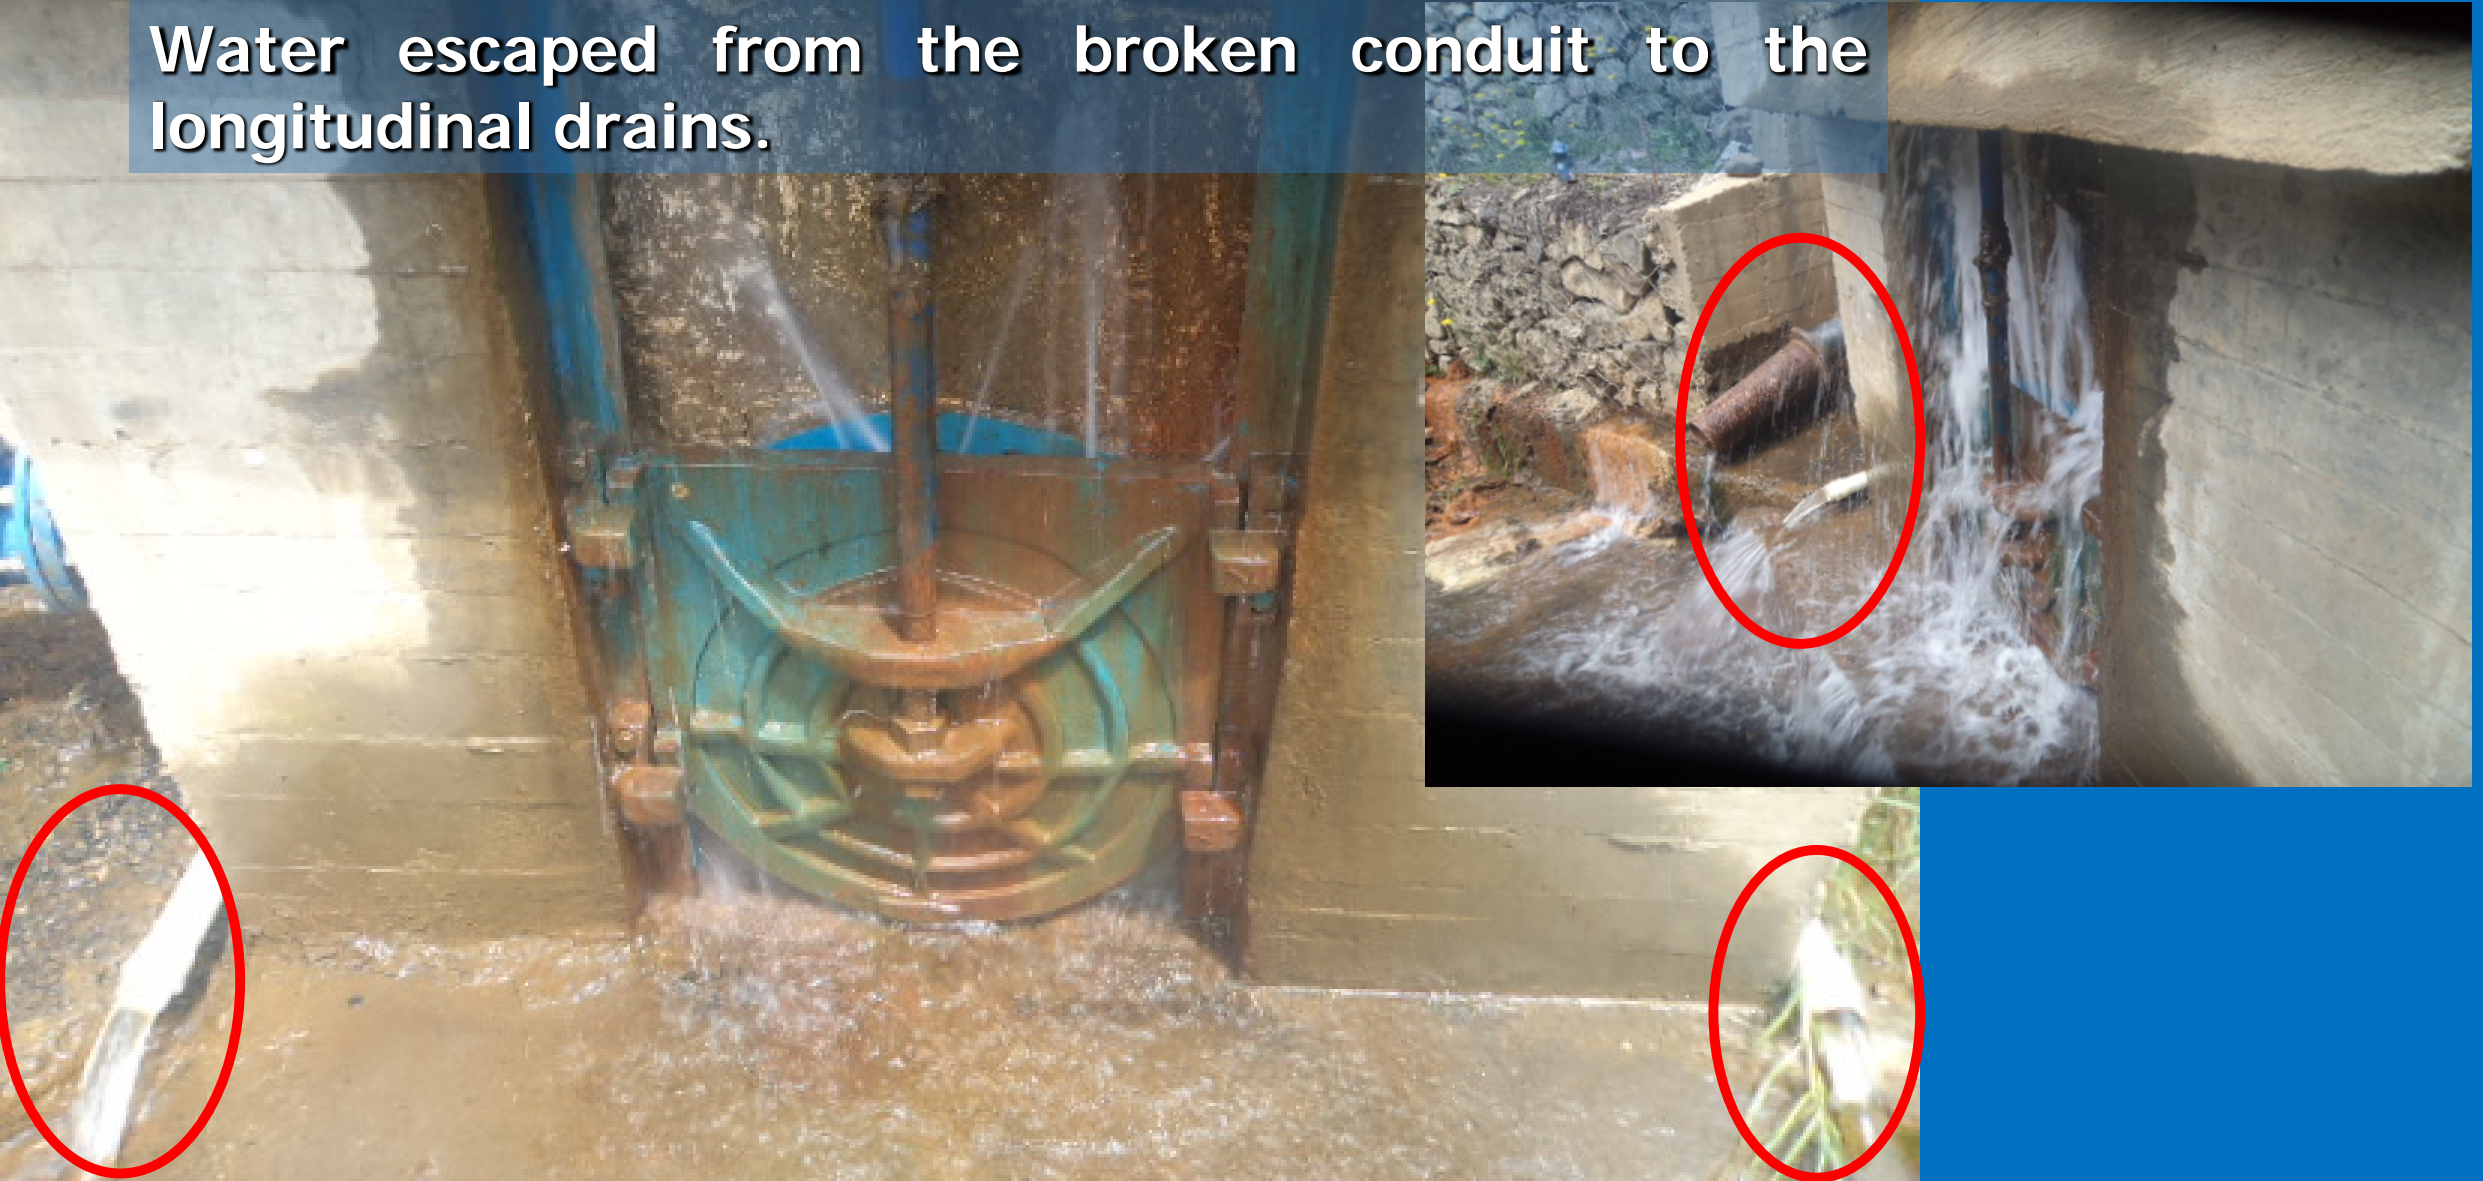
Picture one week after filling the reservoir

Water escaped from the broken conduit to the longitudinal drains.

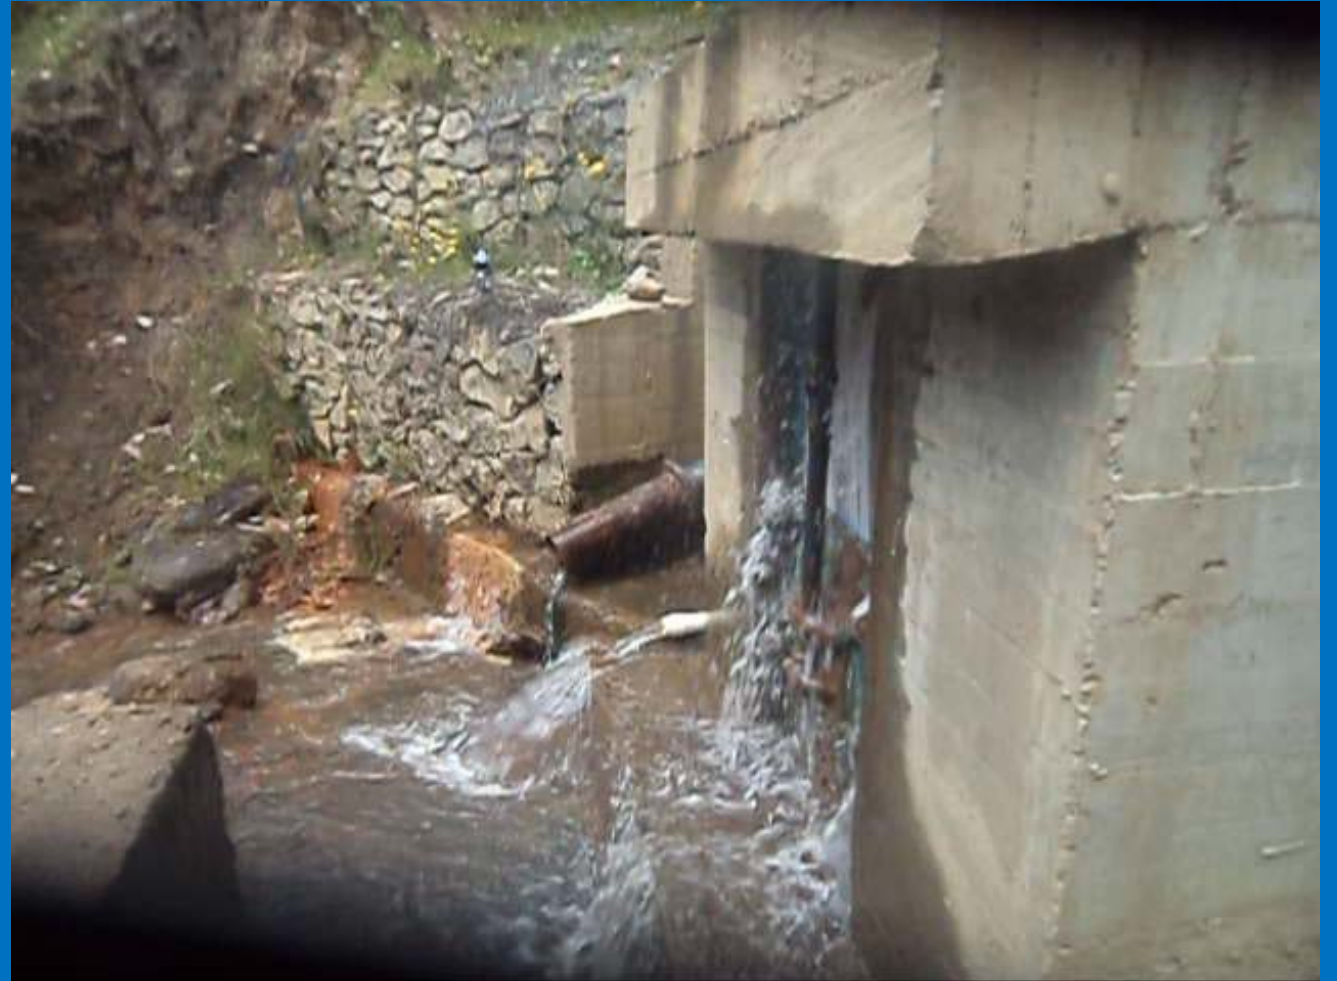
Video one week before failure

Flow on the white conduit comes from drains along the main conduit.

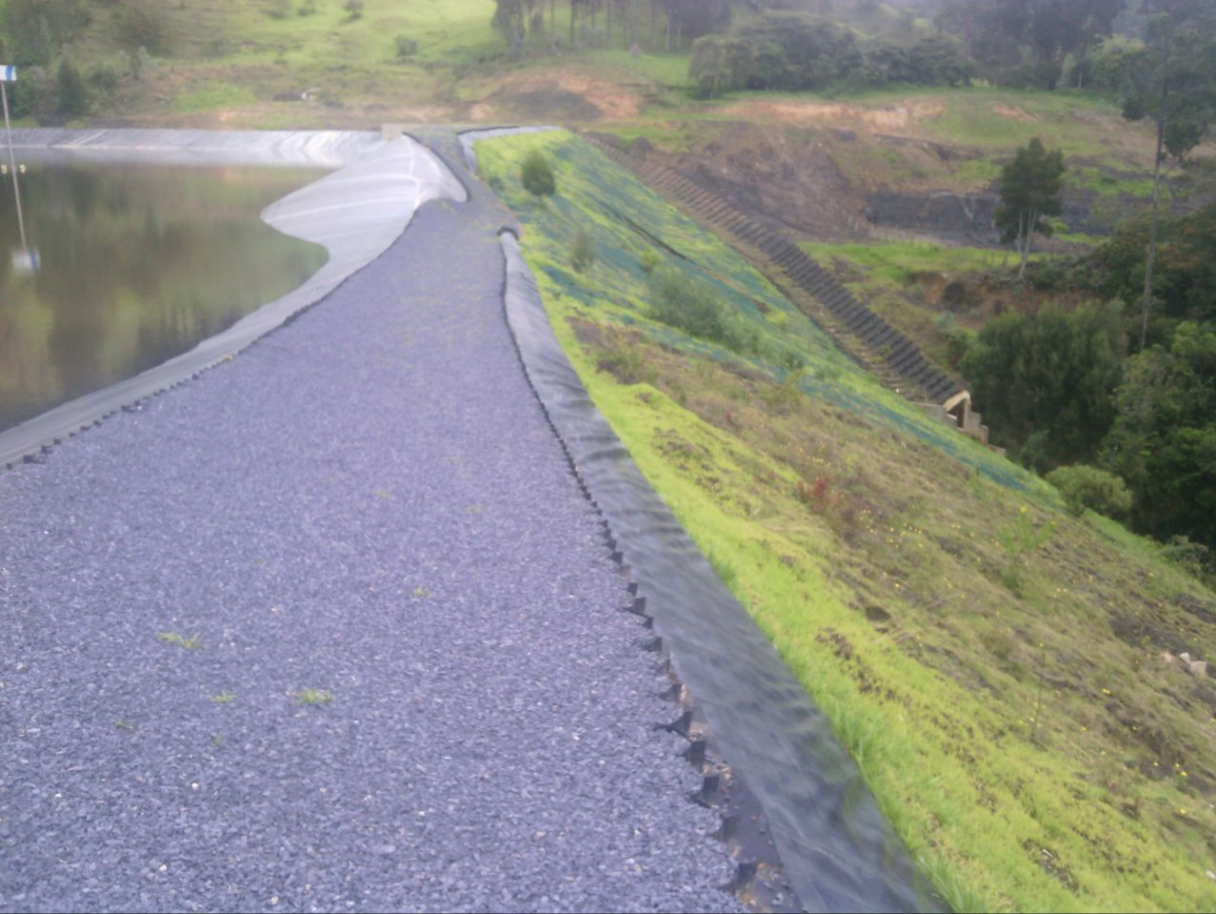
Small amount of water flowing from geosynthetic planar drains.

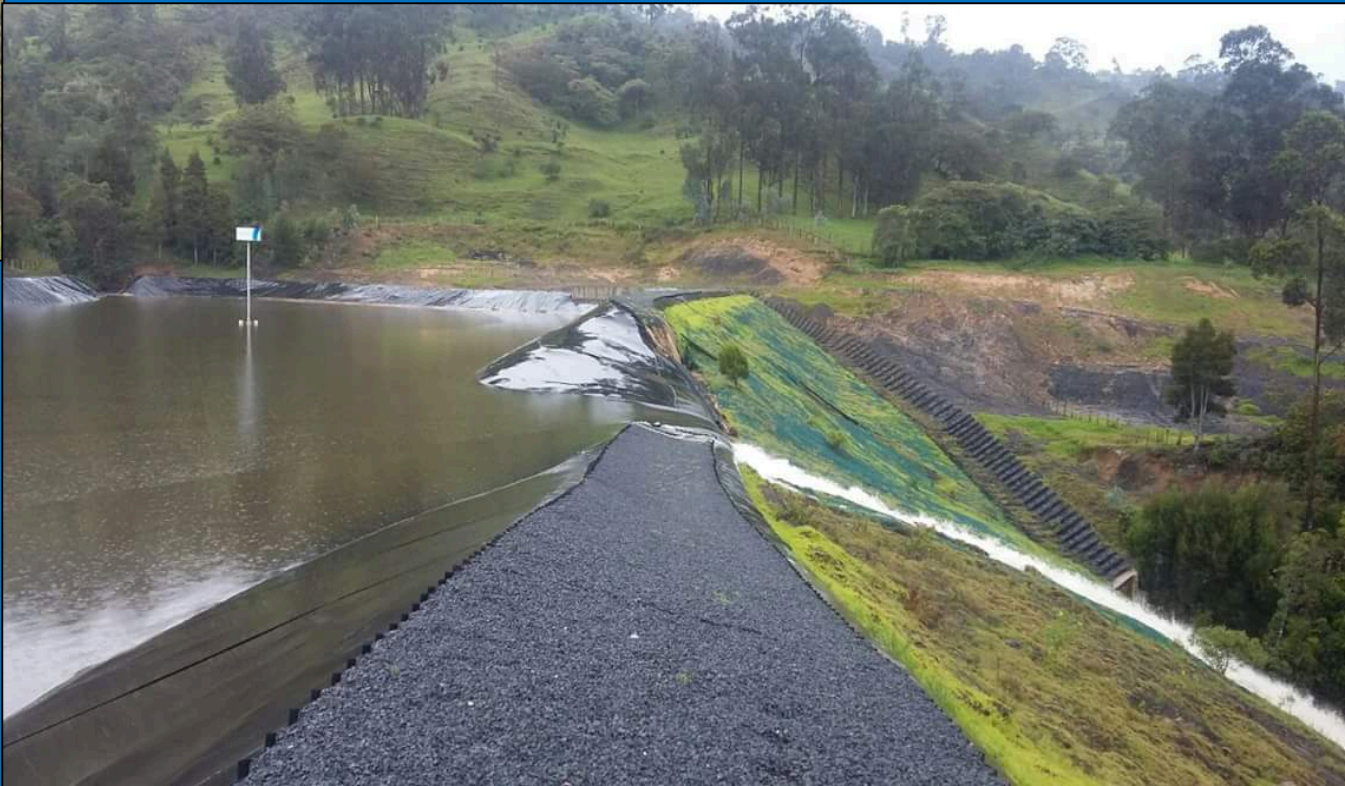
Two weeks after the reservoir filled up slope failure started.
