Dams and Reservoirs; Lessons Learned

Ray E. Martin, Ph.D., P.E., D.GE

Outline of Case Histories

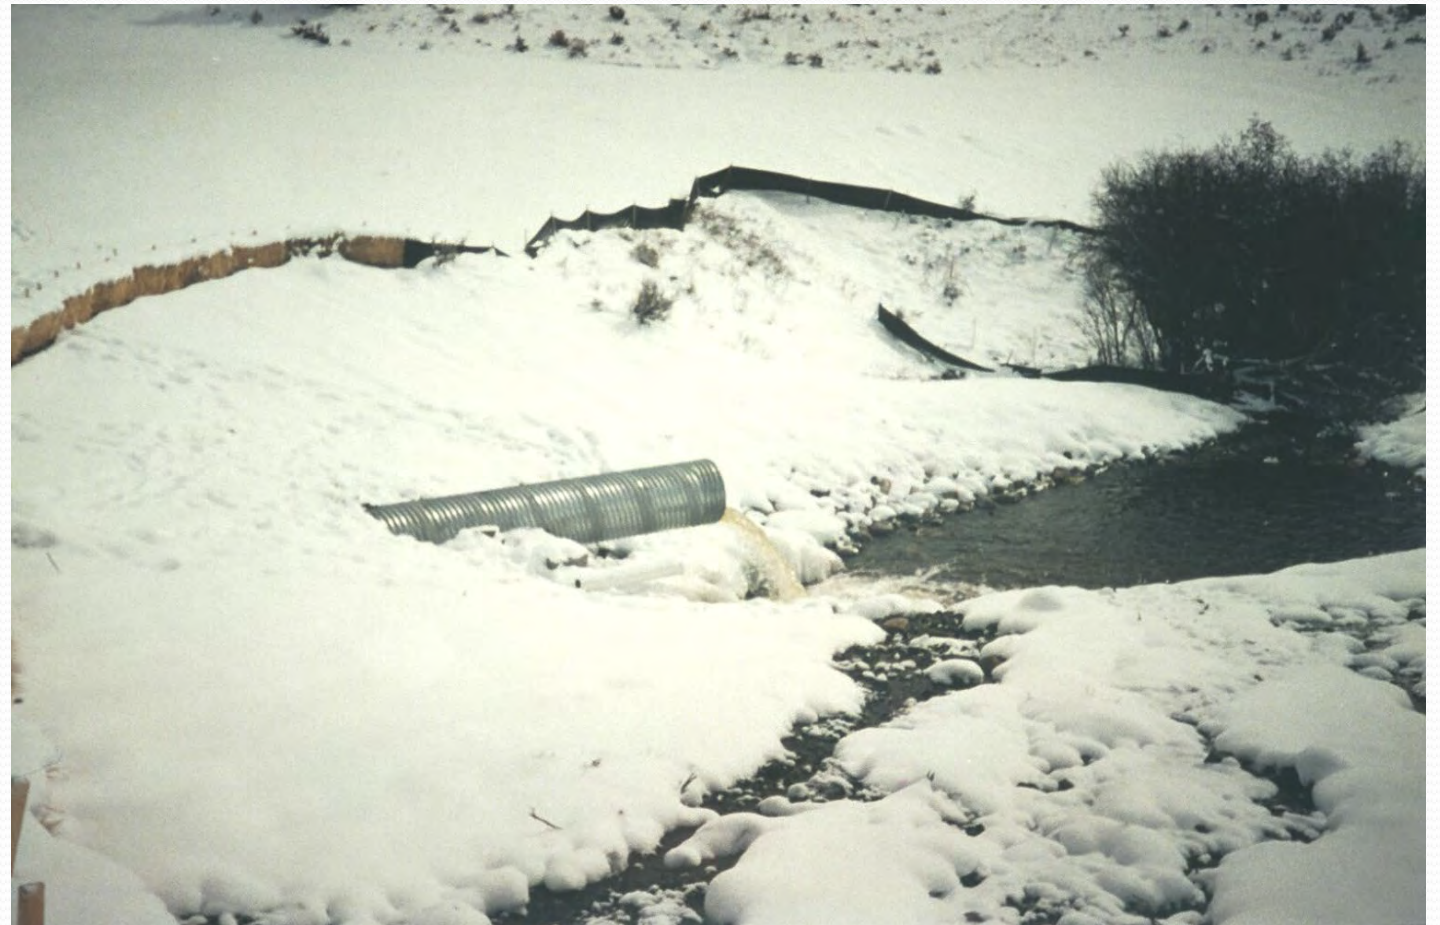
After Reservoir Filled – Urgent Call

- Ranch manager called: “seepage flowing from toe of dam on right side of outfall pipe”
- Ray: “Drain the lake ASAP”
- What caused the seepage?

Repair

- Backfill excavation with compacted fill from borrow pit
- Construct inverted filter-drainage blanked over seepage area

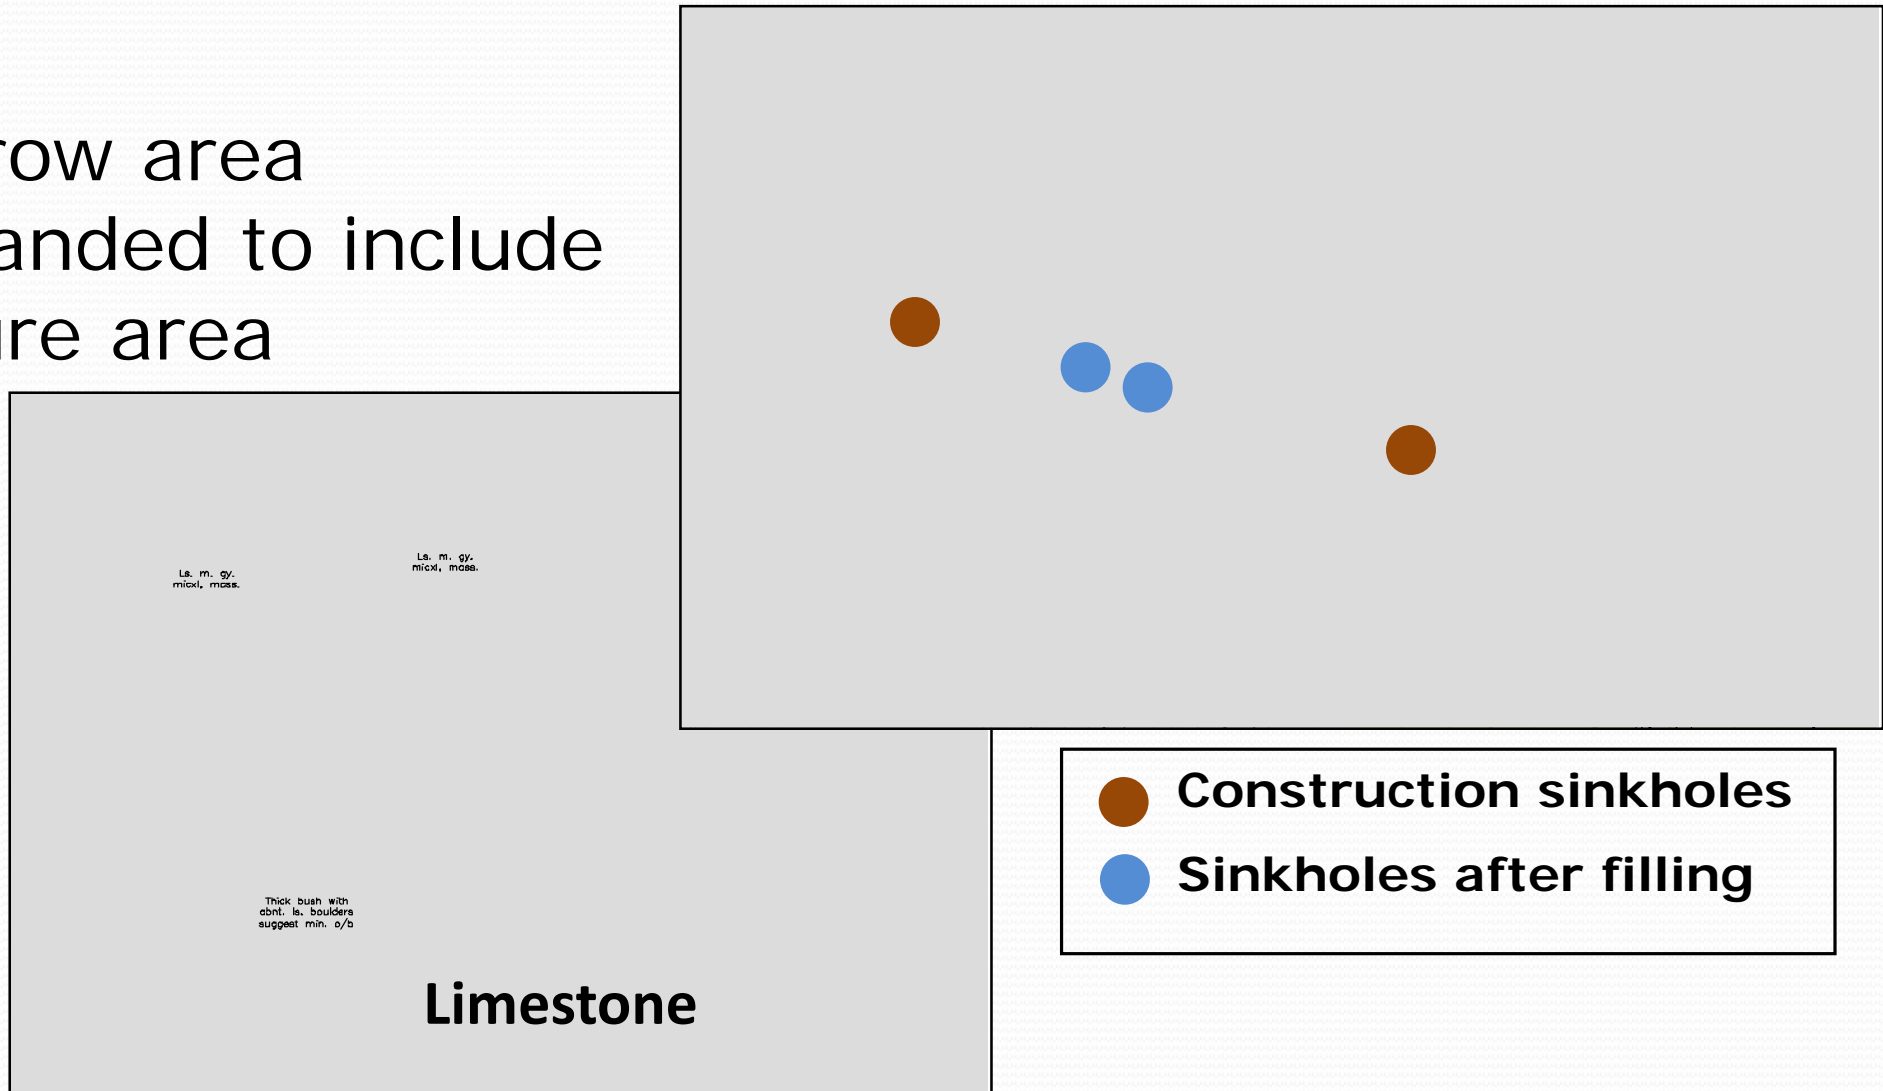
Adverse Geologic Conditions

- Borrow area expanded to include failure area

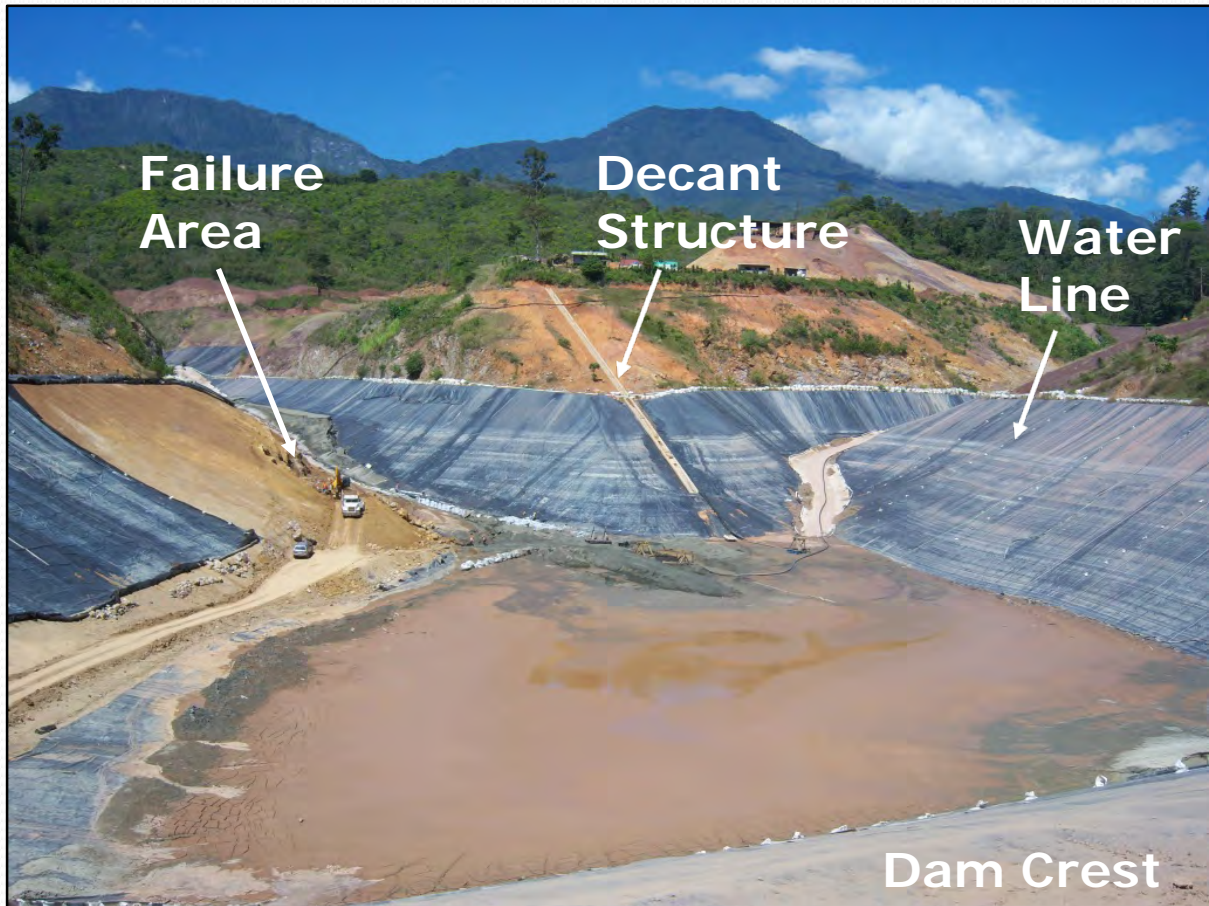
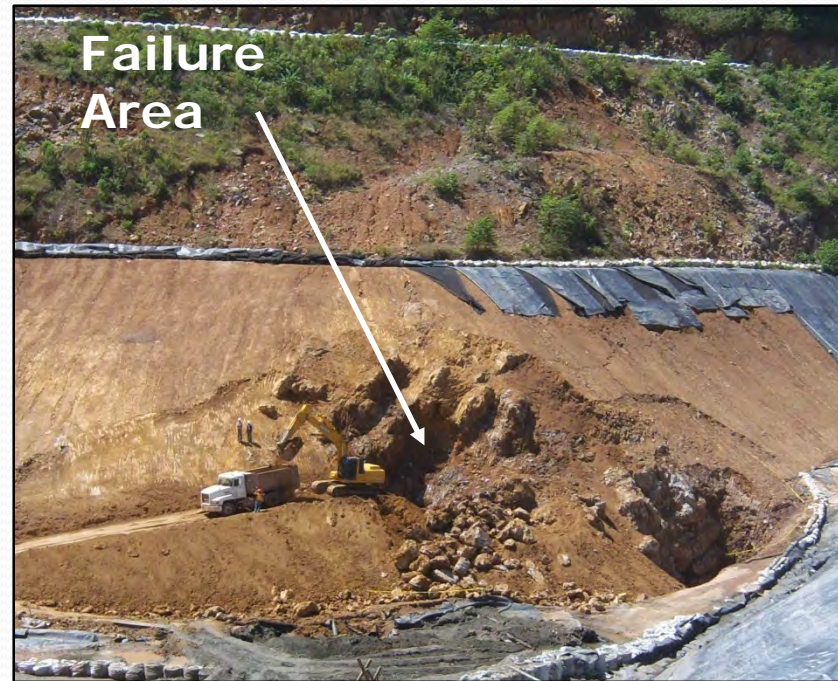
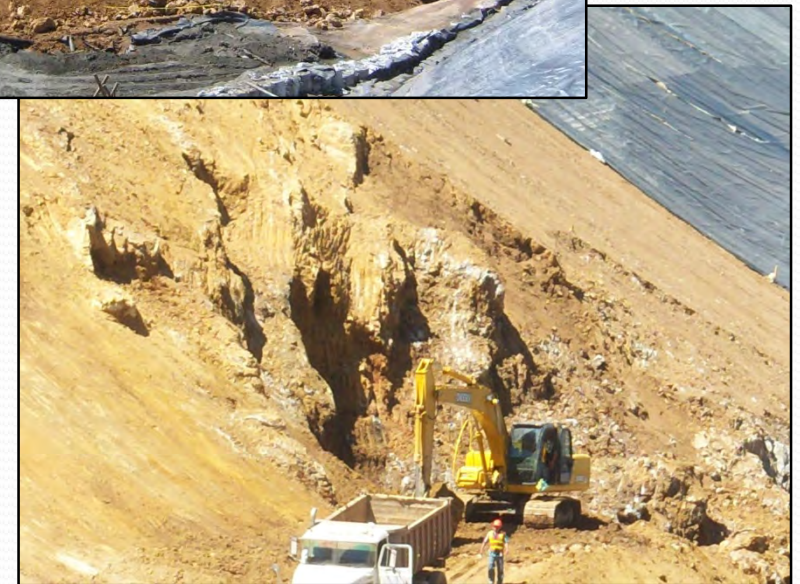
- Liner seams likely failed - differential movement?
- Seepage entered soils reduced in thickness by excavation
- Soil piped into limestone solution features
- Sinkhole formed
- Liner/geogrid failed to support water load over sinkhole
- Pond drained into subsurface and exited downstream
- A large environmental problem in stream

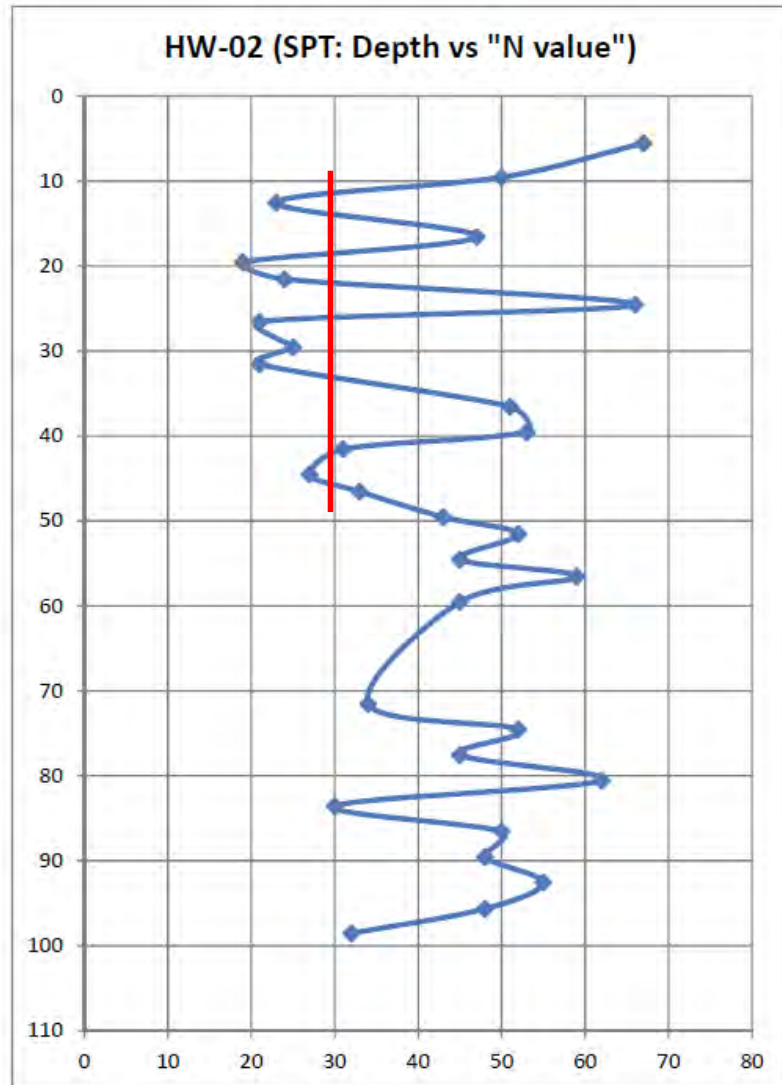
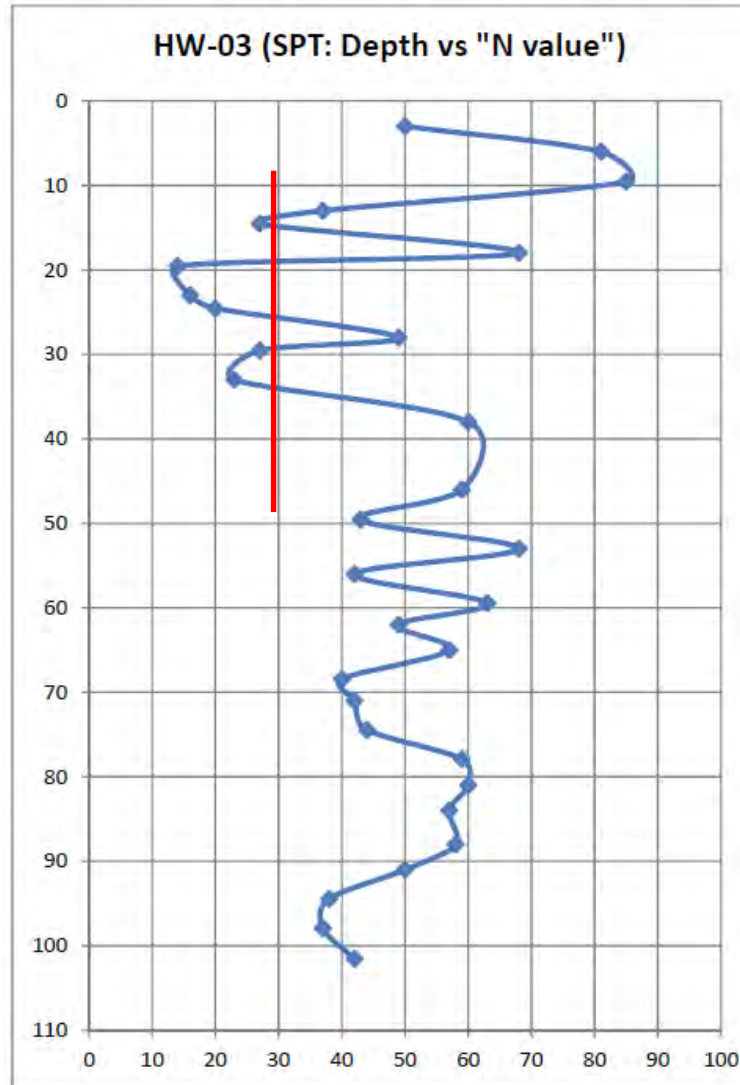
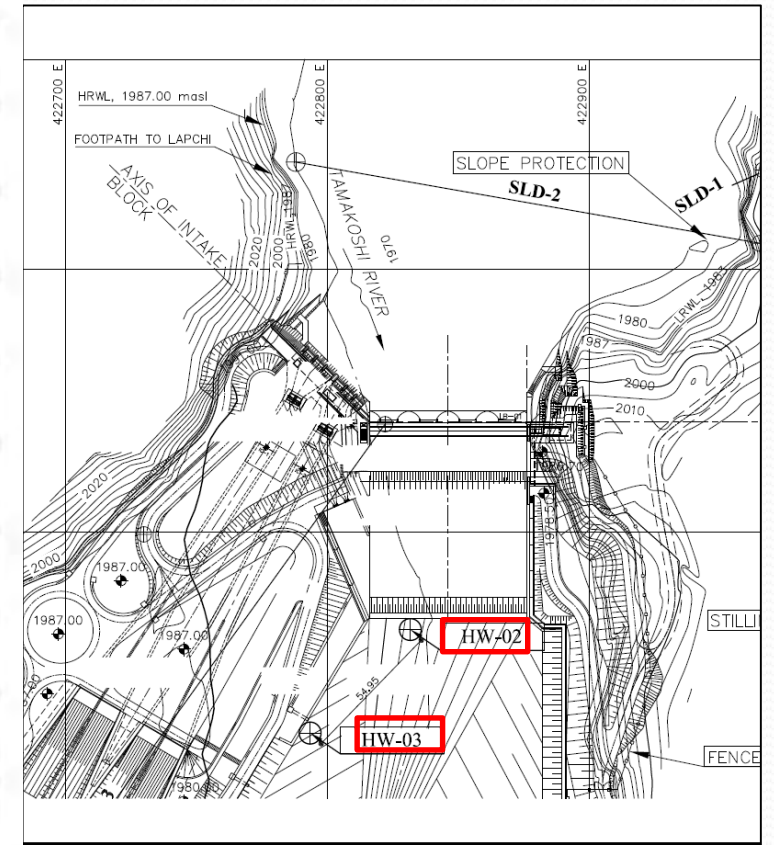
Post Site Visit Borings – Rock 121 m (2016)

- Liquefaction
 - Volumetric strain $\sim 1\%$ - limited depth of liquefiable soil
- Volumetric compression (densification)
 - Volumetric strain $\sim 0.15\%$
- Tectonic movements
 - Possible strike-slip movement on fault in valley
 - Evidence not supportive
- Panel conclusion - densification was likely cause
- How would you have designed the dam?

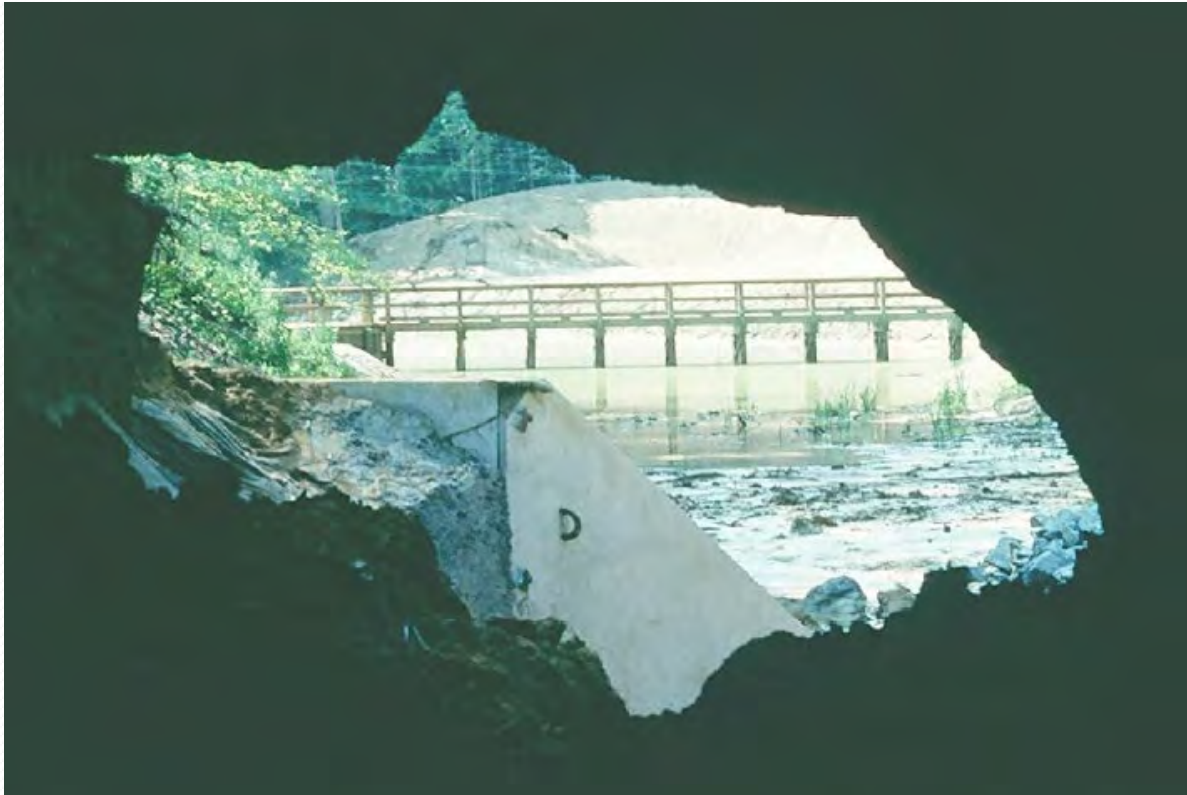
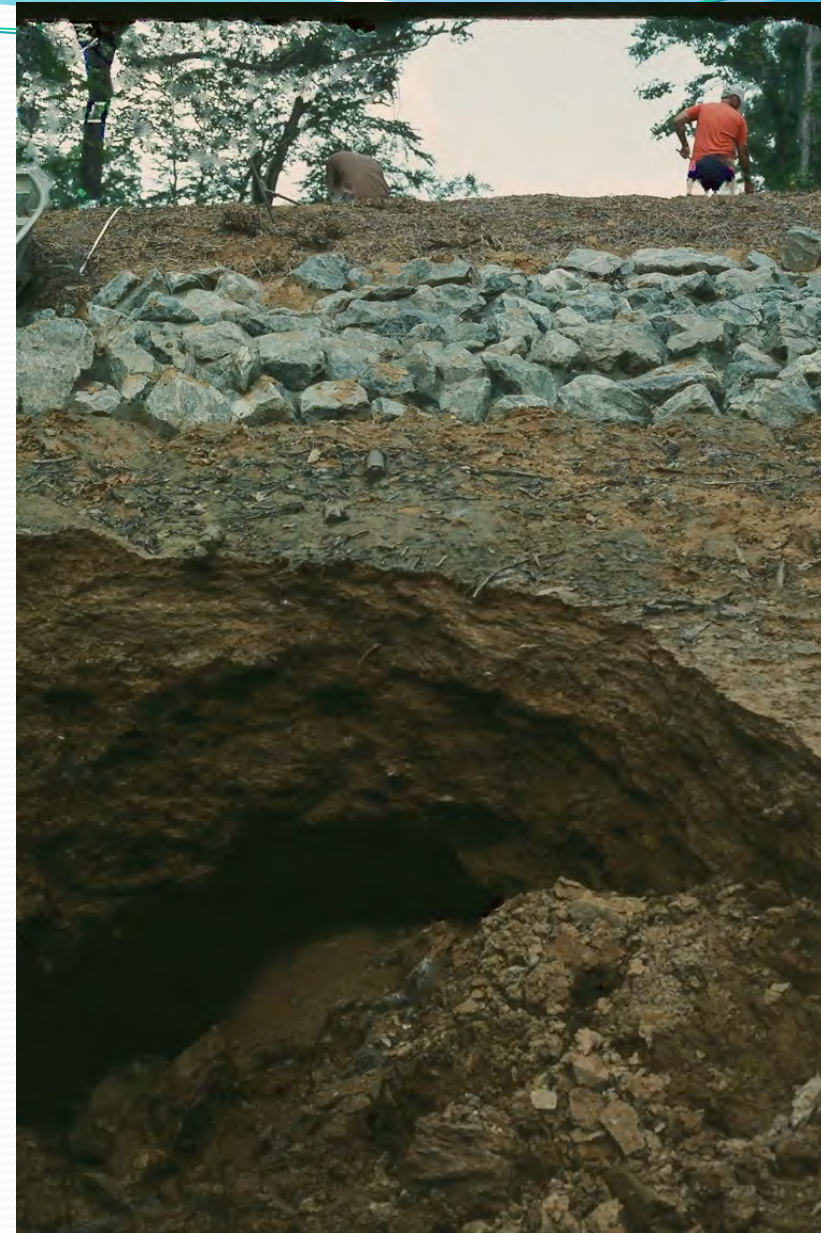
- Small dams can fail by piping
- Homogeneous 15ft high embankment dam constructed of sandy clay/clayey sand
- Cradle in lower 10 percent of pipe
- Reservoir filled – 10ft of head
- Failed over night along pipe

- How did it fail?

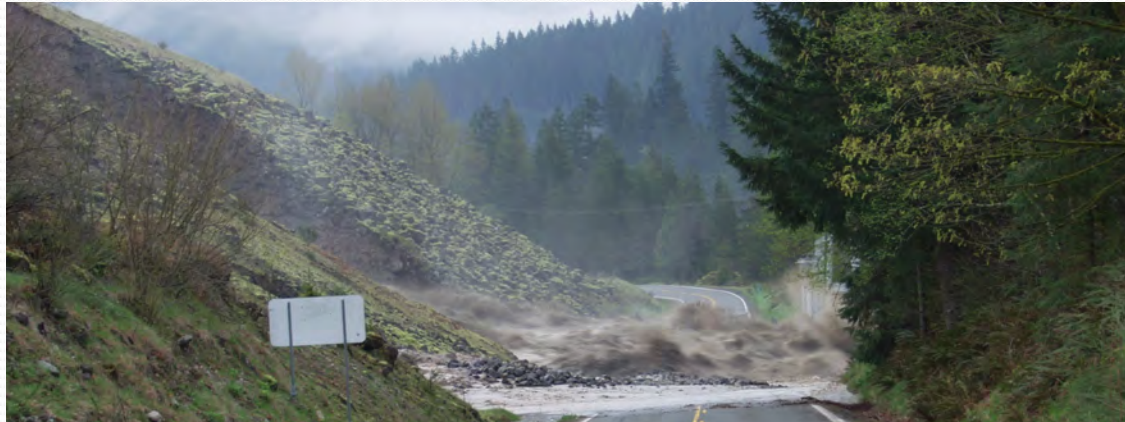
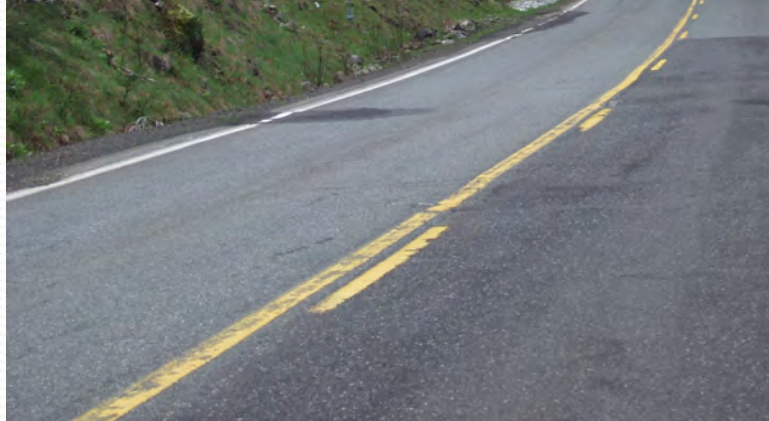
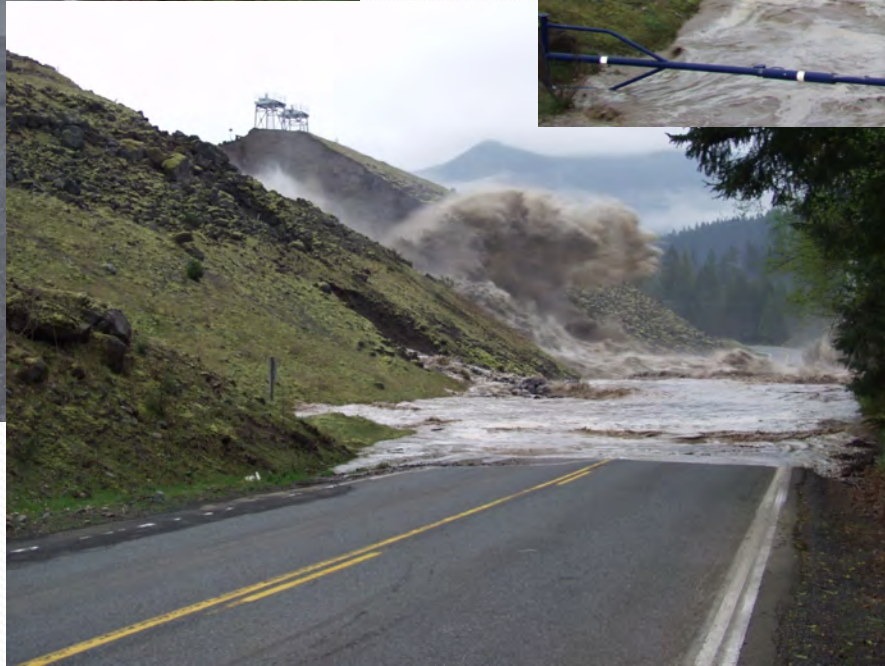
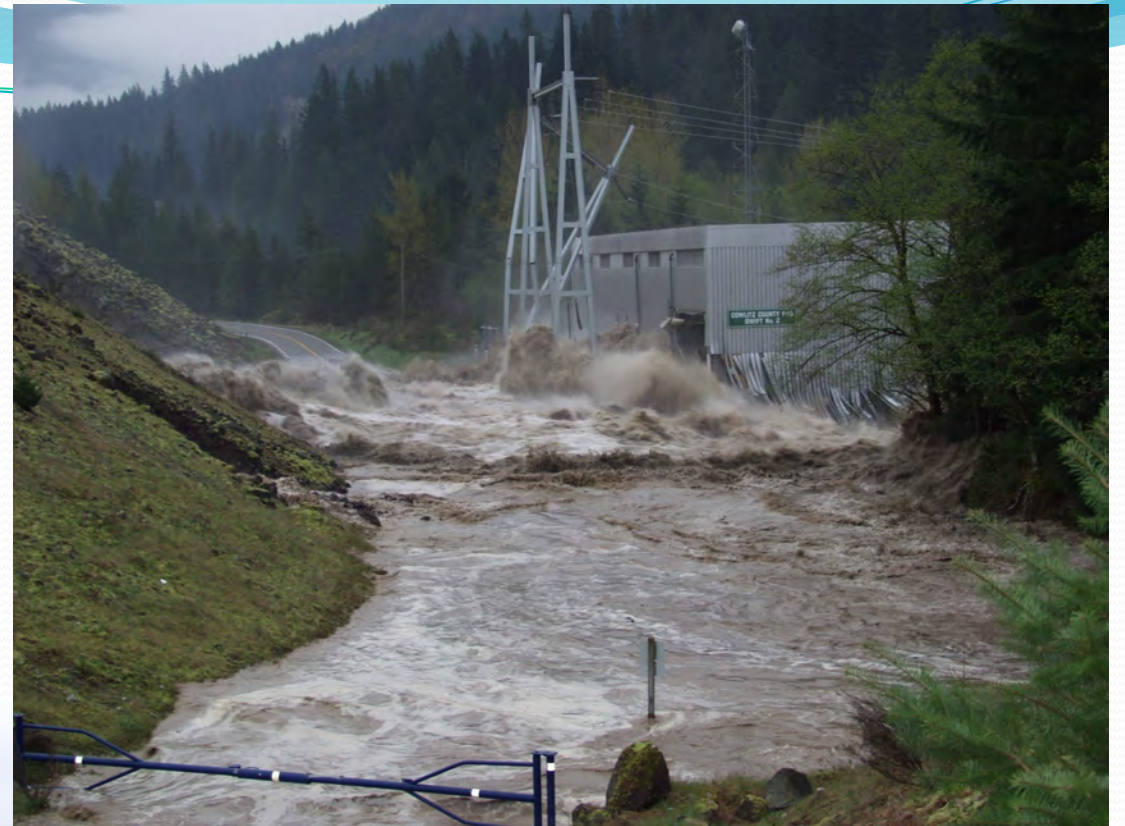
- Blowout occurred at toe of embankment at about 3:00 AM
- Orifice expanded upstream causing breach of the embankment at about 5:20 AM
- Flooding destroyed downstream facilities
- Sinkholes discovered in forebay
- Discharge contained in downstream reservoir

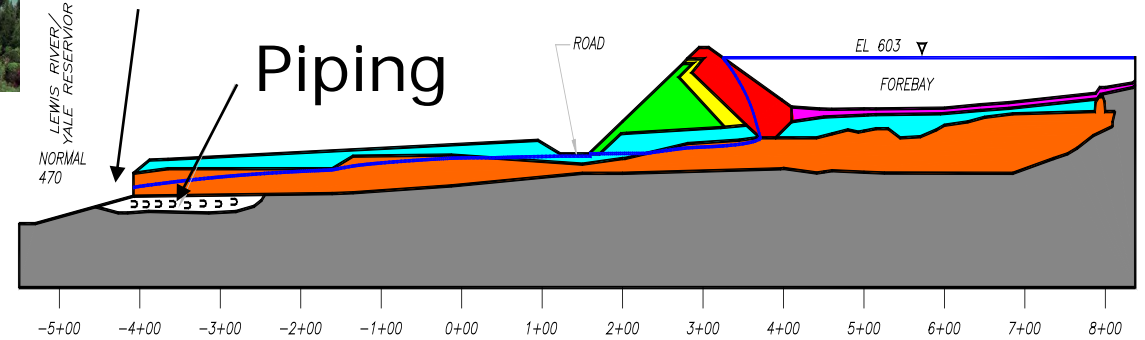
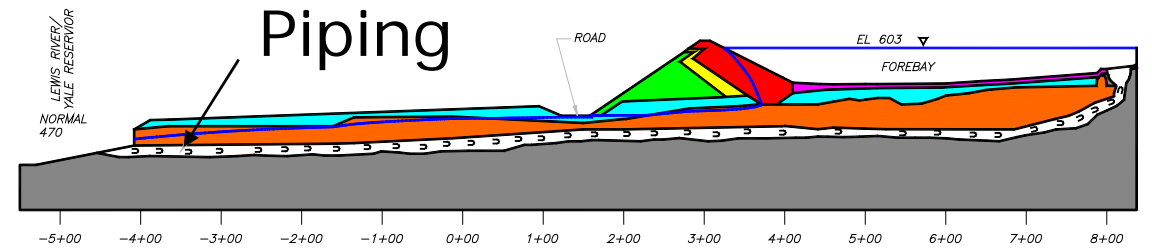
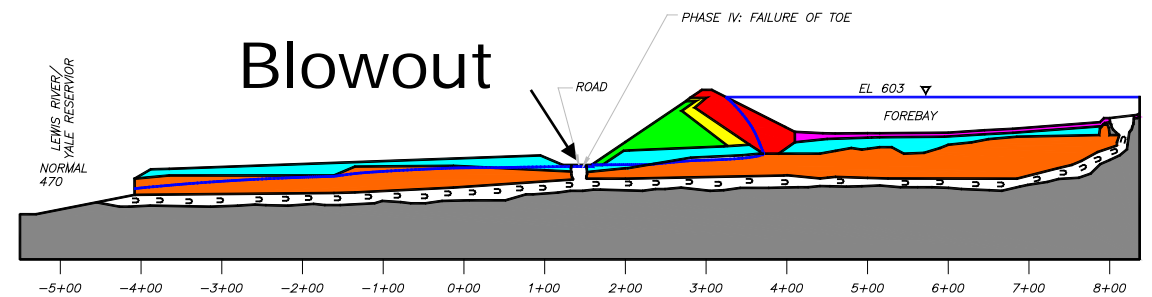
Piping and Blowout Unfiltered Exit

- Why did it take 44 years to fail?

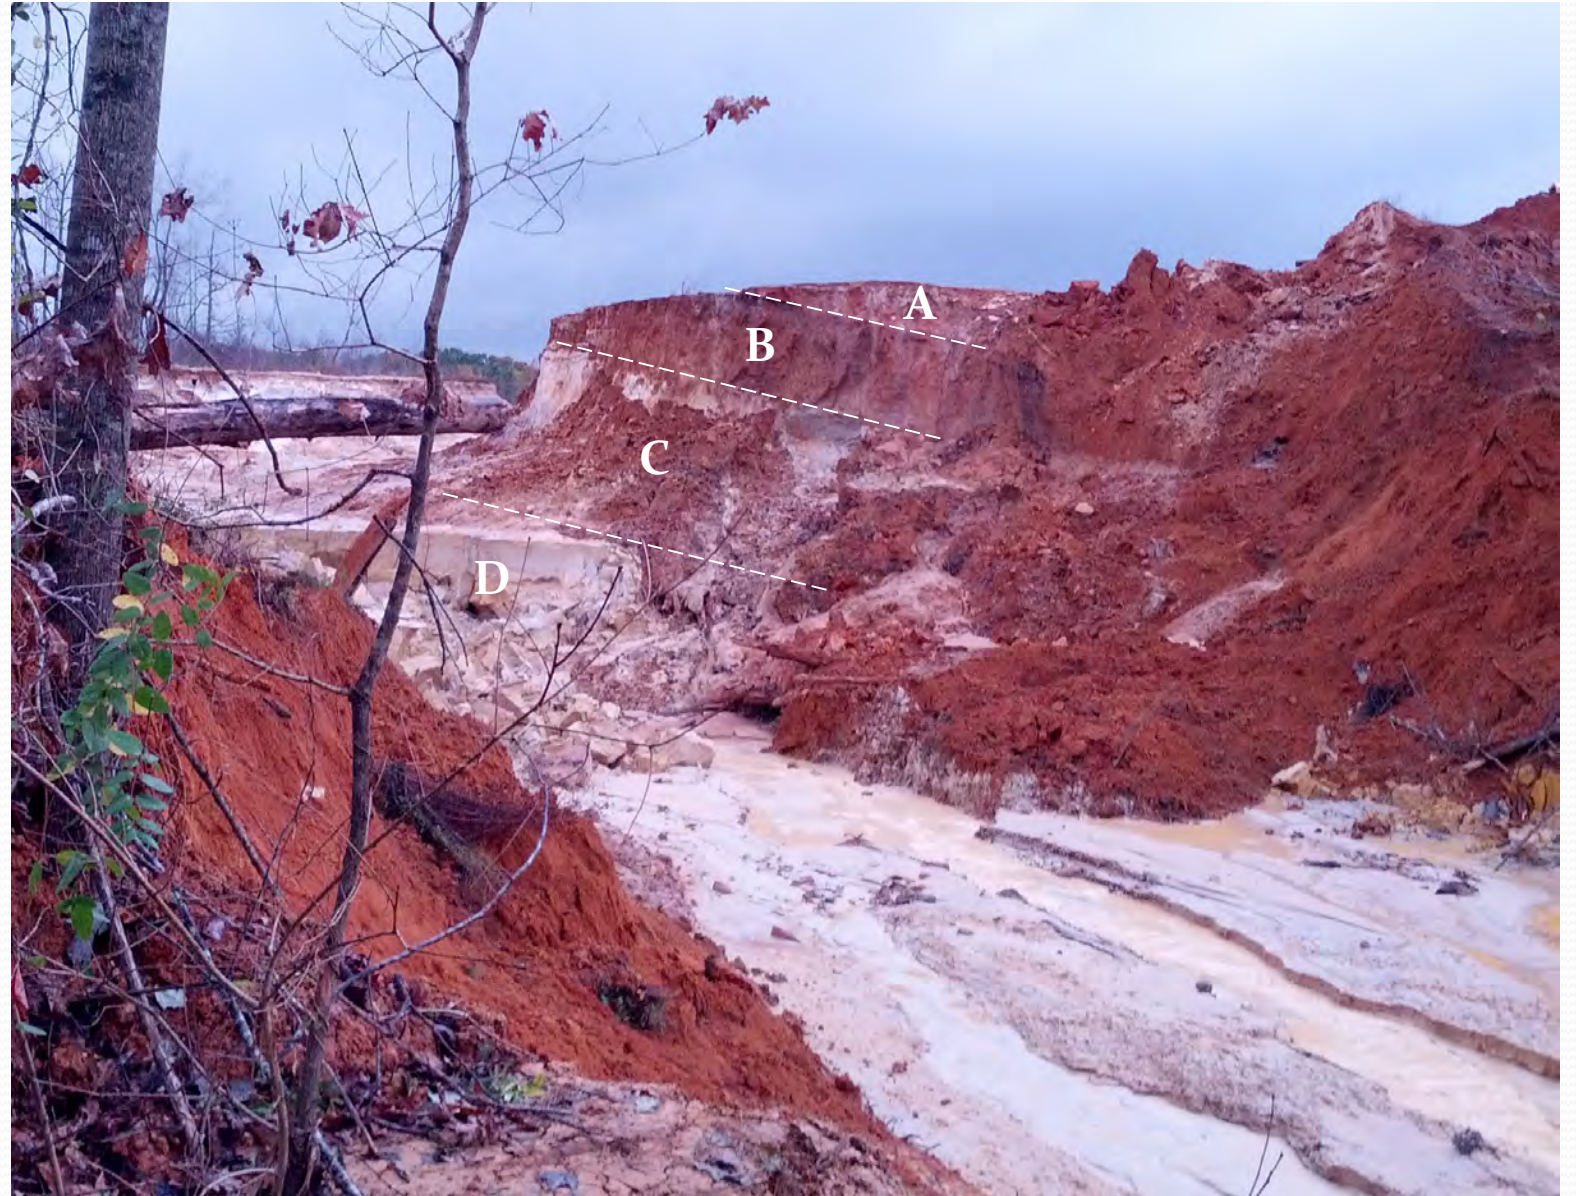
- A - Fill – for access road
- B – Clayey sand
- C - Upper McNairy fine sand
- D - Lower McNairy cemented sand/silt/clay
- Note head cut blocky area in cemented soil
- Water depth at rim – 25.7 ft

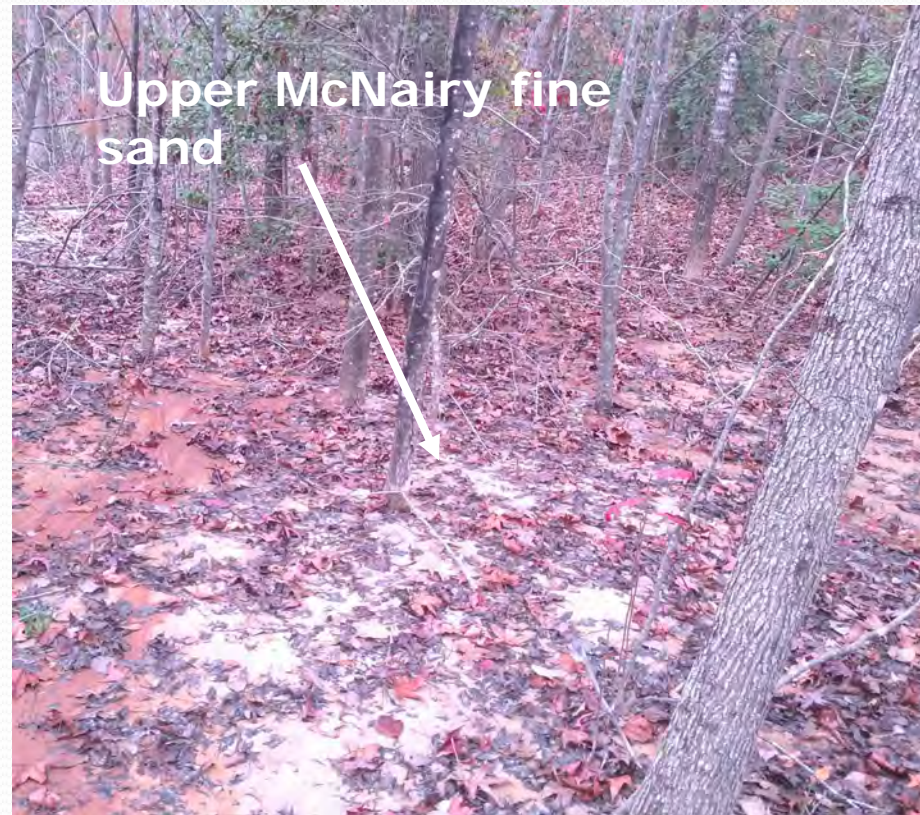
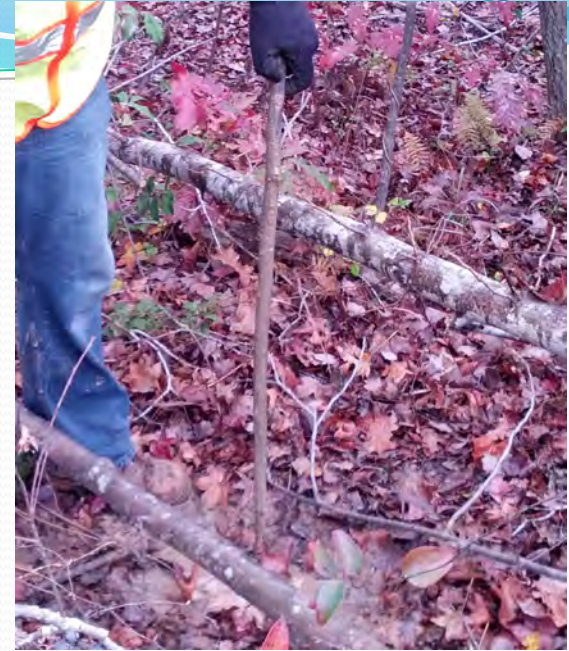
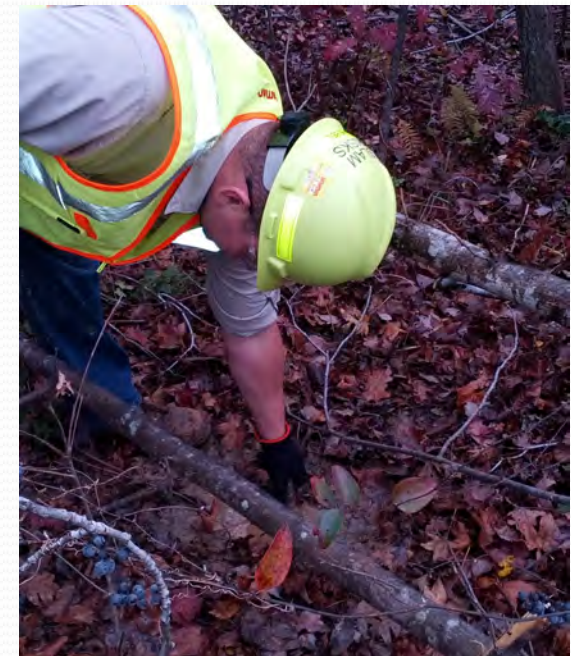
- Ground Surface 3.5 ft higher than at breach
- Head – 22.2 ft or 3.5 ft less than at breach
- Pushed stick in ground 3 ft at location of flow
- How did failure occur?

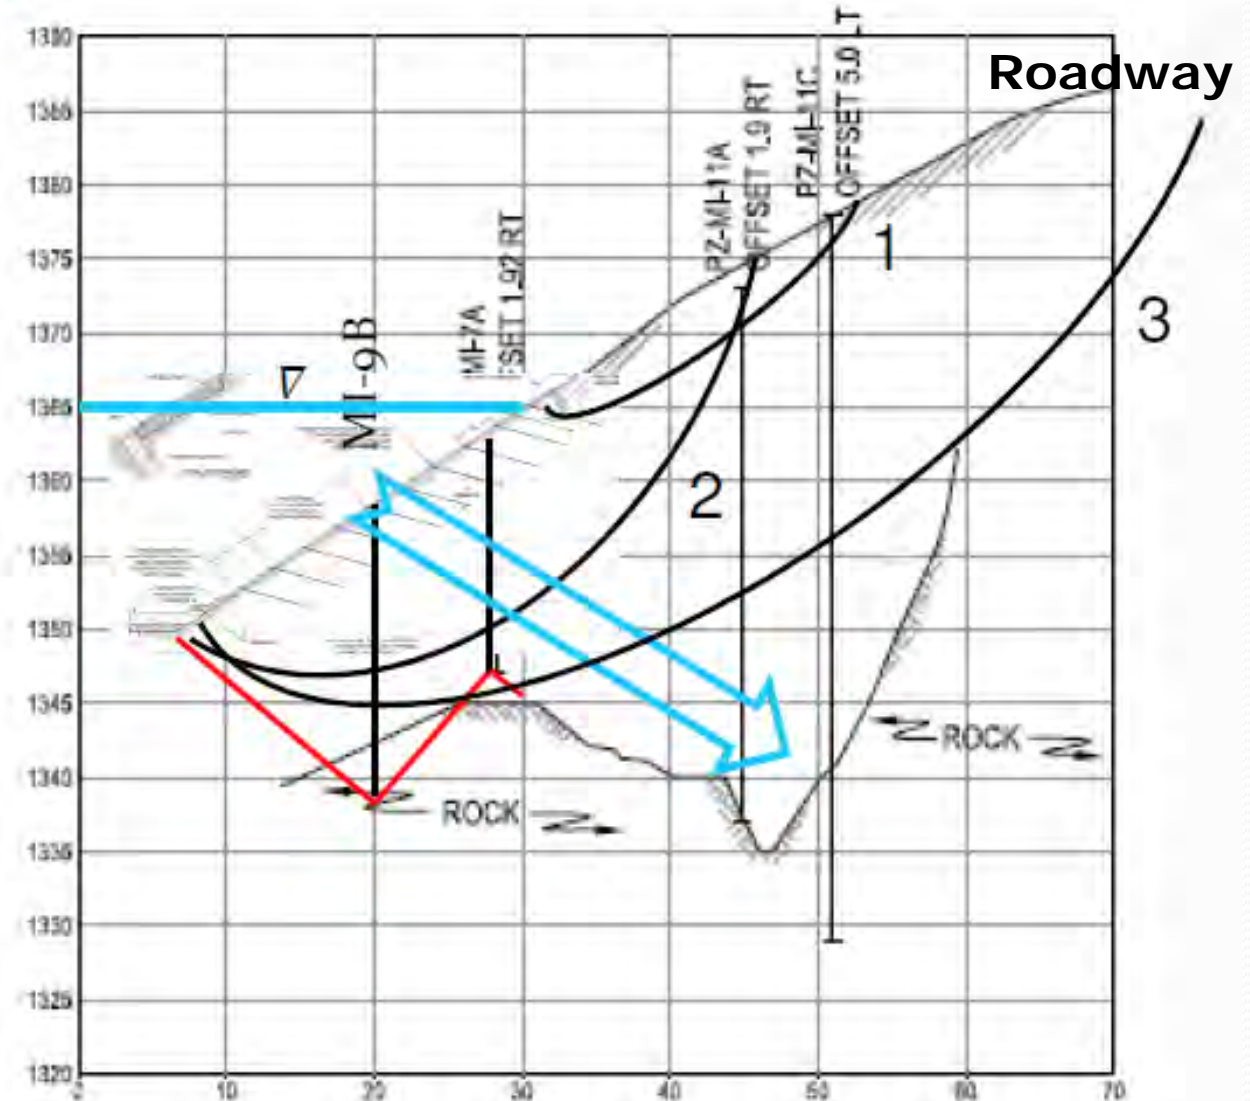
- What concerns would you have with this soil nailed slope protection?
- 1 - Shallow above soil nailed slope protection
- 2 - Deep seated downslope from roadway
- 3 - Deep seated under roadway

- Temporary Solution - design and construct a soil nailed slab over base of landslide to operating level of reservoir
