A recent tailings dam failure and the future of waste dam construction

Scott M. Olson, PhD, PE
University of Illinois at Urbana-Champaign
olsonsm@illinois.edu

GeoVirginia 2019
Lessons Learned in Geotechnical Engineering
Geo-Institute of ASCE
September 23 - 25, 2019

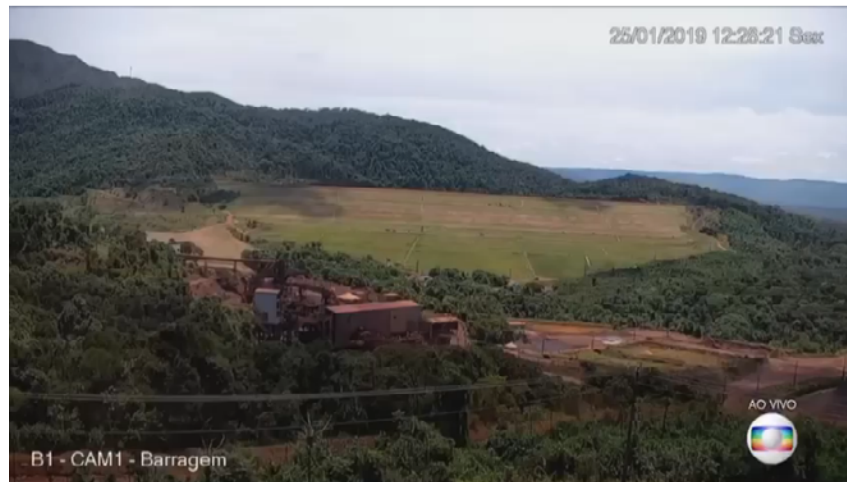
- Dam I, Feijao mine, Brumadinho, Brazil (1/25/19)

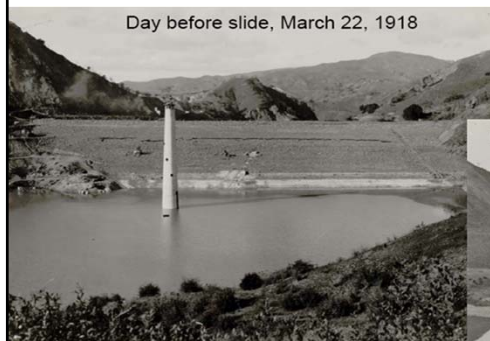
- Rapid placement of hydraulic fill triggered failure of Calaveras dam during construction in 1918
- Hazen (1920) first coined the term "liquefied" after failure

Day before slide, March 22, 1918

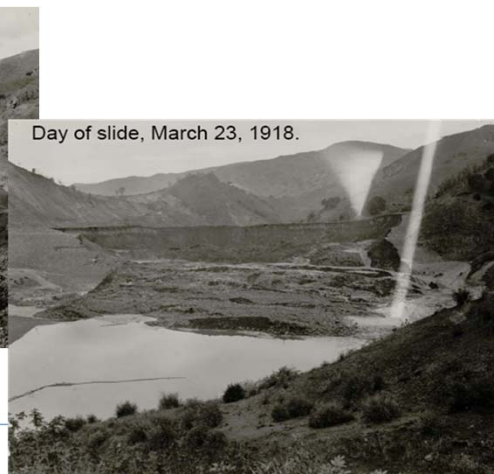
Day of slide, March 23, 1918.

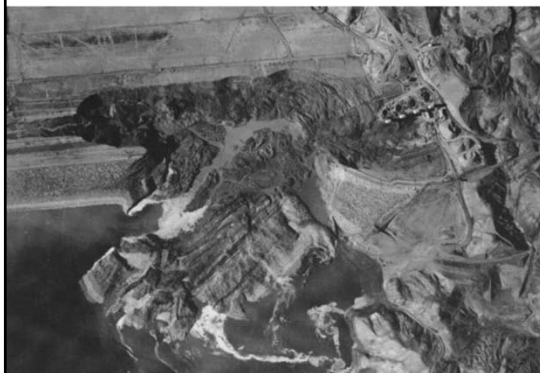
- Best known example: Fort Peck Dam
- Failure along Bearpaw shale foundation layer triggered liquefaction in sluiced fill materials

SEPT. 22, 1933
PARTIAL FAILURE OF FORT PECK DAM AS SEEN FROM THE AIR.

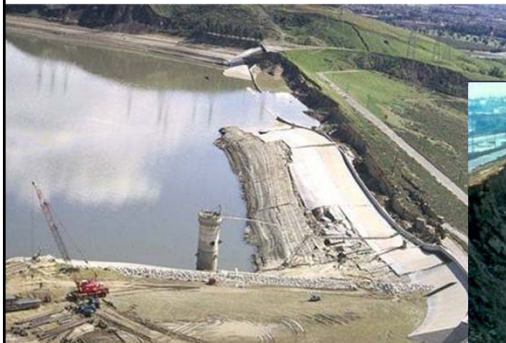
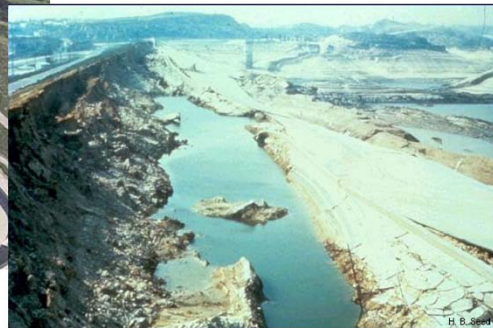
- Best known example: Lower San Fernando Dam
- Hydraulic fill liquefied in 1971 San Fernando earthquake (M 6.6); dam failed ~60 seconds after shaking ceased

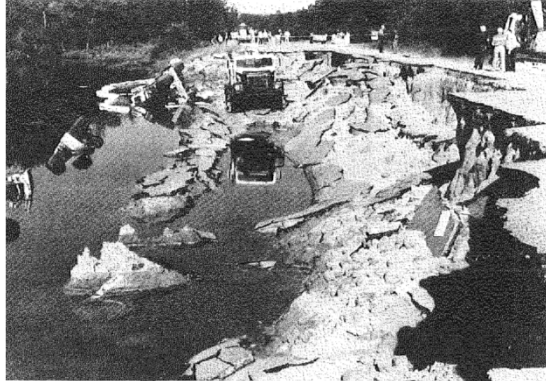
- Dynamic loading can include dynamic compaction, railroad traffic, geophysical surveys, among others
- Best known case: dumped fill embankment along Lake Ackermann, Michigan, USA

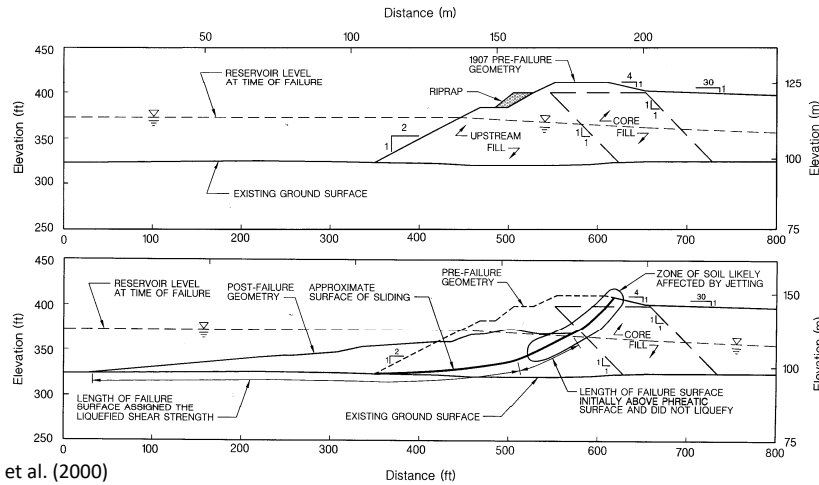
- Dumped fill used to create North Dike of Wachusett Dam in 1907 failed during first reservoir filling

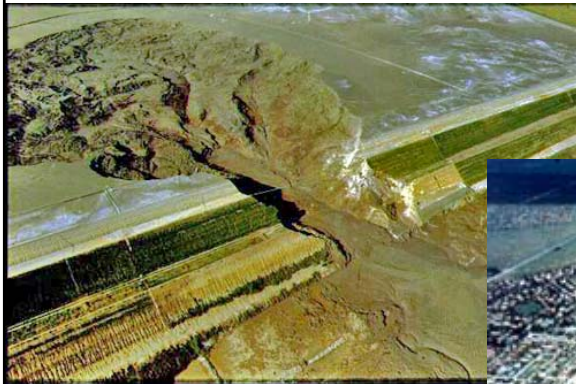
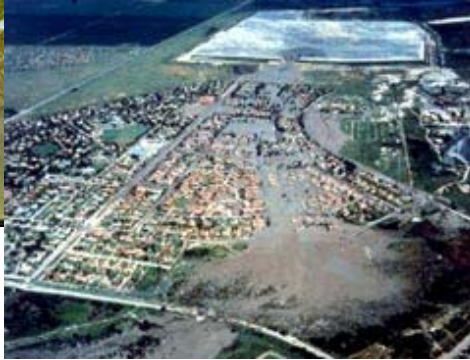
- Merriespruit (South Africa) gold mine tailings failure in 1994

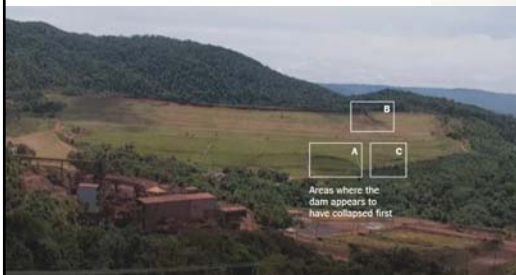
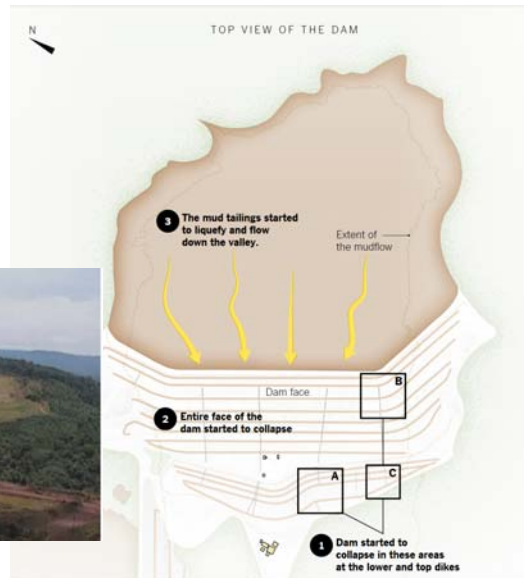
- Clearly, something triggered liquefaction
- International panel investigating the failure

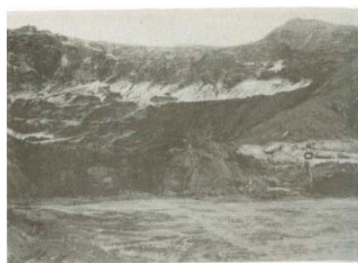
Vista da barragem por jusante após a ruptura.

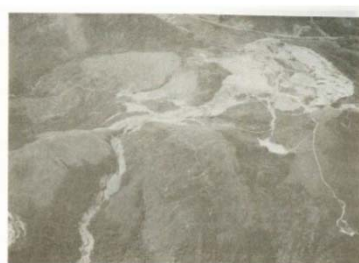
Vista aérea da barragem e do talvegue a jusante, após a ruptura.

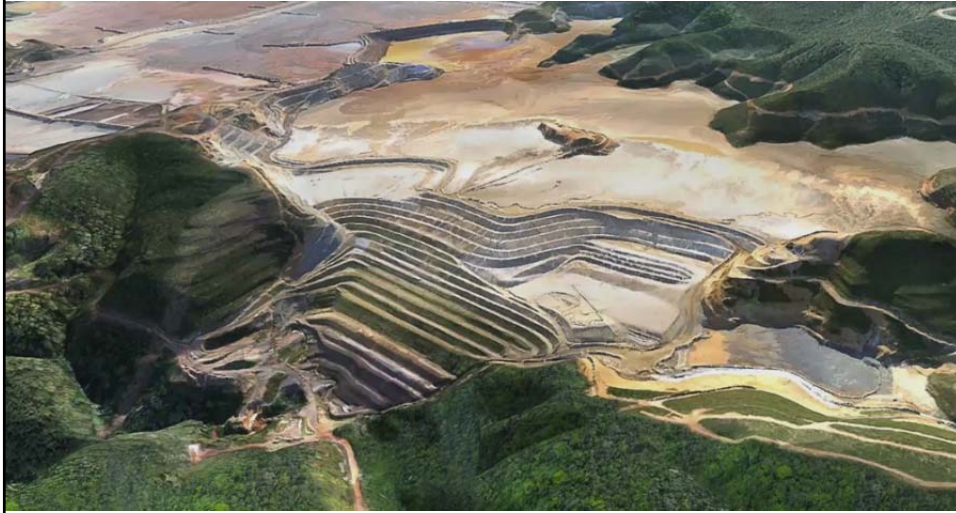
- No, not in Brazil...even recently (November 2015)

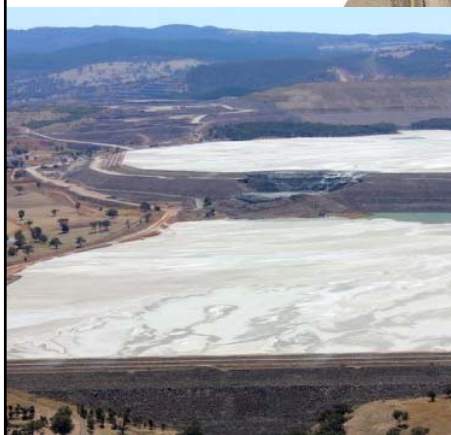
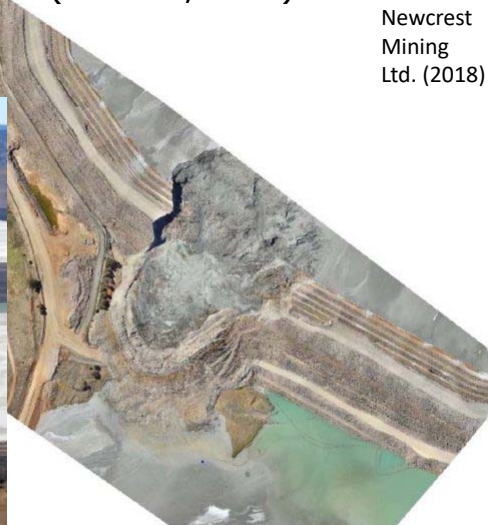
- Cadia gold mine, Australia (March 9, 2018)

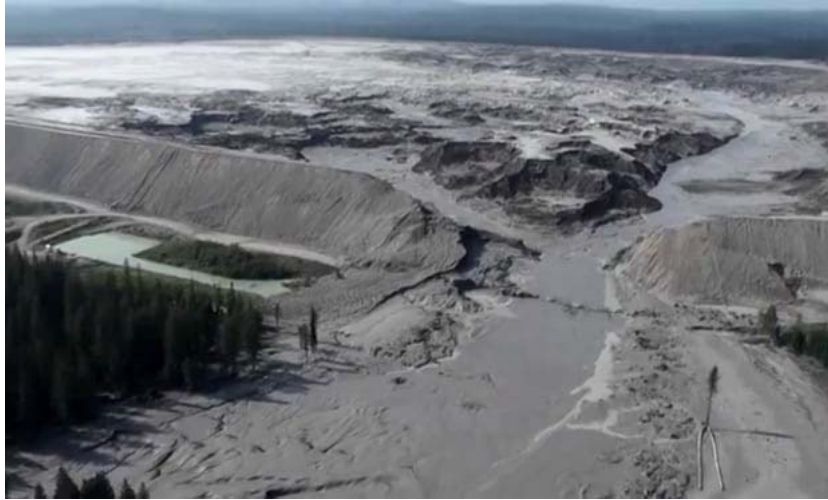
- Mount Polley, Canada (August 4, 2014)

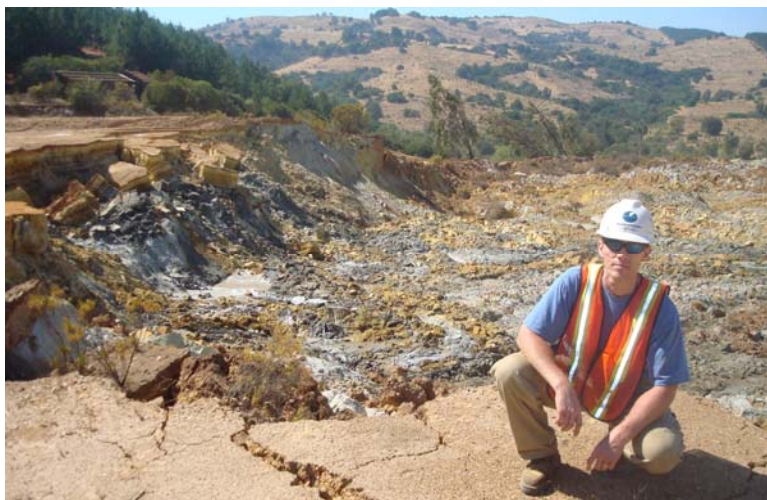
- Las Palmas, Chile (February 27, 2010)

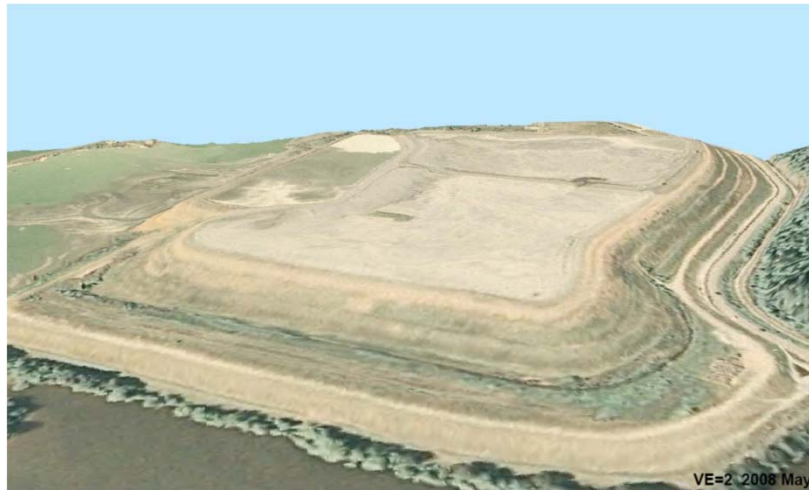
- Kingston fossil plant, USA (December 22, 2008)
