# MORETRENCH

Lateral and Vertical Pressures on  
Structures During Artificial Ground  
Freezing

Lessons Learned from  
First Street Tunnel, Washington, D.C.

Access Shaft No. 3, Buenos Aires,  
Argentina

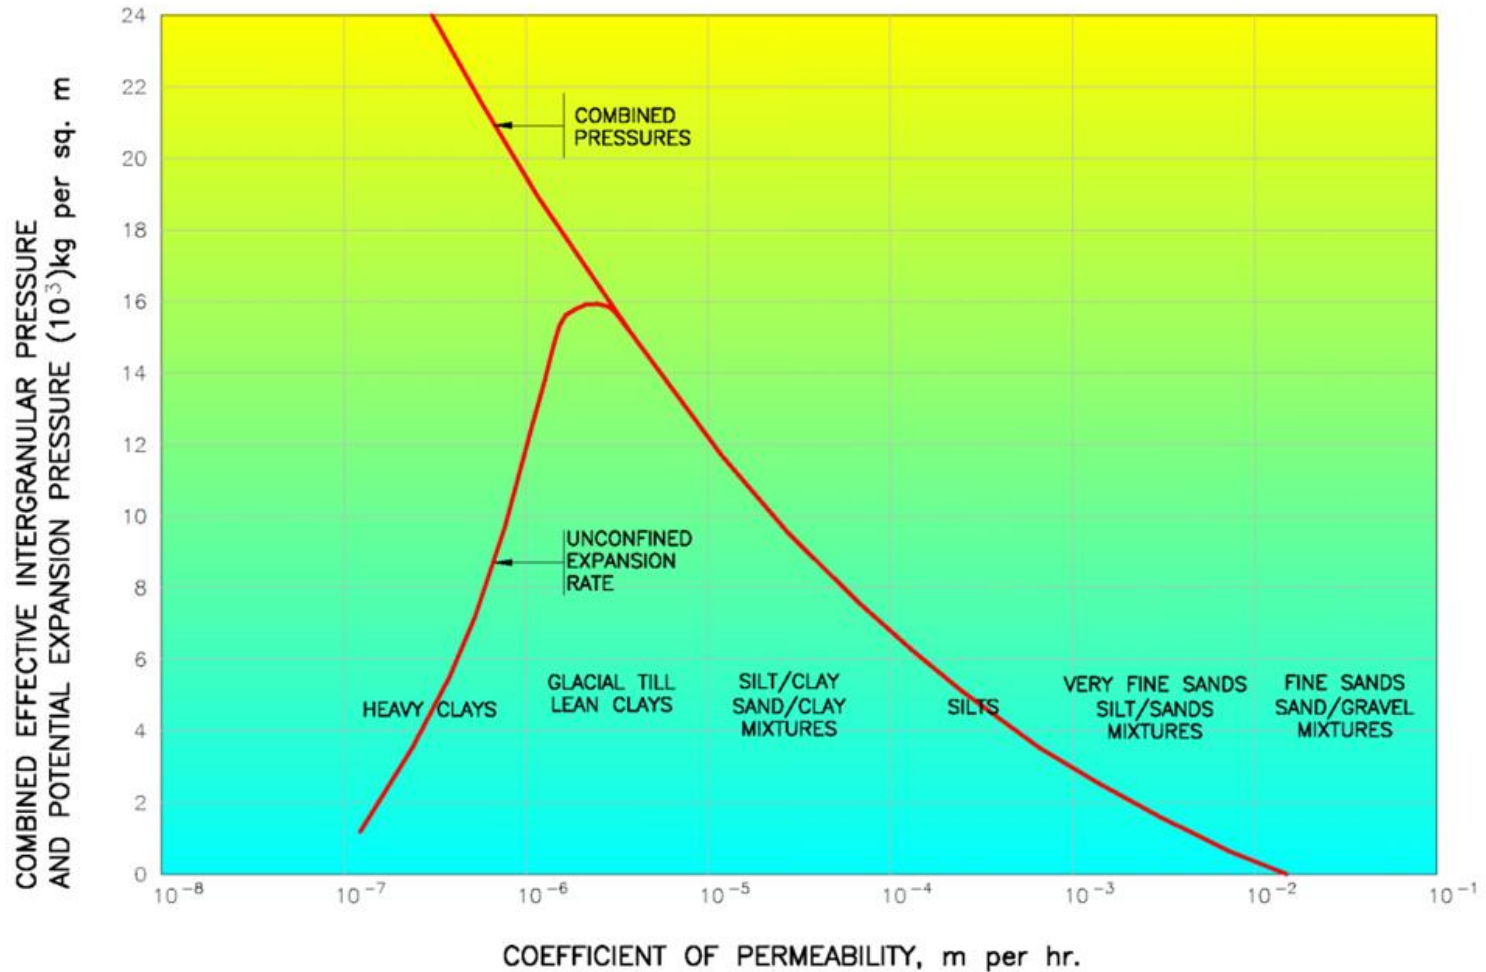
# FROST PRESSURE - PERMEABILITY

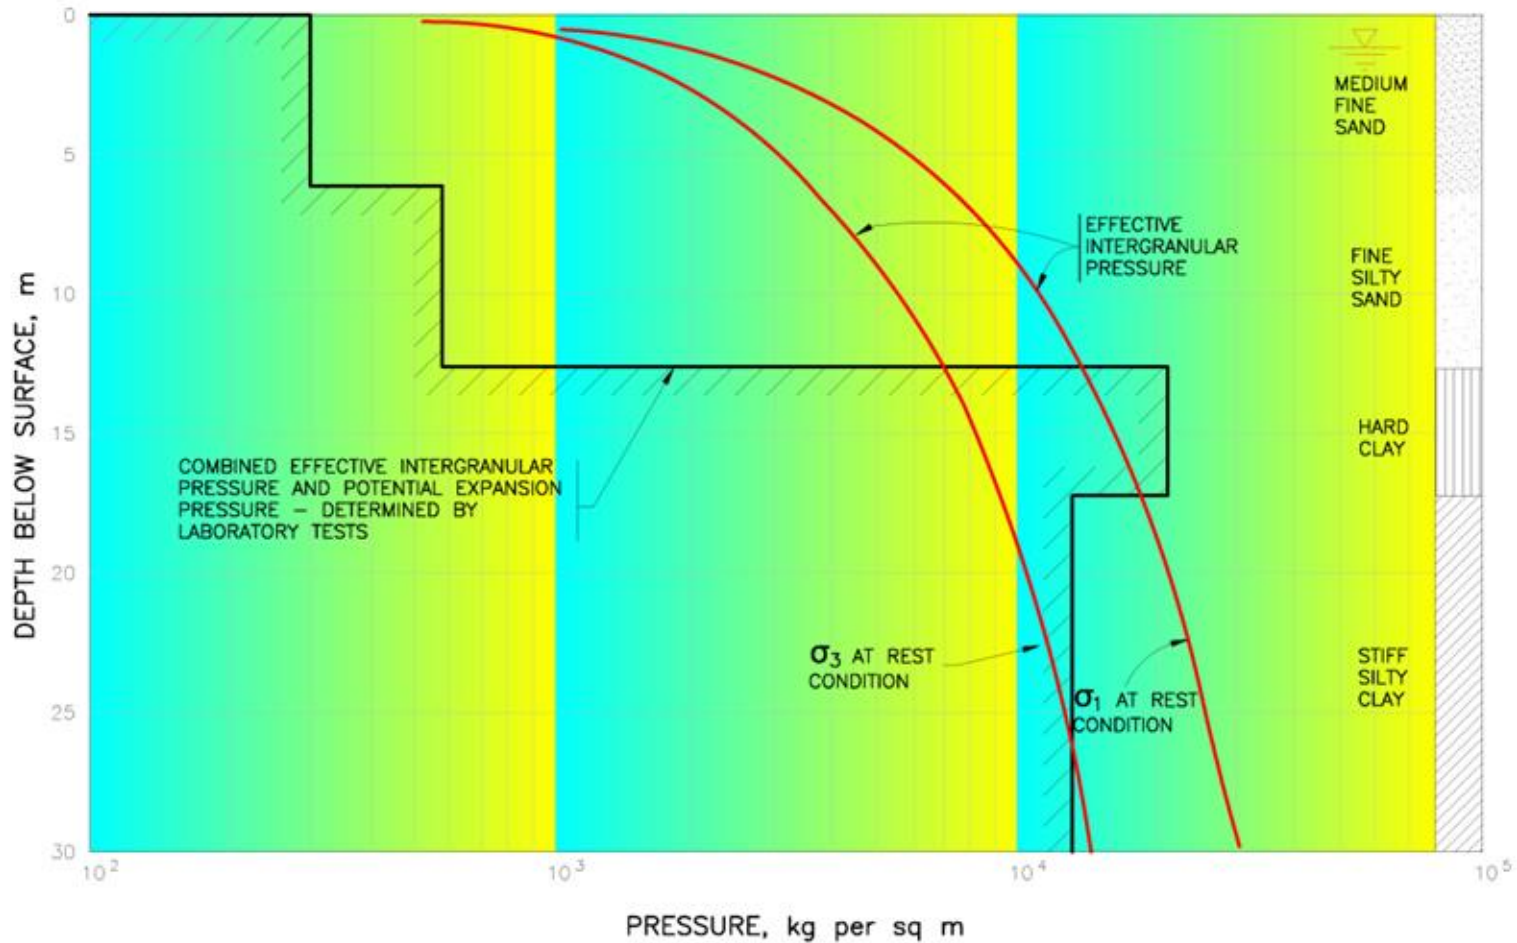
# EFFECTS OF OVERBURDEN

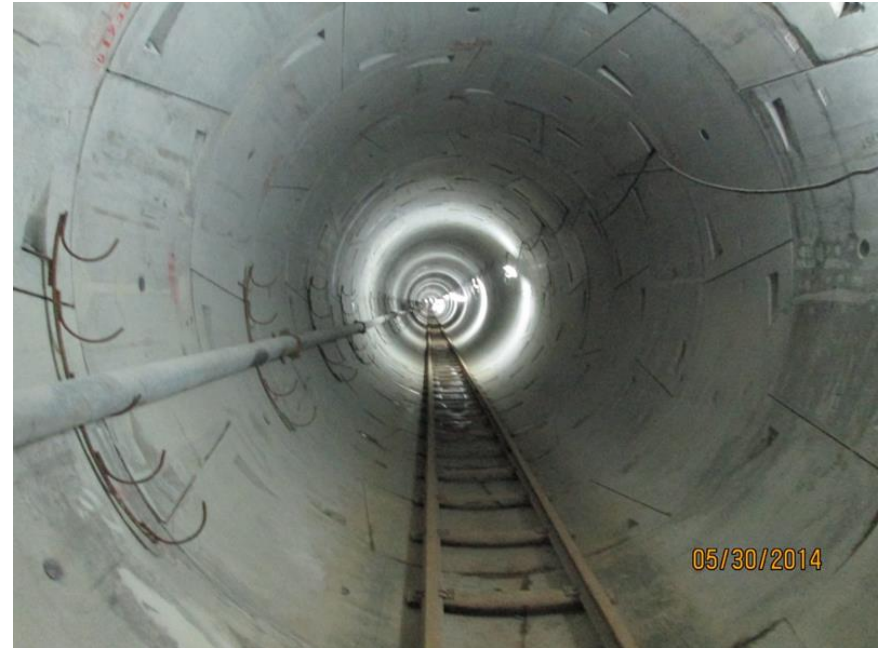
# TUNNEL – PARANA RIVER TO WATER TREATMENT PLANT

- 3.6m diameter
- 15km long
- 18-22m deep
- Bored with 2 TBMs
- 5 Access shafts

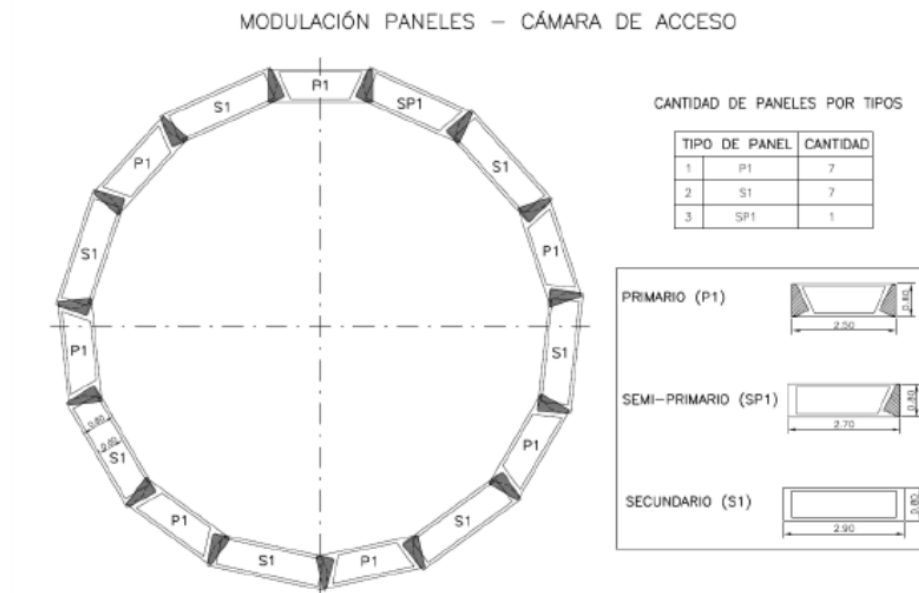
# ACCESS SHAFT #3 (CA3)

- 10.8m diameter
- Diaphragm wall panels and jet grouted bottom seal

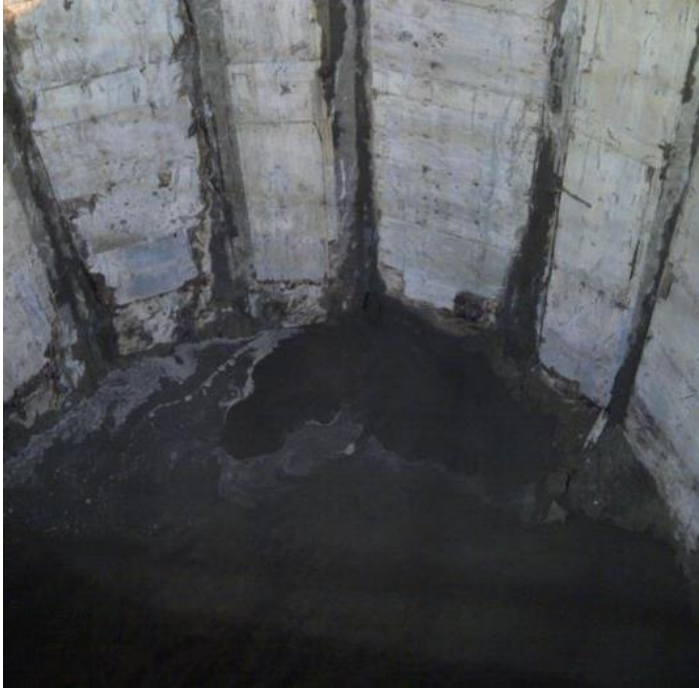
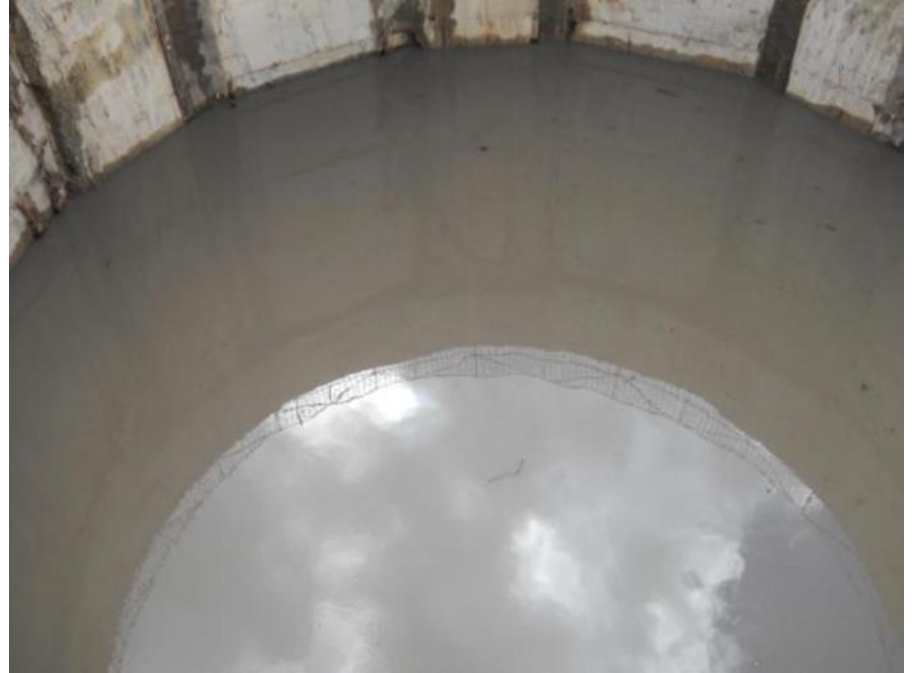
# LEAKS - OCTOBER 10

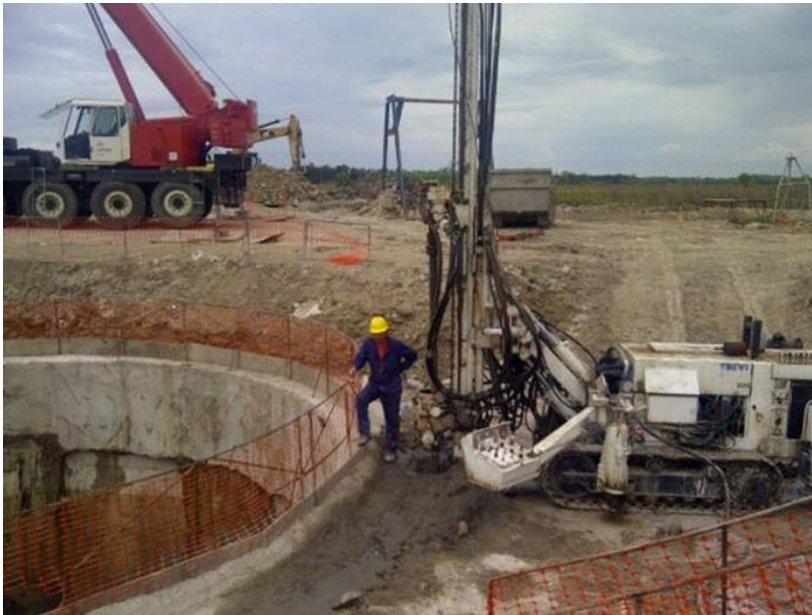
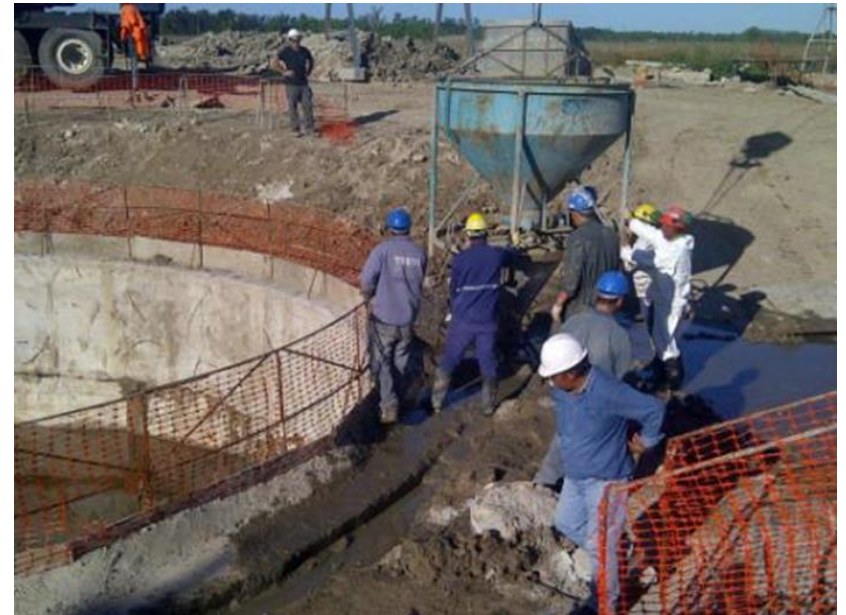
# REPAIR – TREMIE GROUTING

- October 12, 2012 Injected 4m<sup>3</sup> of grout

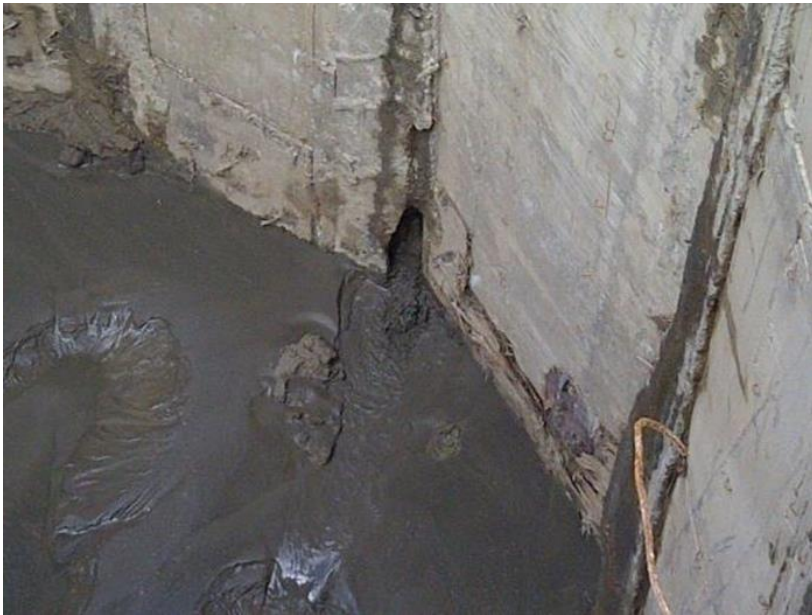
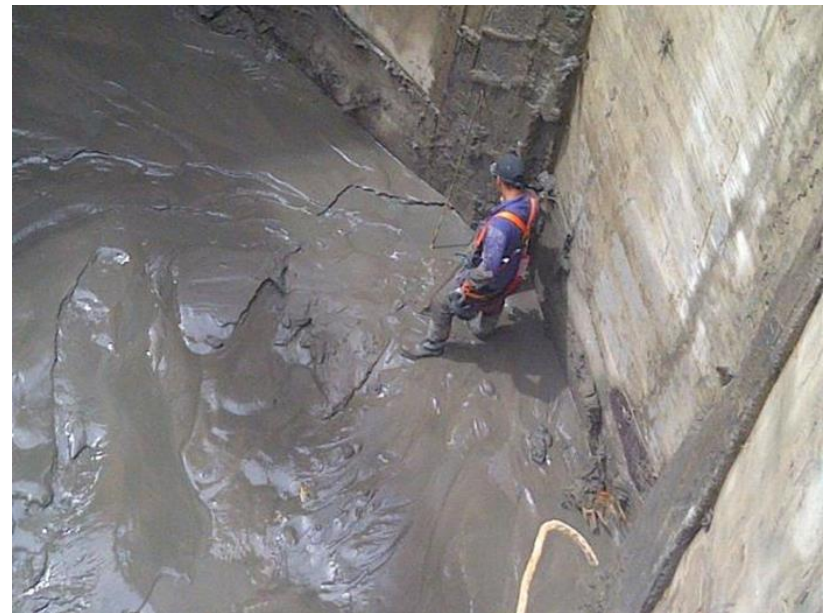
# MORE LEAKS – OCTOBER 15, 2012

- Permeation grouting near joints
- Jet grouting
- Dewatering
- December 5, flooded again

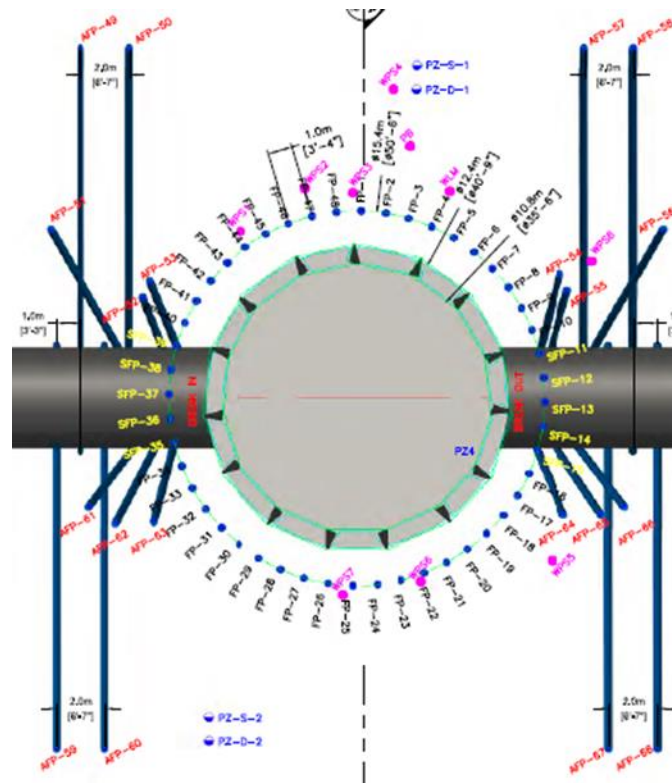
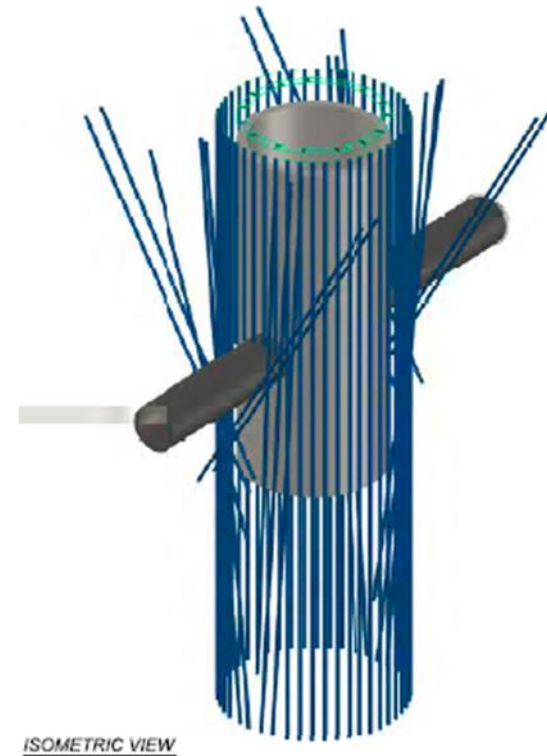
# GROUND FREEZING OPTION

- 48 Vertical refrigeration pipes around the perimeter of the shaft
- 20 Angled refrigeration pipes to form a cradle under the tunnel

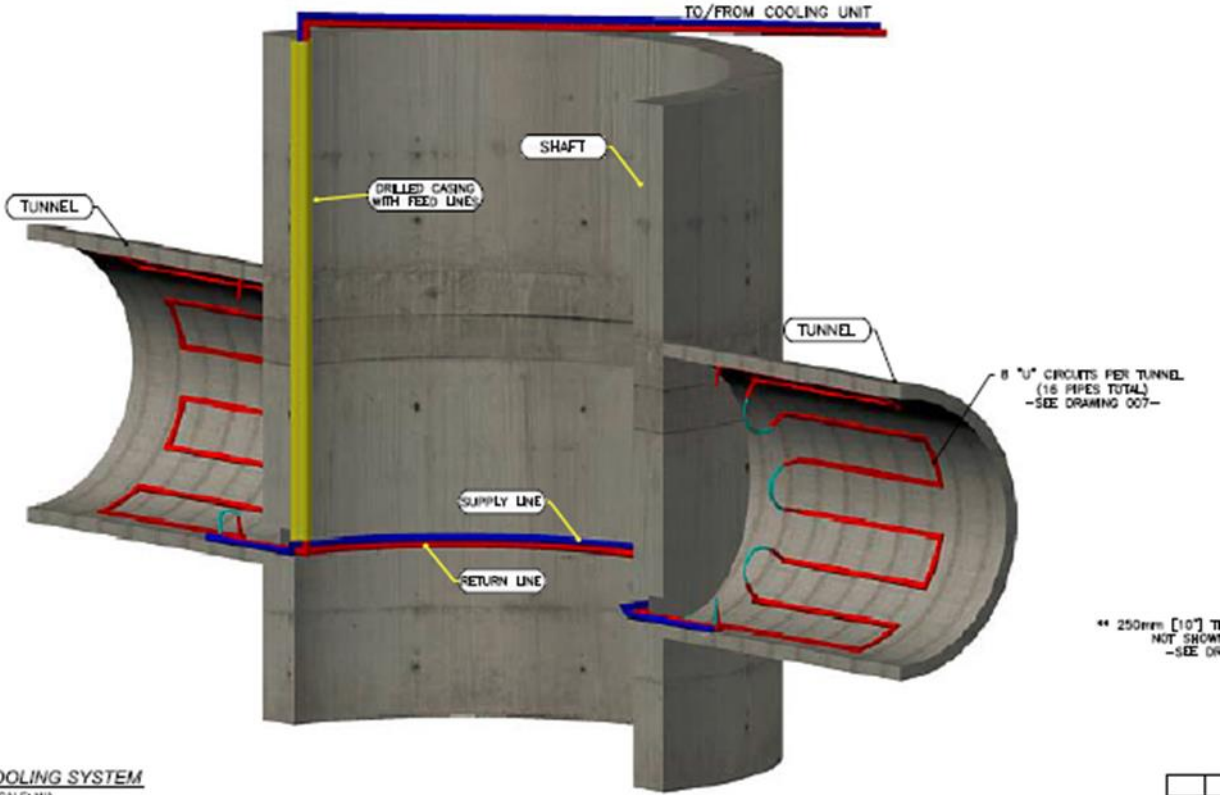
TUNNEL COOLING SYSTEM  
SCALE: N/A

# TUNNEL COOLING SYSTEM

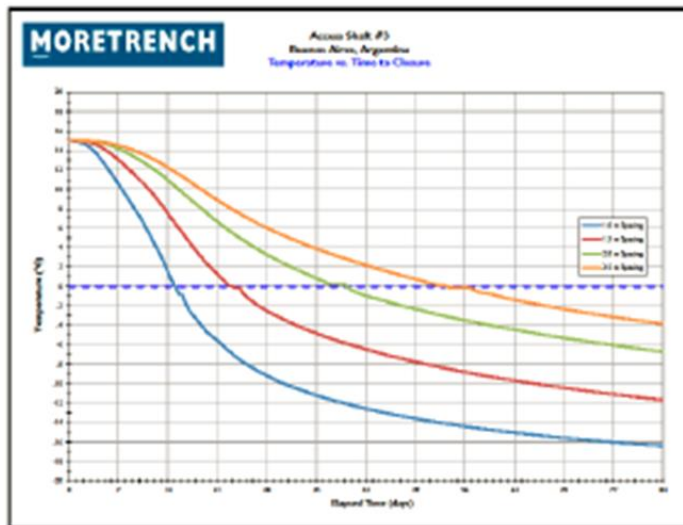
Figure 1A – Computed Freezing Times to Wall Closure

- Design based on lowest strength sandy silt
- Not a structural wall, limited to groundwater cutoff
- Compute freezing time and required refrigeration capacity

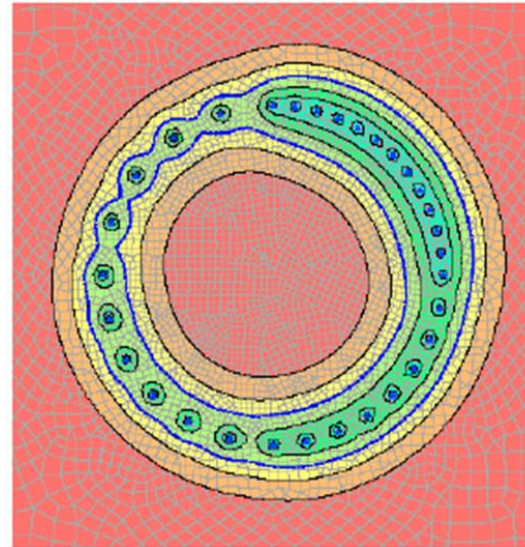
Figure 2 – Thermal Model after 8 Weeks

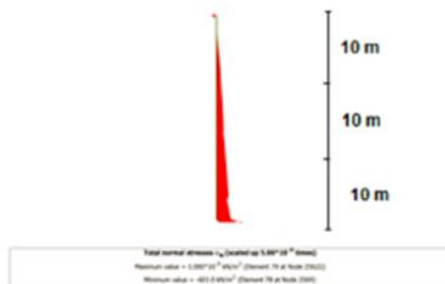
## Pressure on Slurry Wall

- Before frozen ground

- Computed soil pressures on slurry wall before and after freezing
- Used hoop stresses to calculate load on tunnel lining

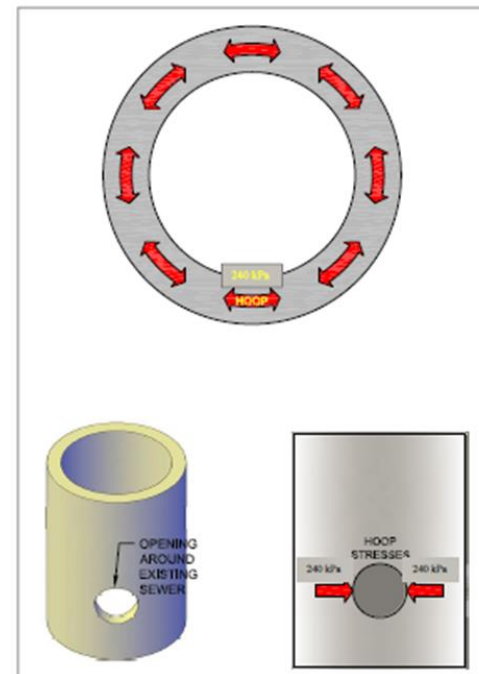
Figure 7 – Hoop stresses acting on tunnel in two-dimensional analysis

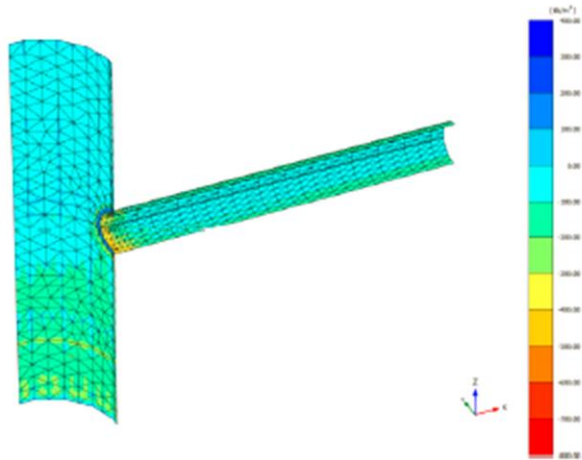
Figure 8 – Computed stresses on the existing shaft and tunnel in three-dimensional analysis

- Computed maximum pressures using PLAXIS 3D

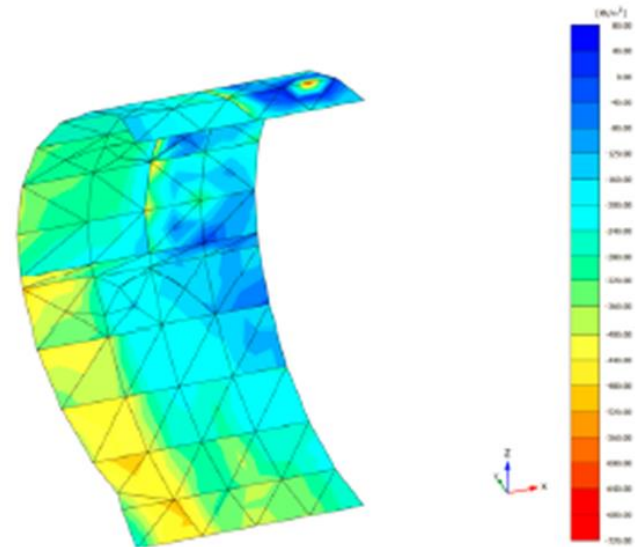
Figure 9 – Computed stresses on the existing tunnel in three-dimensional analysis

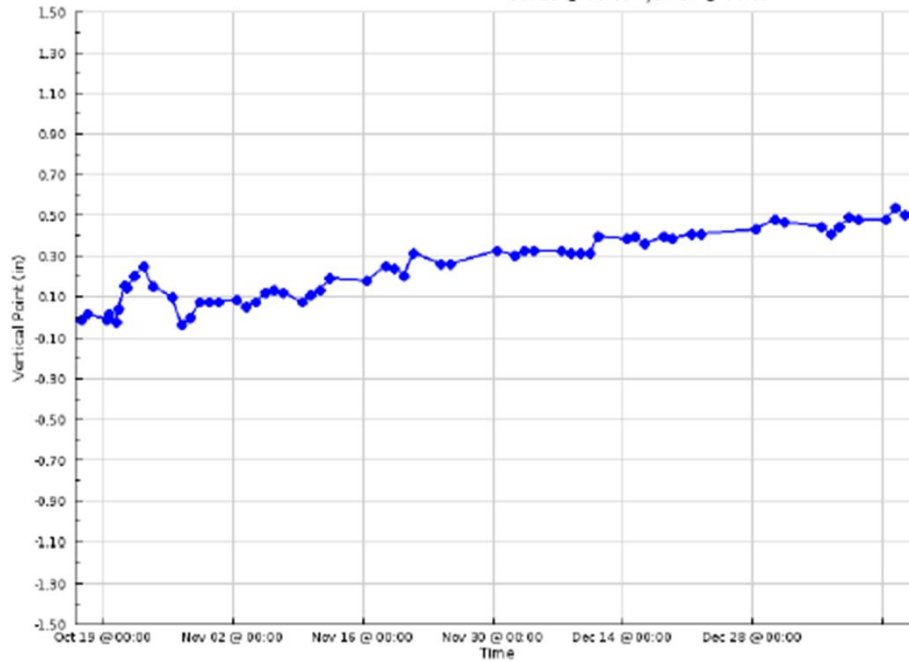
# UTILITY HEAVE

UTL-AS-001 @30 in Water Line (DCCRID 020150B)

Oct 15 @ 00:00 - Jan 15 @ 00:00

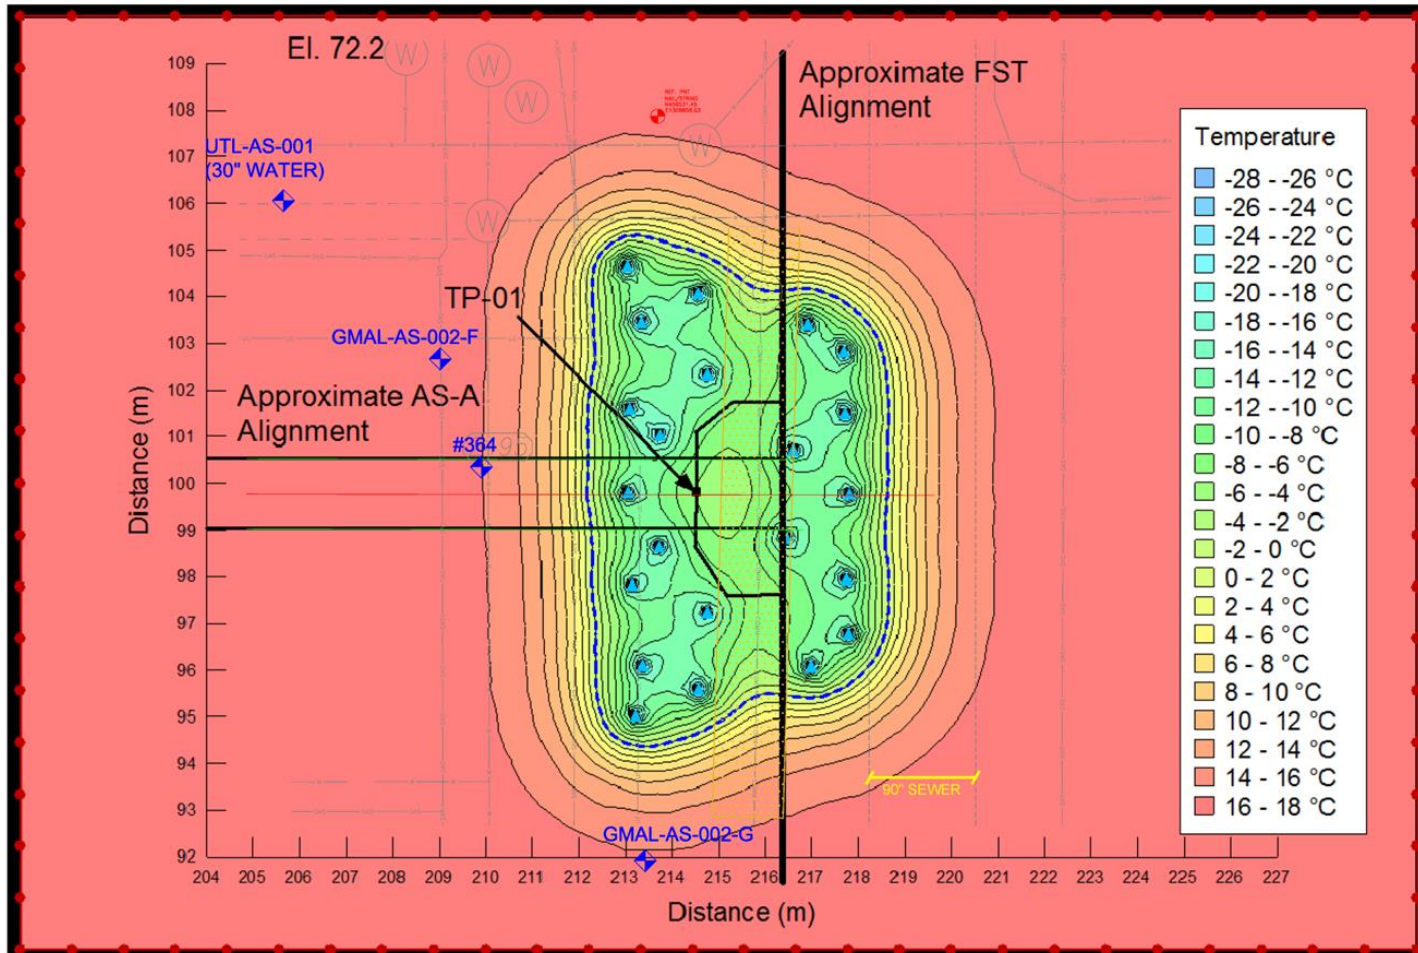
# INSTALLATION OF HEATING PIPES

- We are getting better at lateral pressures
- Vertical heave is hard to predict, but can be prevented with heating pipes

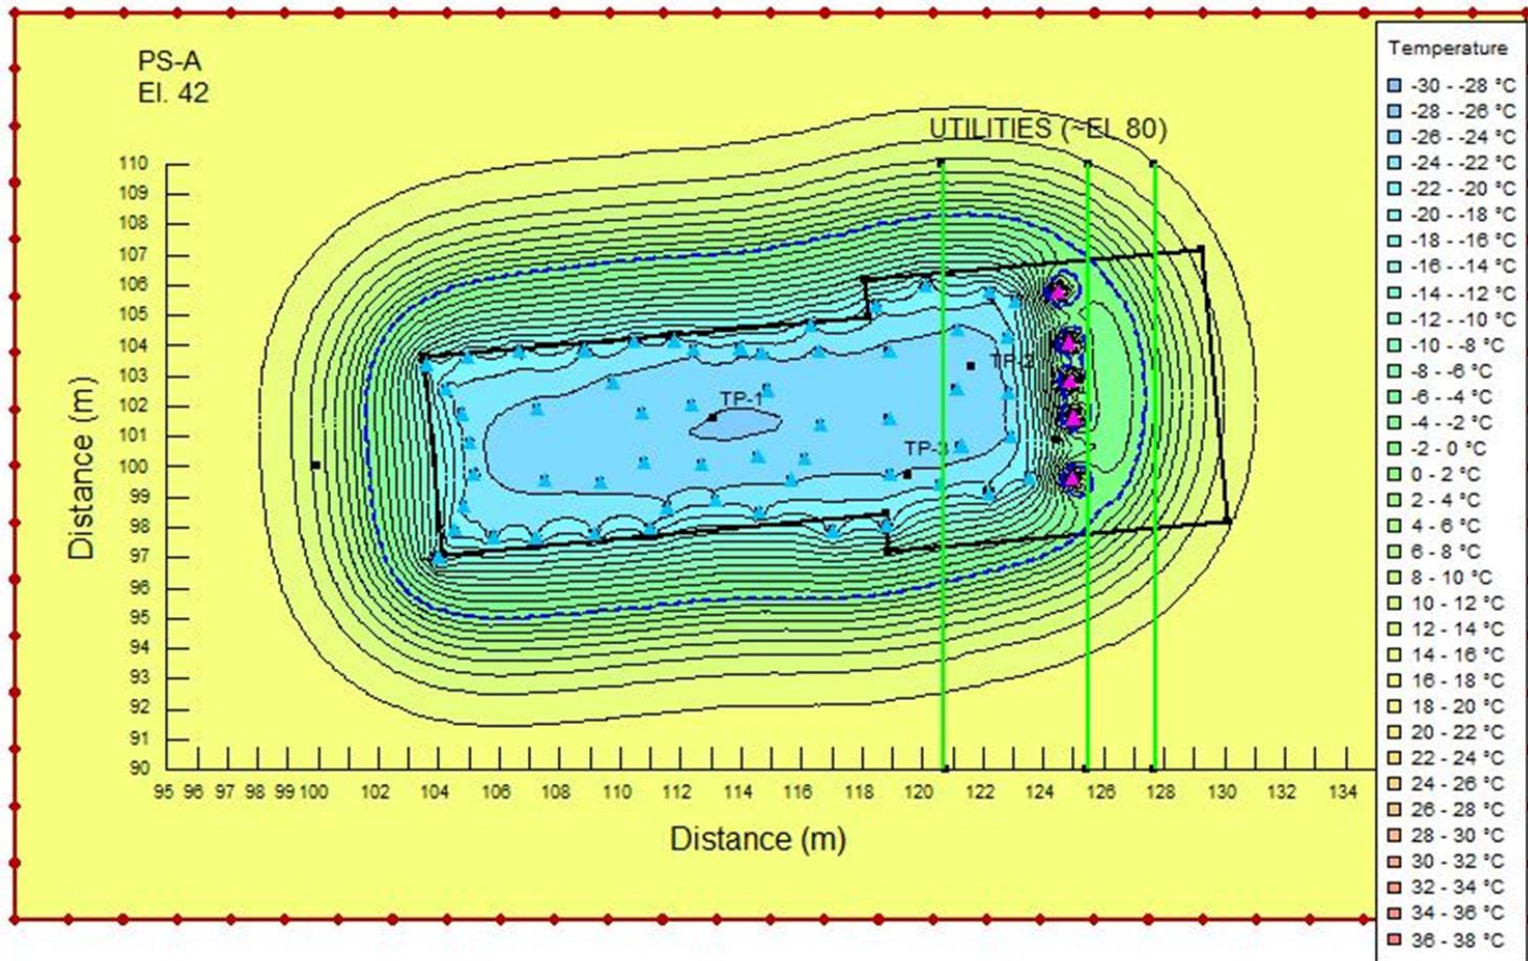
# ACTIVATION OF HEAT PIPES
