Dismantling the Tallest Reinforced Fill in North America - The Observational Method Applied at the Yeager Airport

Allen Cadden, PE, DGE
October 12, 2016
Geo-Virginia 2016

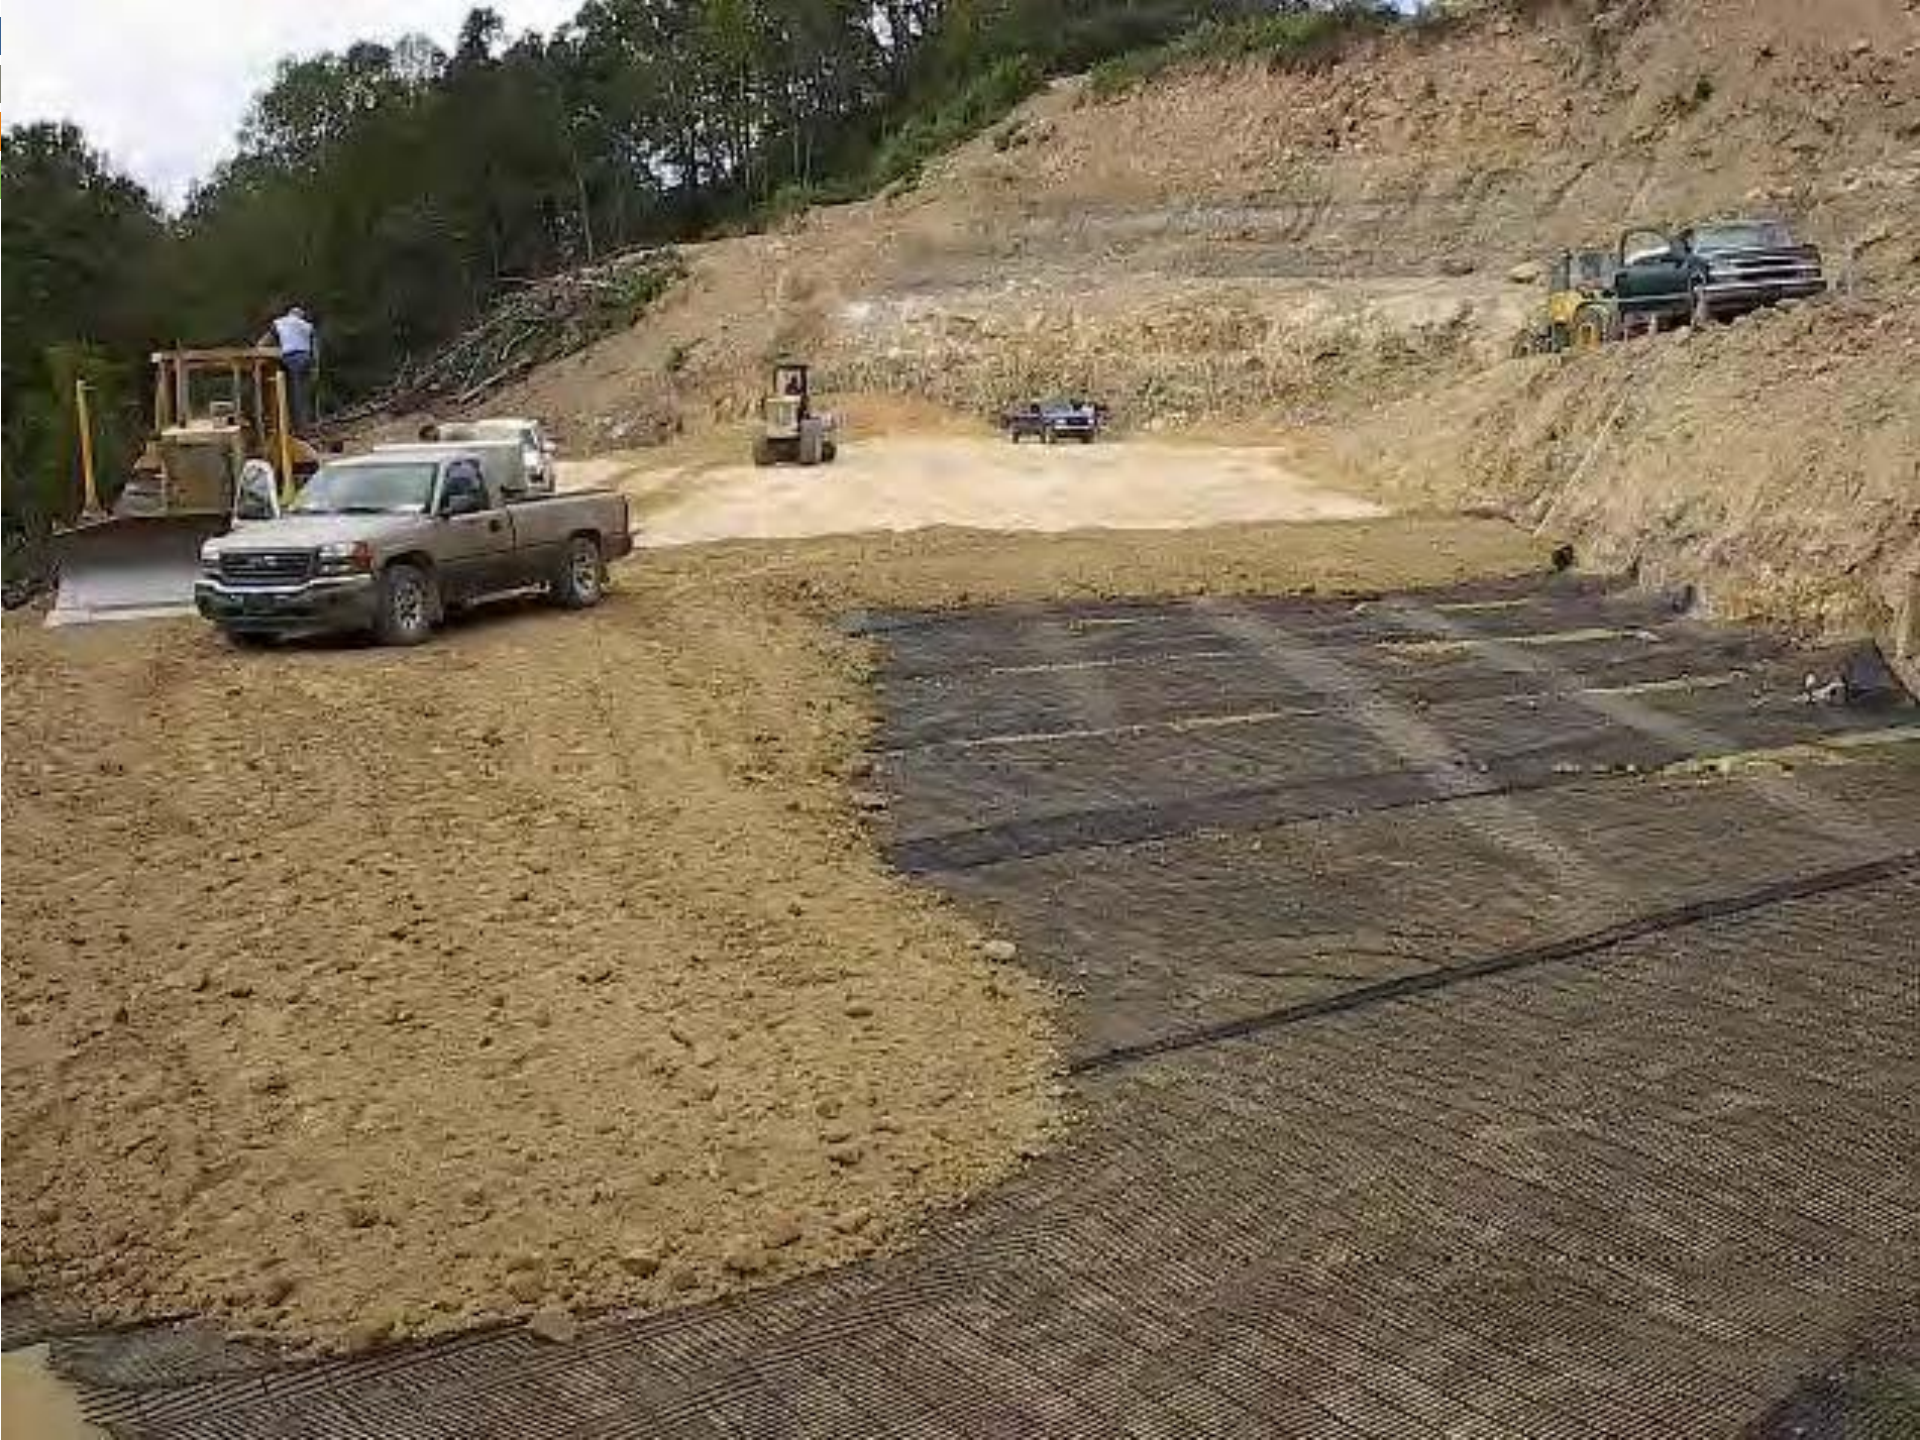
- Runway Safety Area requirements caused a need for a fill at the end of Runway 5
- Reinforced fill was selected with an Engineered Materials Arresting System (EMAS)
- An additional 500' of runway length was added to RW 23 to extend the total runway length to 6,801'
- Project completed in 2008
- Project was touted as the largest reinforced fill in North America

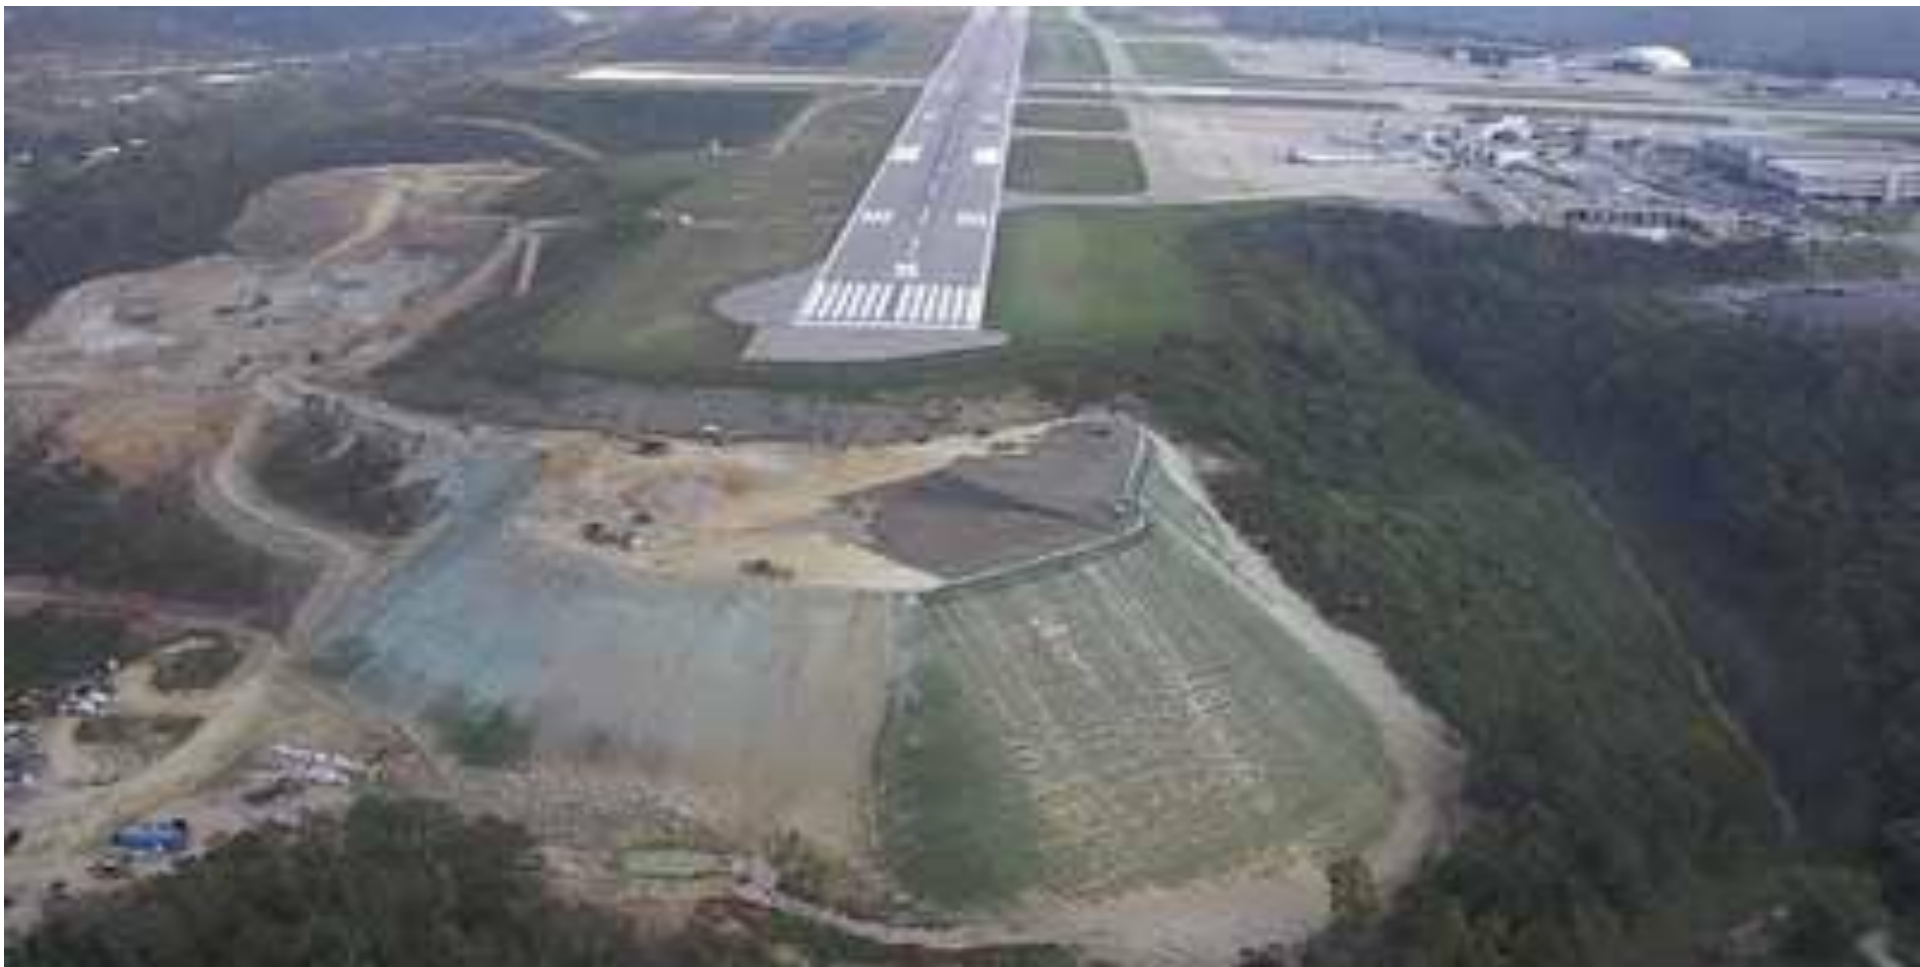
EMAS Reinforced Fill Construction

Statistics

- Height of 240 feet
- 1H:1V outslopes with Geogrid every 3 feet vertical
- Lengths of as much as 175 feet
- Volume of >1,000,000 cy

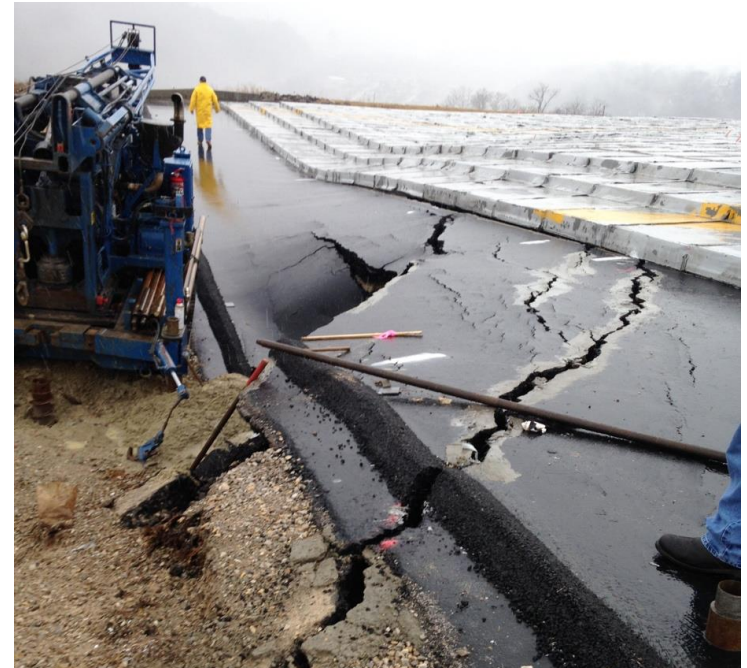
- Crack noticed in 2013
- Southwest corner drops a few feet
- Drops a couple of feet each day in early March 2015

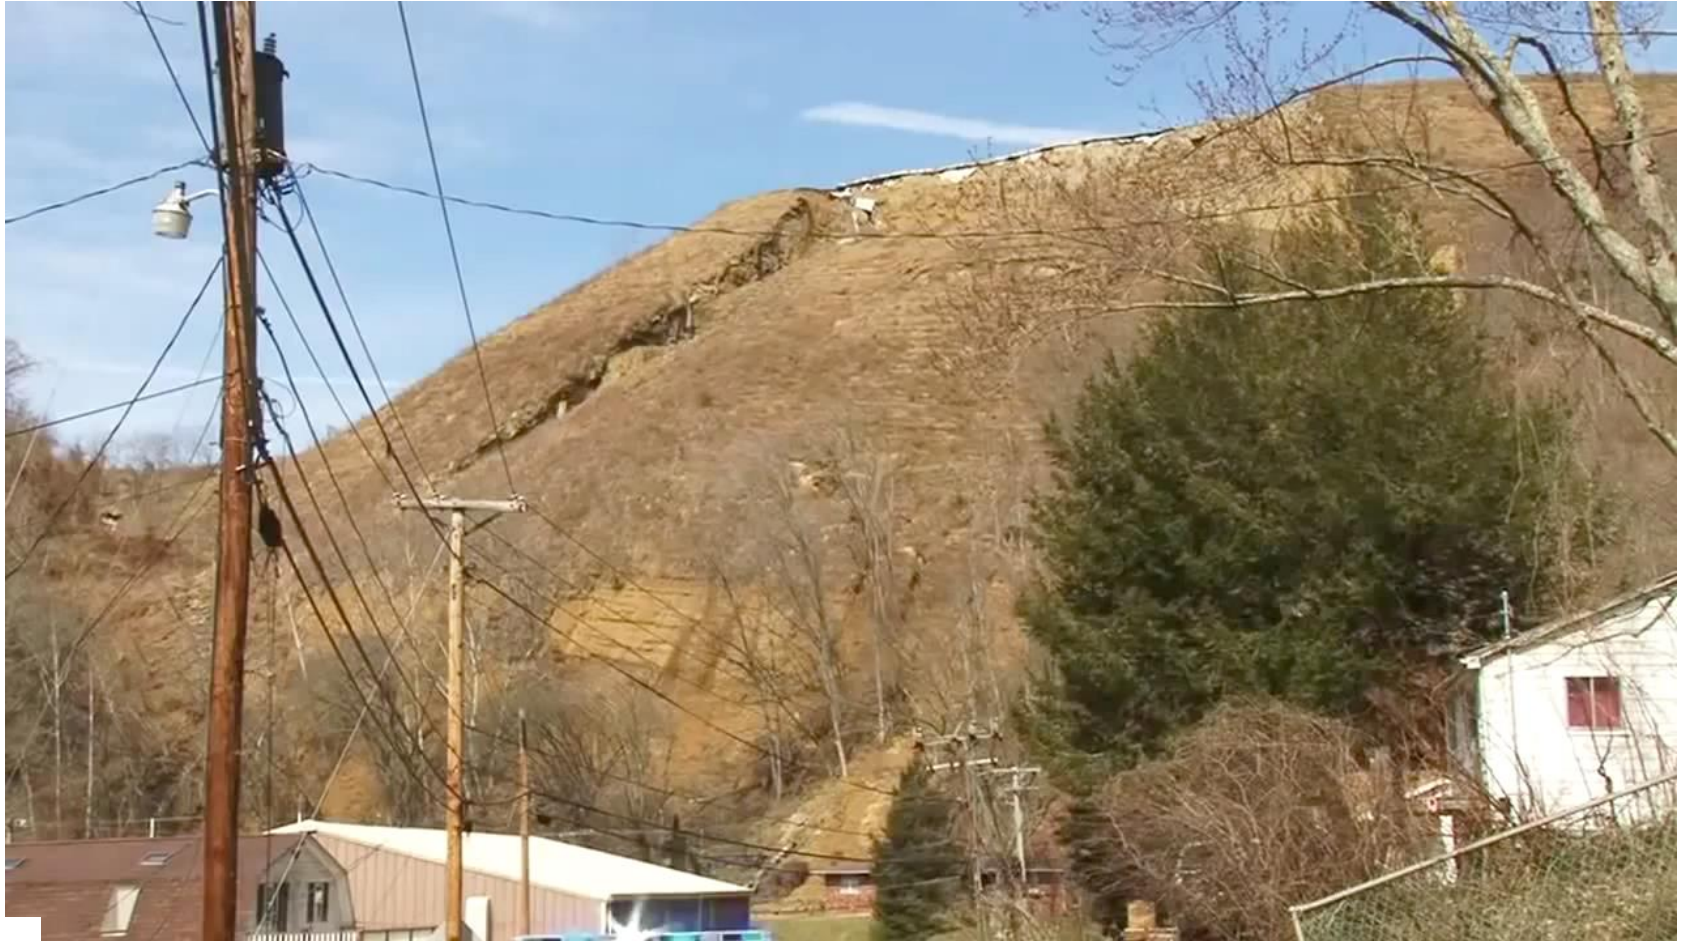
Day of Slope Failure

- An Airport employee was stationed at the base of the fill in parking lot of the Keystone Apostolic Church to watch for movements
- At approximately 12:15 PM the employee noticed significant movement and notified Airport management
- The Airport immediately responded and closed Keystone Drive

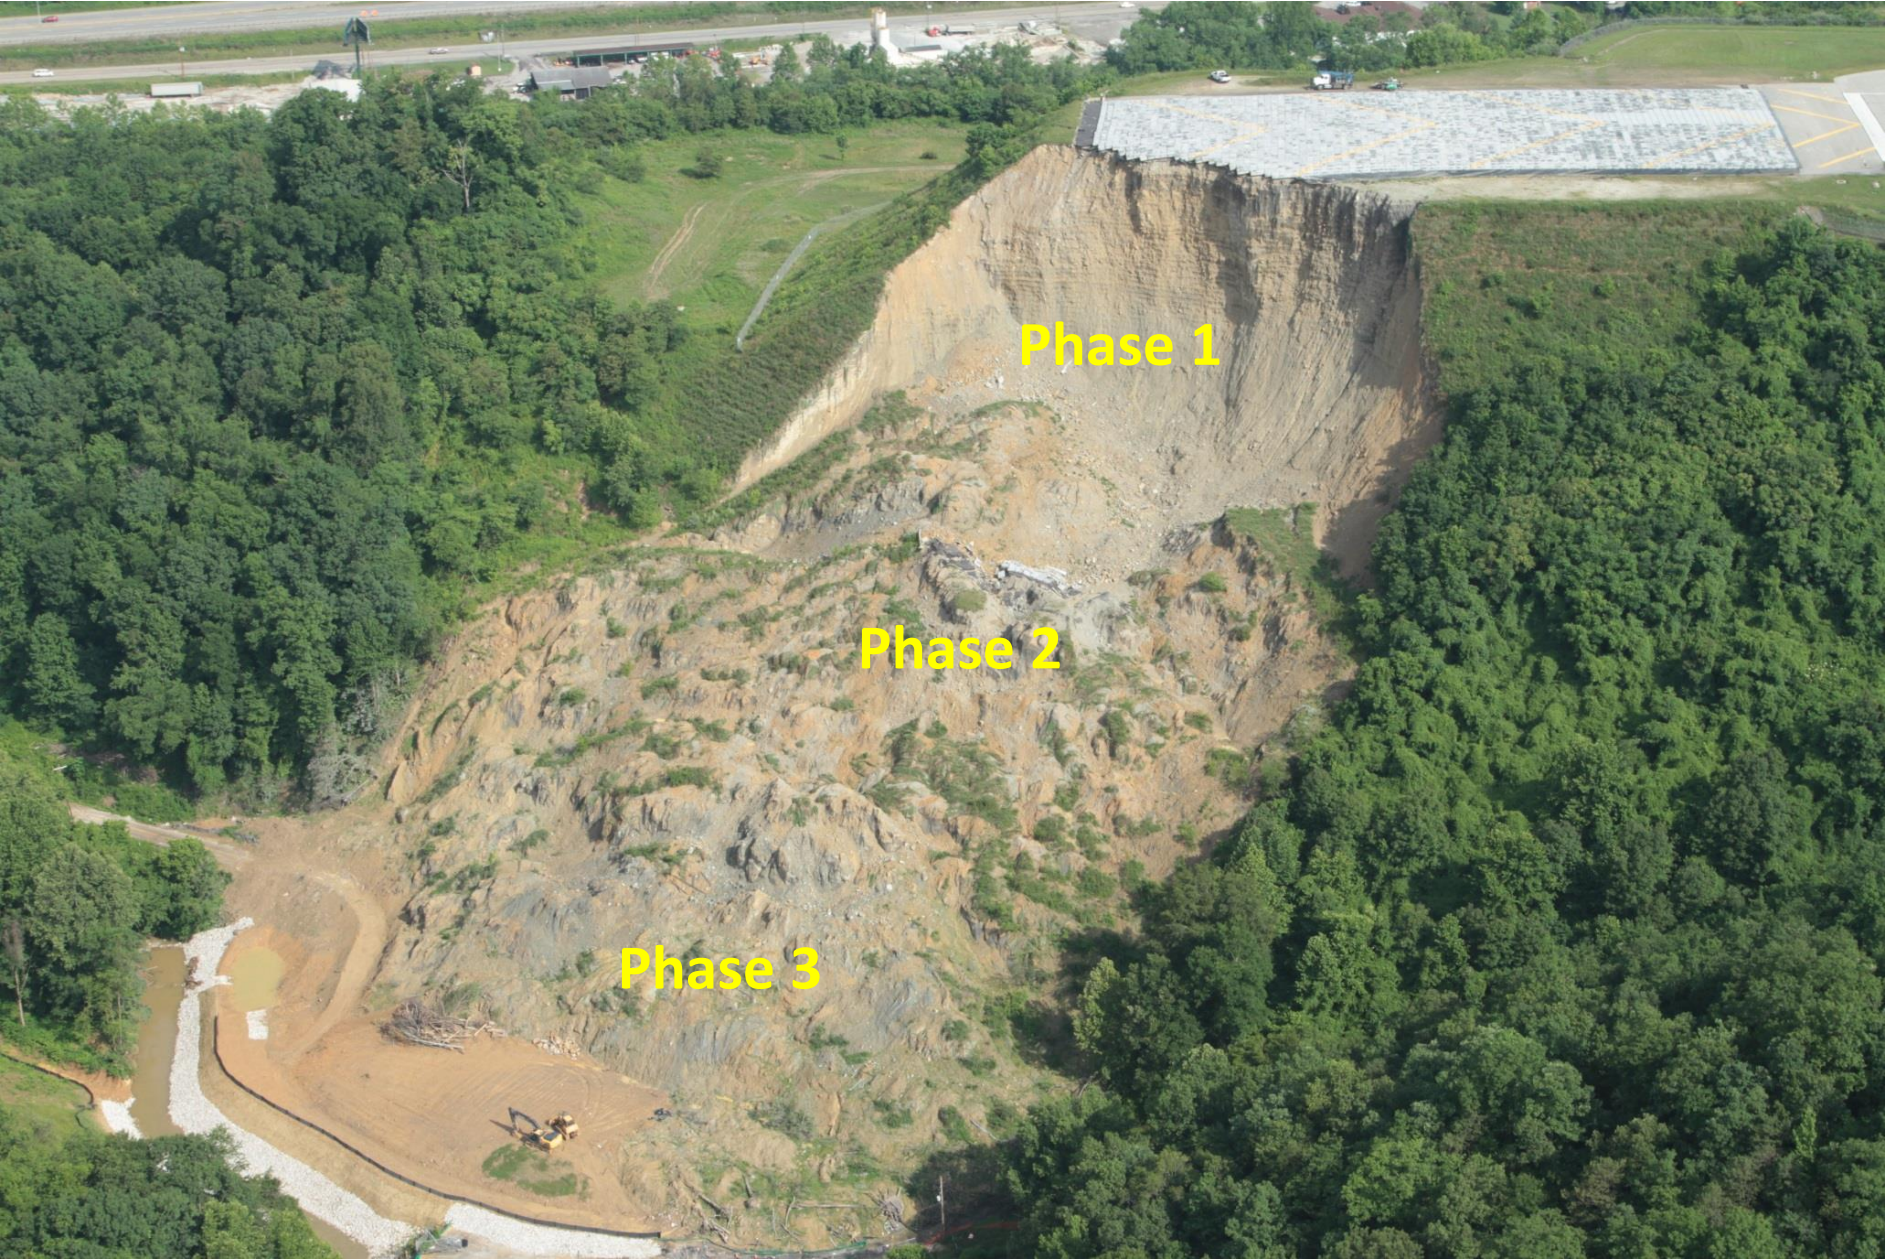
Phase 1

Phase 2

Phase 3

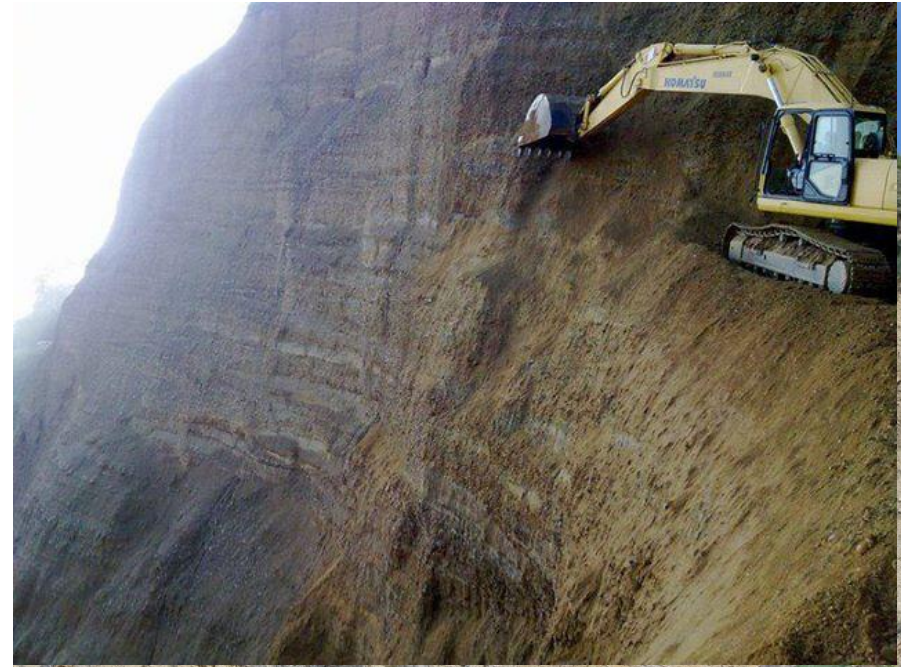
- Not easily explained
- Remaining sheared grid was a benefit
- Concerns about equipment/personnel safety
- Practical limitations of equipment reach vs. boomph

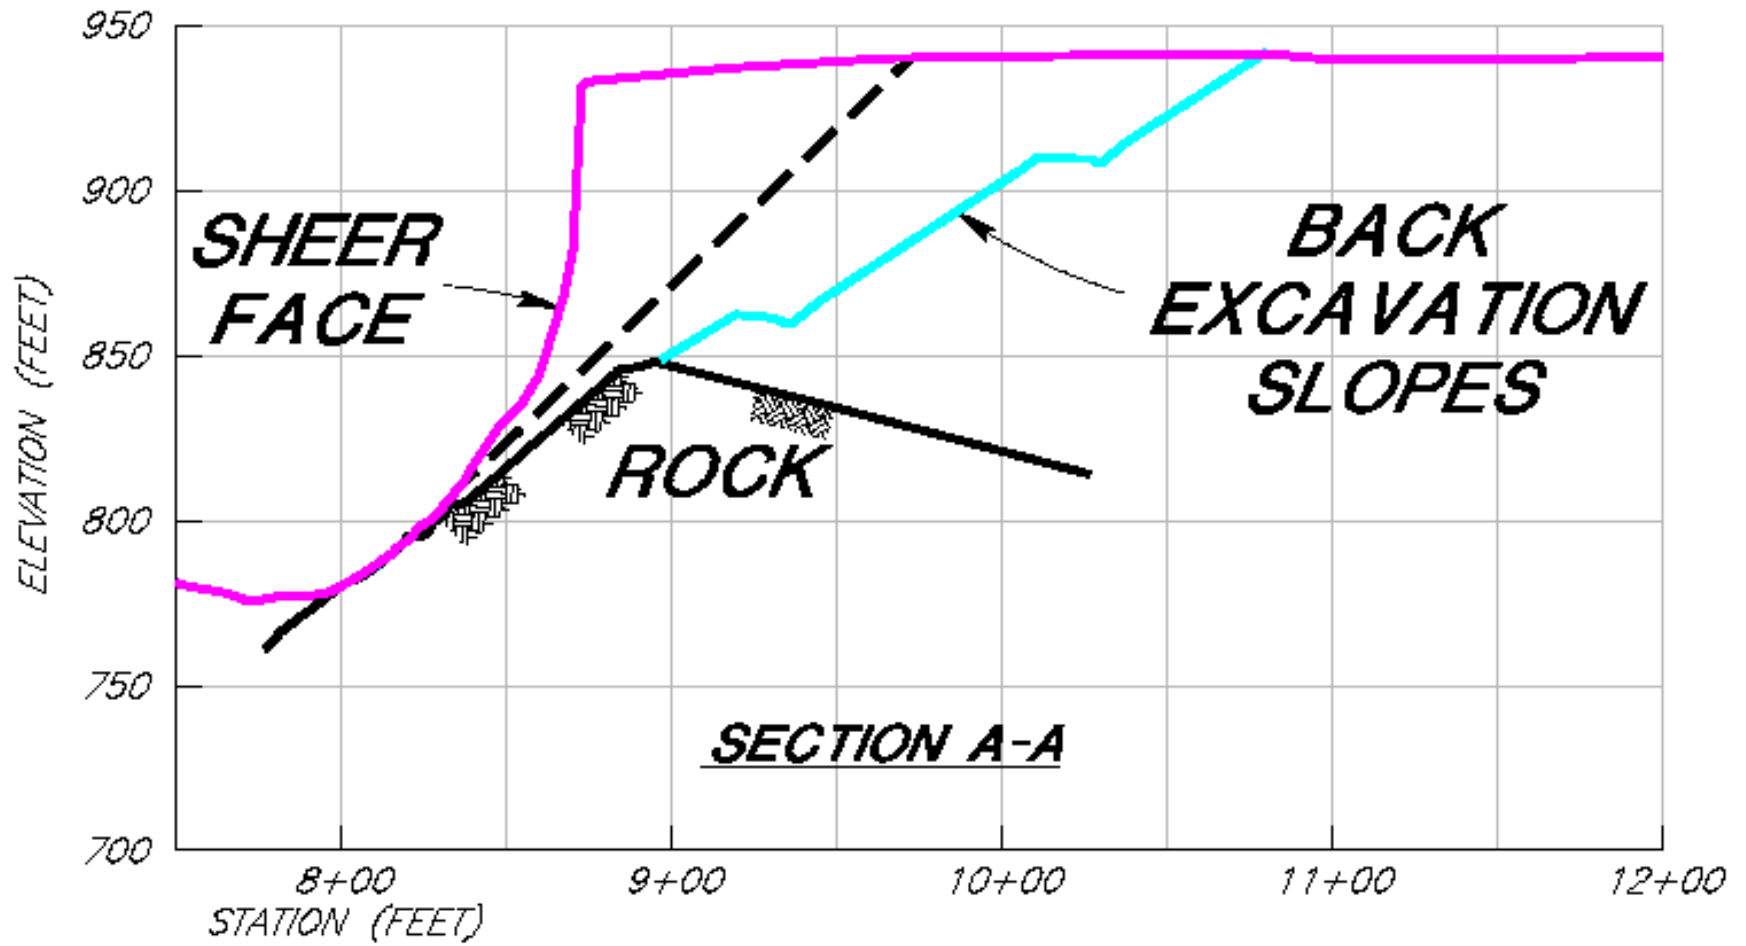
- Survey points on outer edge of face with continuous monitoring
- Visual observations
