Lessons Learned from Landslides in the Panama Canal

J. Michael Duncan

GeoVirginia:
Lessons Learned in Geotechnical Engineering
Williamsburg, Virginia, April 30 to May 2, 2012

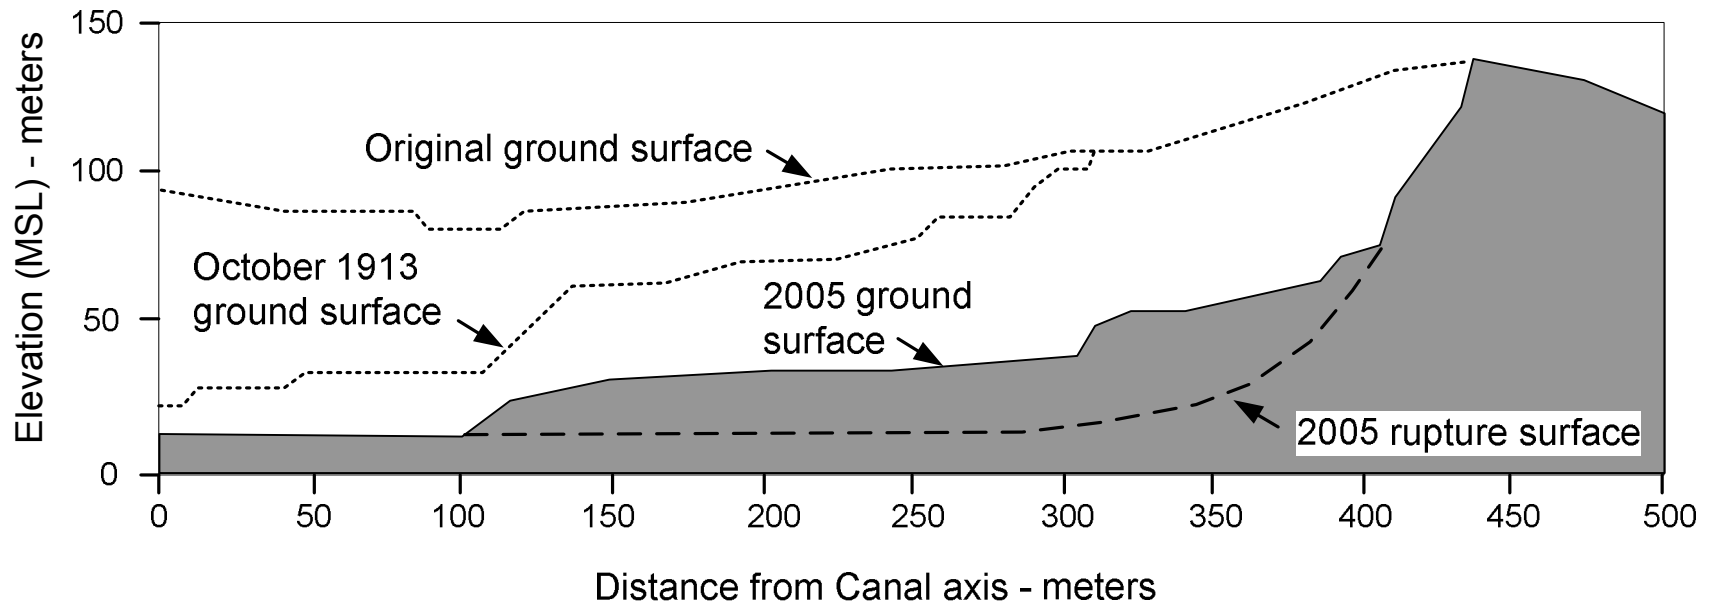
An example - West Culebra

West Culebra

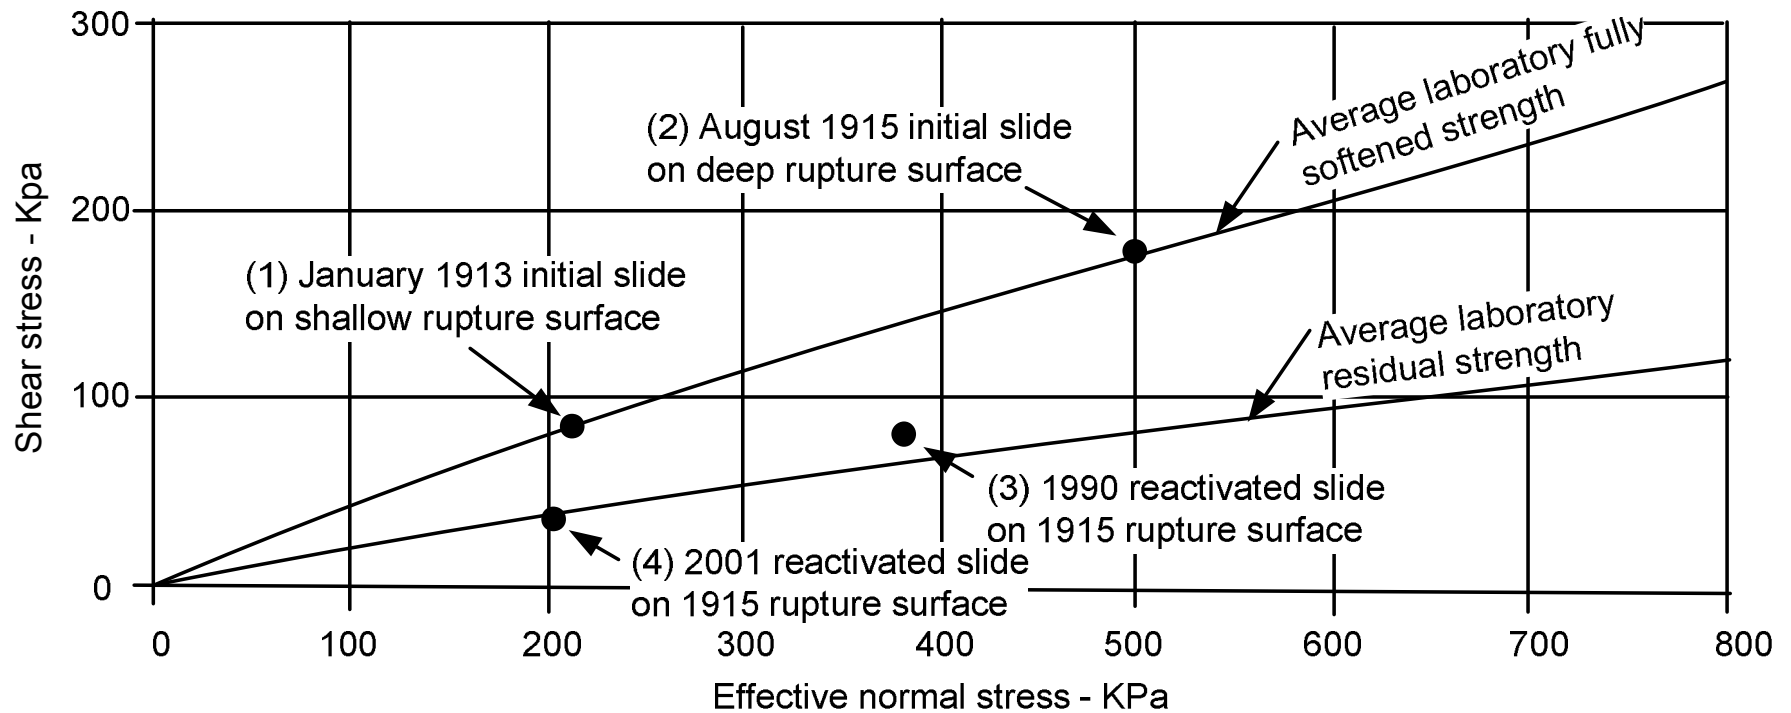
West Culebra - declining soil strength

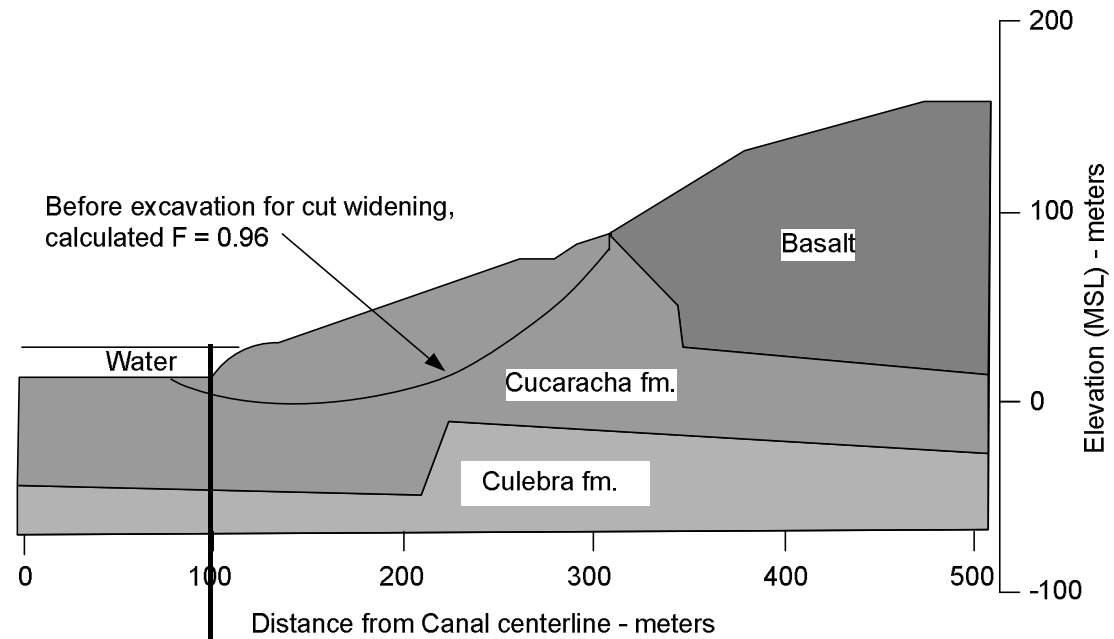
Model Slope Excavation for cut widening

- Perform analyses of the original slope profile and the profile after reshaping by excavation
- Guiding philosophy - excavation should never reduce the computed factor of safety
- Change in factor of safety should be positive, but need not be large

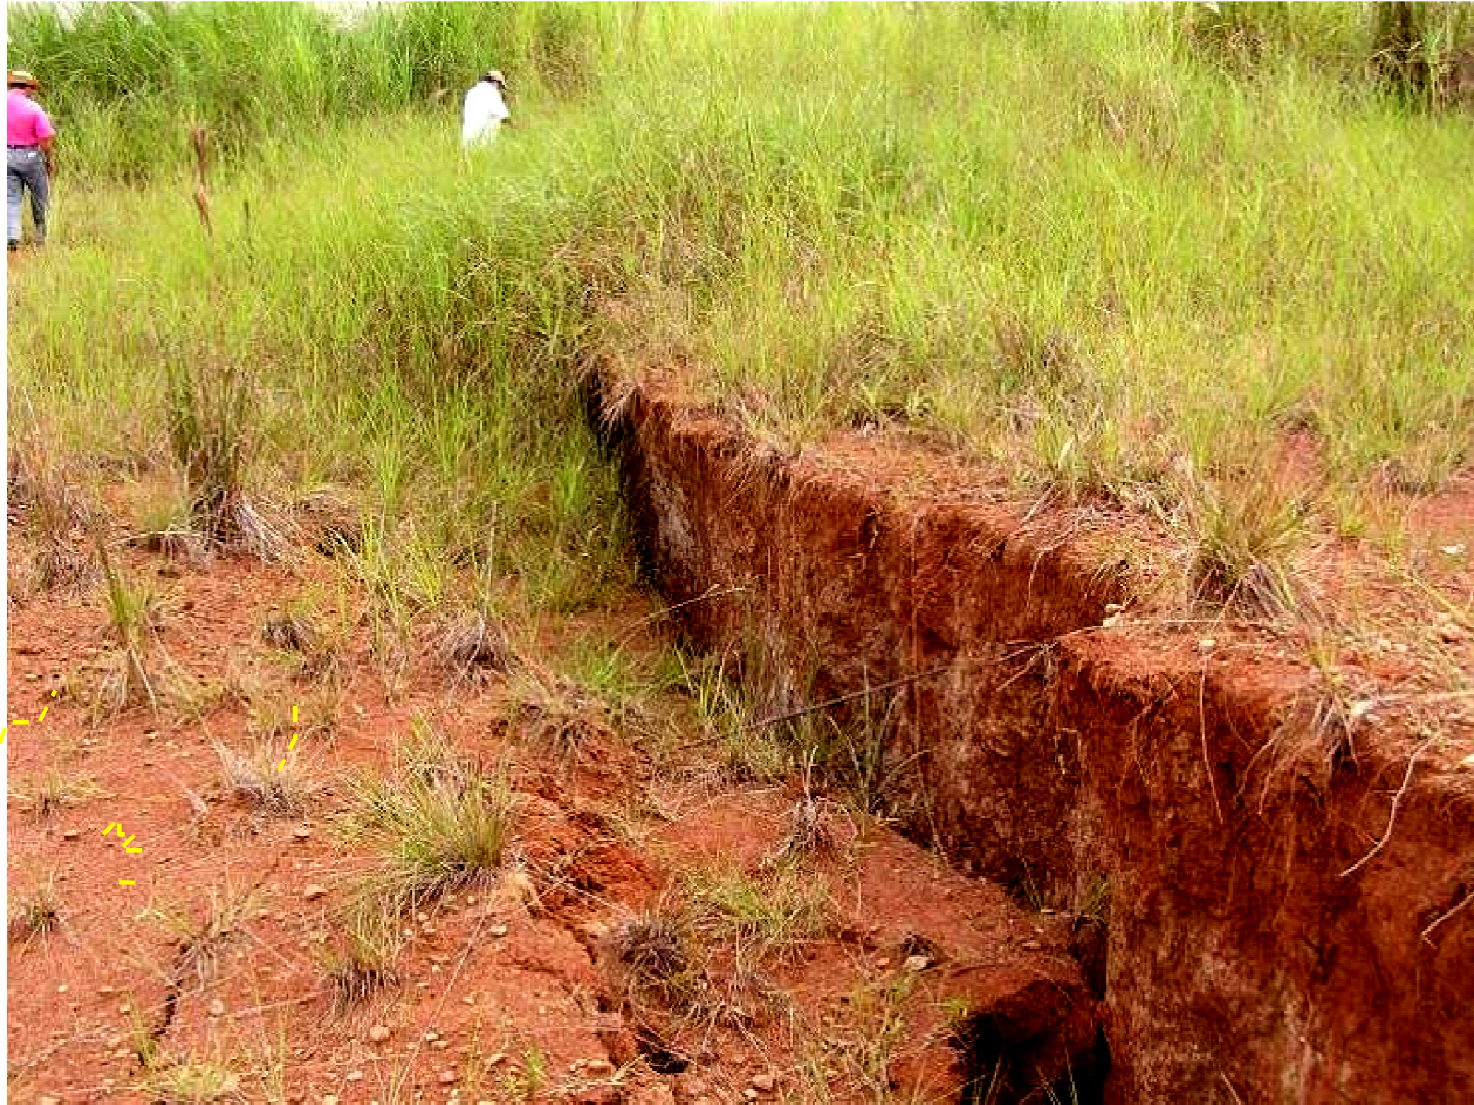
October 17, 2005 : The backscarp of the slide was discovered. The rate of movement was about 10 cm/week

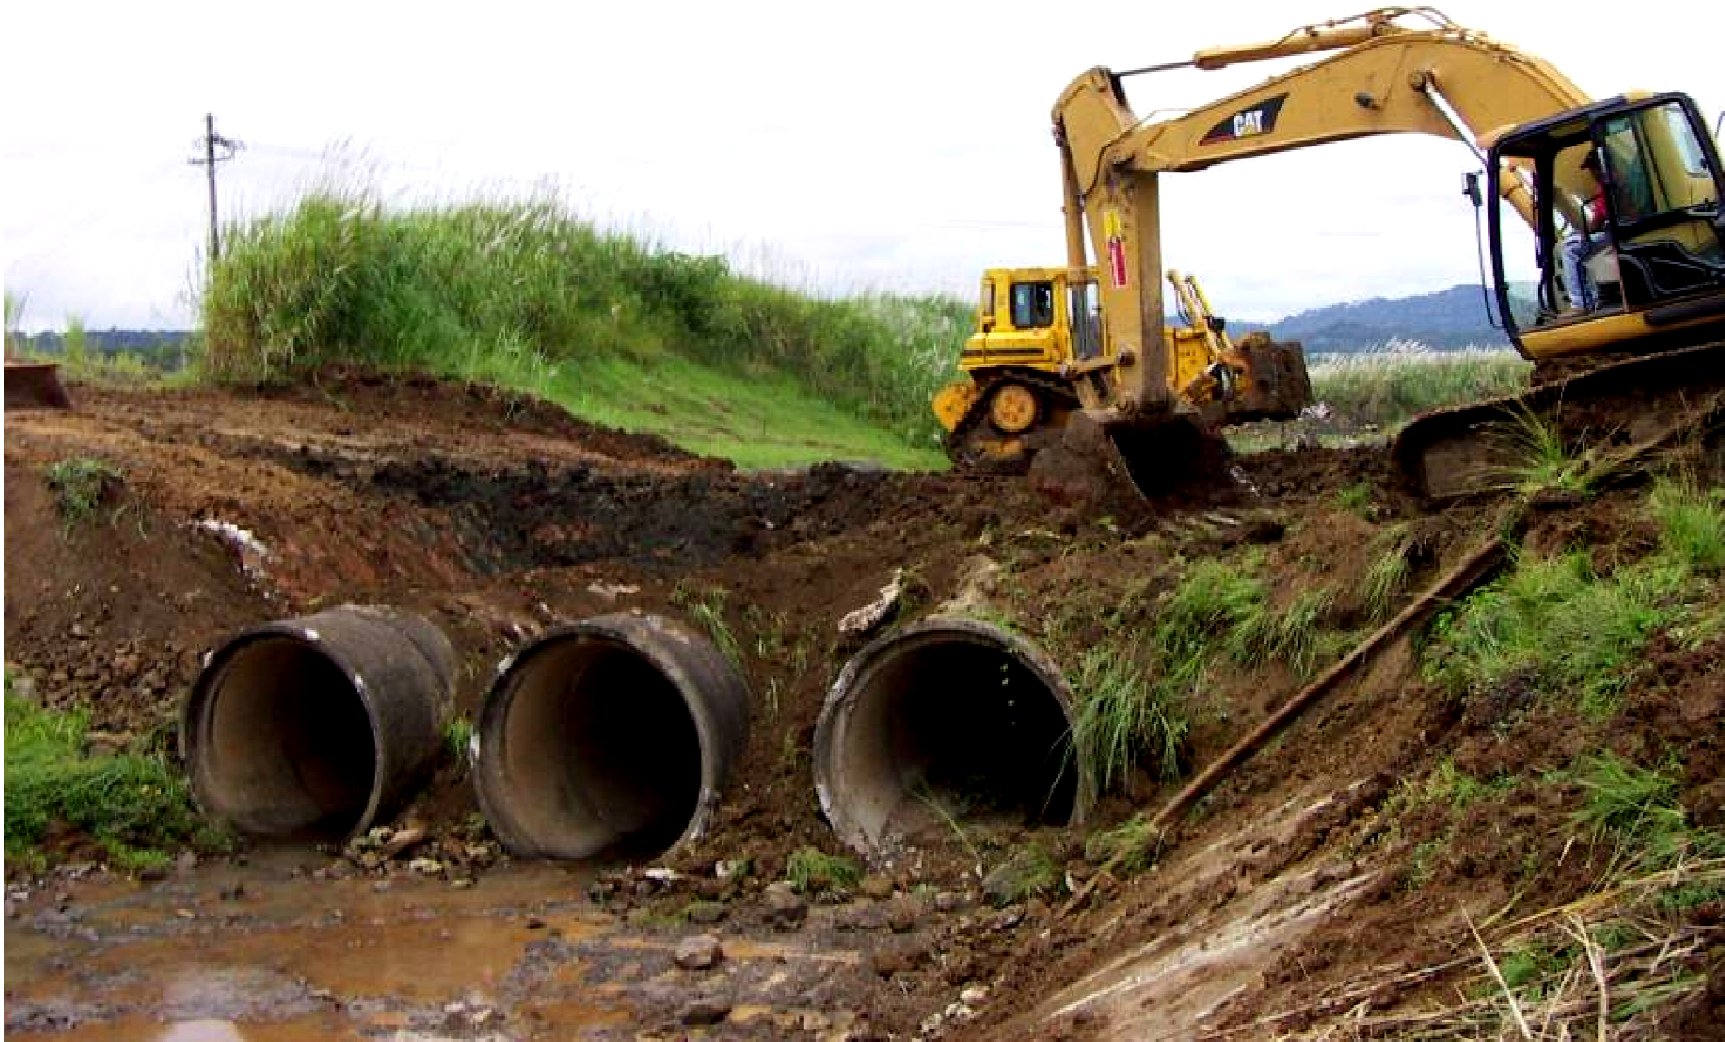
October 22, 2005 : Removal of culverts that created a bottleneck in the diversion

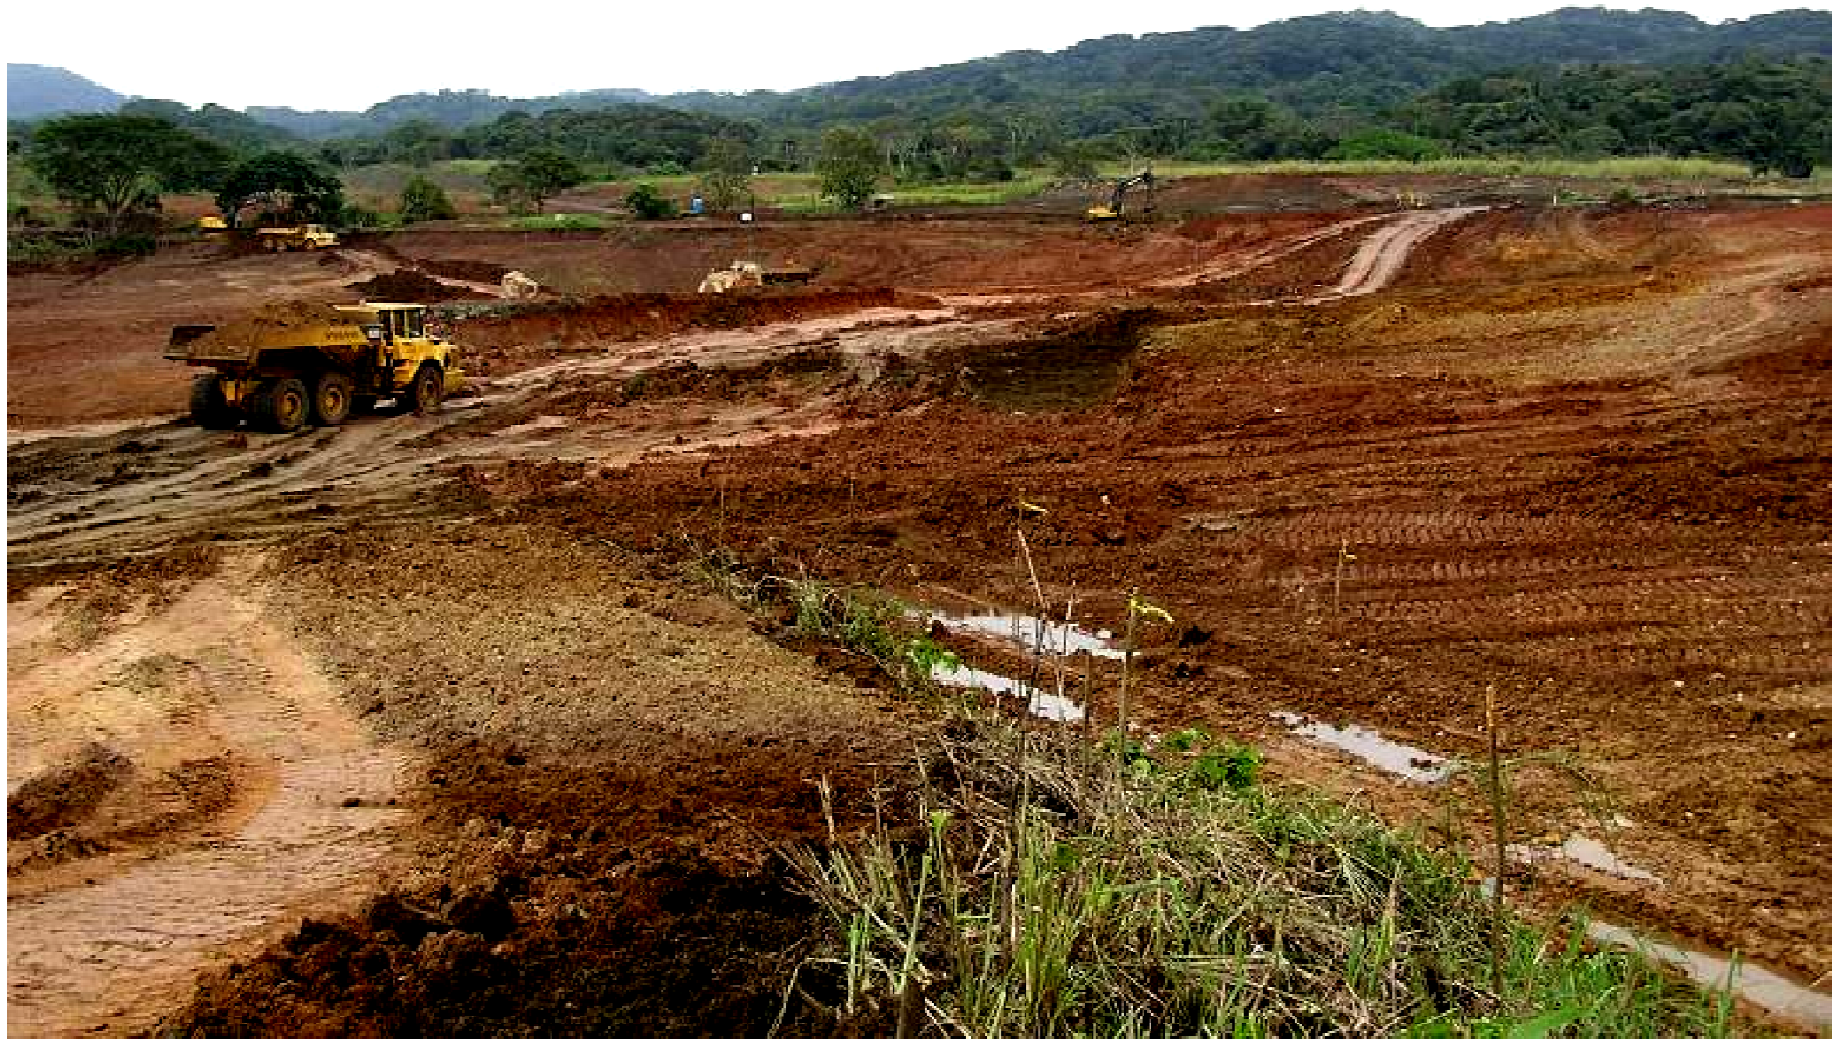
Excavation under way - late November 2005

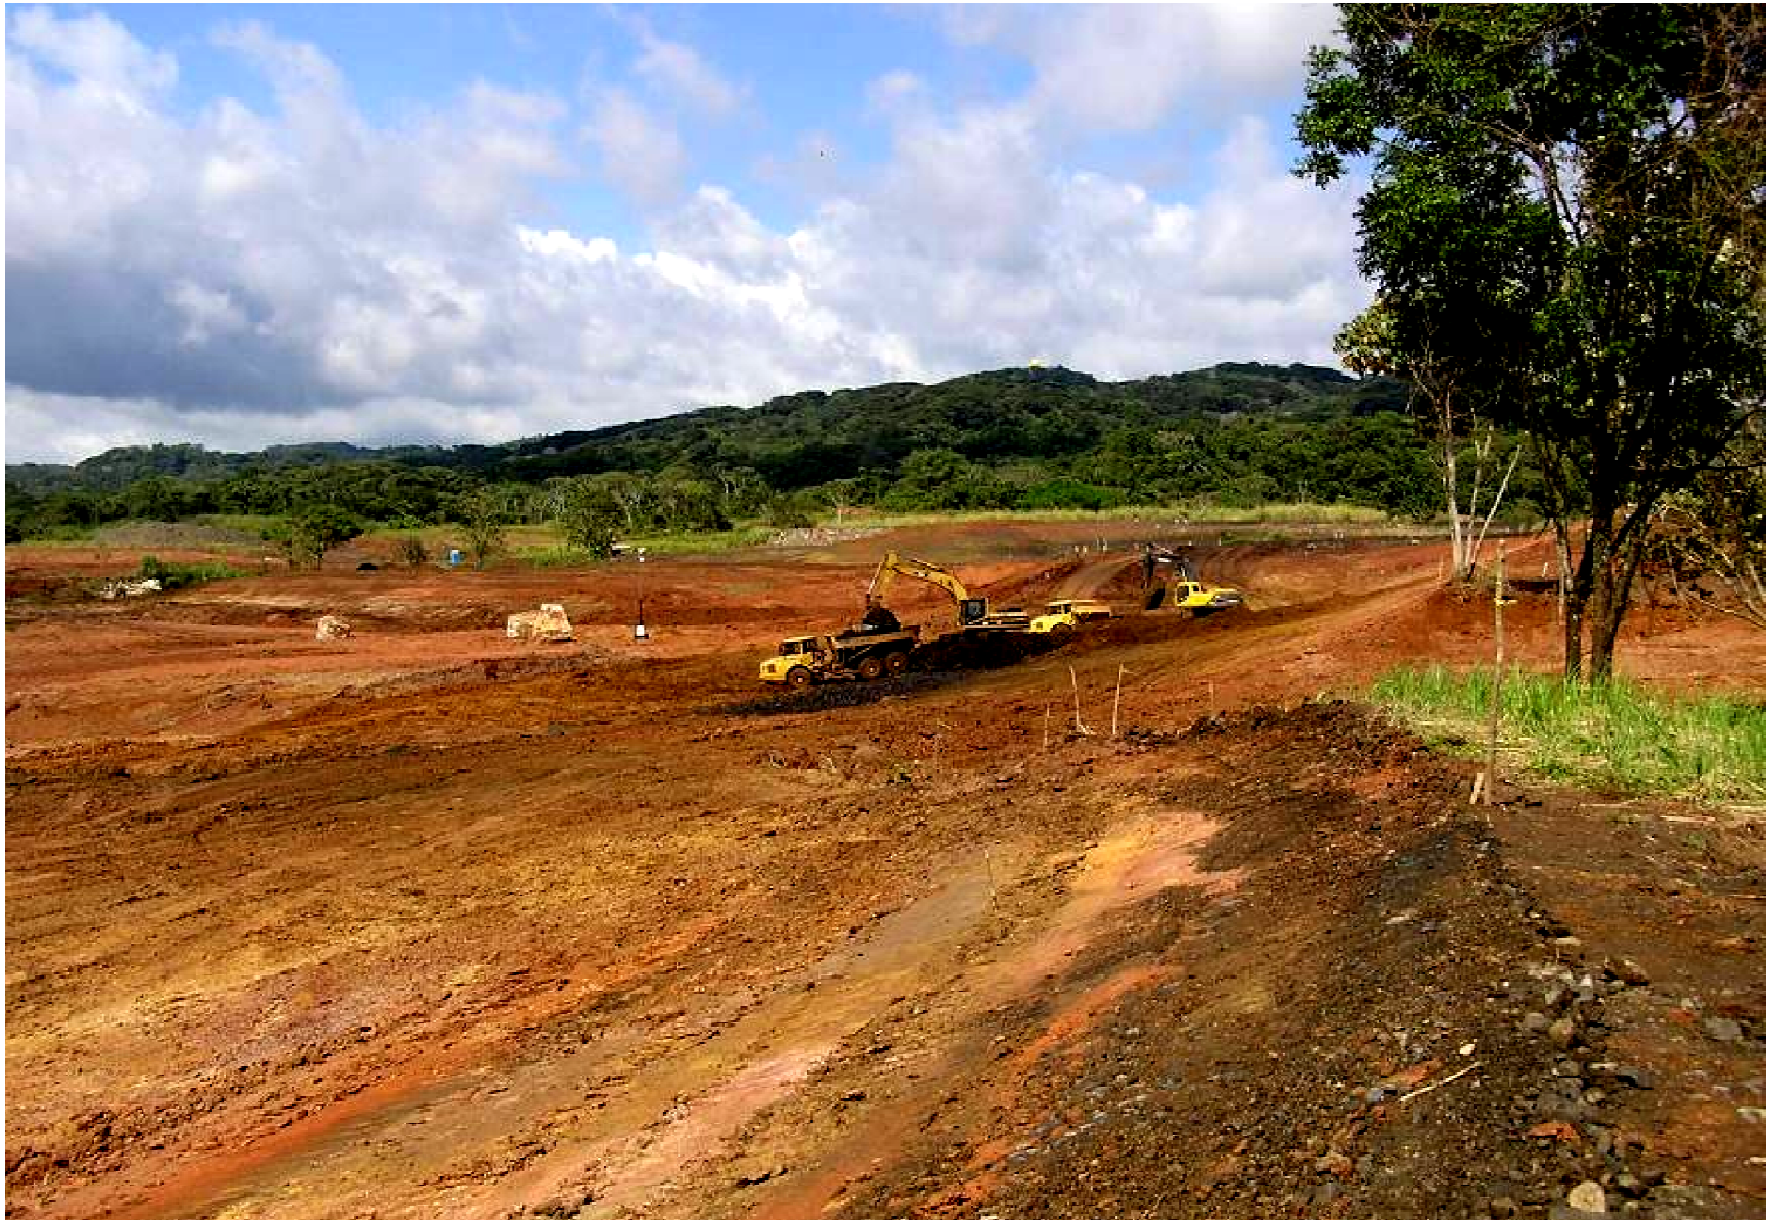
Excavation under way - mid-December 2005

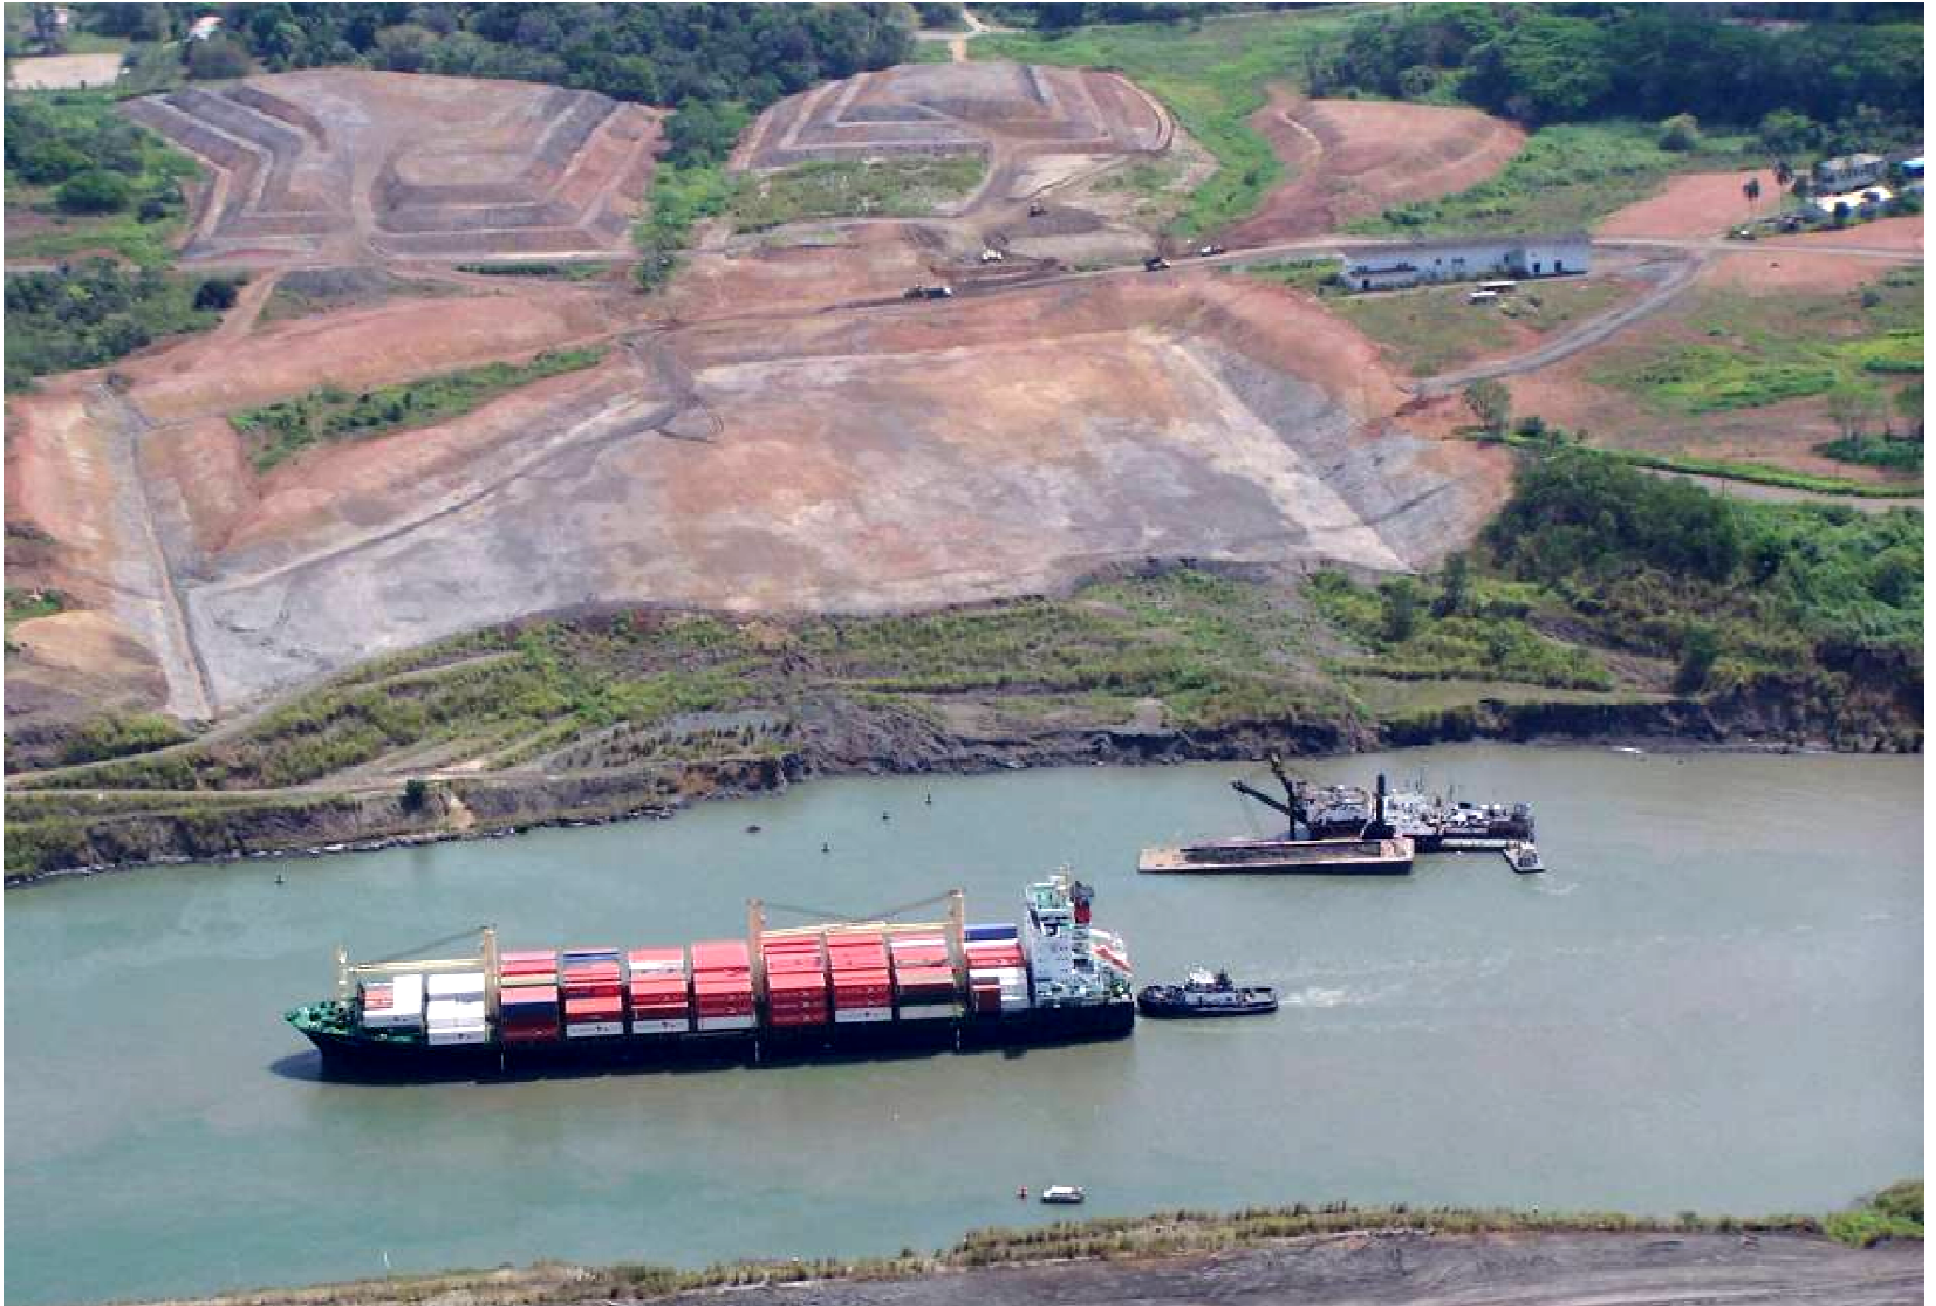
Excavation complete - February 2006

- October 17, 2005 - slide discovered, drainage improvements started.
- October 27, 2005: Plans and specifications for 411,000 m³ excavation completed.
- October 31, 2005: Contract awarded for US\$950,000 - \$2.30 per m³.
- February 4, 2006: Excavation completed.
- 110 days from discovery of slide to completion of the repair project
