# ***Constructing in Congested Areas Without Damaging Existing Structures***

**Hugh S. Lacy, PE, D.GE, F.ASCE**  
**Gregg V. Piazza, PE**

**Mueser Rutledge Consulting Engineers**

***GeoVirginia 2016***  
***October 10-12, 2016, Williamsburg, VA***

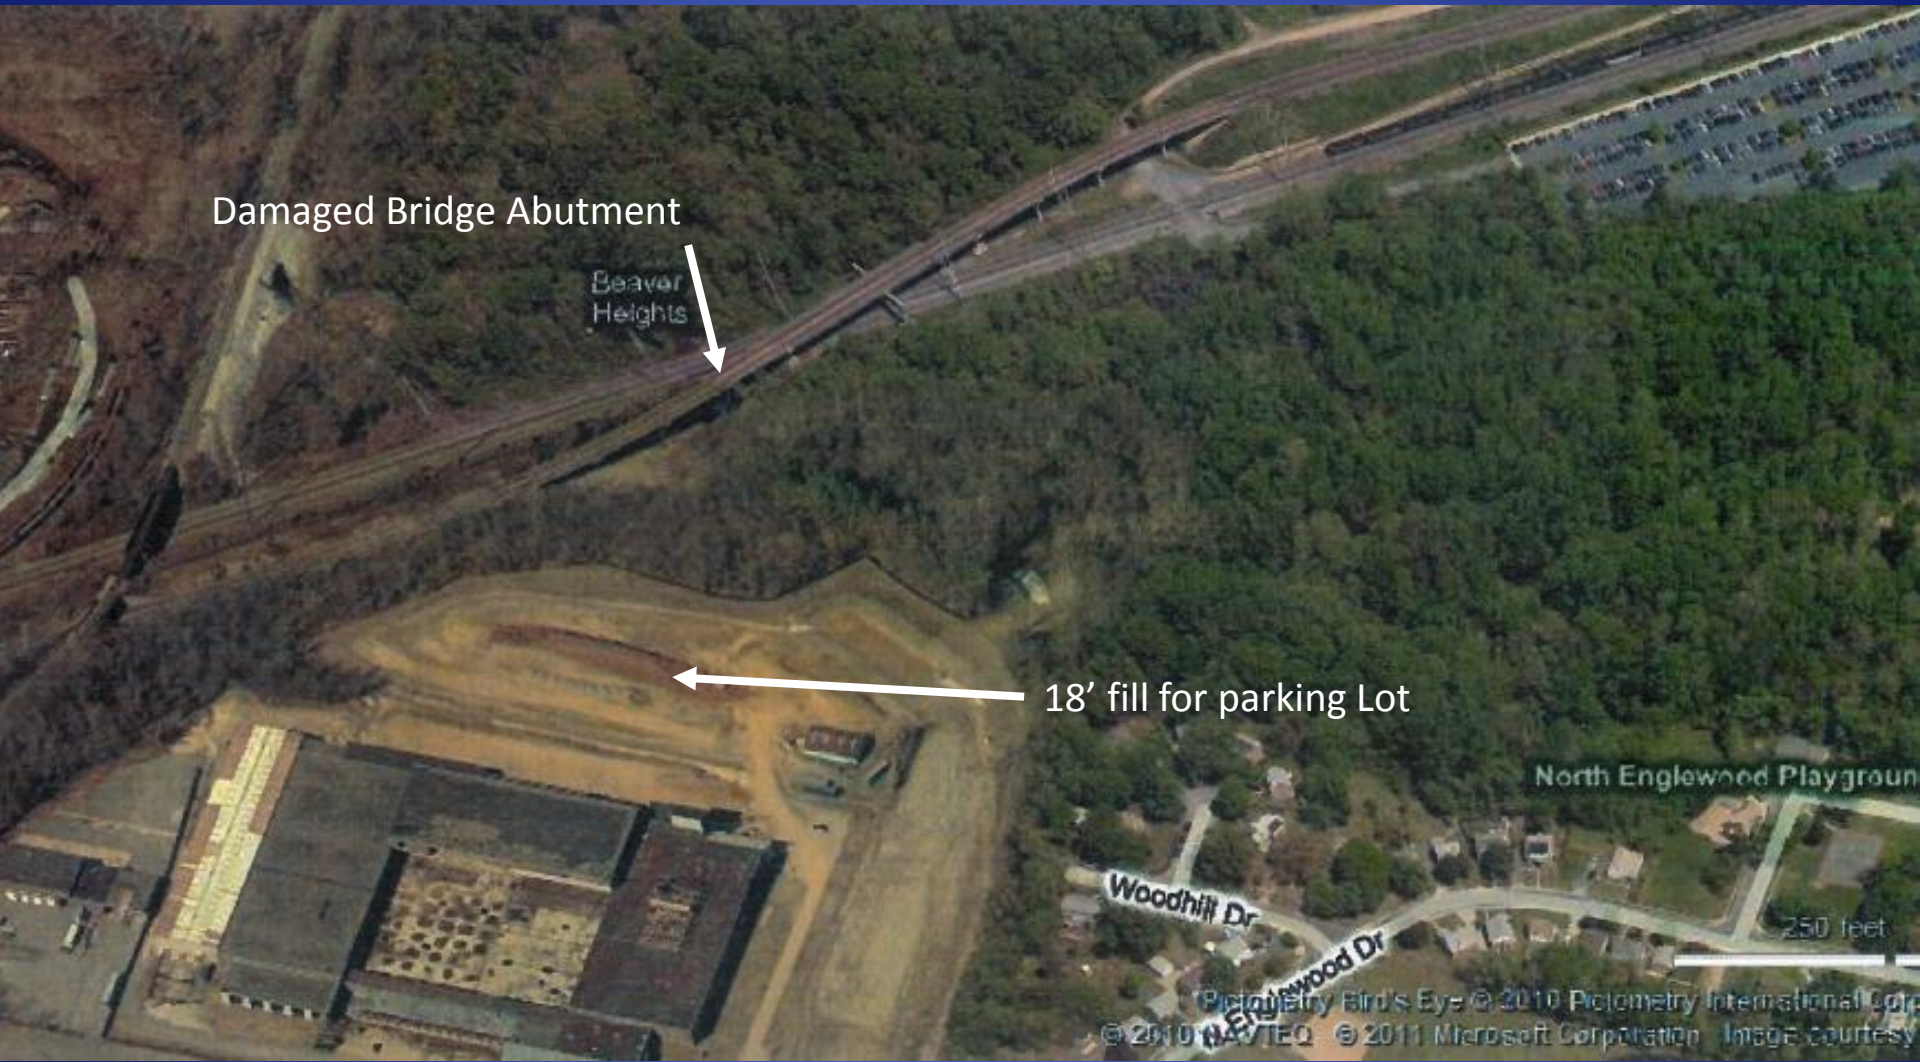
# Site Conditions

- **Movement in a slope flatter than 1V:3H**
- **2.3' lateral movement of a WMATA bridge pier near the base of slope**
- **Site was underlain by hard fissured clay**
- **Stability analyses – marginal stability**

Damaged Bridge Abutment

18' fill for parking Lot

# Cause of Failure

- **18 ft. of fill recently placed for a parking lot at the top of the slope**
- **Fill placed on private land**

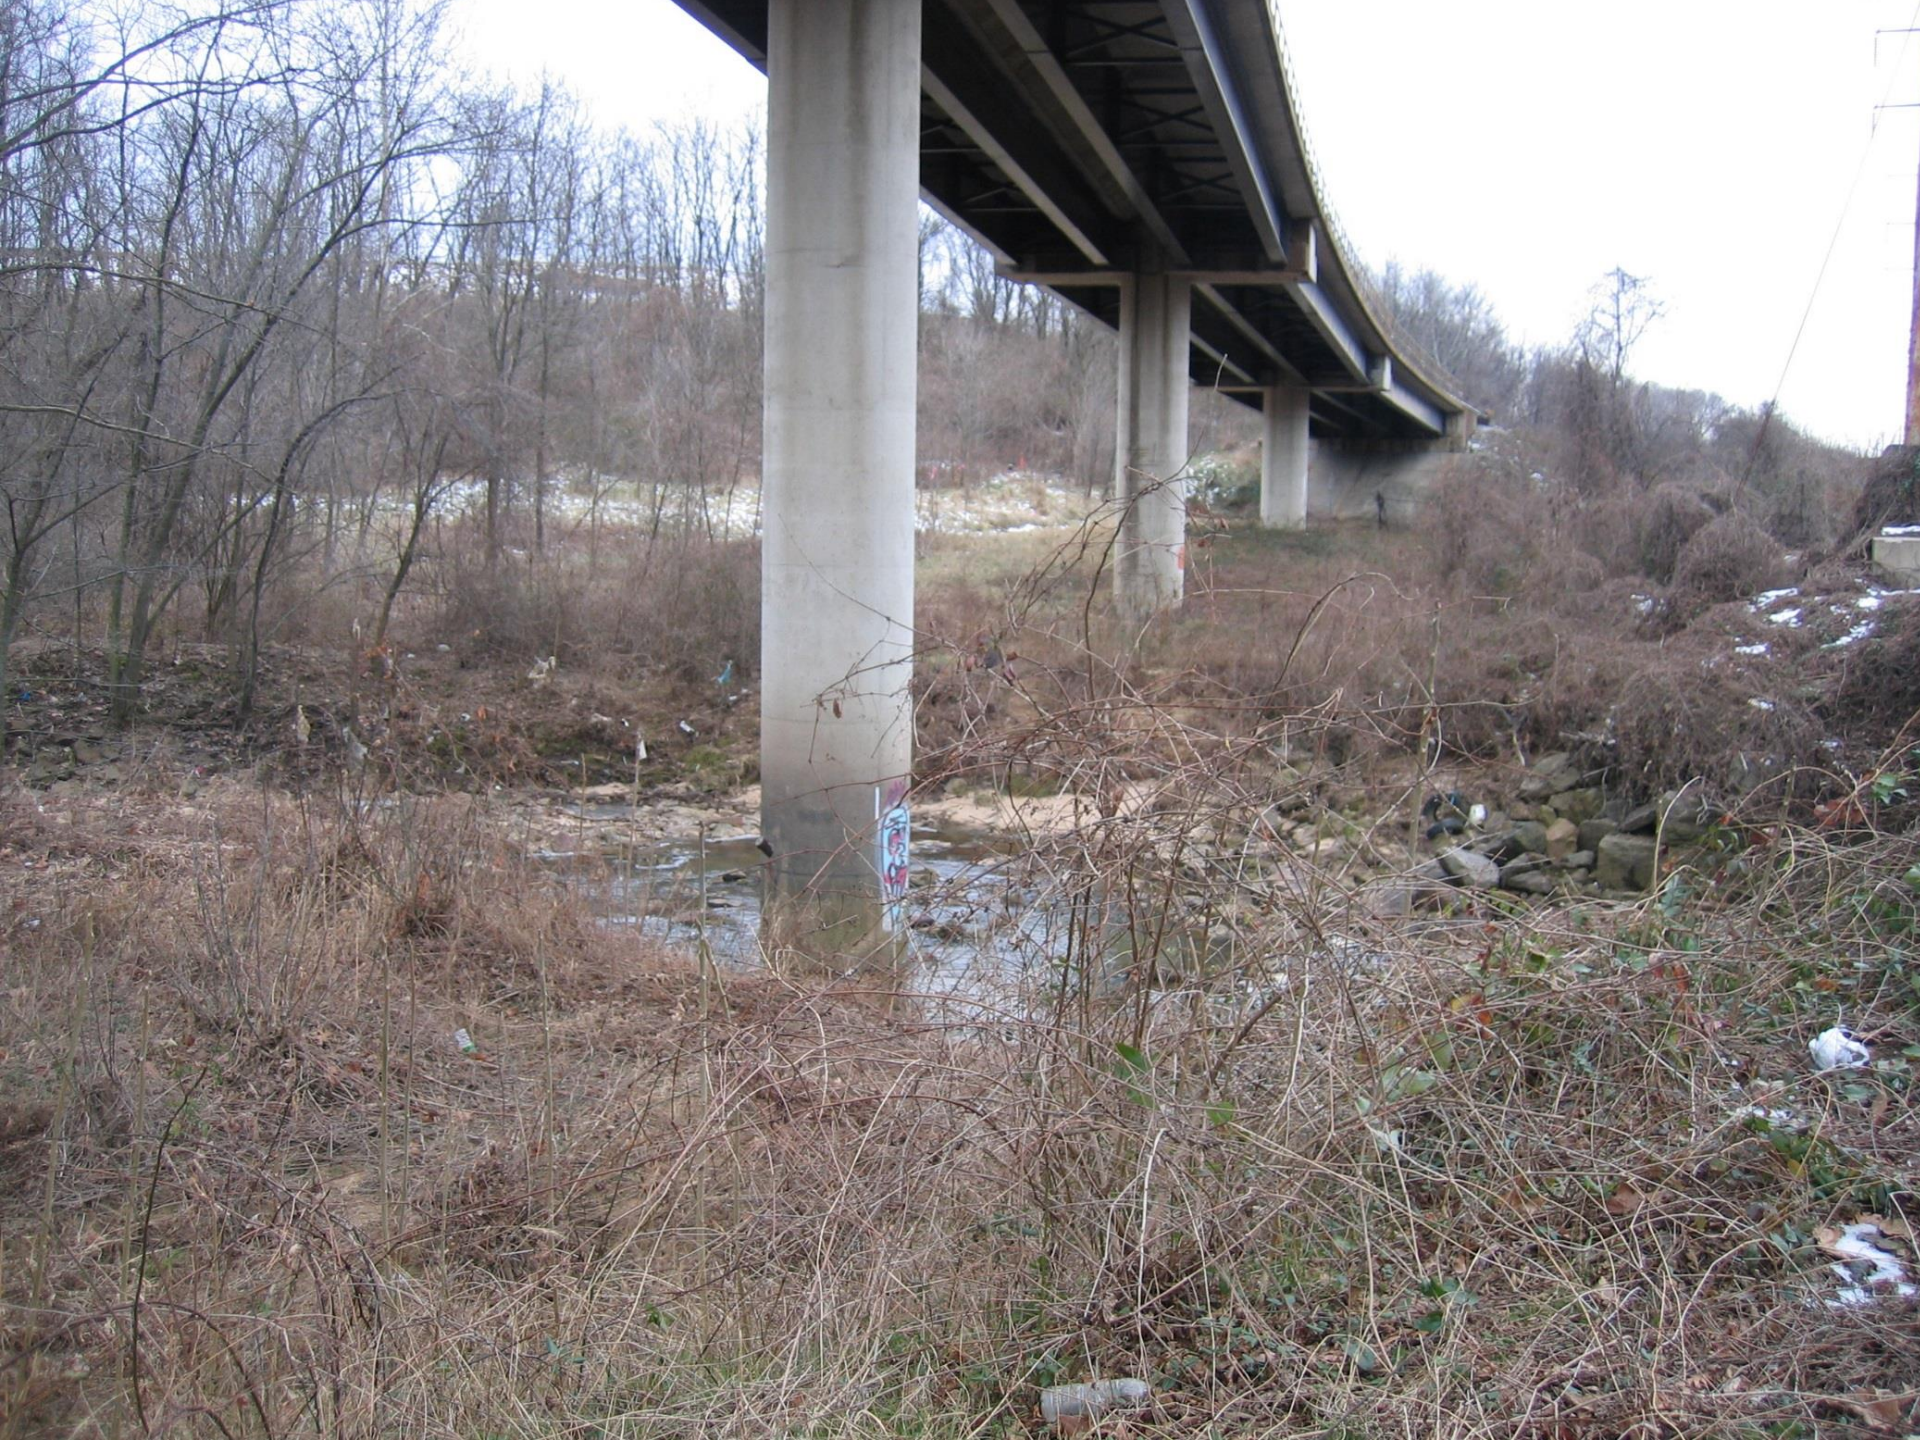
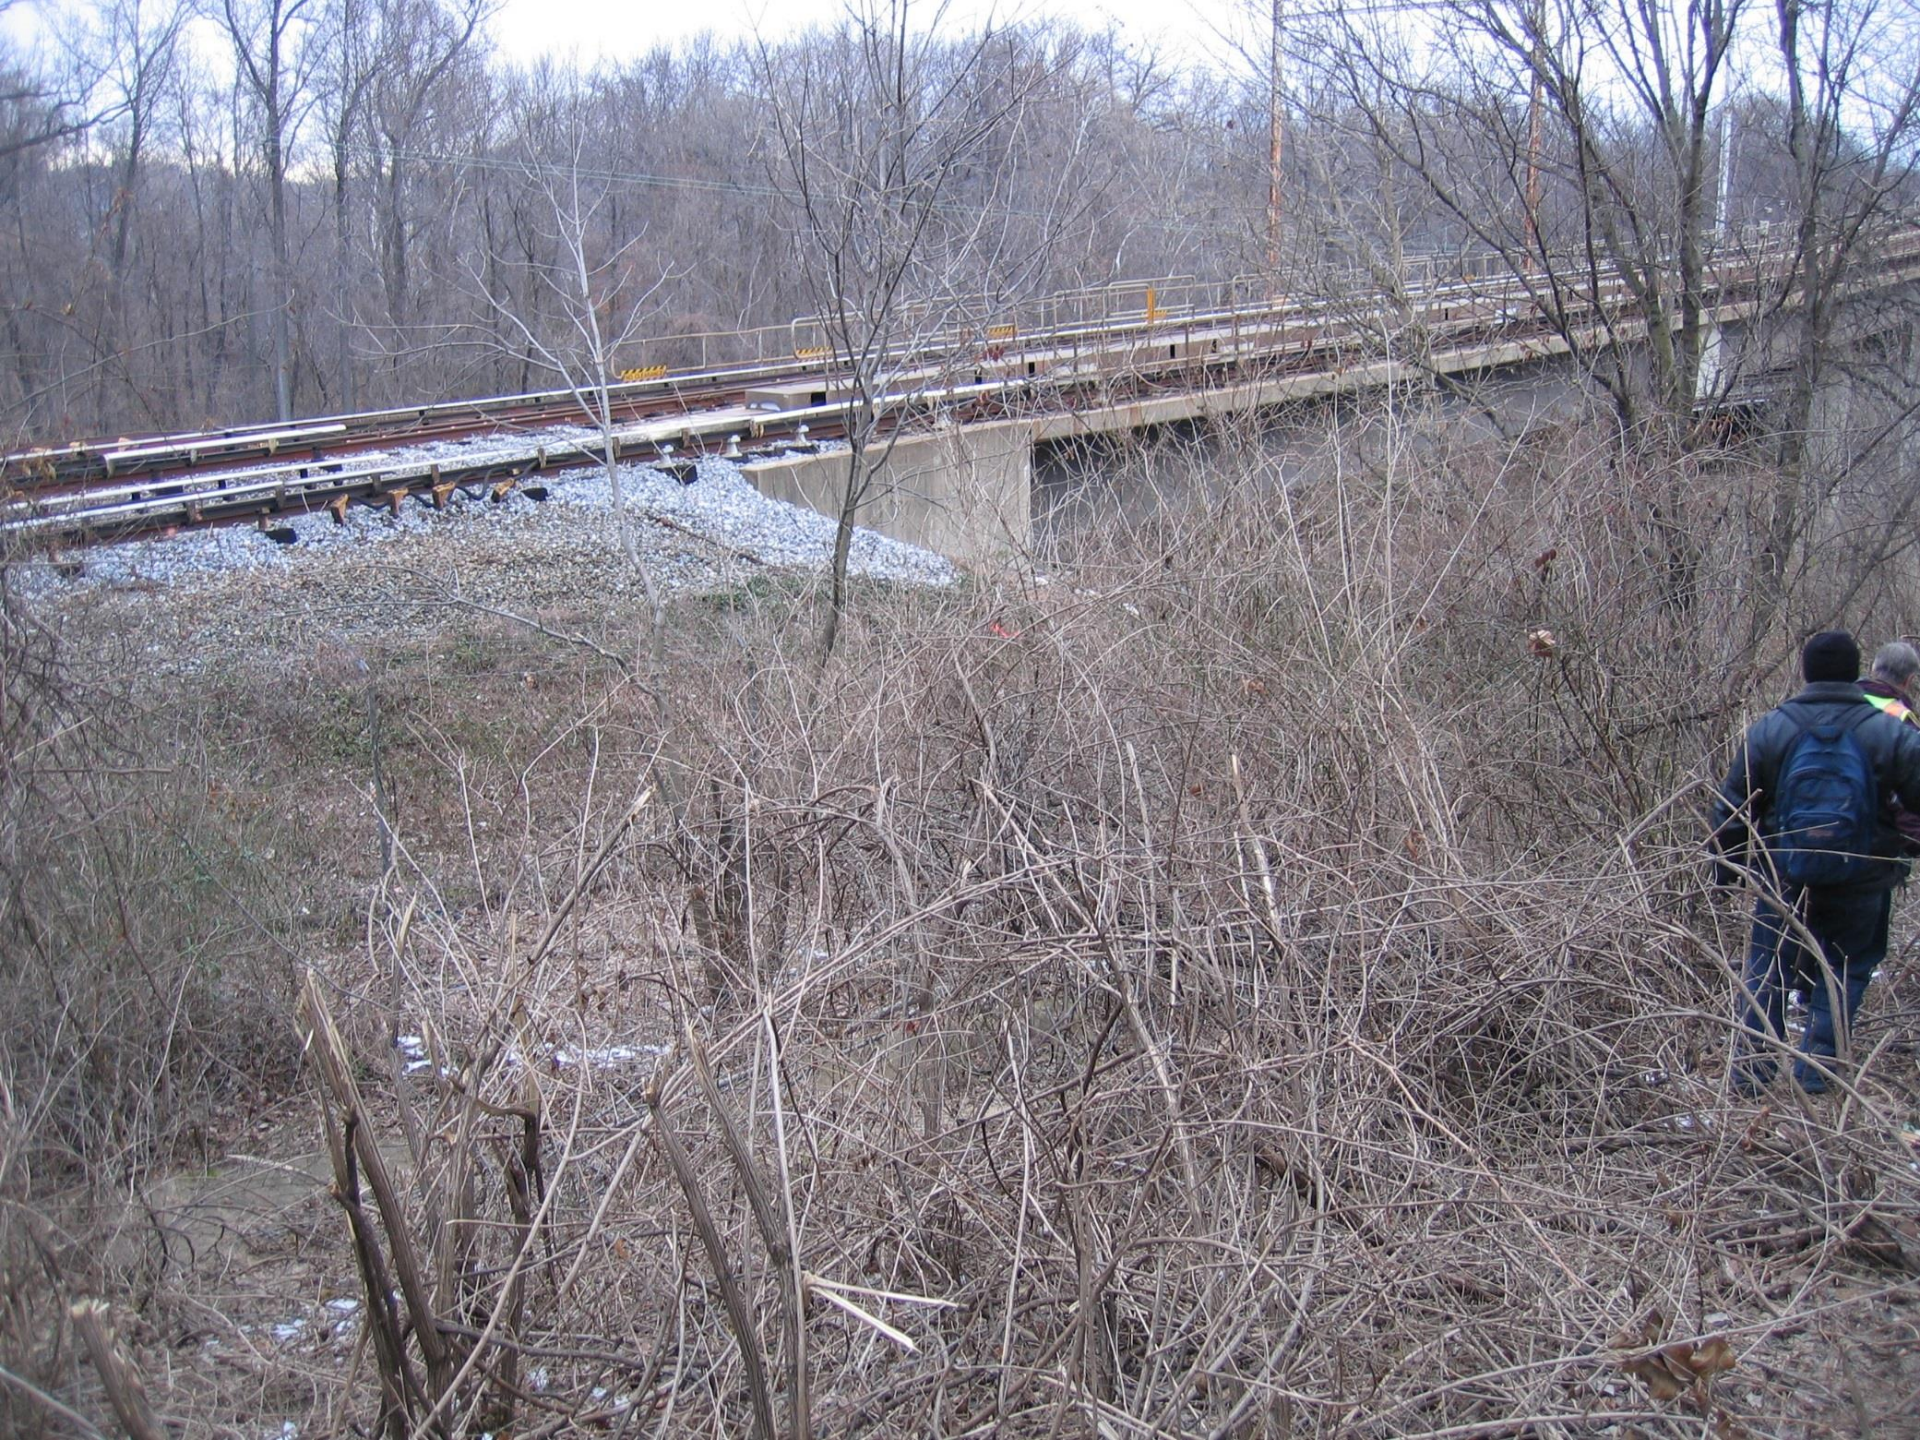
**CHEVERLY ABUTMENT REHABILITATION BORING LOCATION PLAN**

**LEGEND**

- PREVIOUS BORING AND INSTRUMENTATION LOCATIONS (BY P<sup>2</sup>D)
- APPROXIMATE BORING LOCATION - DRILLED (THIS CONTRACT)
- APPROXIMATE BORING LOCATION - NOT DRILLED (THIS CONTRACT)

NOTES: 1) BASE PLAN USED PROVIDED BY ALPHA CORPORATION  
 2) I = INCLINOMETER BORINGS  
 W = WATER OBSERVATION WELL  
 PMT = PRESSUREMETER TEST BORING

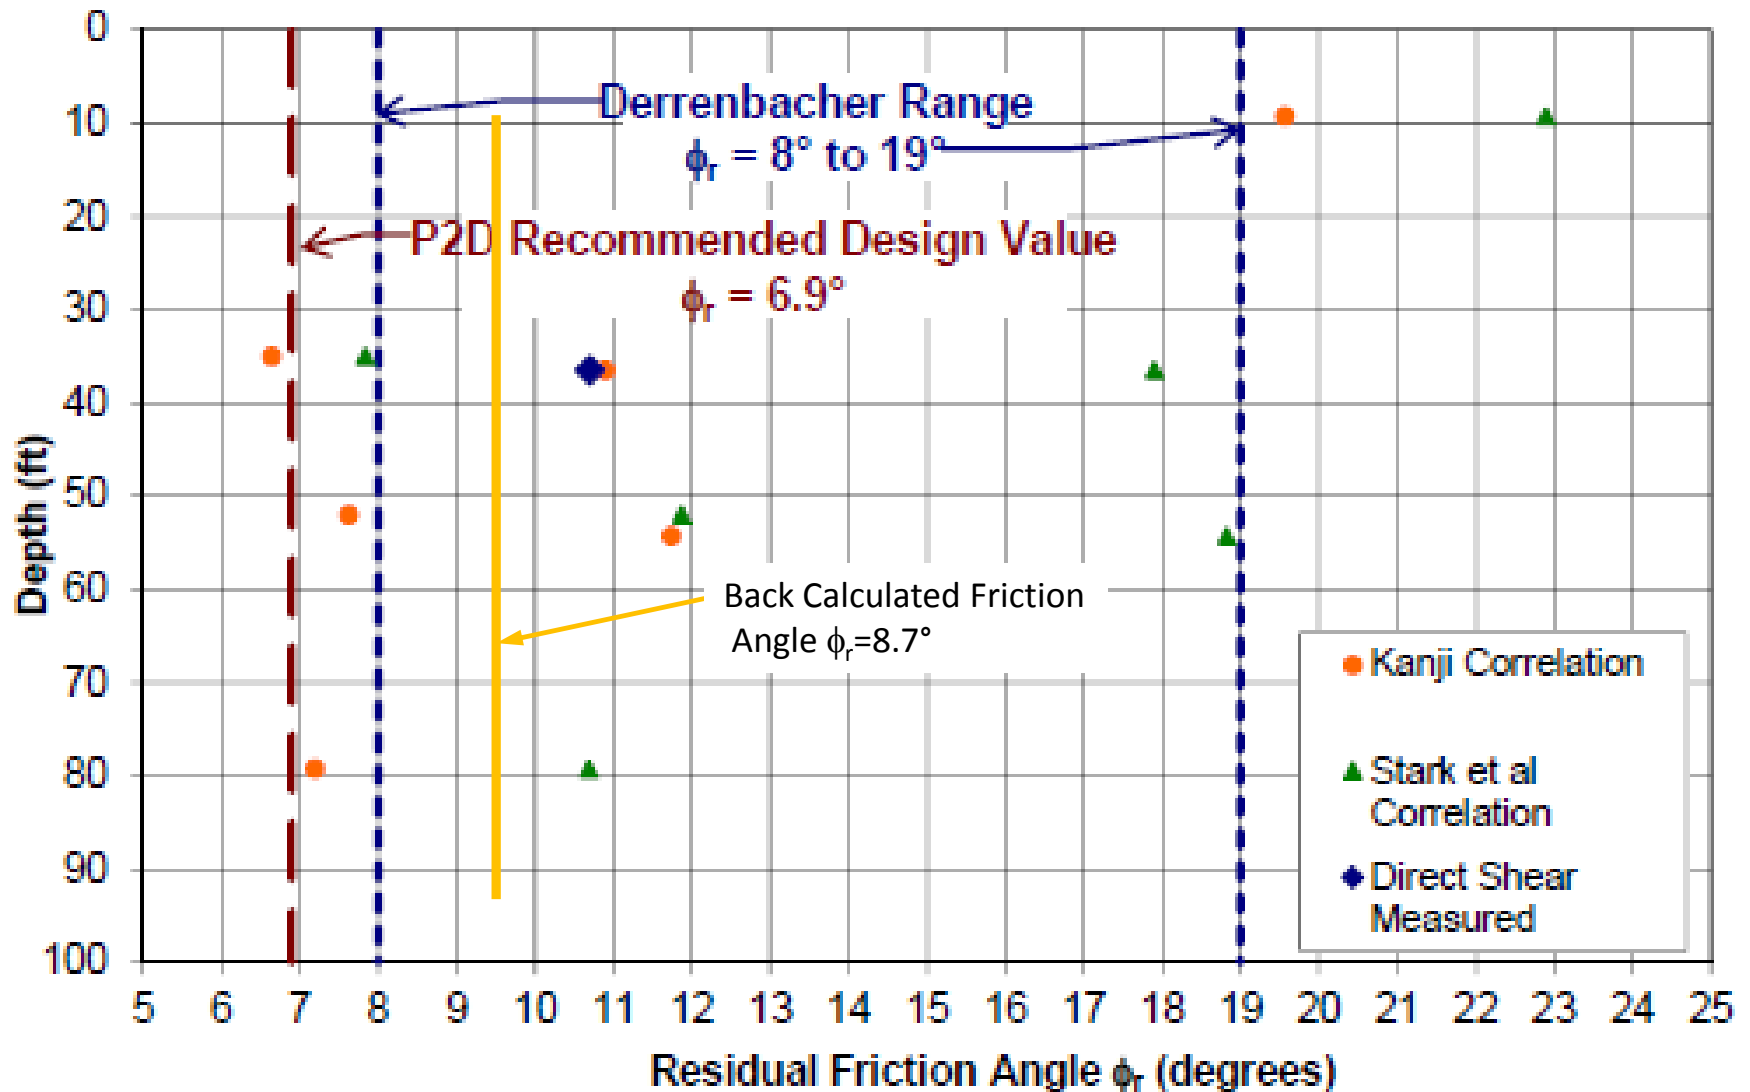
Figure 2 - Residual friction angle vs. depth east of the Abutment

## Stratum P1 Residual Friction Angle - East of Abutment

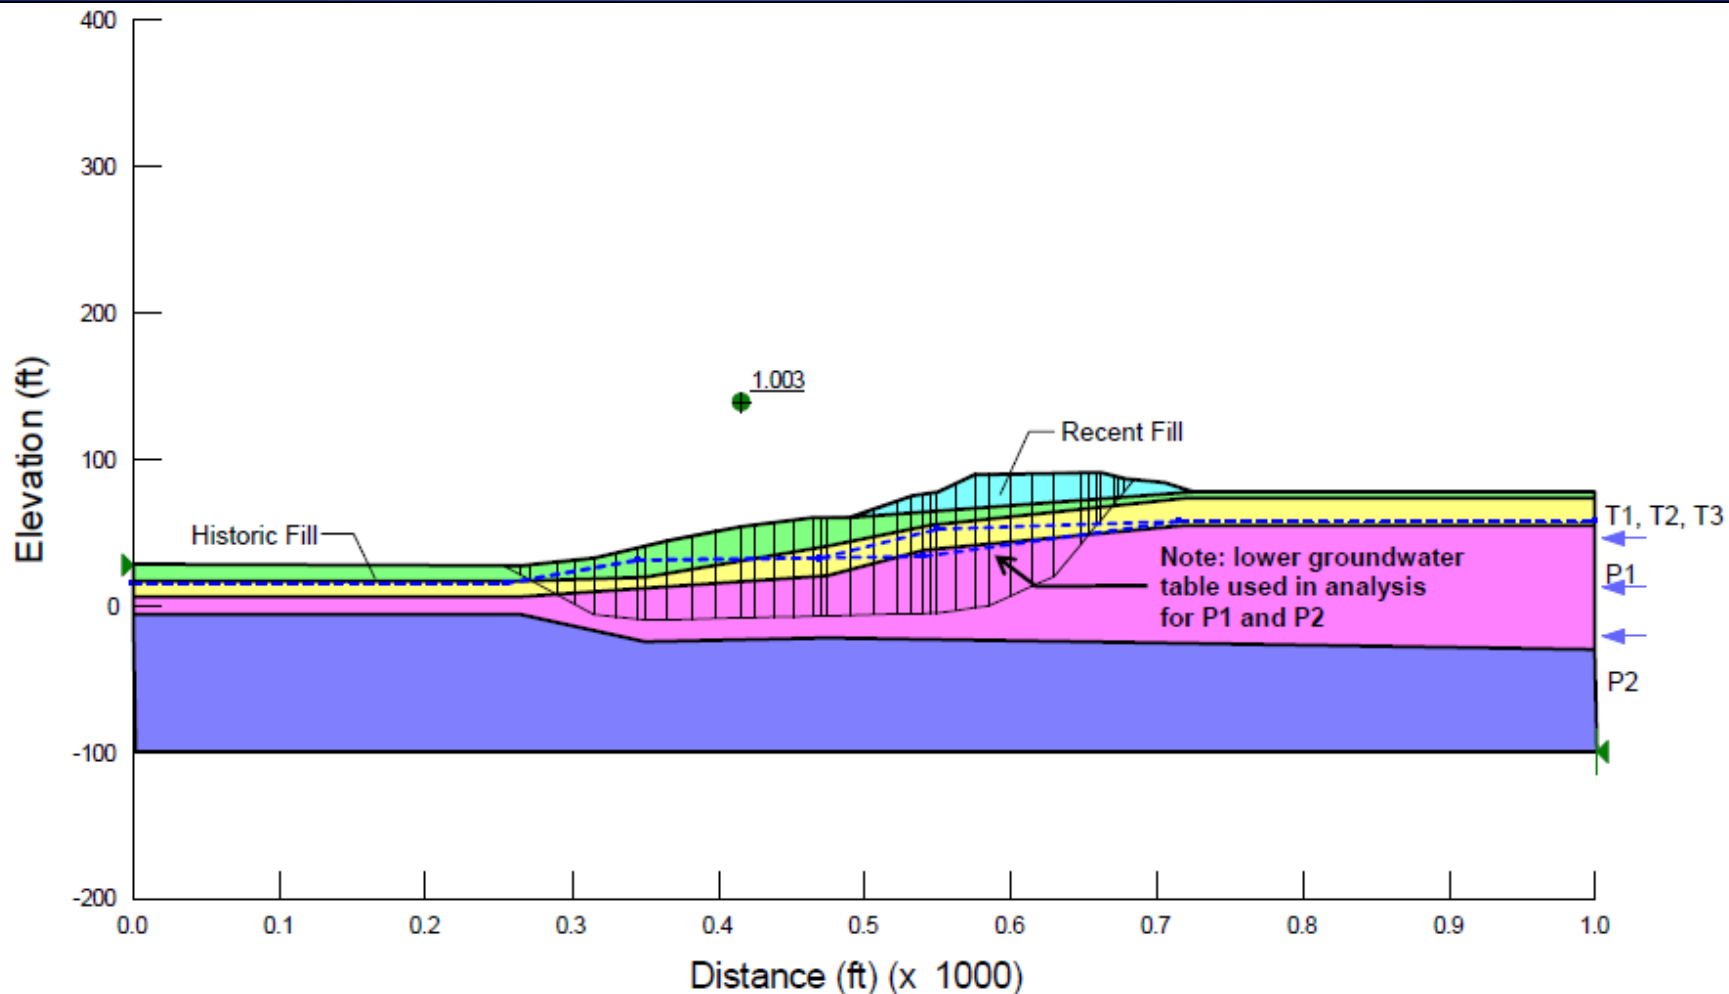
Name	Moist Unit Weight* lb/ft <sup>3</sup>	Cohesion lb/ft <sup>2</sup>	Internal Friction Angle
Recent Fill	120	0	28°
Historic Fill	120	0	28°
T1, T2, and T3	130	0	30°
P1	125	0	8.7°
P2	130	0	36°

\*Note: Saturated unit weight is 5 lb/ft<sup>3</sup> more than moist for all soils.

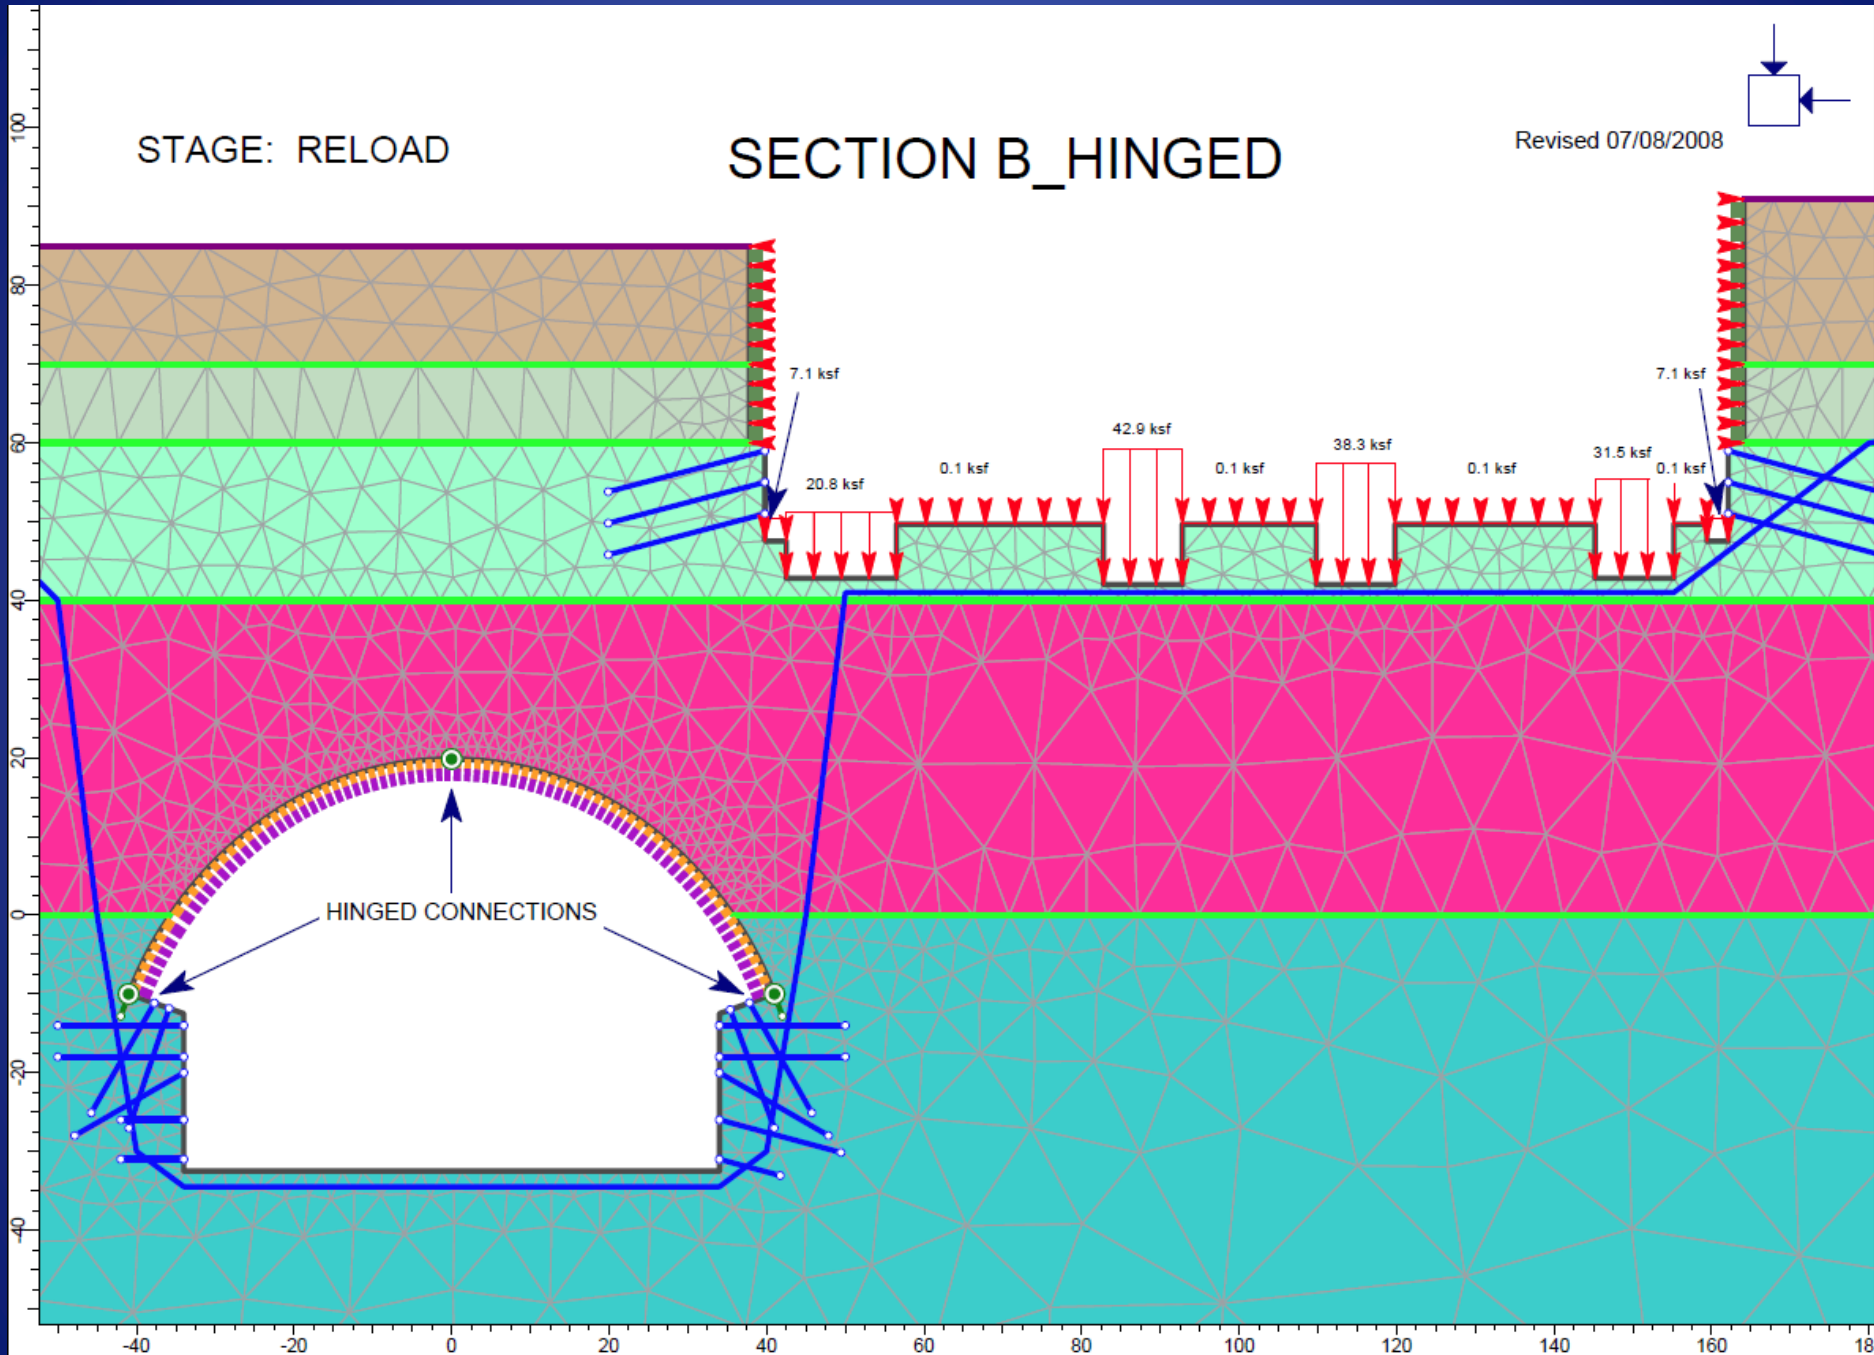
STAGE: RELOAD

HINGED CONNECTIONS

- **Analysis Program**
- **Stress Change in Station Lining**

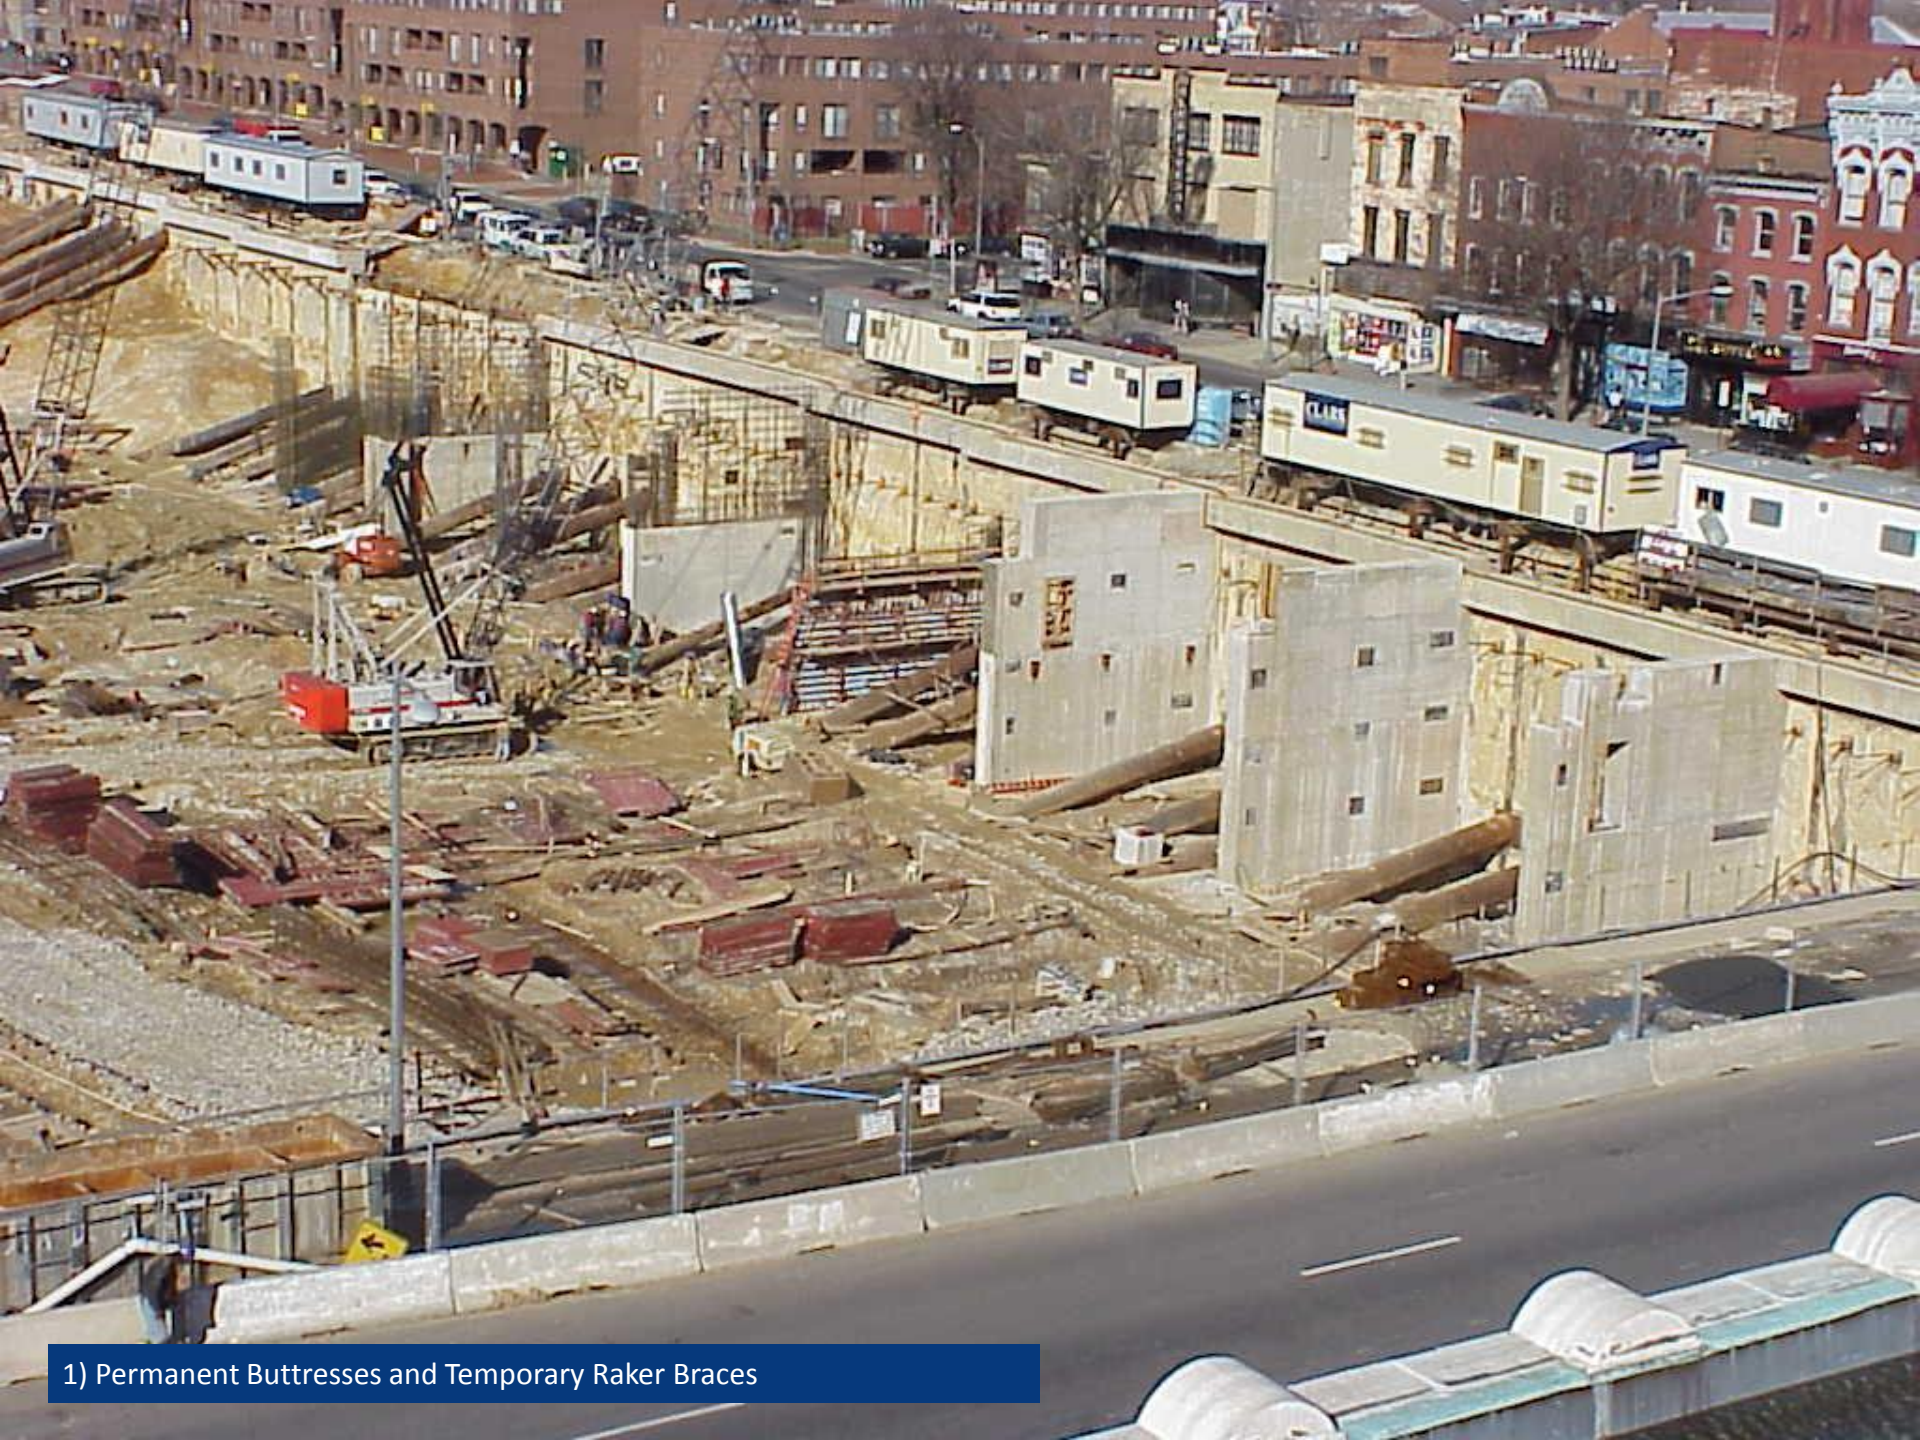
1) Permanent Buttresses and Temporary Raker Braces

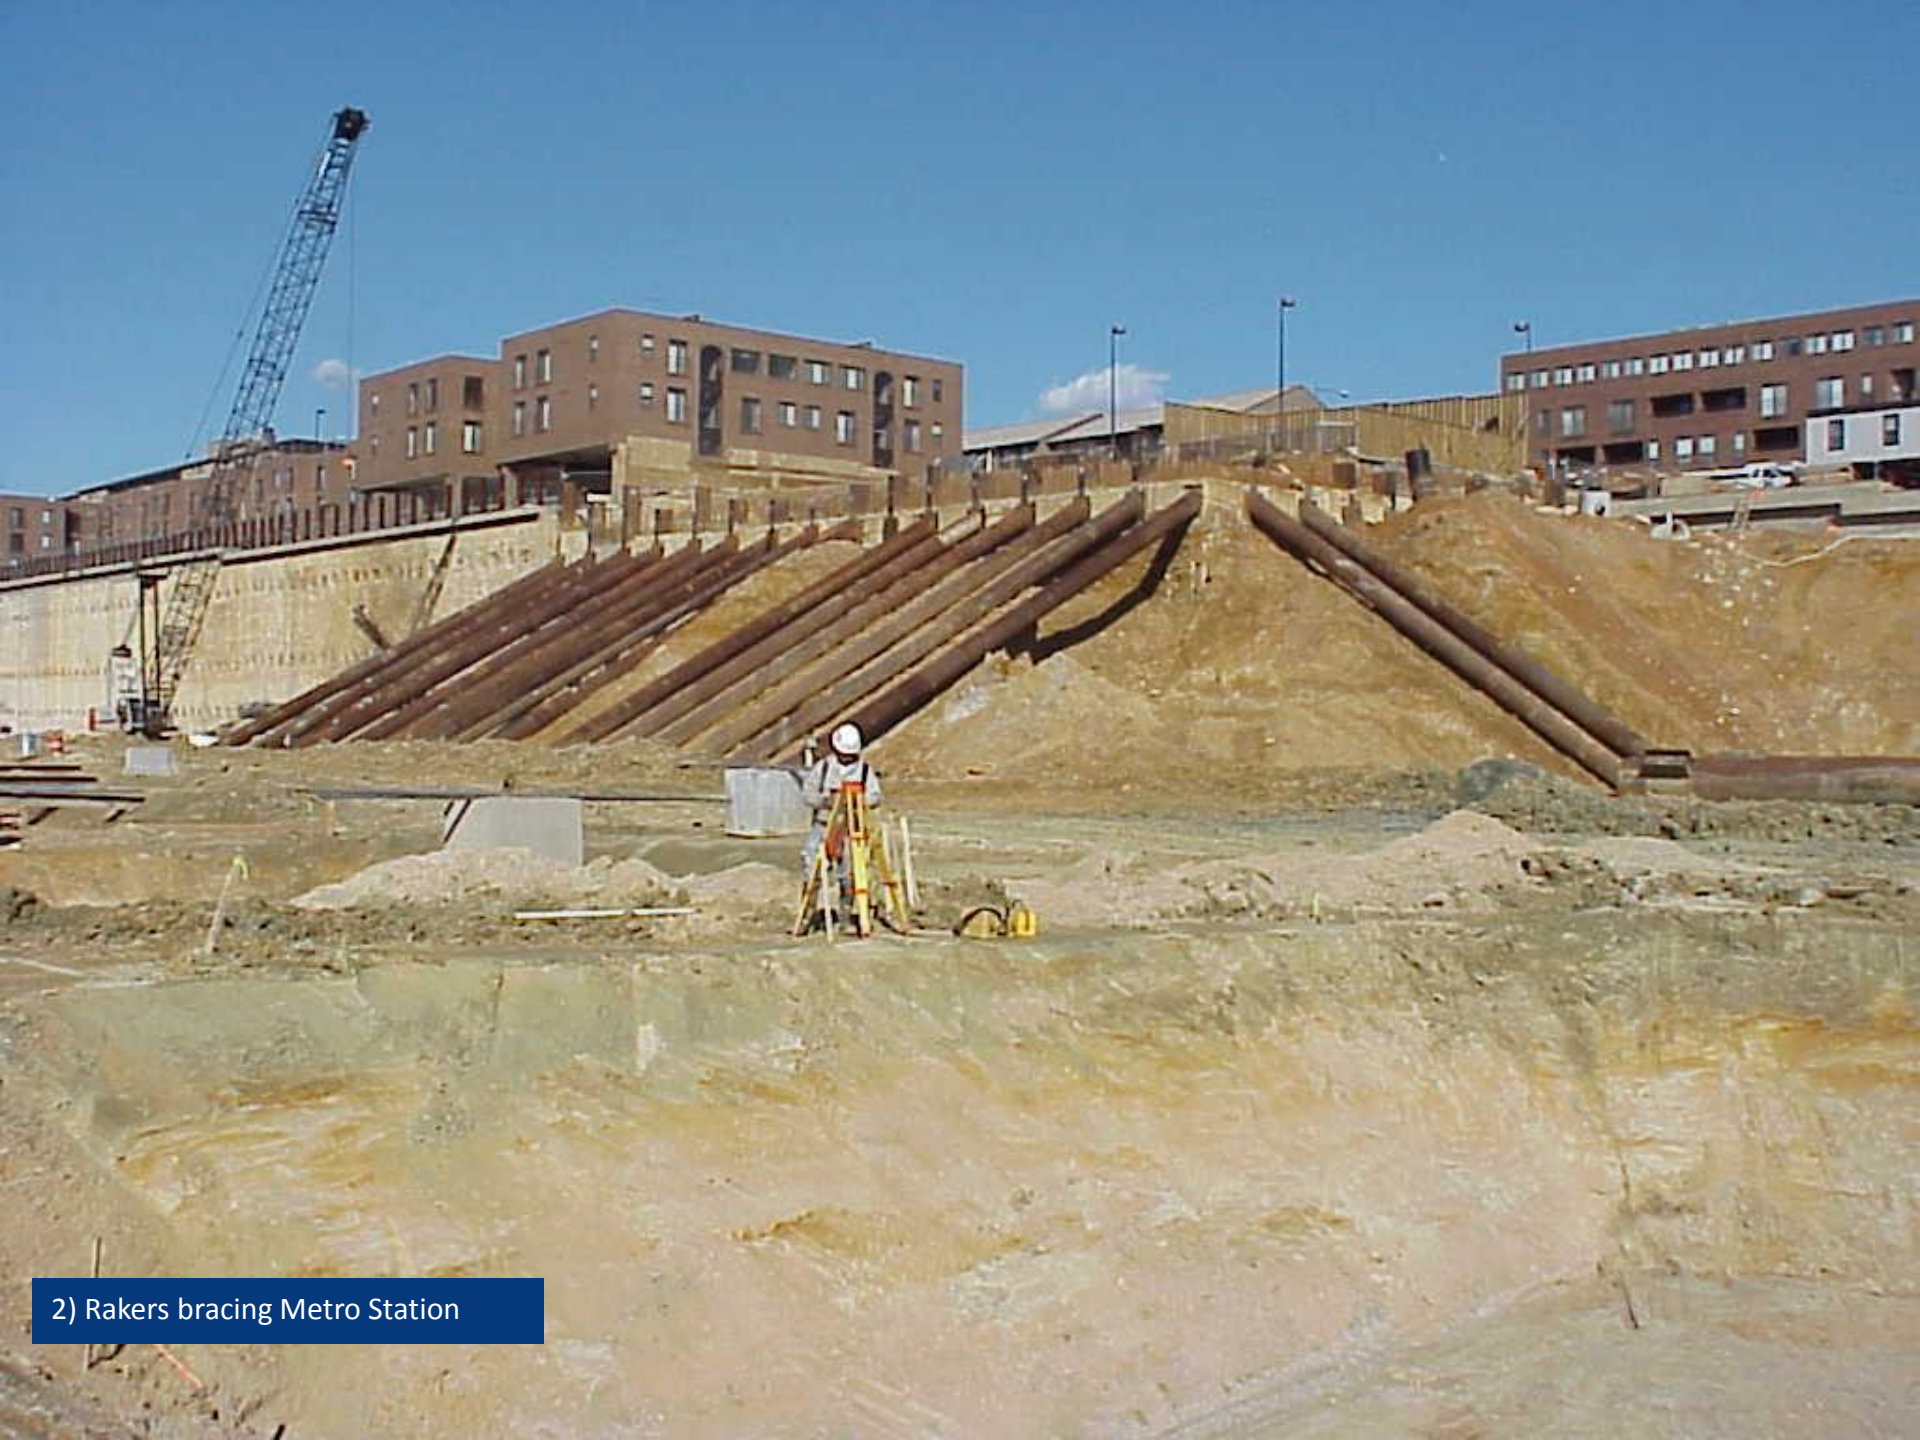
2) Rakers bracing Metro Station

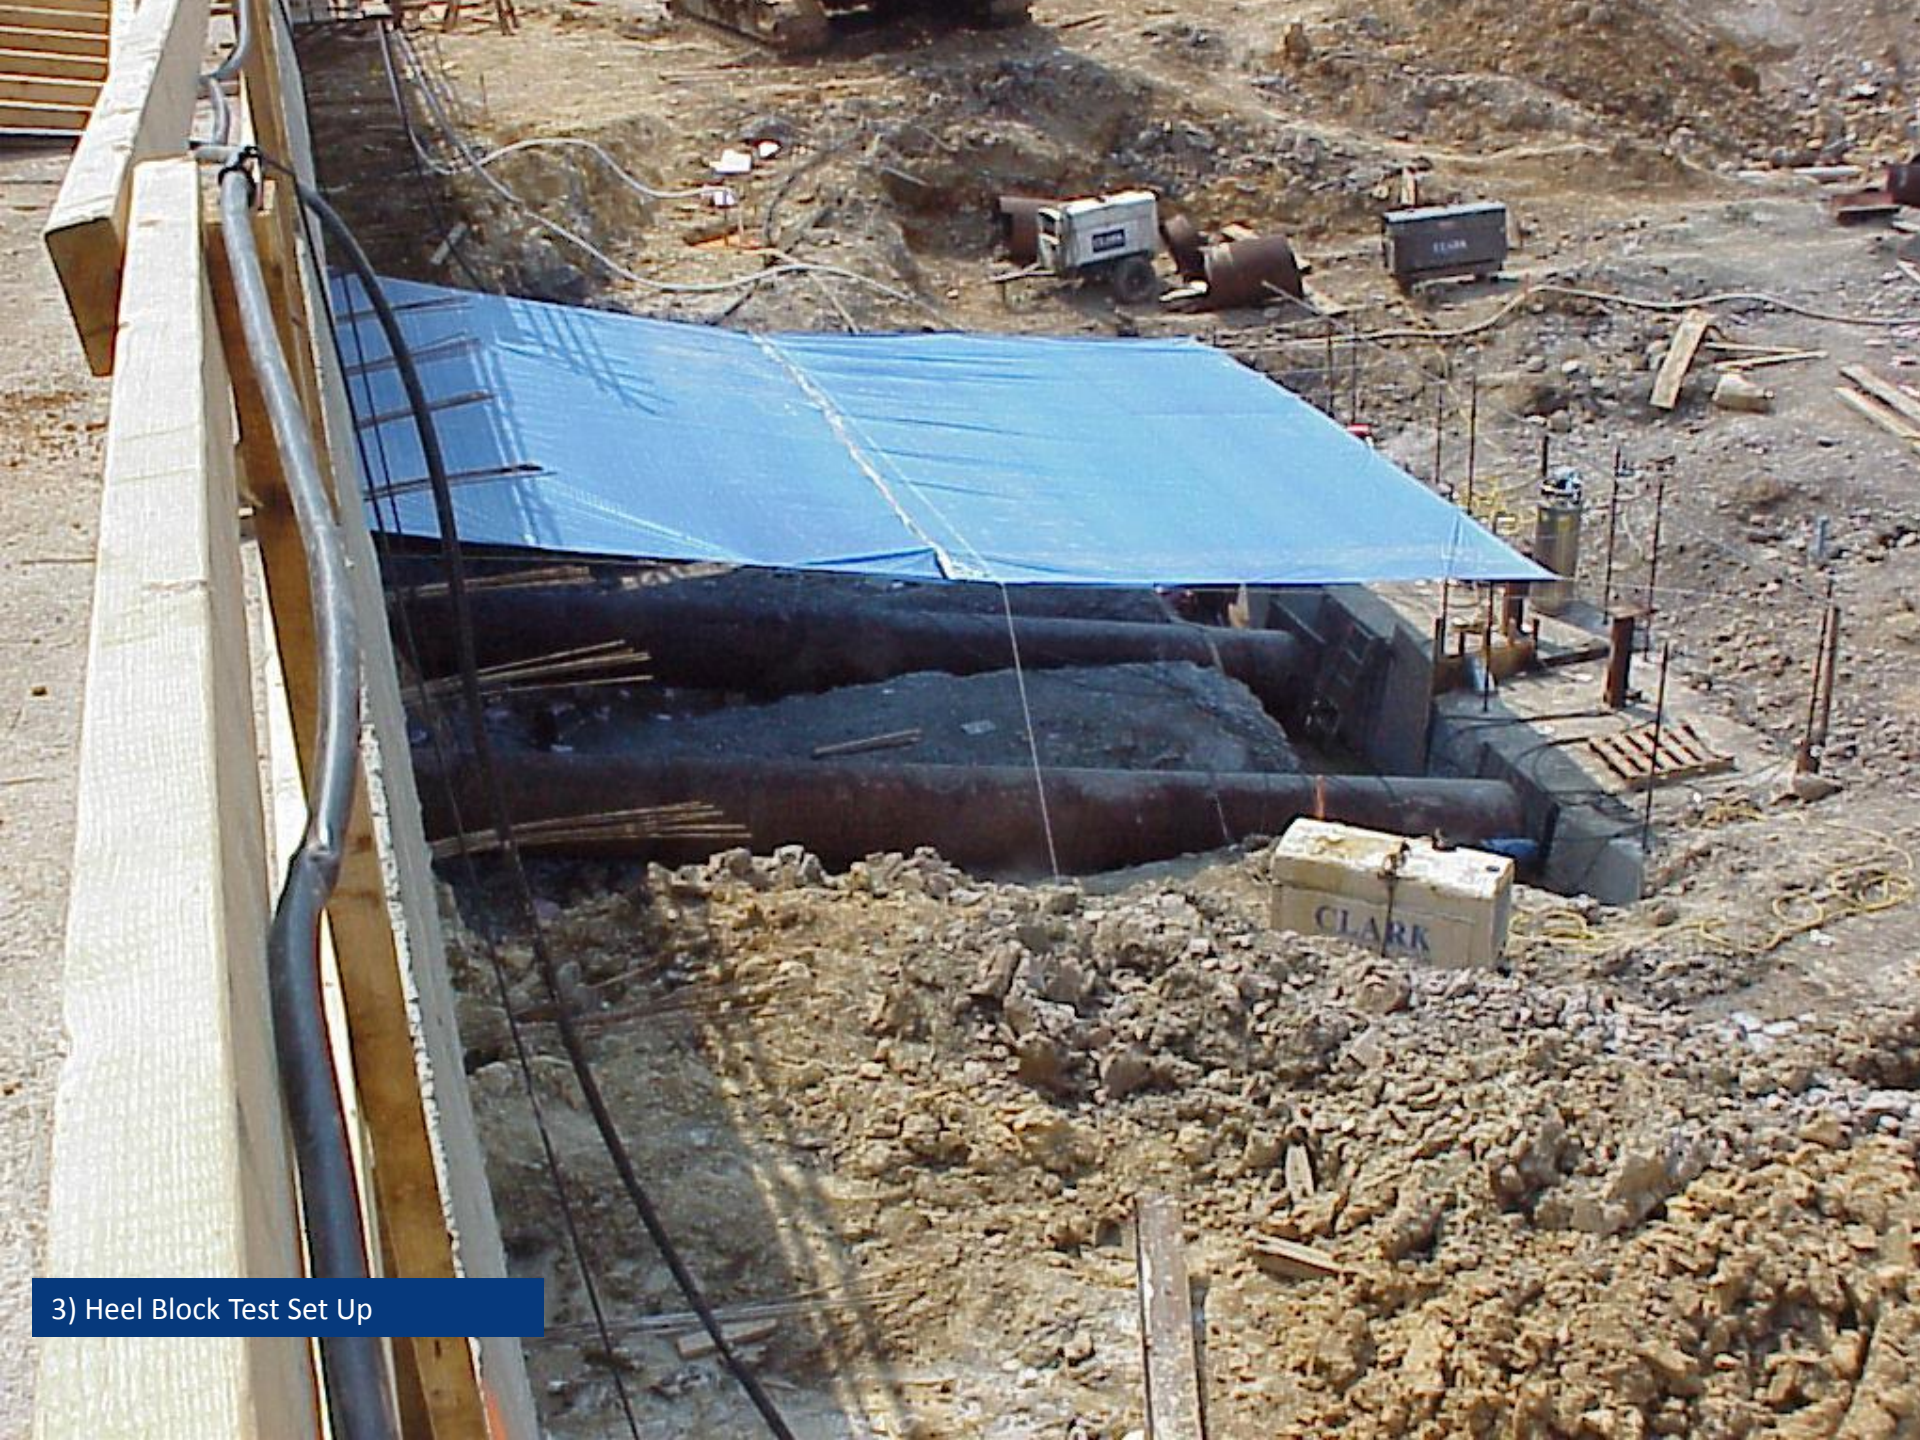
3) Heel Block Test Set Up
