# ***Constructing in Congested Areas Without Damaging Existing Structures***

**Hugh S. Lacy, PE, D.GE, F.ASCE**  
**Gregg V. Piazza, PE**

**Mueser Rutledge Consulting Engineers**

***GeoVirginia 2016***  
***October 10-12, 2016, Williamsburg, VA***

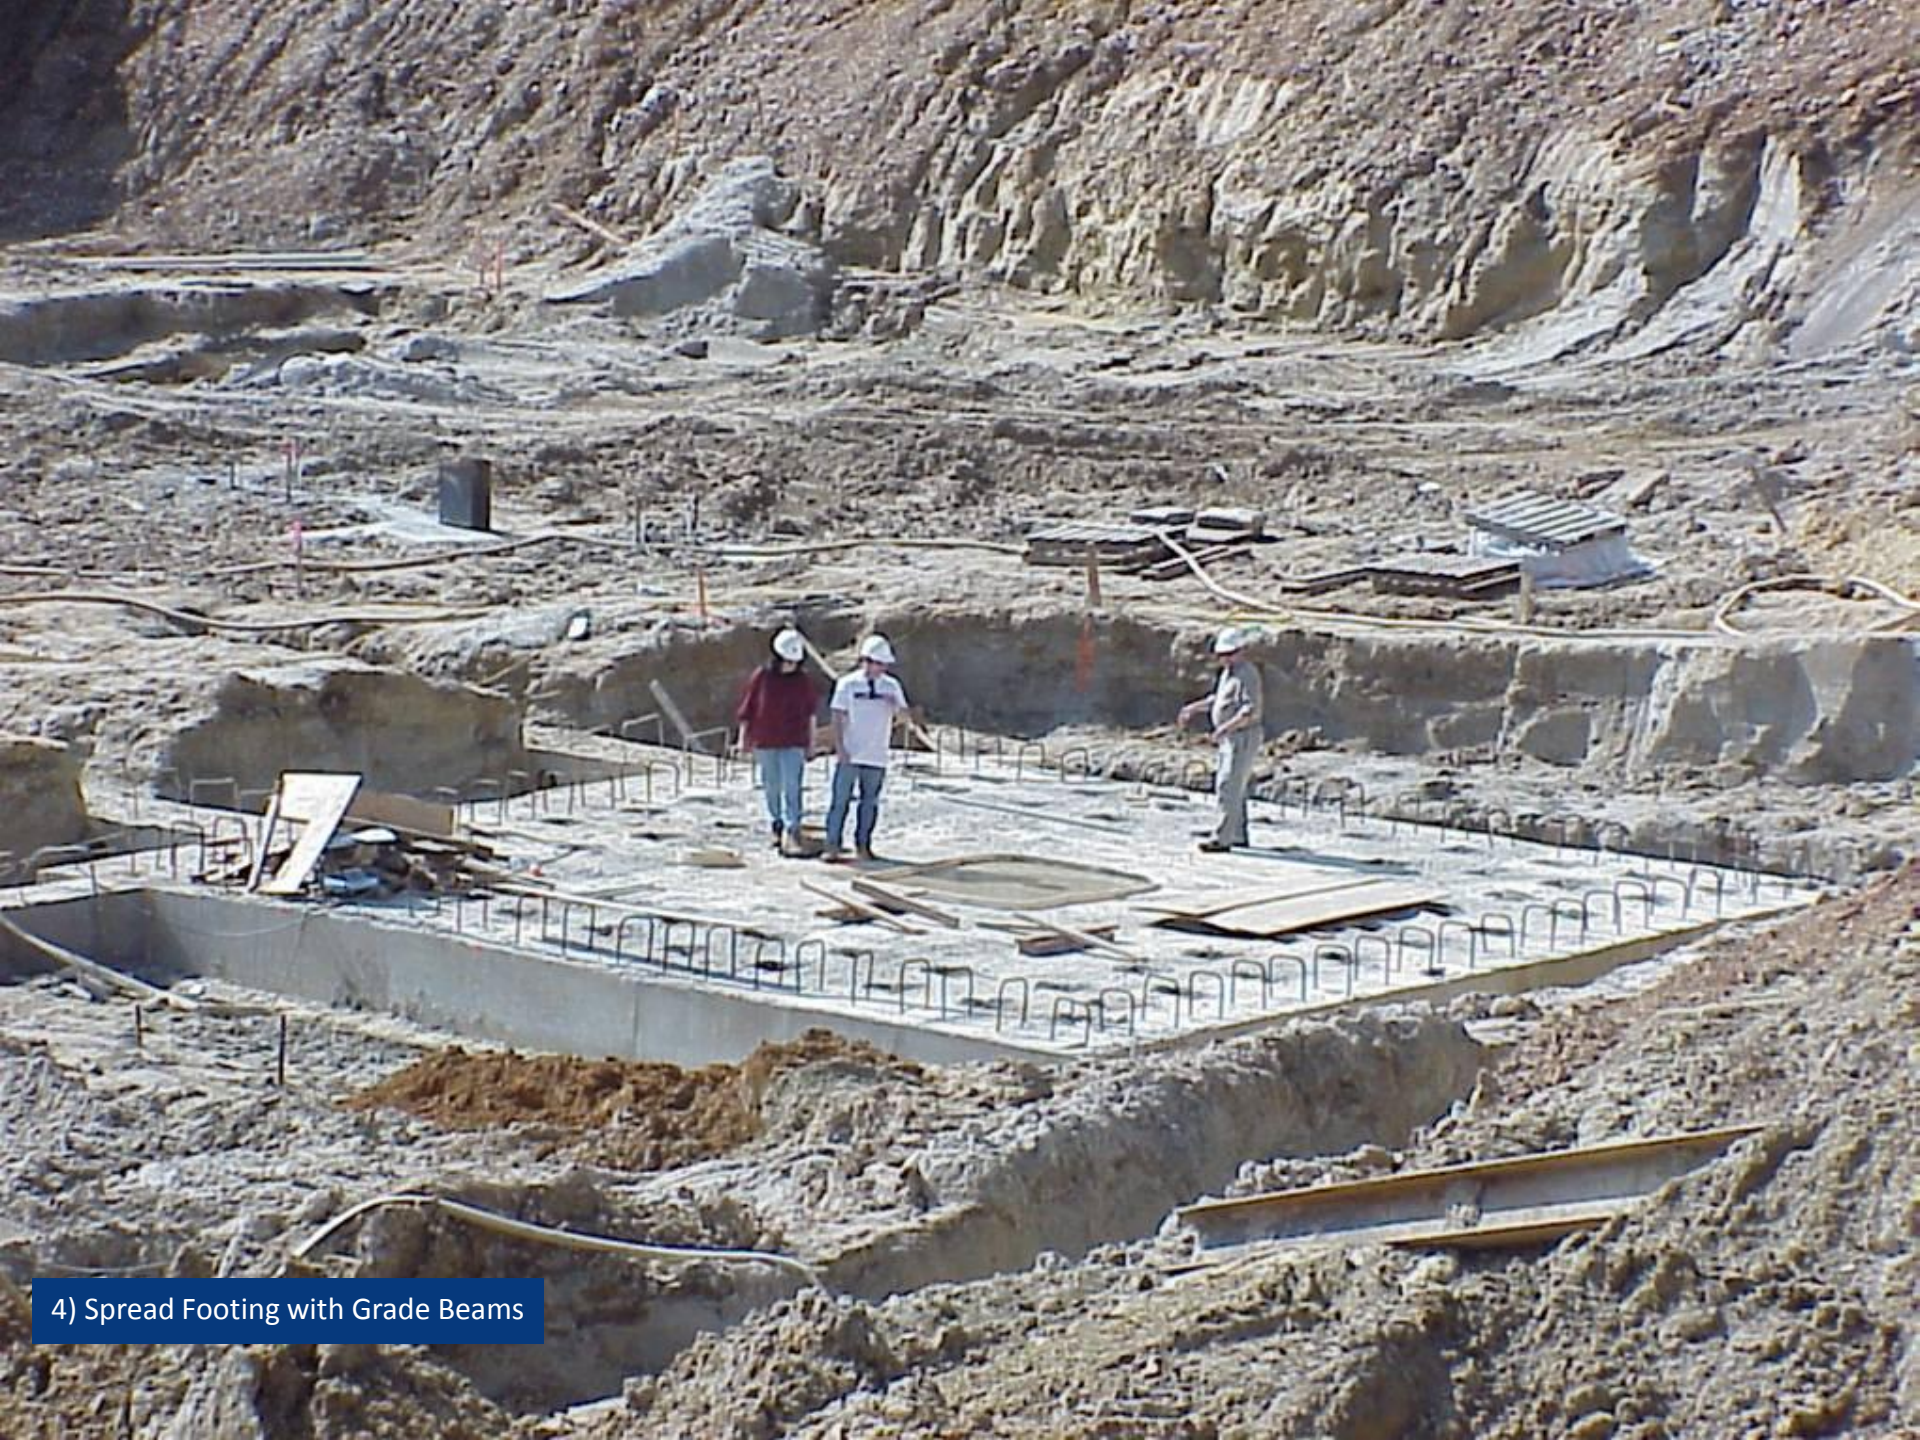
4) Spread Footing with Grade Beams

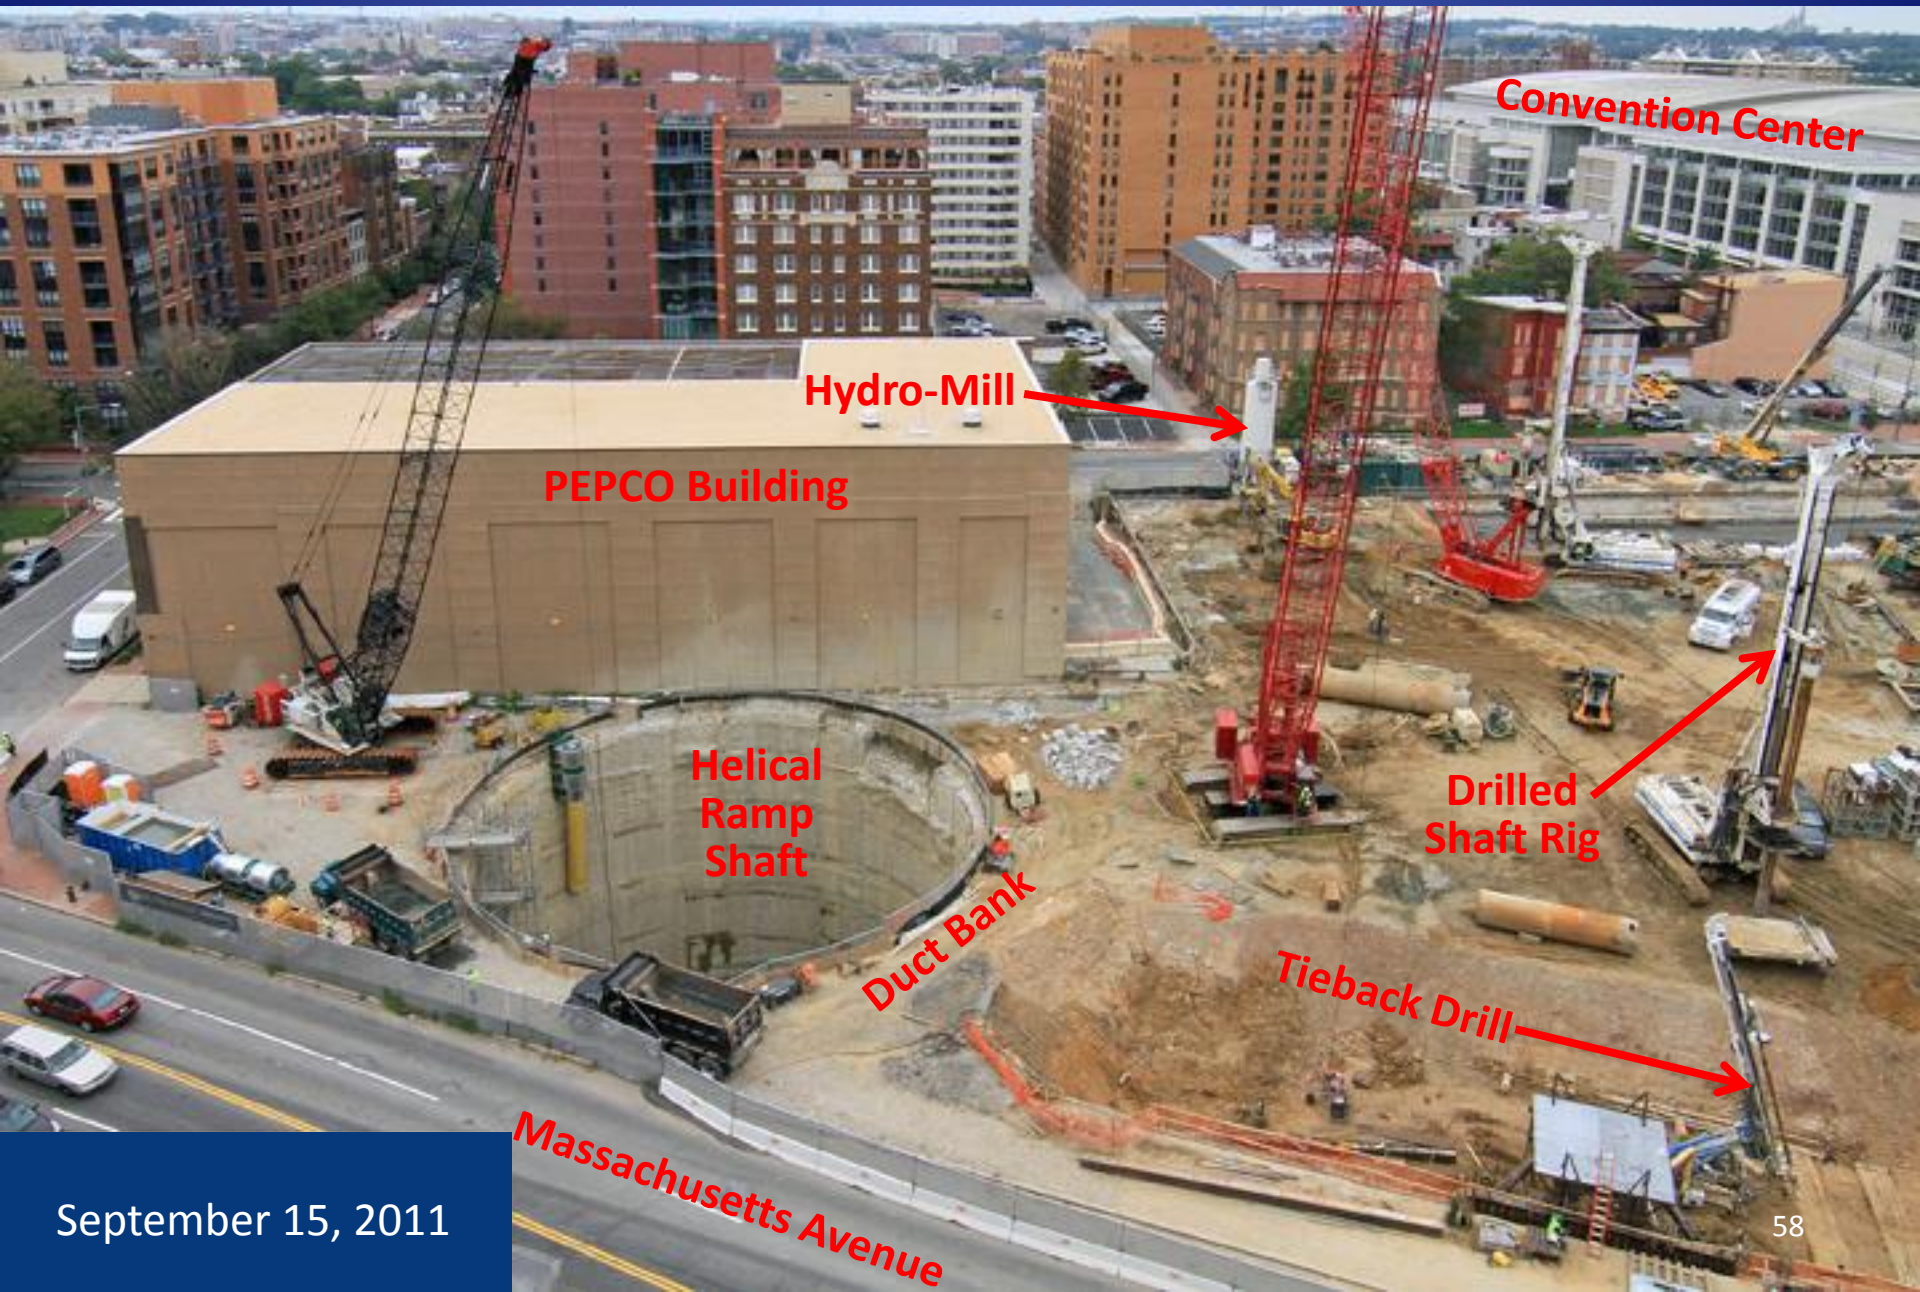
# Looking North at West End of Site

Hydro-Mill

Helical  
Ramp  
Shaft

Drilled  
Shaft Rig

Tieback Drill

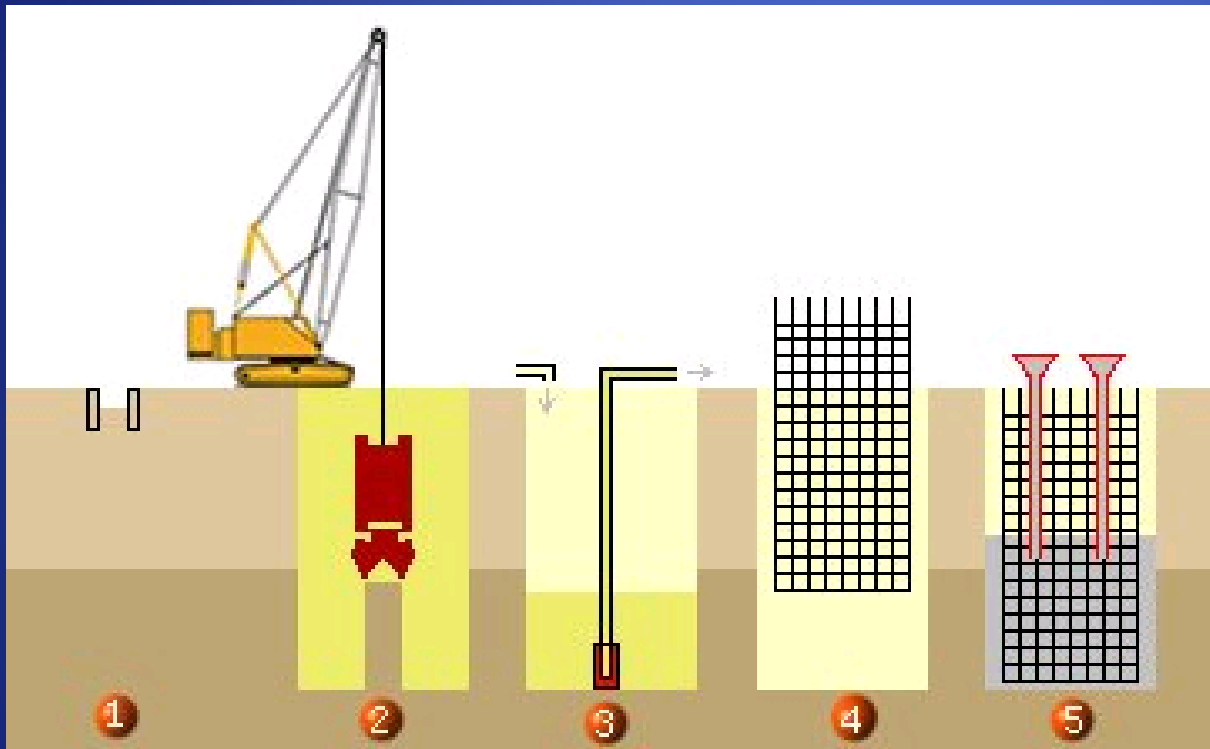
# Slurry Wall Construction

1. Construct guide walls
2. Excavate panel
3. Desand excavated panel
4. Install rebar cage
5. Place concrete

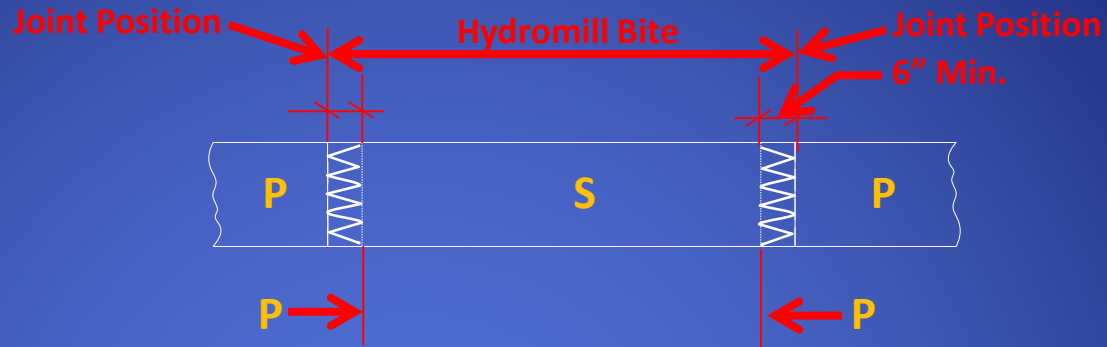
**Typical Joint**  
20' to 24' Primary  
and 9'-3" Secondary

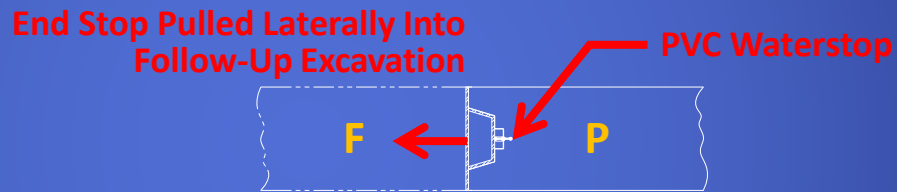
**Water Stop Joint**  
(Used Along 9<sup>th</sup> Street)  
(20' to 24' Panels)

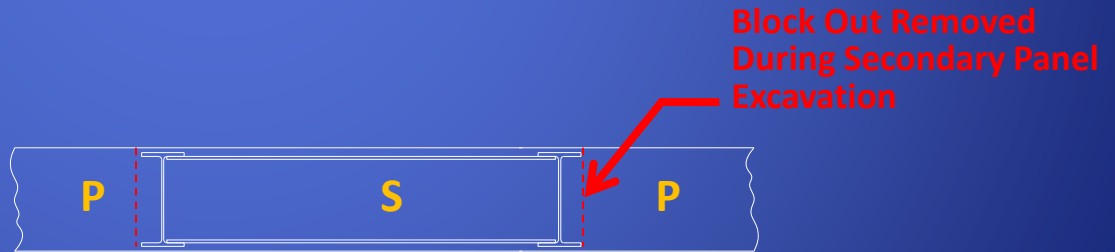
**Steel Beam (w) Joint**  
(used below shallow utilities)

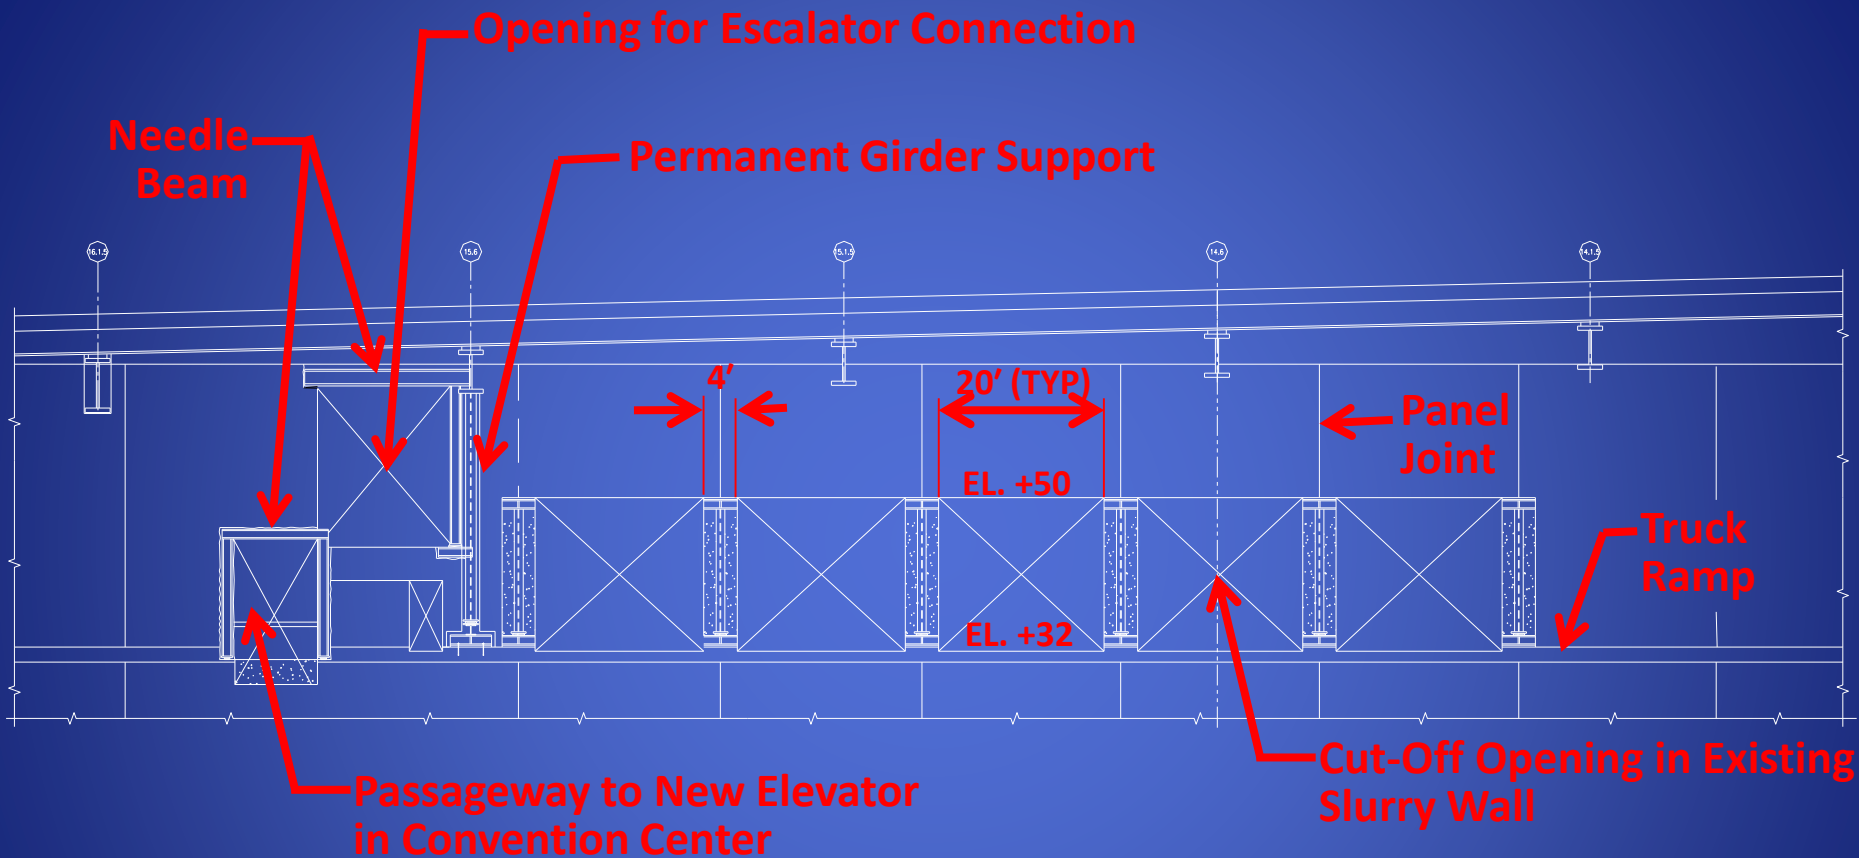
# Convention Center Slurry Wall – Looking West

- Construction Procedure**
1. Cut 4'0" Wide Slot at Panel Joints
  2. Place Stub Columns in Slots for Panel Support
  3. Cut-Off and Form Openings

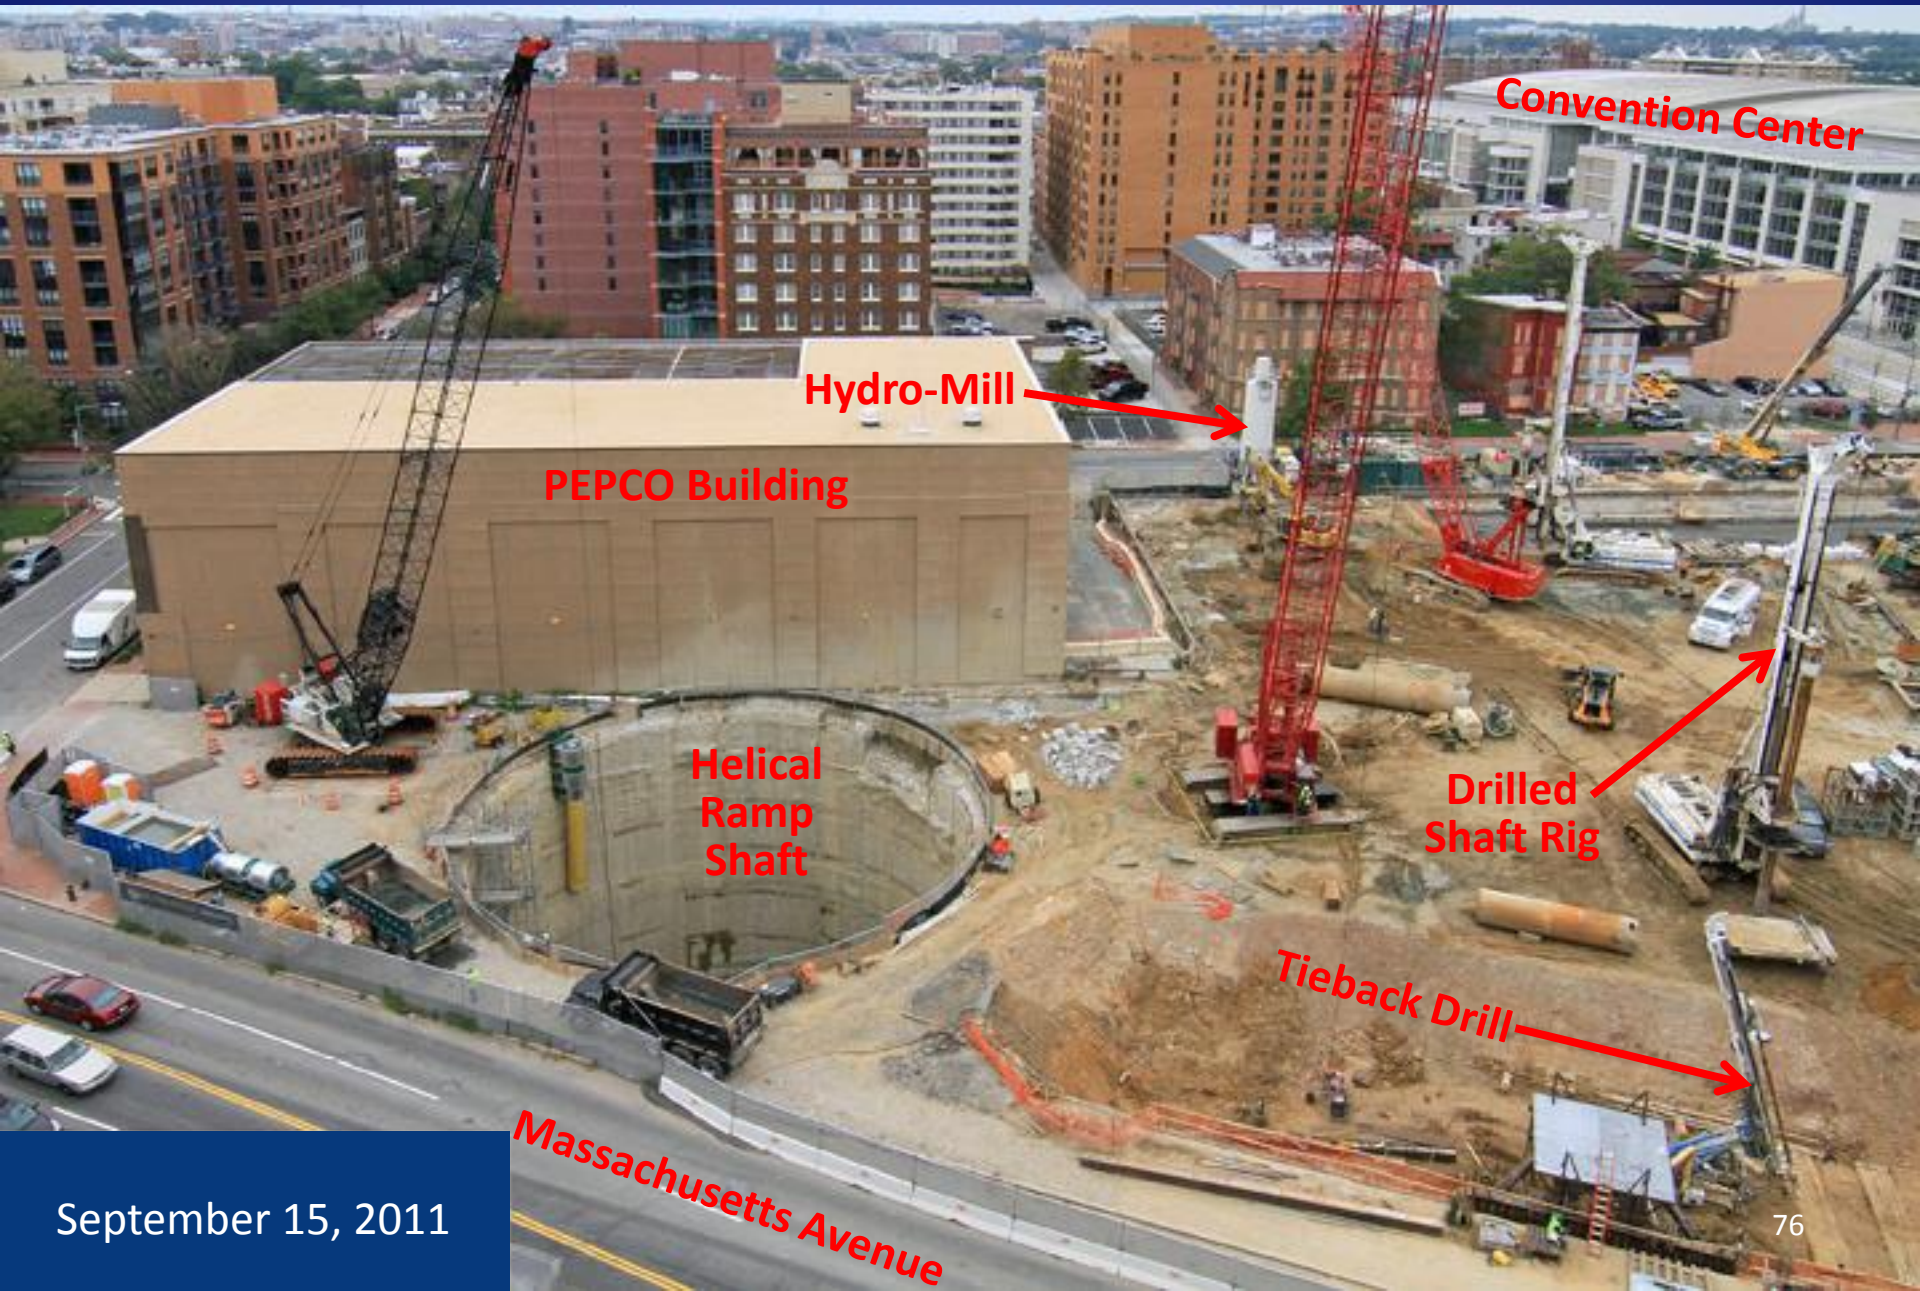
# Looking North at West End of Site

Convention Center

Hydro-Mill
