Toppling - - Failure of Rock Slopes

by Richard E. Goodman

"Toppling - - a fundamental failure mode in rock masses

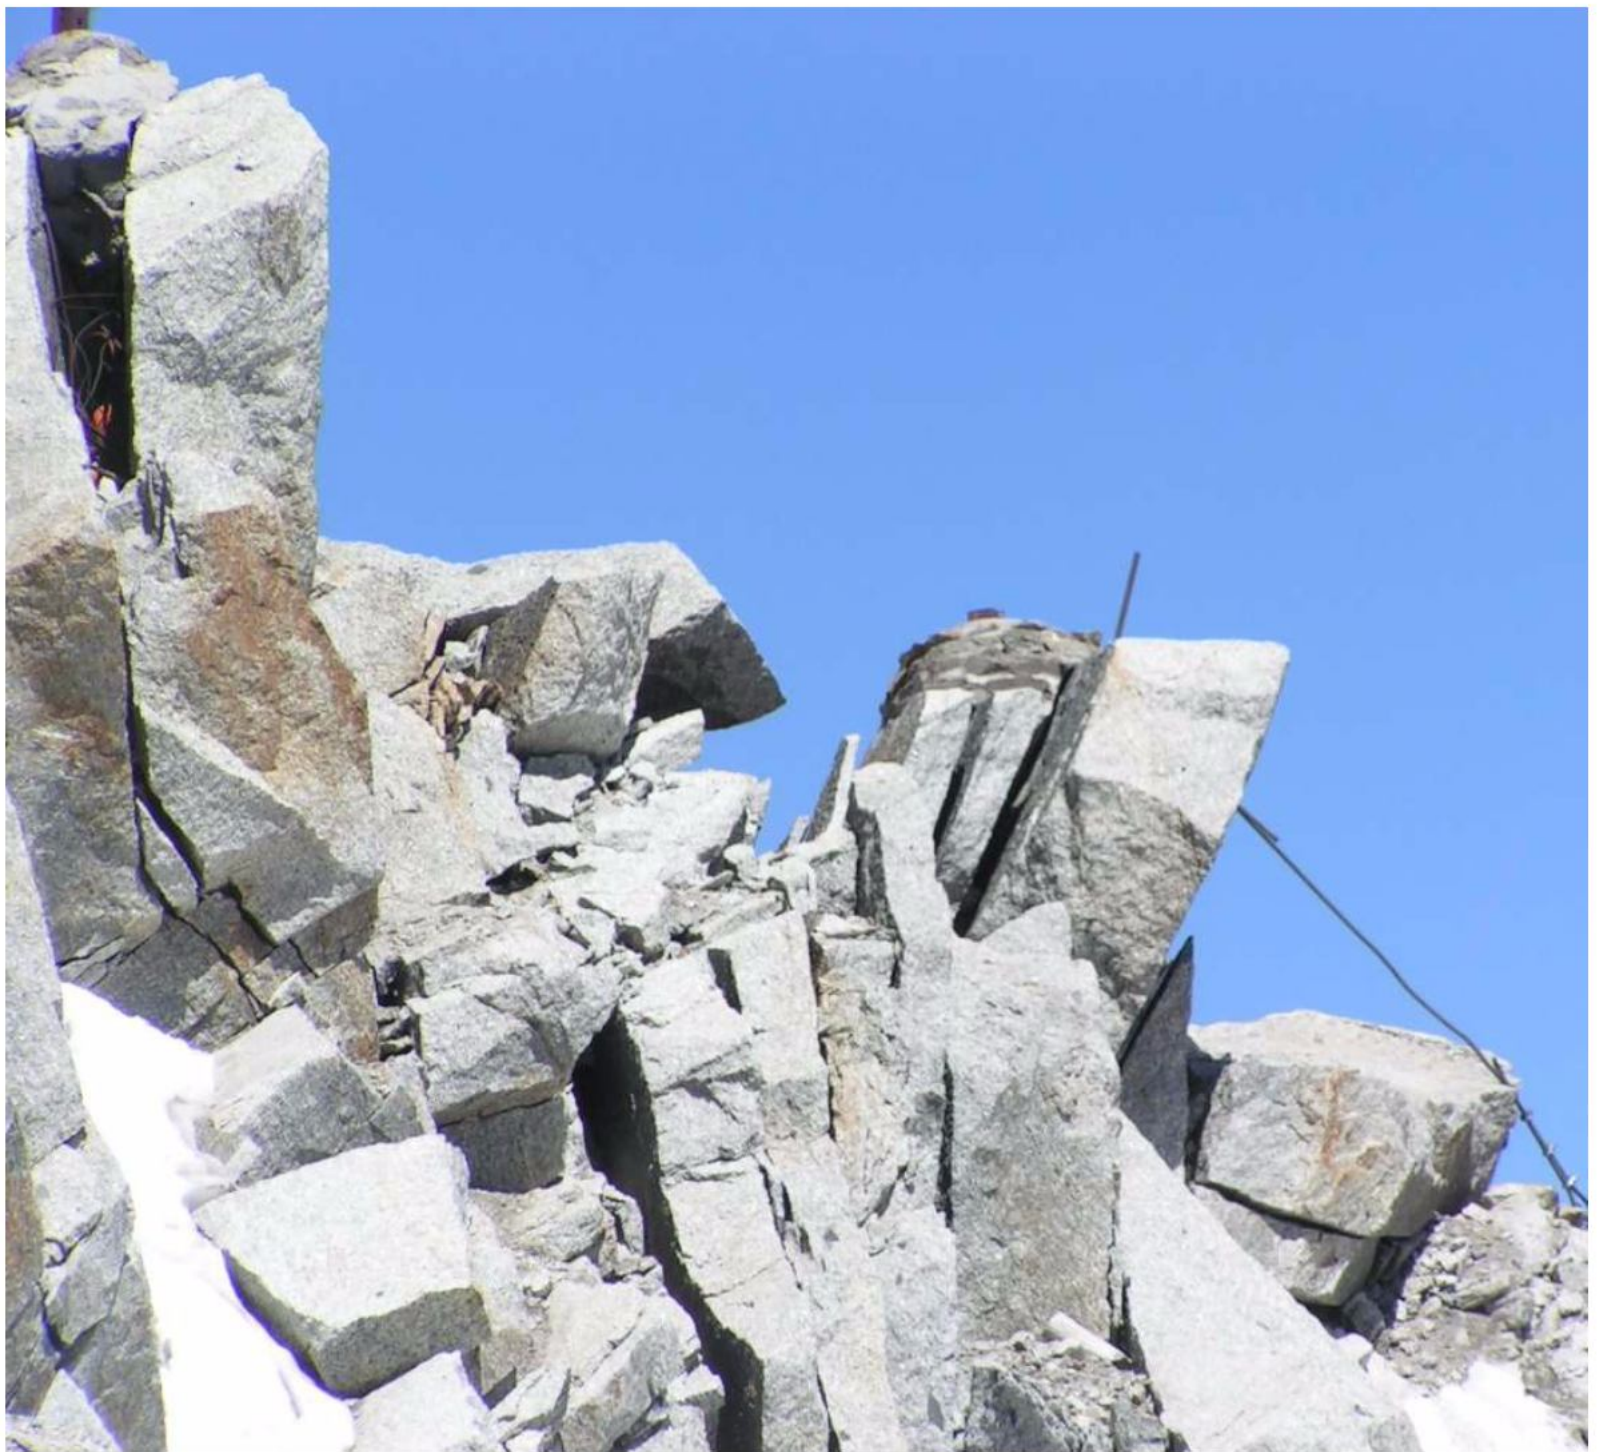
Figure 2 –Aiguille du Midi (Near Mont Blanc)

Figure 2.) Toppling and opening of extension cracks in outcrops on Aiguille du Midi, near Mt. Blanc

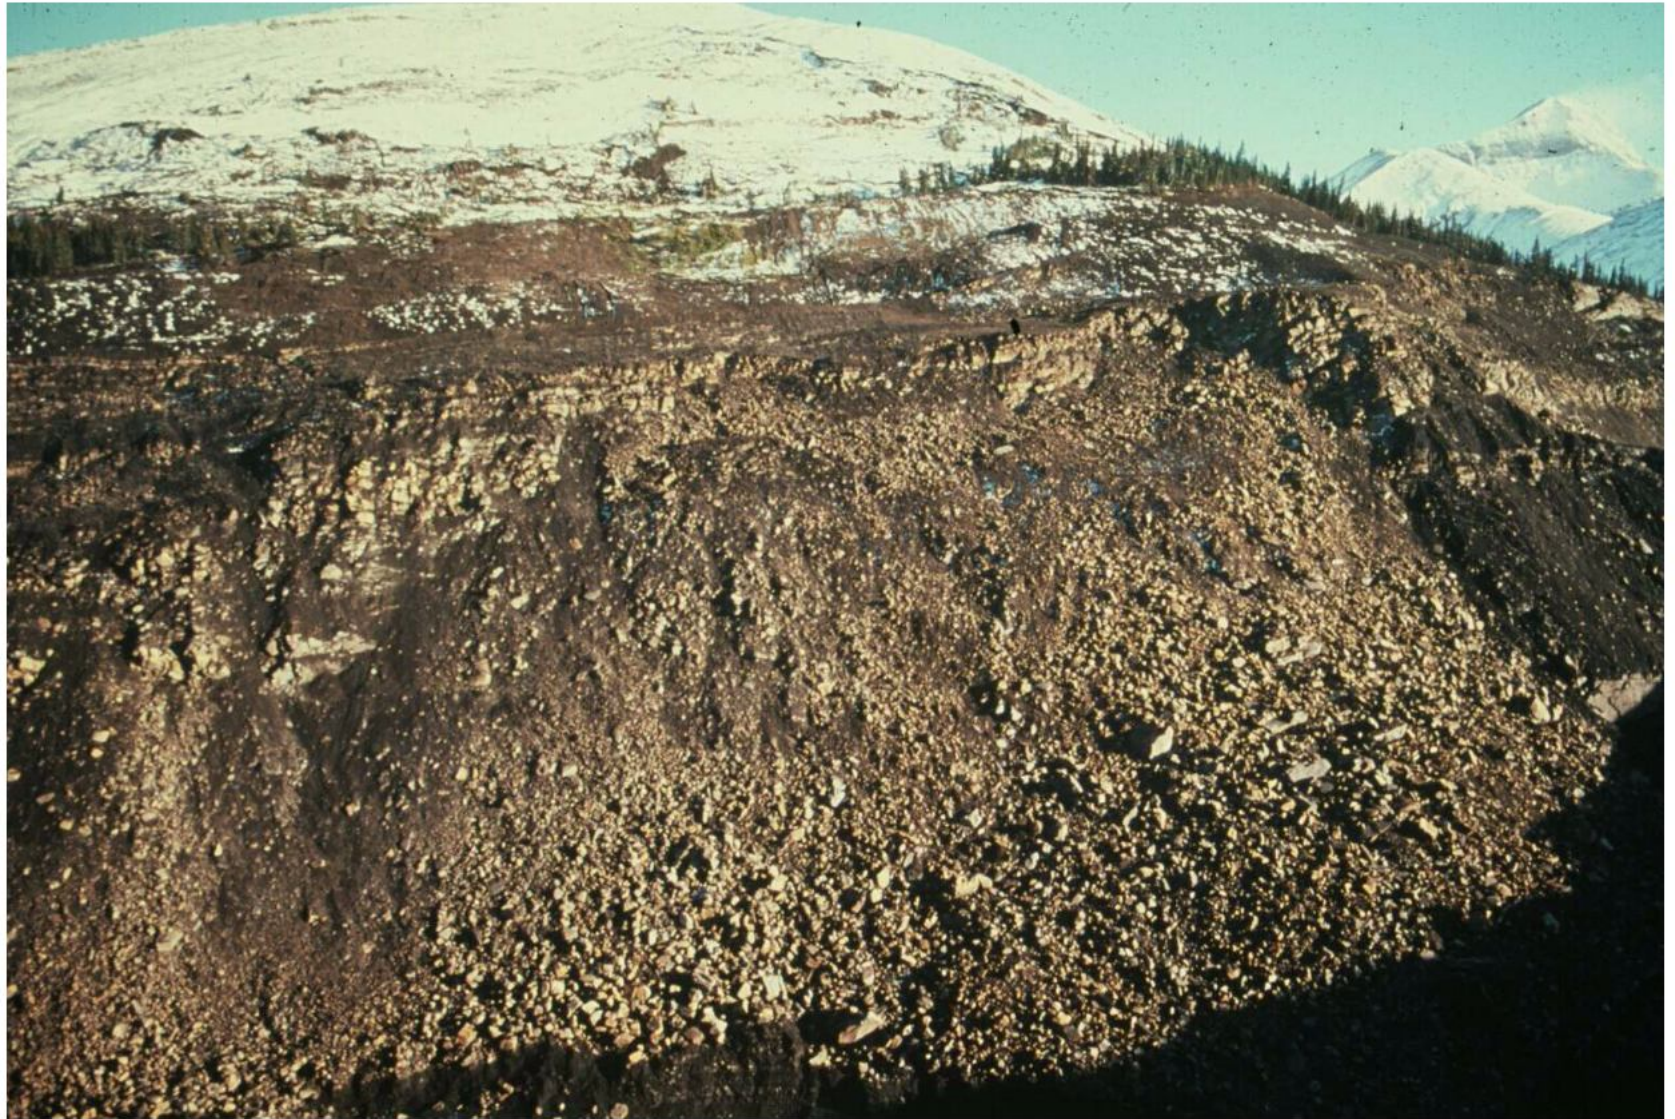
FIGURE 3 – Cardinal River Coal Mine Topple,
(Wyllie and Munn, 1978)

BUT – Wyllie and Munn’s handling of the Cardinal River Coal Mine toppling failure proves that reliable predictions can be relied on when the mode of failure is well known.

Figure 3 - The failed wall of Cardinal River Coal Mine, Alberta; photo by Duncan Wyllie

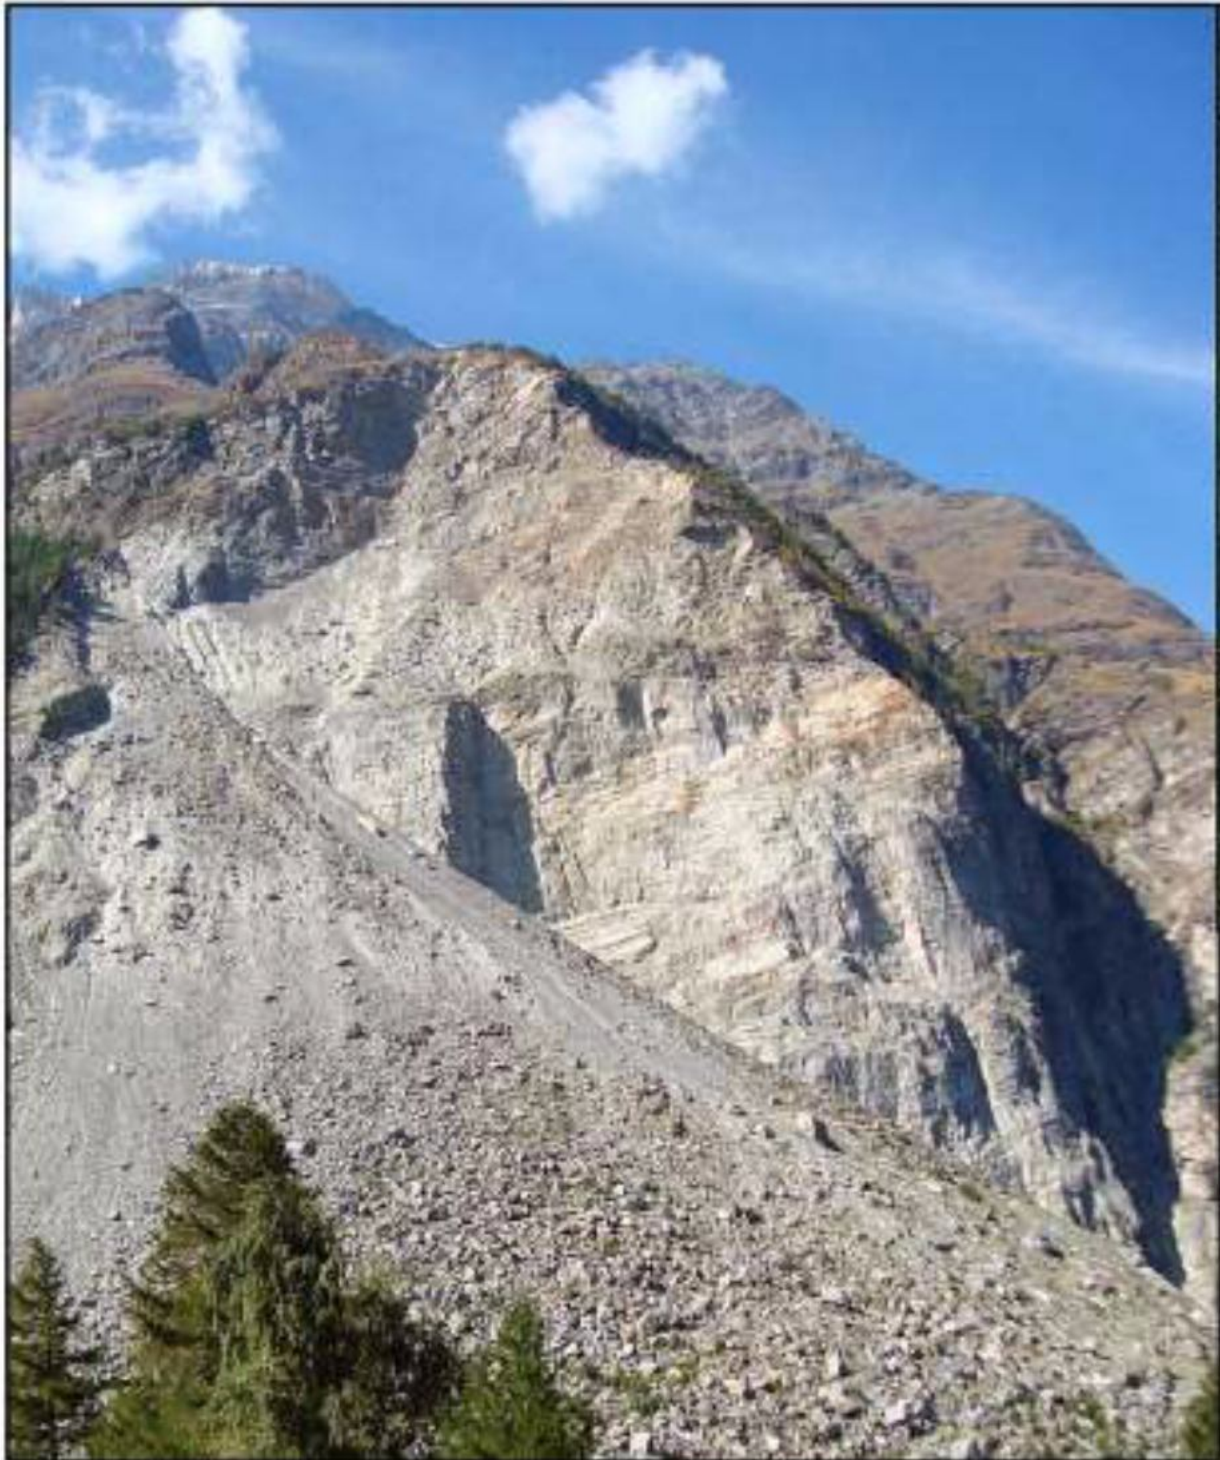
Composite rock slope kinematics at the current Randa instability, Switzerland, based on remote sensing and numerical modeling
V. Gischig^{a,1}, F. Amann^a, J.R. Moore^a, S. Loew^a, H. Eisenbeiss^b, W. Stempfhuber^{b,1}

The current rock fall hazard is due largely to **secondary toppling** from the main scarp of a 30 million cubic meter rock fall from 1991. At present, there are 5 to 6 million cubic meters of unstable rock exposed in the inaccessible, 850 meter high scarp .

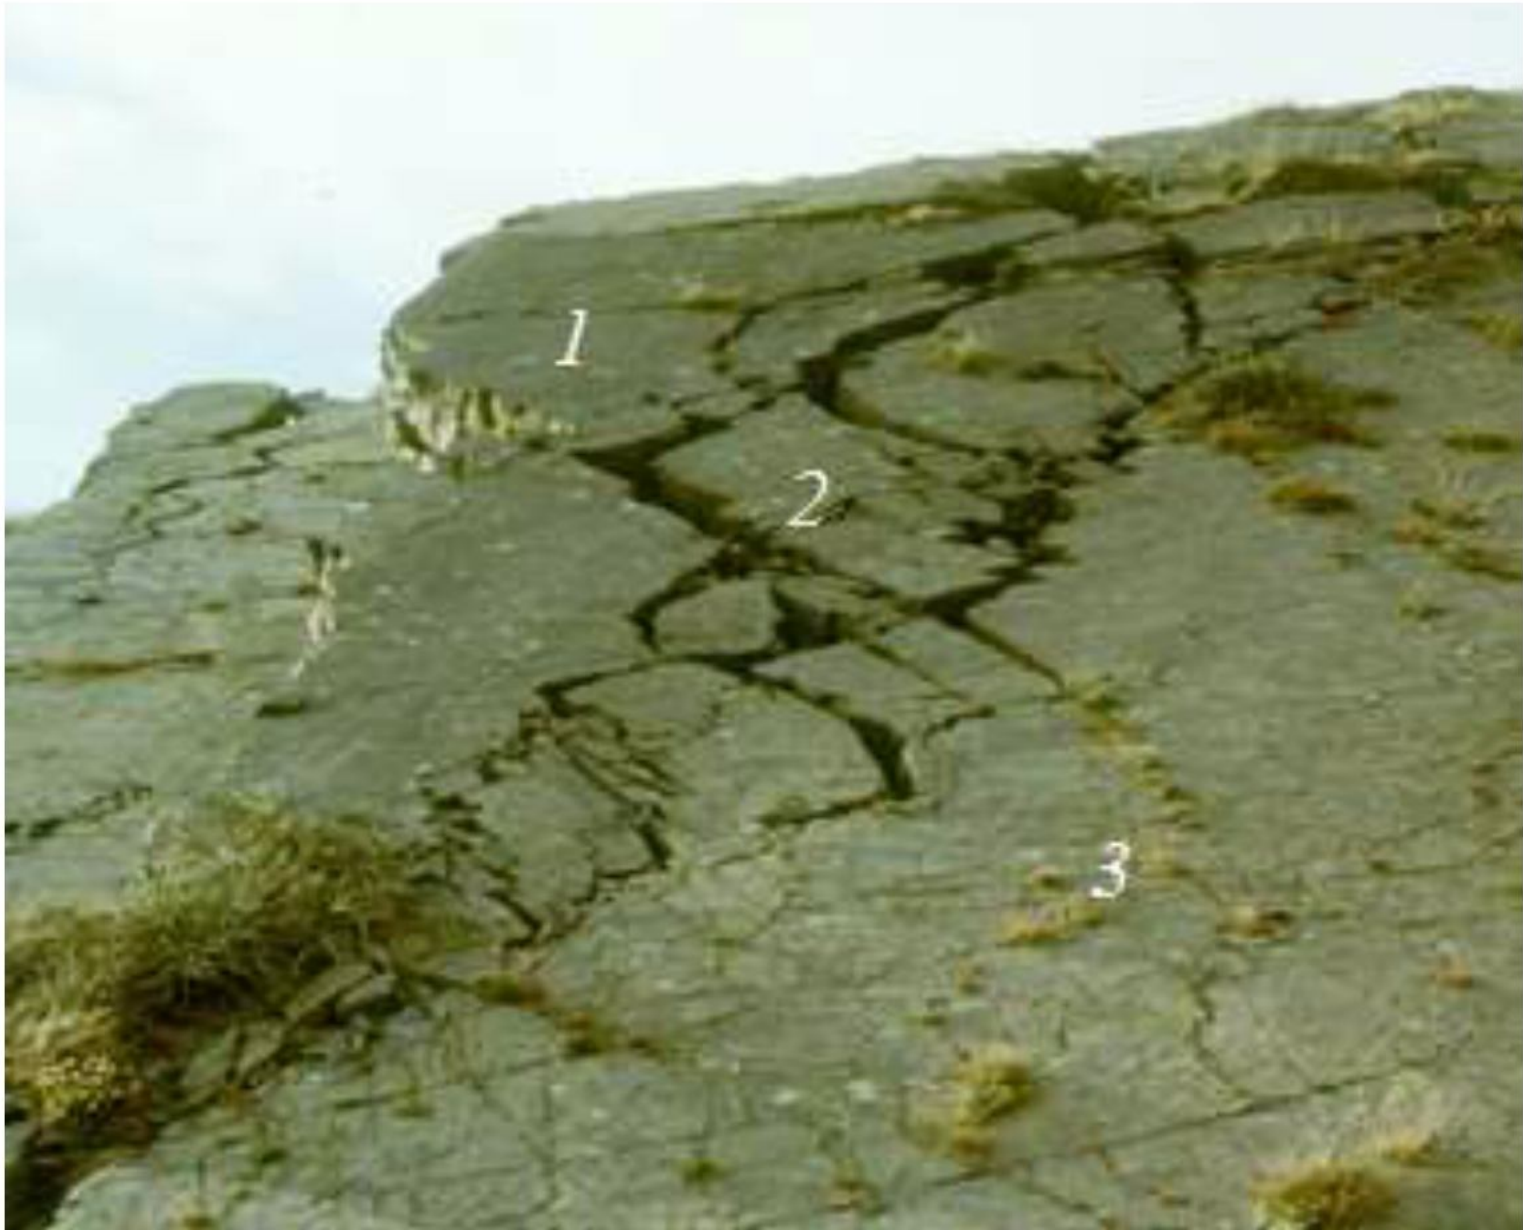
Toppling tends to produce three offset layers of differing rock-mass properties

Here is a developing three layer case:

In this case, the upper layer (1) is a rather thick dead zone, but still more or less riding along on the toppling mass of the middle zone (2). The opening of the flexural cracks between the upper and middle (toppling) zone has reduced the shear stress required to sustain active flexure in the layers of the upper zone..

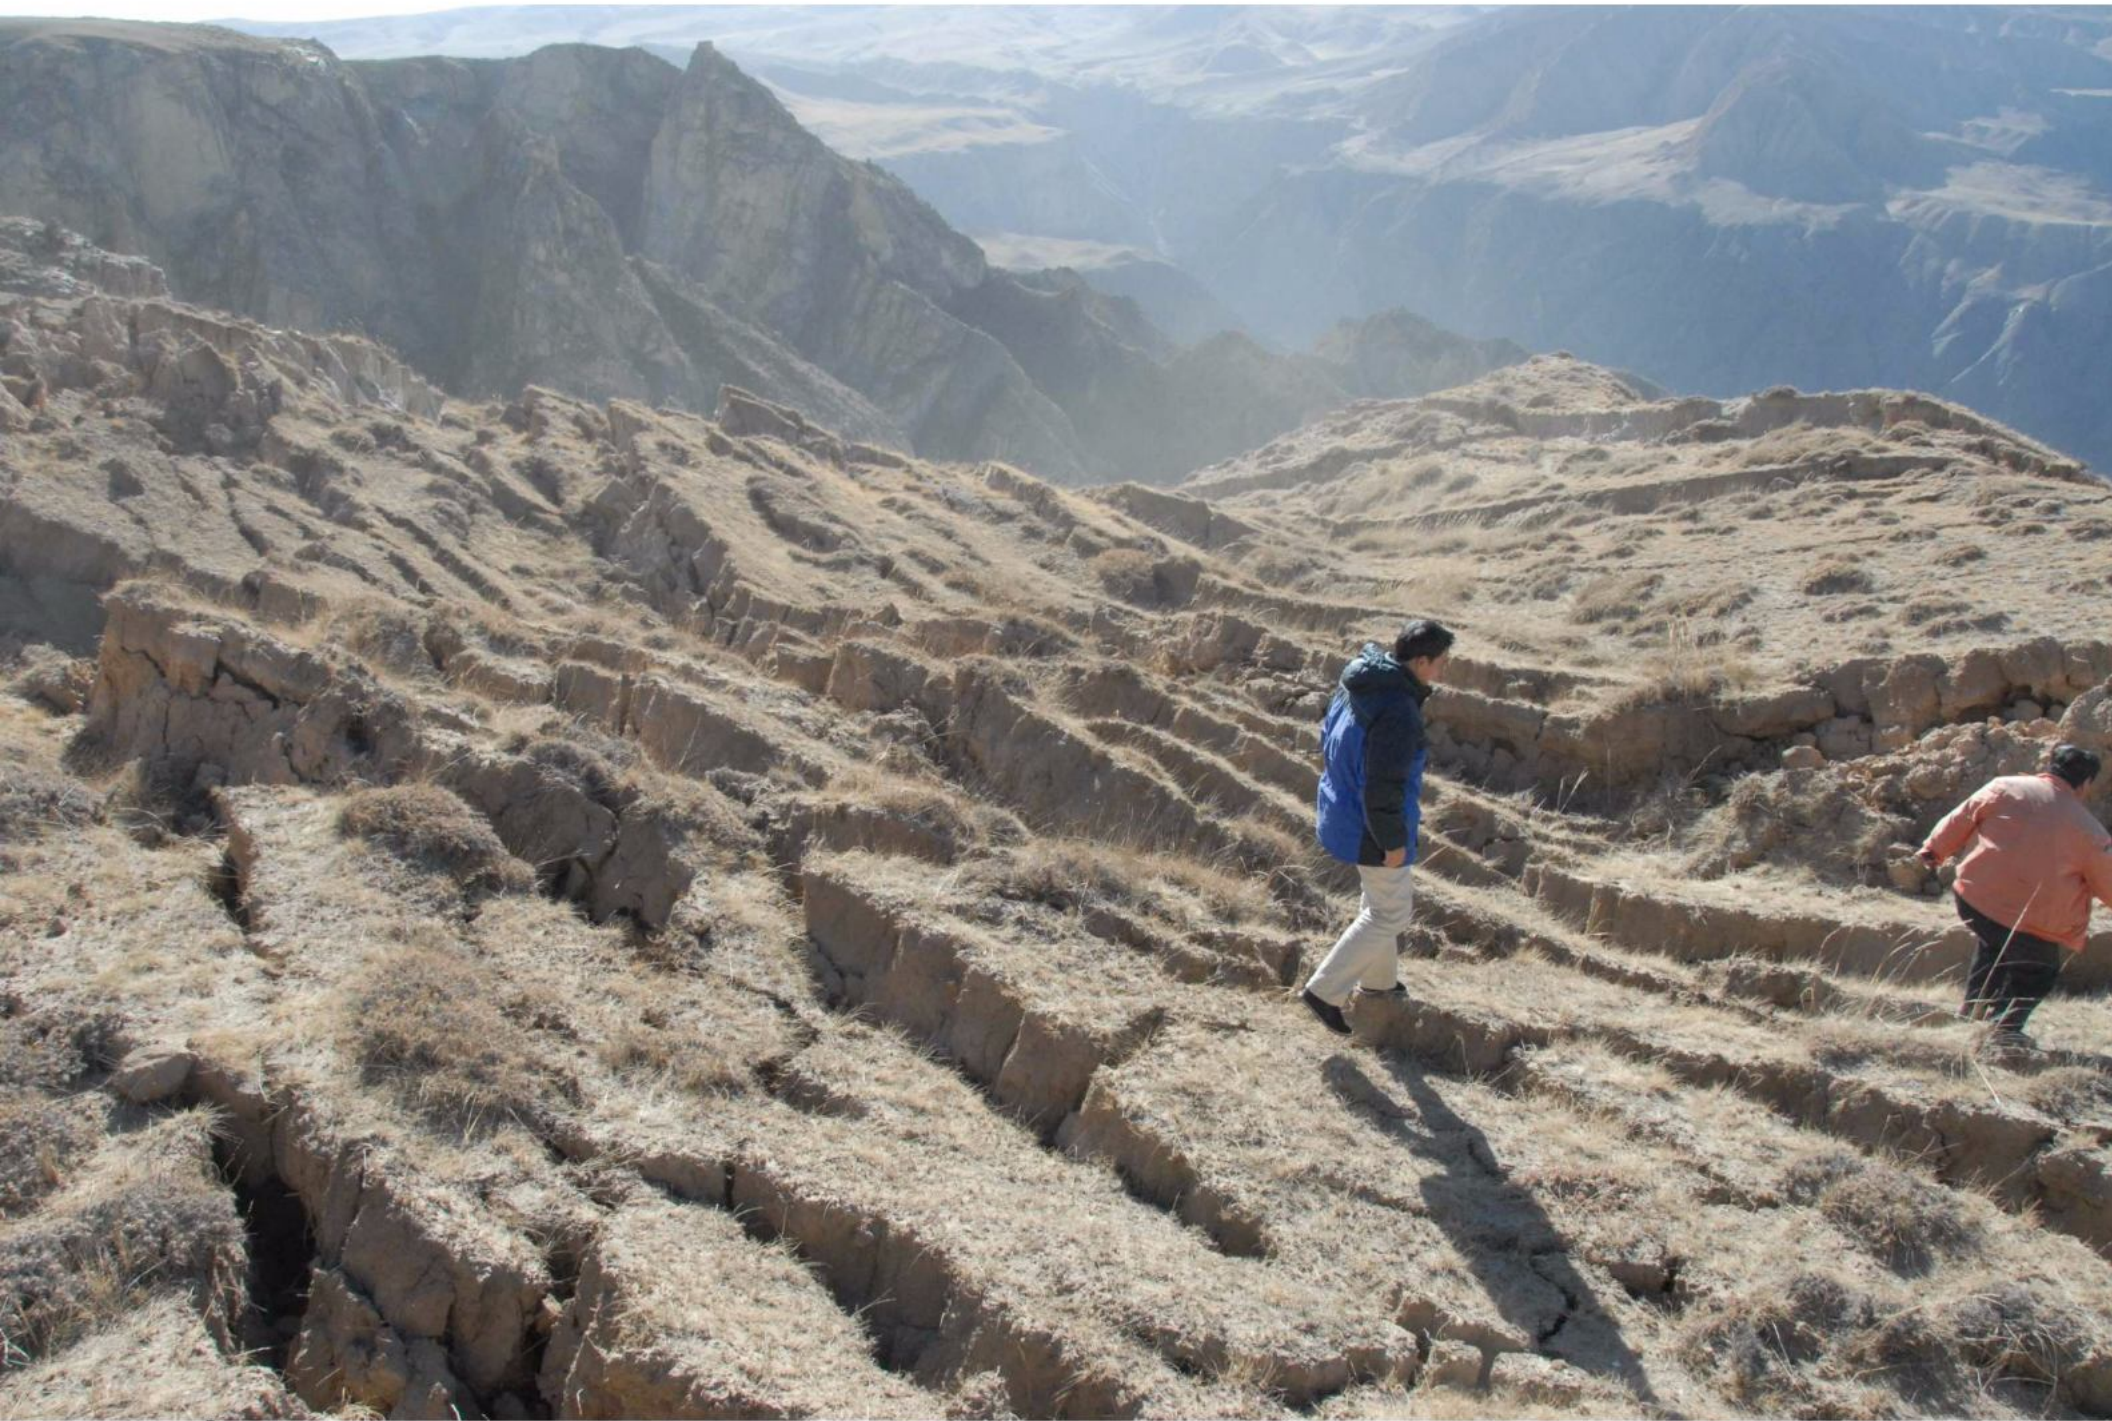
Two of many obsequent
scarps mapped in the
French Alps near Les Arcs
ski resort; (Hippolyte,
Brocard, Tardy, Nicoud,
Bourles, Braucher, Menard,
and Souffache
**Tectonophysics, 418, no 3
(2011)**

Model of gravitational sacking deformation at Les Arcs. (a, b, c) observed in the Aiguille Grive massif. The ridge top troughs (C) are tension cracks resulting from toppling of vertical rock layers in the two slope directions. The tensional antislope (obsequent) scarp (B) results from toppling of the rock layers and erosion mainly of the steep uphill face (Jahn, 1964). (d) Topographic cross-section of the Aiguille Grive massif (location in Fig. 2) with location of the deformation. The valley glacier was settled on the Carboniferous silts and sandstones

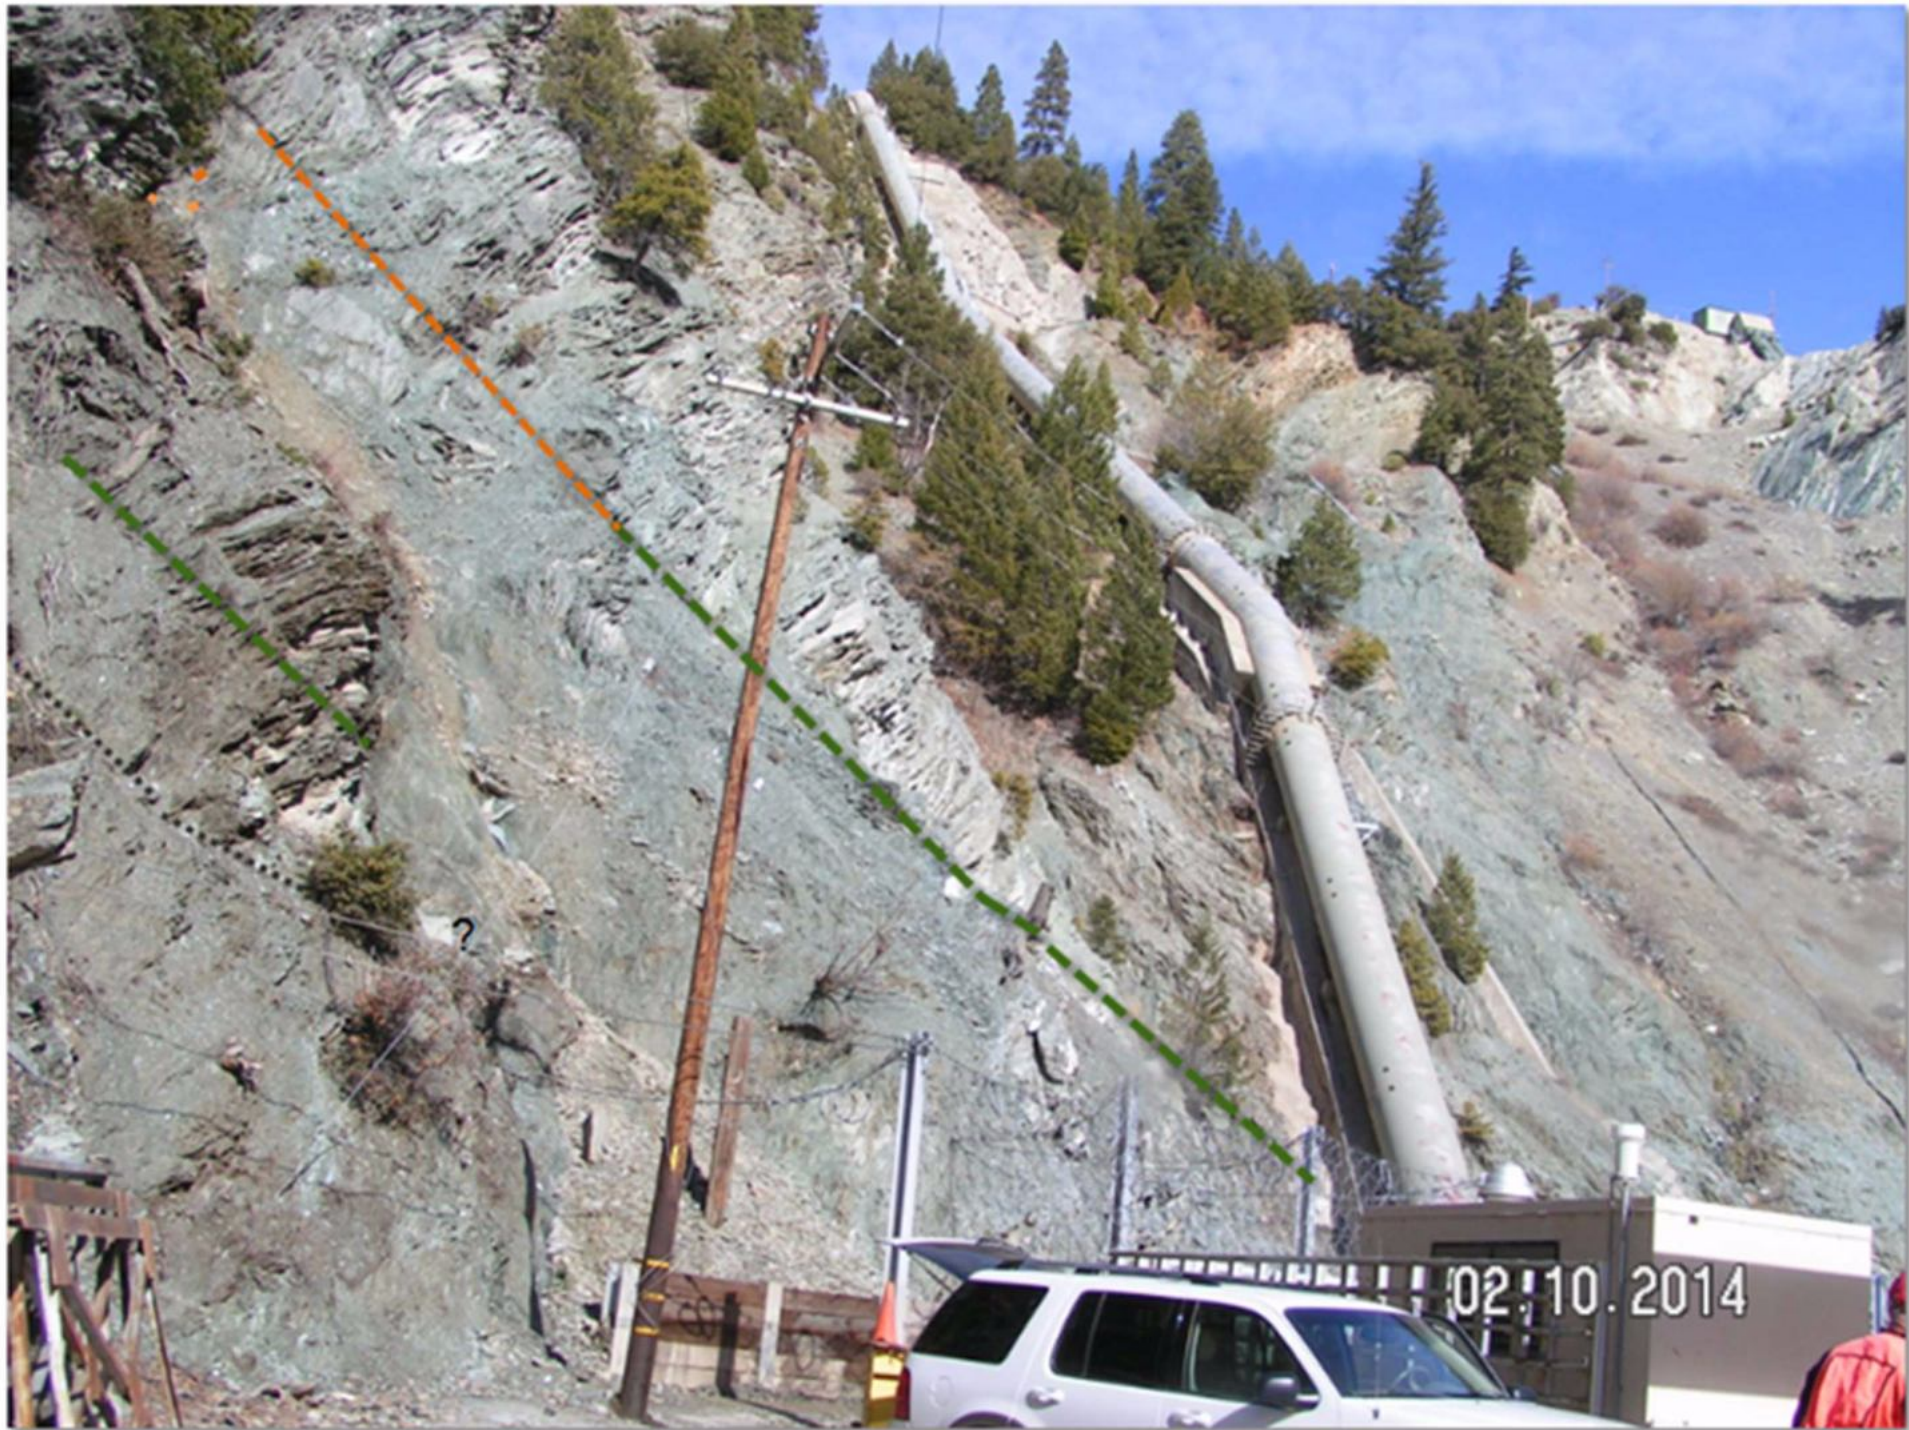
An aerial photograph showing a large, dark-colored pipeline or tunnel structure cutting through a dense forest of evergreen trees. The pipeline starts in the upper left and curves downwards and to the right, eventually following a road or path. The surrounding terrain is hilly and covered in thick forest. The text "BELDEN TUNNEL 2 PORTAL" is overlaid in white capital letters in the center-right portion of the image.

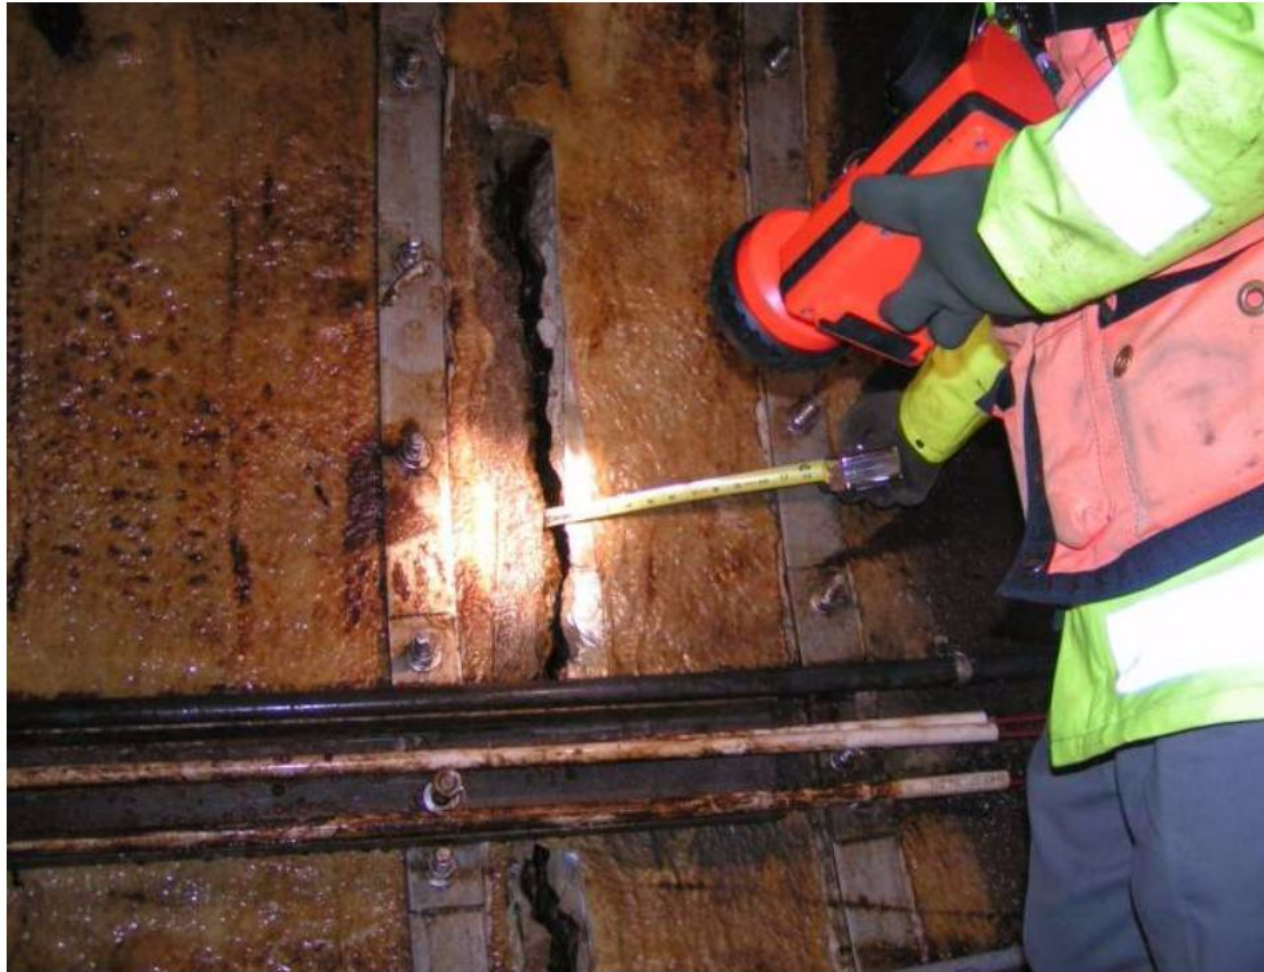
Crack in the lining of Belden Tunnel

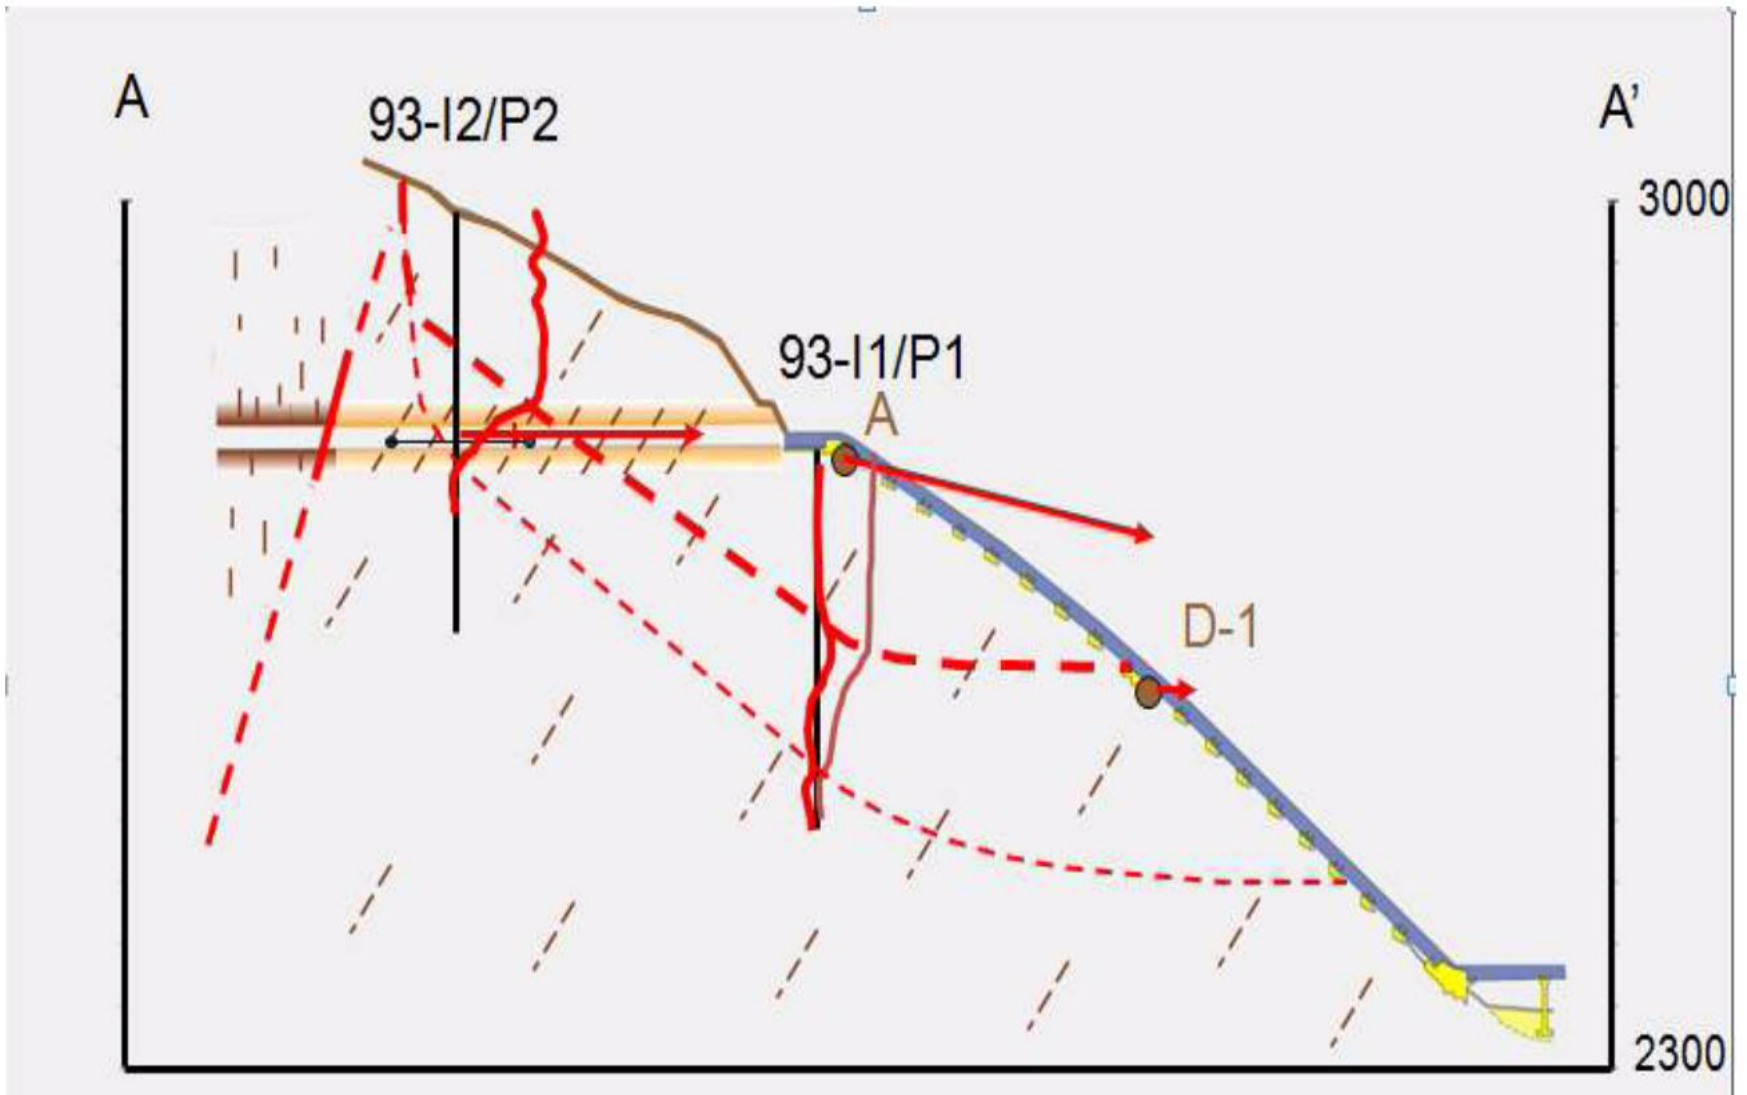
Belden Tunnel Instrumentation shown in a geologic section

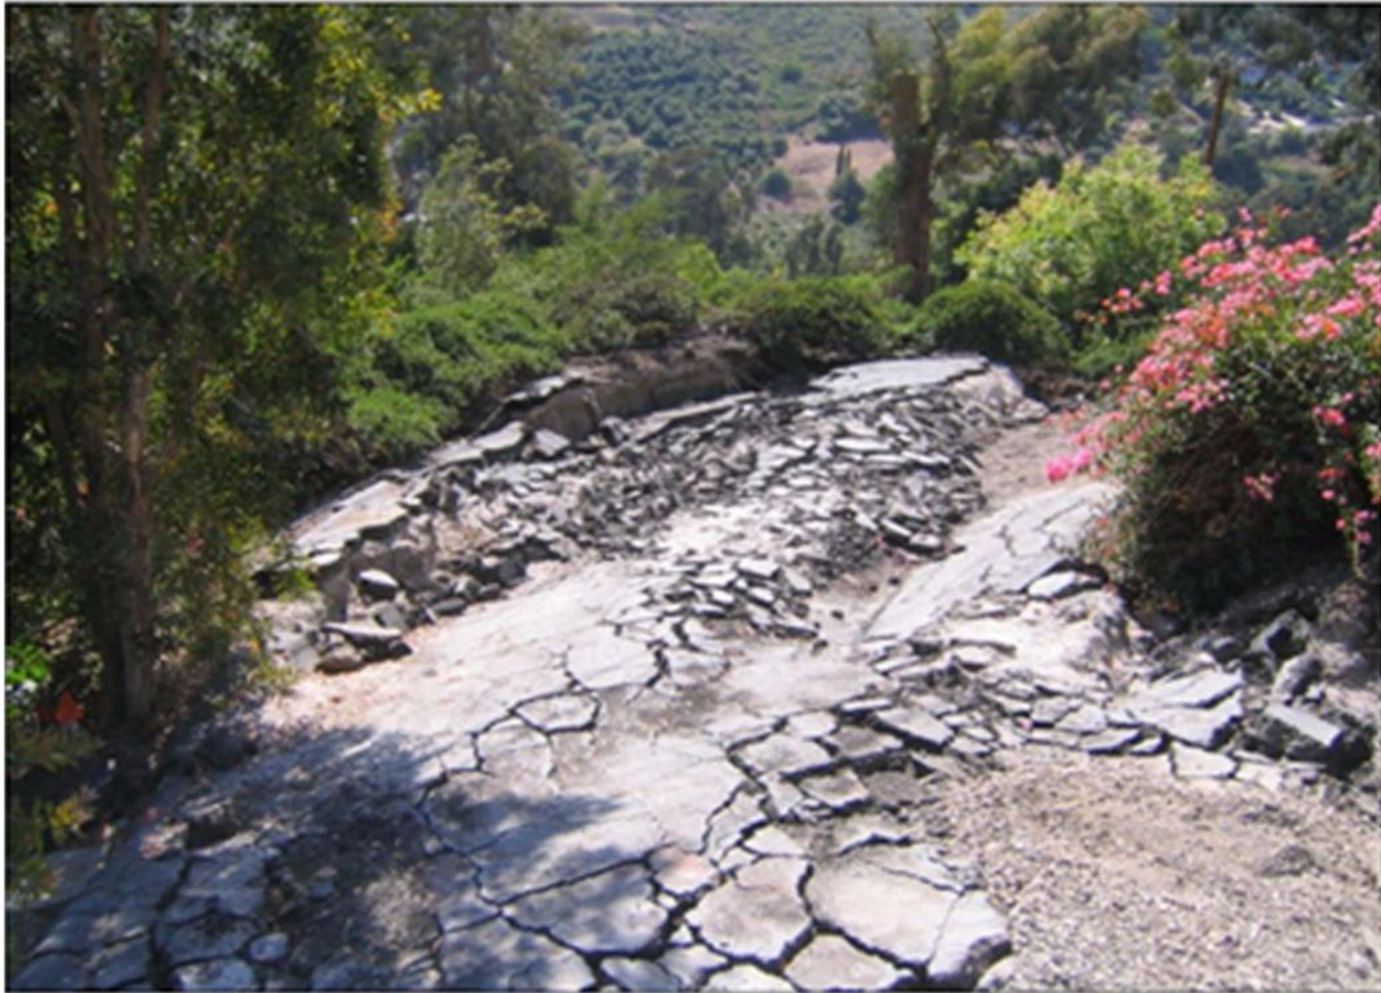
Severe damage from development of obsequent scarps by leftward toppling

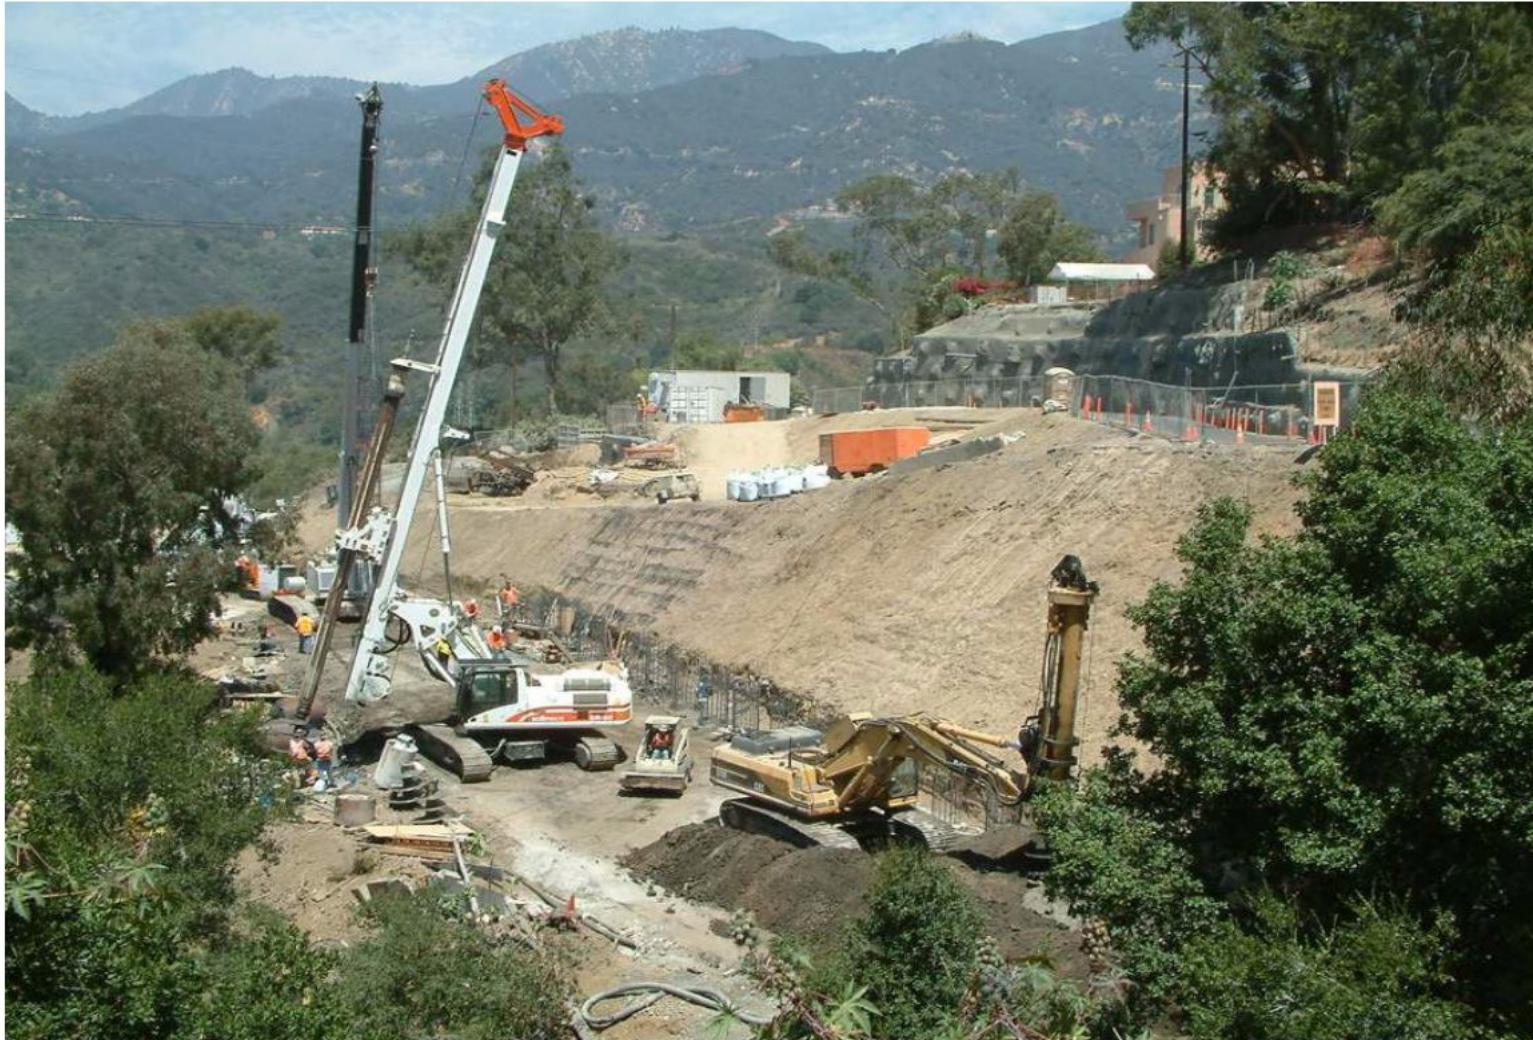
-- Tied-back walls designed by Cotton- Shires to provide resisting moment to the incipient toppling behind each wall

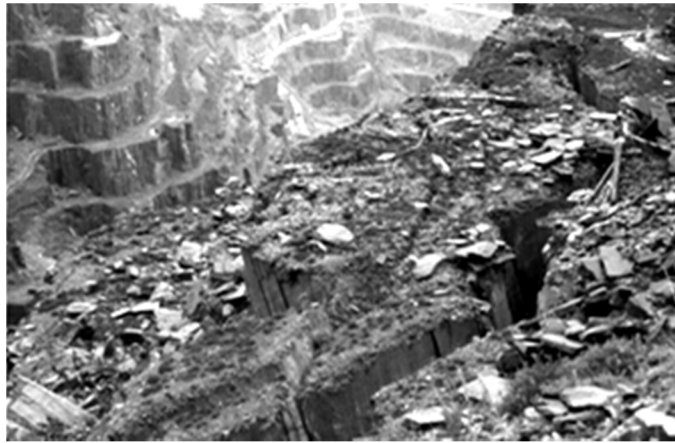
Figure 6 - *Obsequent*, or *antislope* scarps (uphill facing normal faults) that typically form by rotational extension behind a toppling face.

A main characteristic of a toppling failure is the development of *obsequent scarps* - - normal-fault type extension scarps (also called *anti-slope scarps*, and *upslope facing scarps*). They occur at the top and behind the toppling mass with strikes sub-parallel to the topple-crest and dipping away from the steep, free-surface. Approaching the top of the scarp from behind, a succession of these scarplets typically greets one as a set of stairs with gently inclined tread, as can be seen in Figure 6. They characteristically display normal fault offsets - - with the toppling layers moving upward and outward relative to the rock behind the topple.¹

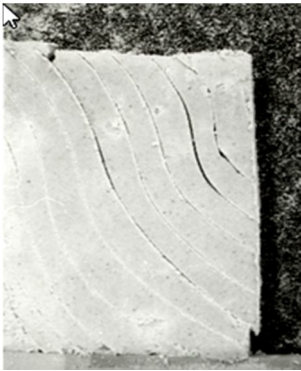
Figure 10 a

In the example of Figure 10, incipient shear creep along the layers causes toppling of the toe and complete destruction of the entire slope. In Figure 10a, we can see that sliding begins to develop interbed gaps which set up flexural cracking of certain beds. As this proceeds, the potential sliding mass begins to over-ride the toe, causing foundation crushing beneath the toe of the slope (Figure 10b). The consequent rotation of the toe opens imbricate flexural cracks delimiting a major toppling mass. Moment is now delivered from the rock mass behind and above the topple (Figure 10c). This culminates in a complete destruction of the rock slope (seen in subsequent frames not copied here).

Another form of secondary toppling - - **sliding-induced toppling** - - can initiate from deformation of the rock mass caused by initial sliding. Figure 10 is a base friction model of toppling that is generated by incipient sliding along non-circularly folded bedding. The base friction model, (Bray and Goodman (1981)) allows easy and quick repetition of two dimensional experiments facilitating study of relative influences of surface geometry, joint spacing, roughness, orientation, and strength characteristics of several sets of joints. The results can be strictly correct only for static equilibrium, such that no block acquires significant momentum. That limitation proves generally non-consequential because most of the blocks are within the interior of the simulated rock mass and cannot acquire momentum until large deformation has already been achieved. Thus results observed during an experiment are acceptable, except for blocks that may be "falling" into the free space.

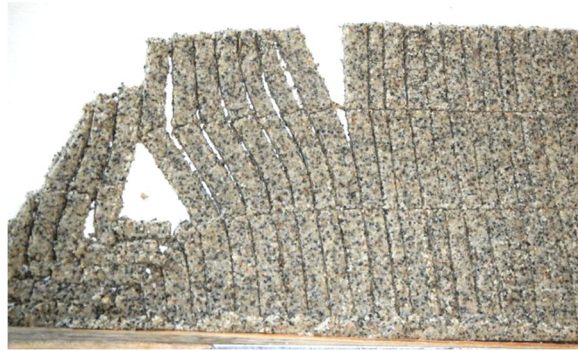
Figure 12(a)(left) - Initial cut-slope, in a block-jointed rock mass with one set dipping steeply into the hillside.
12(b)(right) - Buckling initiated by toppling of this slope.

Buckling is a failure mode applicable to long, slender, steeply inclined columns, often of weak rock. It is a known hazard in open pit mining of steeply inclined coal beds. Removal of coal prejudices the stability of the weak strata that typically lie behind (underlie) the coal. Buckling can also be initiated by toppling, as individual rock columns separate from the rock mass. A column that is cross jointed, or has accumulated flexural cracks that cut almost entirely across the column (as in Figure 10), can be said to be formed of *stacked sub-blocks*. As toppling rotations develop, the upper sub-blocks of any column may generate insupportable moment at one or more intra-column hinges as shown in Figures 12 and 13.

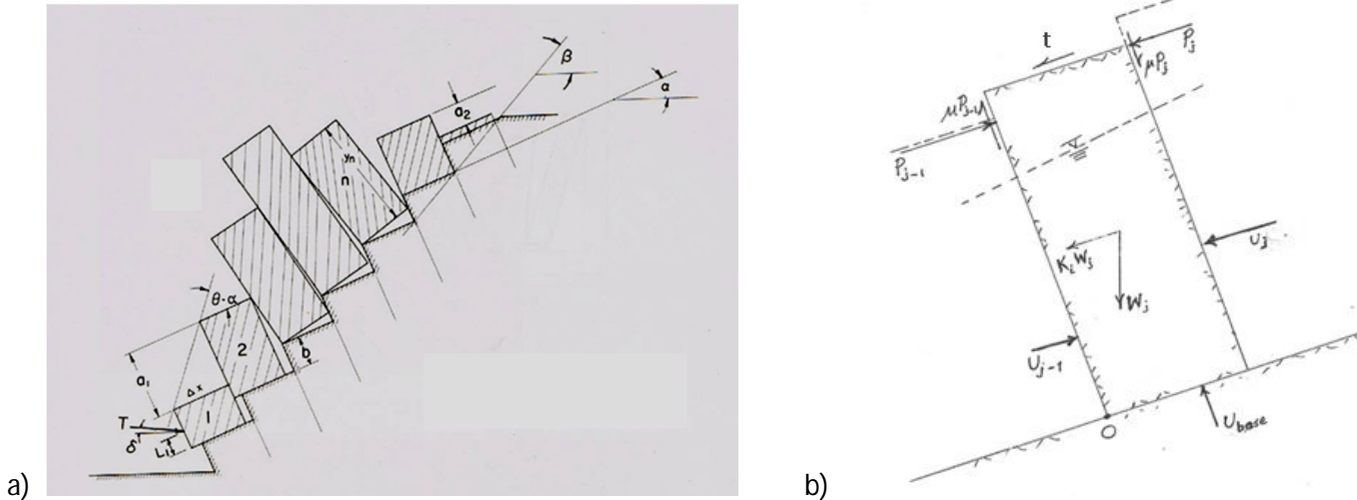
Figure 16: a) Model for analysis of toppling on a stepped base, from Goodman and Bray (1976). b) Forces on block j with respect to rotation about O : P_j = normal force from upslope neighboring block ($j+1$); P_{j-1} = normal force from downslope neighboring block; \square = block side-friction factor; W_j = weight of block j ; K_i = acceleration coefficient of an earthquake in the most critical direction ($//$ to base); t = creep force of overlying soil; and U_j , U_{base} , and U_{j-1} are resultant water pressures on the upper side, base, and lower side of the block respectively.

The value of the reaction force P_0 thus calculated for stability of the *lowest* block, measures the stability of the whole group of blocks: if it is negative, the system is in equilibrium without additional support; if zero, the system is at limiting equilibrium; if positive, the block system is unstable and will fail if the bottom (toe) block is not supported. According to whether the toe block is sliding or toppling (meaning whether the minimum required reaction force for the toe block is derived from the equilibrium equation for sliding or for toppling), safety can be provided by acquiring shear or moment resistance with an anchored wall or appropriately directed tie-back. Alternatively, safety can be sought by binding pairs or triplets of blocks together with rock reinforcement to effect an increase in the apparent thickness of columns; however this may be hard to realize in practice and may not prove to be cost-effective in any particular case..
