Toppling - - Failure of Rock Slopes

by Richard E. Goodman

"Toppling - - a fundamental failure mode in rock masses

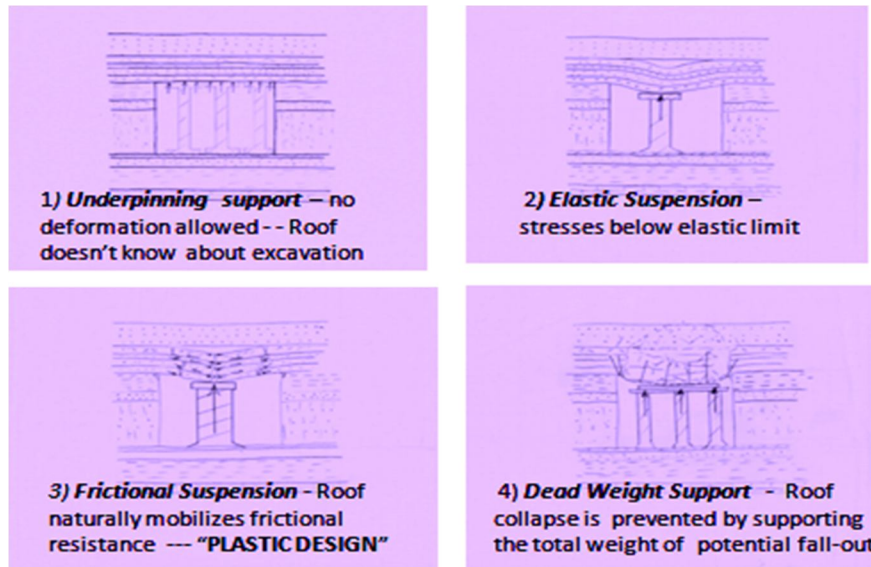
Figure 23. A continuum of four design philosophies, in order of increasing initial support force and permitted rock deformation for a hypothetical underground gallery in rock.

4) If the initial support can not be placed to prevent destruction of the rock mass's own support capabilities, an upper bound support force may be applied. In underground work this might be taken as a support force equal to the total weight of the roof rock. This assumes that the rock will have lost all internal support capability. We can refer to this approach as ***dead weight design***.

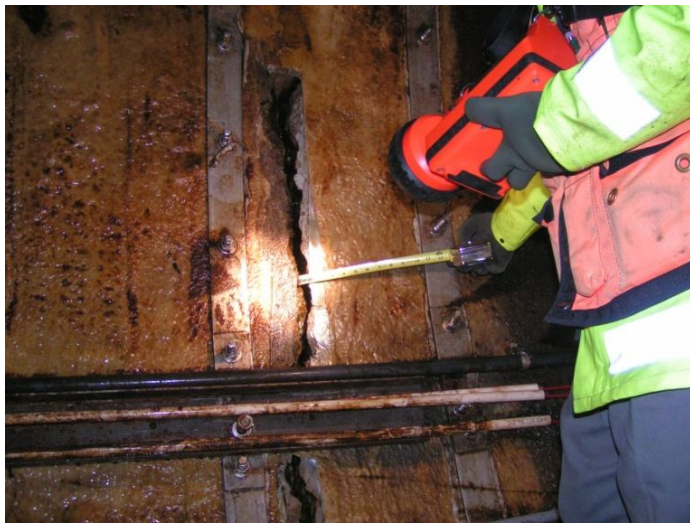
a)

Fig. 29 One of the main cracks through the Belden Tunnel in 2006

Shortly after the initial operation of the facility in 1969, the system was dewatered and the tunnels were inspected, revealing a 0.5 inch (1.27 cm) open crack crossing the entire 15 foot (4.55 m) diameter, circular concrete lining (Figure 29a). The crack occurred 300 feet (130 m) into the tunnel, 80 feet (24 m) short of the transition between gently dipping, soft phyllite and the steeply dipping hard phyllite (Fig. 29b). For some time, the mechanisms causing the movement and cracking could only be conjectured. Possible hydraulic fracturing or hydraulic jacking of the tunnel rock was considered but *in-situ* tests reported a hydraulic jacking pressure value well above the tunnel water pressure. A valley-side slide was supposed, but no geomorphic evidence for that theory could be discovered.

Engineering geologic mapping and instrumentation confirmed that the rock mass in the downstream section of the tunnel was toppling. Figure 29b shows the three layers of a toppling mass (compare with Figs. 13 and 14), mapped from surface observations by Cotton Shires and confirmed by the response of borehole extensometers *11* and *12*. Extensometers across the main cracks placed during an outage, and displacements surveyed at point A on the surface at the portal (Figure 29b) revealed similar rates of movement, which continued for 47 years until the problem was corrected by installing a waterproof PVC lining. Leakage from the cracks of the pressure tunnel was entering the rock mass along shear and foliation surfaces in the rock outside the tunnel, effectively jacking apart rock blocks of an ancient topple. These forces accumulated along the siphon (confirmed by closure measurements of the Dresser Couplings between the cans), and were ultimately reacted by a stiff dyke in the rock foundation at the foot of the slope. Thus the slope itself did not fail. Leakage through the weep holes probably contributed to the regeneration of toppling movements.

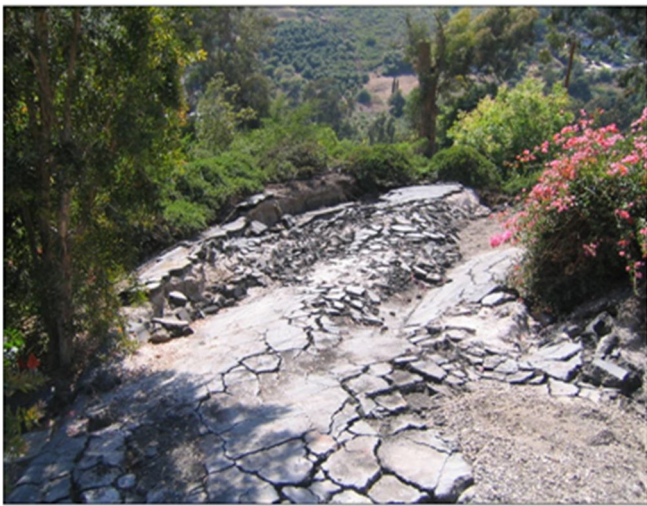
Figure 33 – Severe damage from development of obsequent scarps, caused by toppling towards the left.

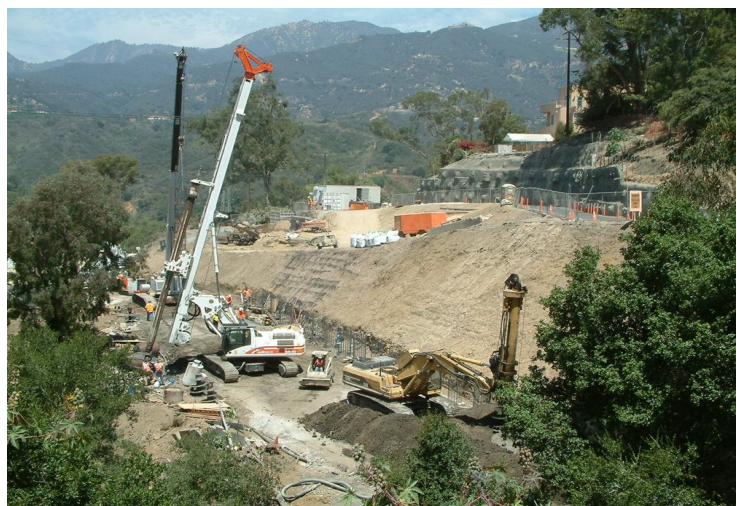
Figure 34 Construction of tied-back support walls designed by Cotton Shires.
