# Lessons Learned from a Bridge Abutment Failure

GeoVirginia 2015

# The Project - Bridge Overpass, Chesapeake, Virginia

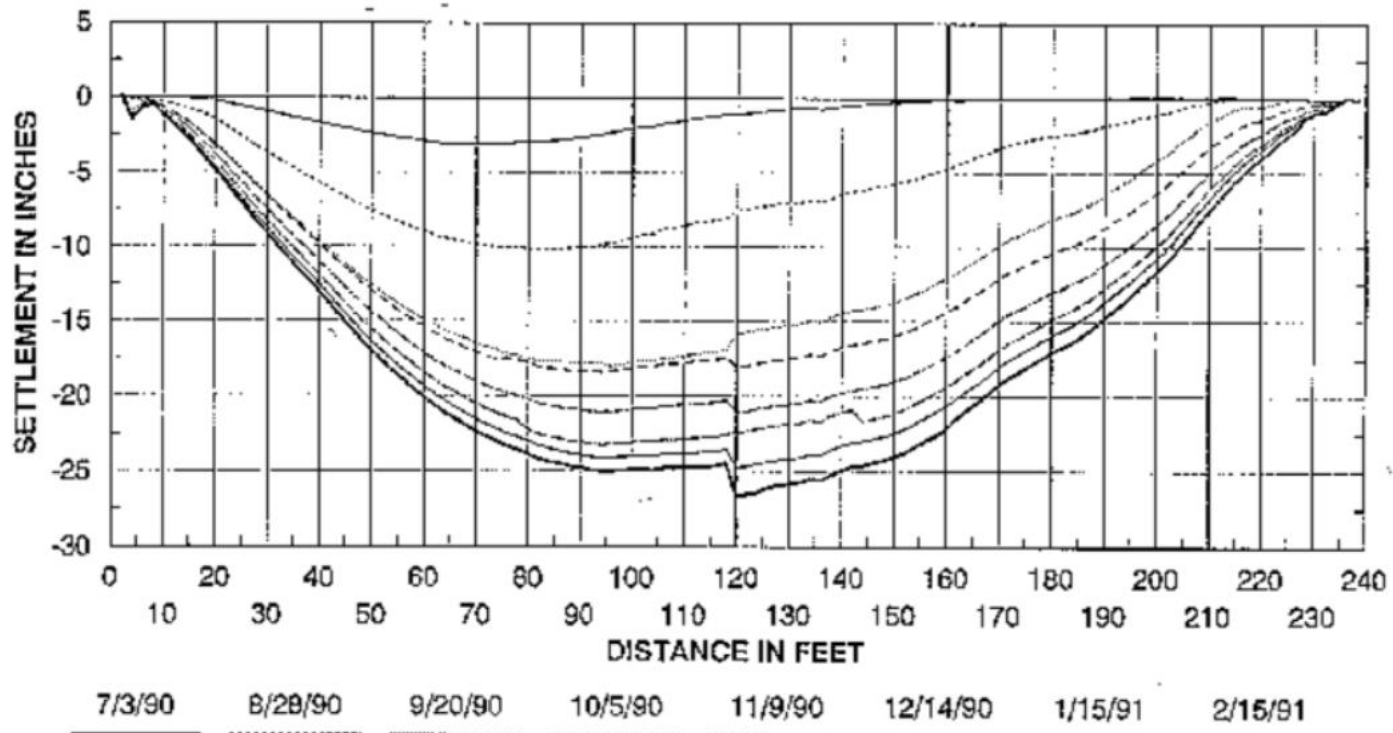
Drawing 10

# Field Data – Horizontal Indicator

SOUTH HORIZONTAL INDICATOR

- “Horizontal indicators indicate that the (vertical) settlement is still occurring”.
- “Horizontal movement continues...may still be experiencing plastic flow”.
- “While pore water pressures have reduced, values indicate consolidation is still occurring”.
- “Construction of the overpass bridge and pier foundations can proceed”.

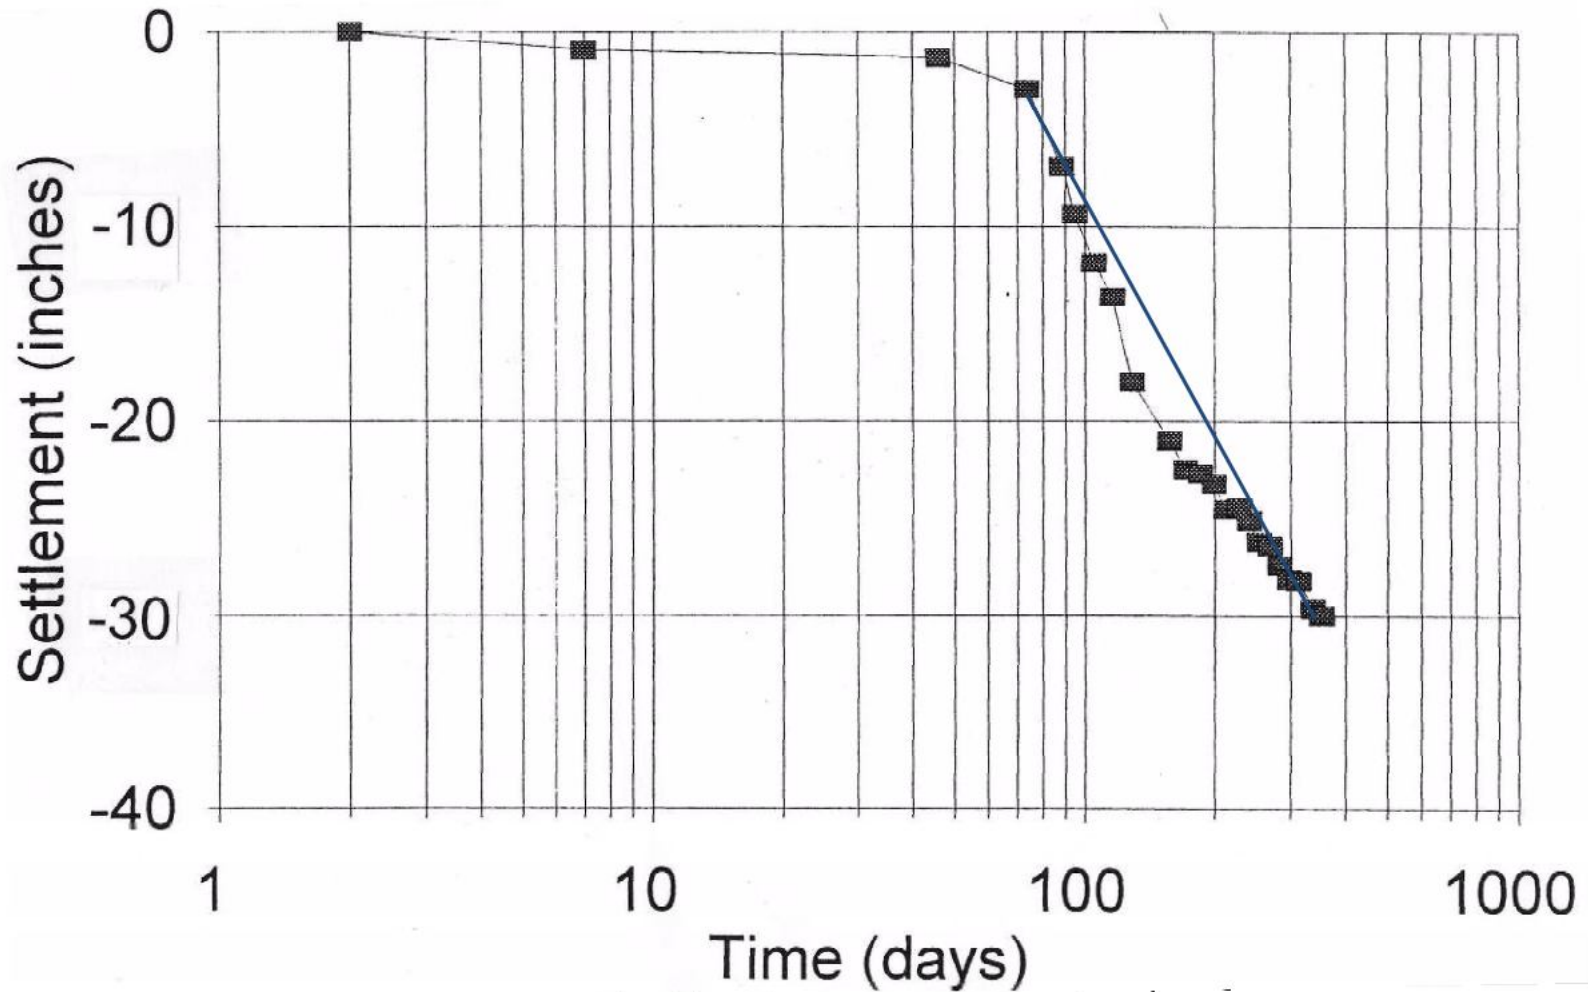
# Semi-log Plot of Embankment Time-Settlement Data

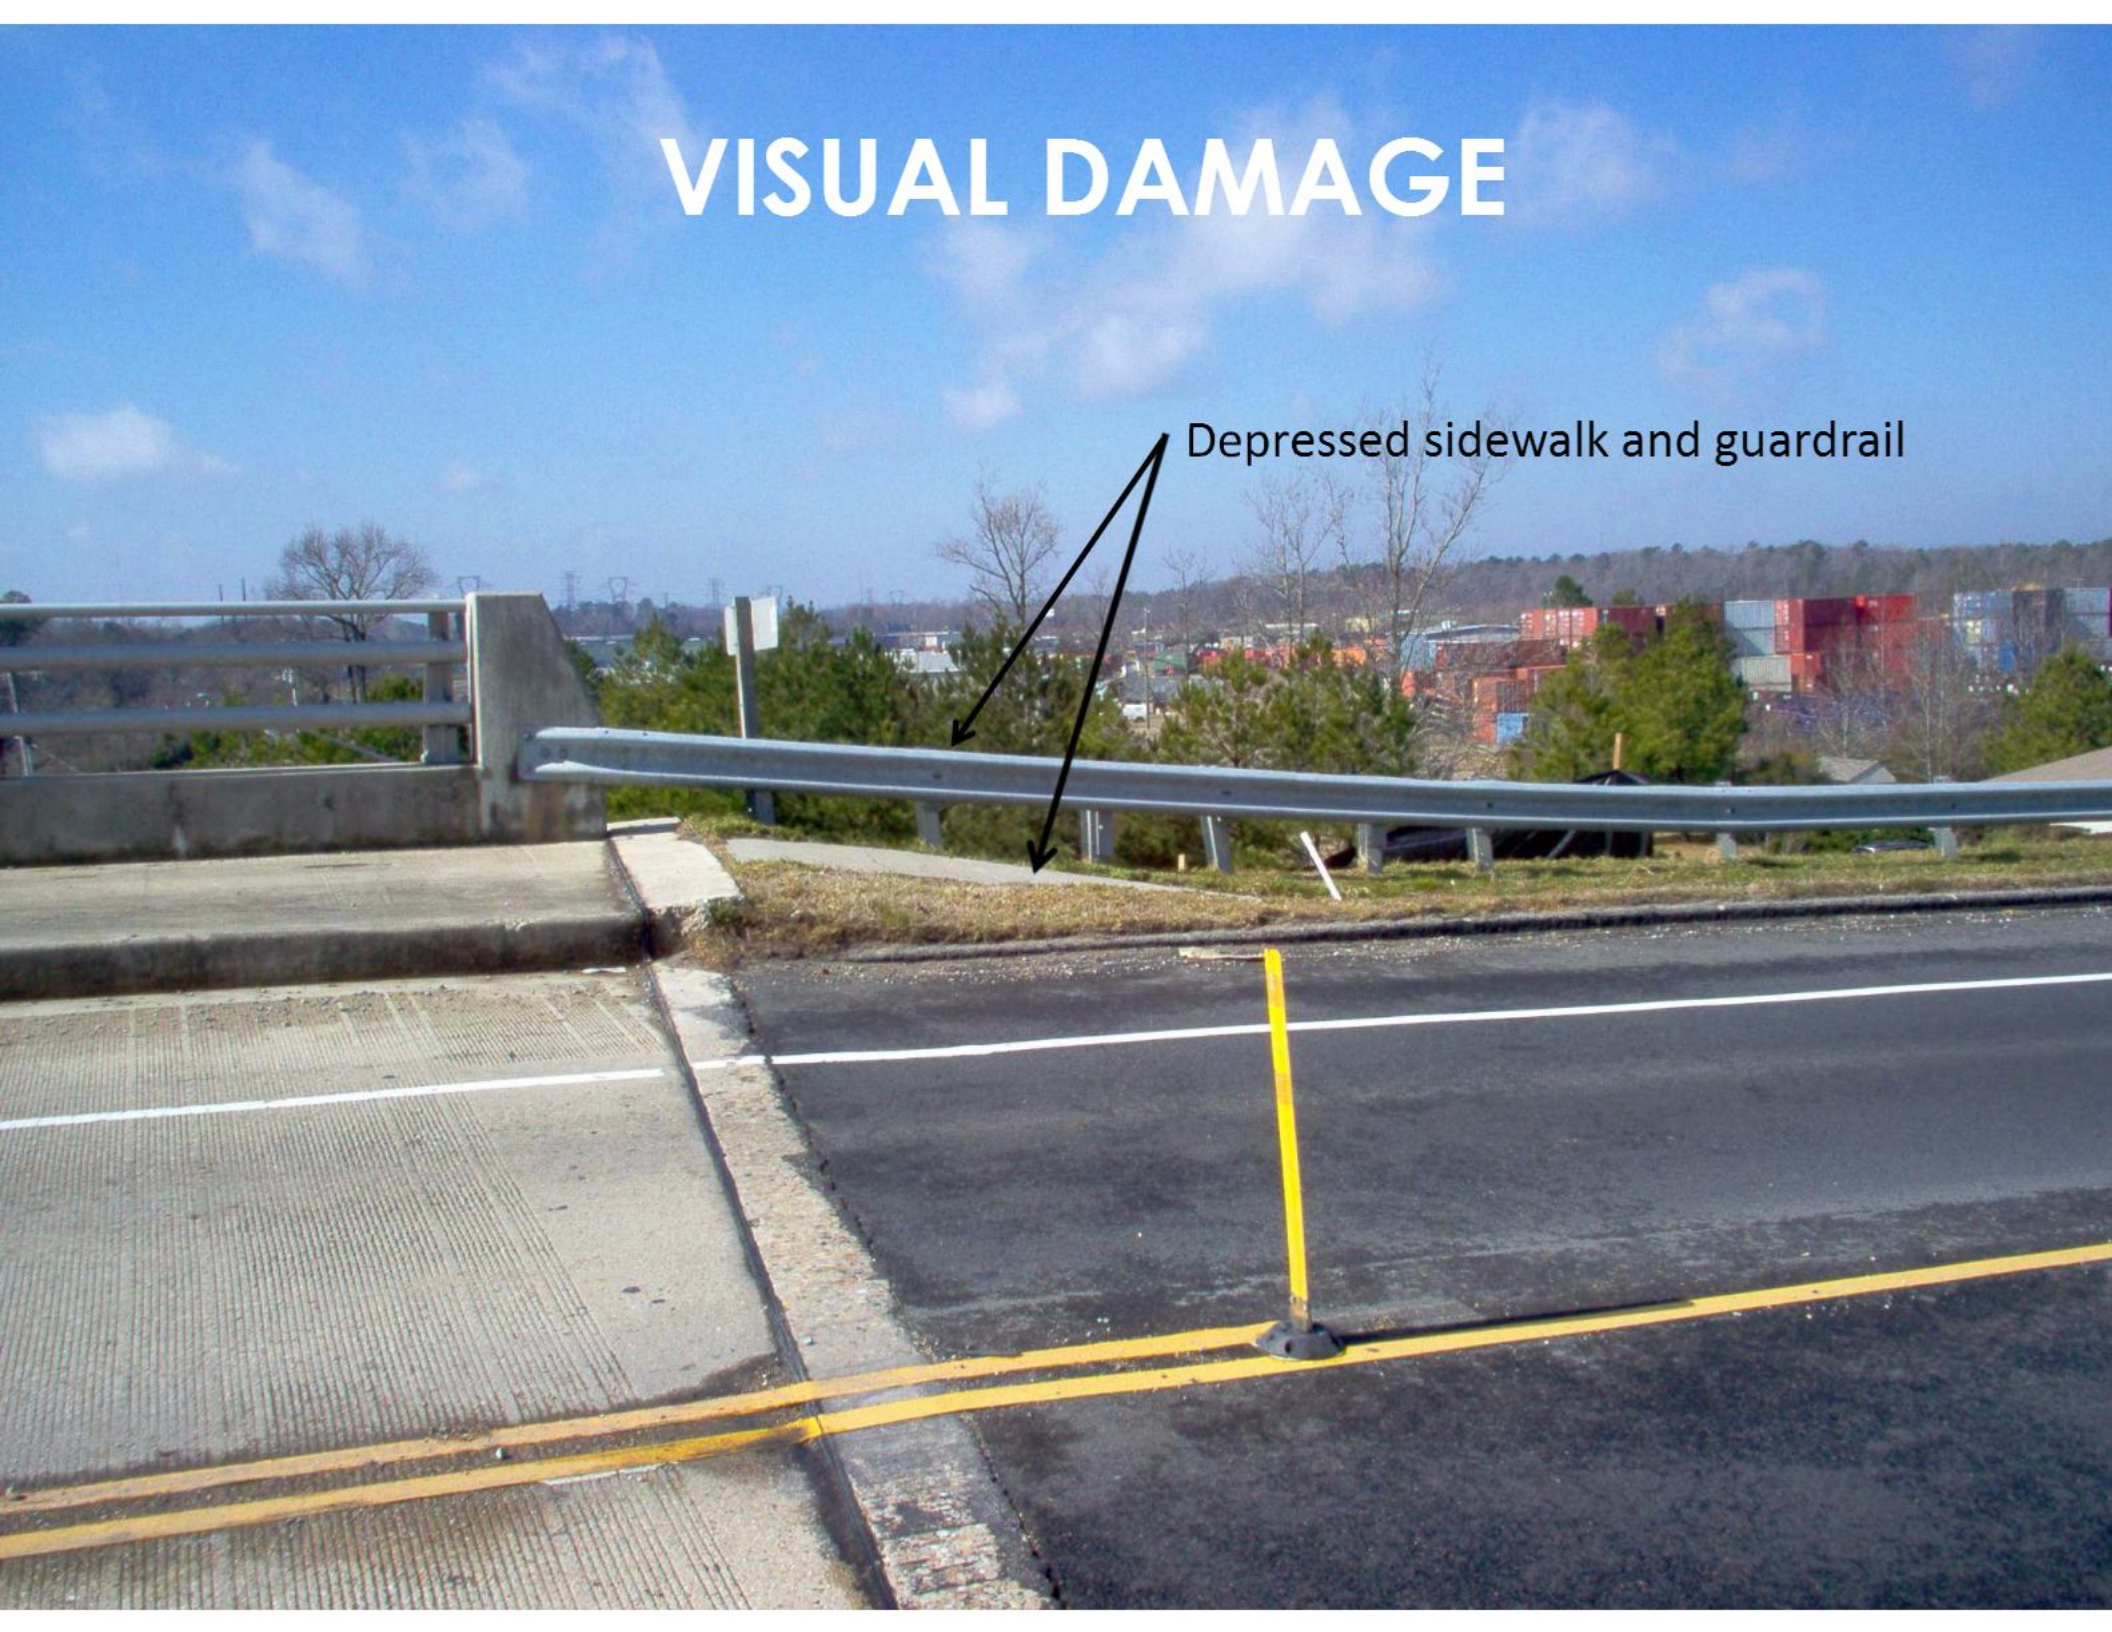
# VISUAL DAMAGE

Depressed sidewalk and guardrail

- Maintenance costs for filling approach slab depressions five times over 10 years totaled about \$500,000
- Bridge inspections were performed periodically since completion
- No one asked what is going on underground to cause structural damage, or if it would get worse

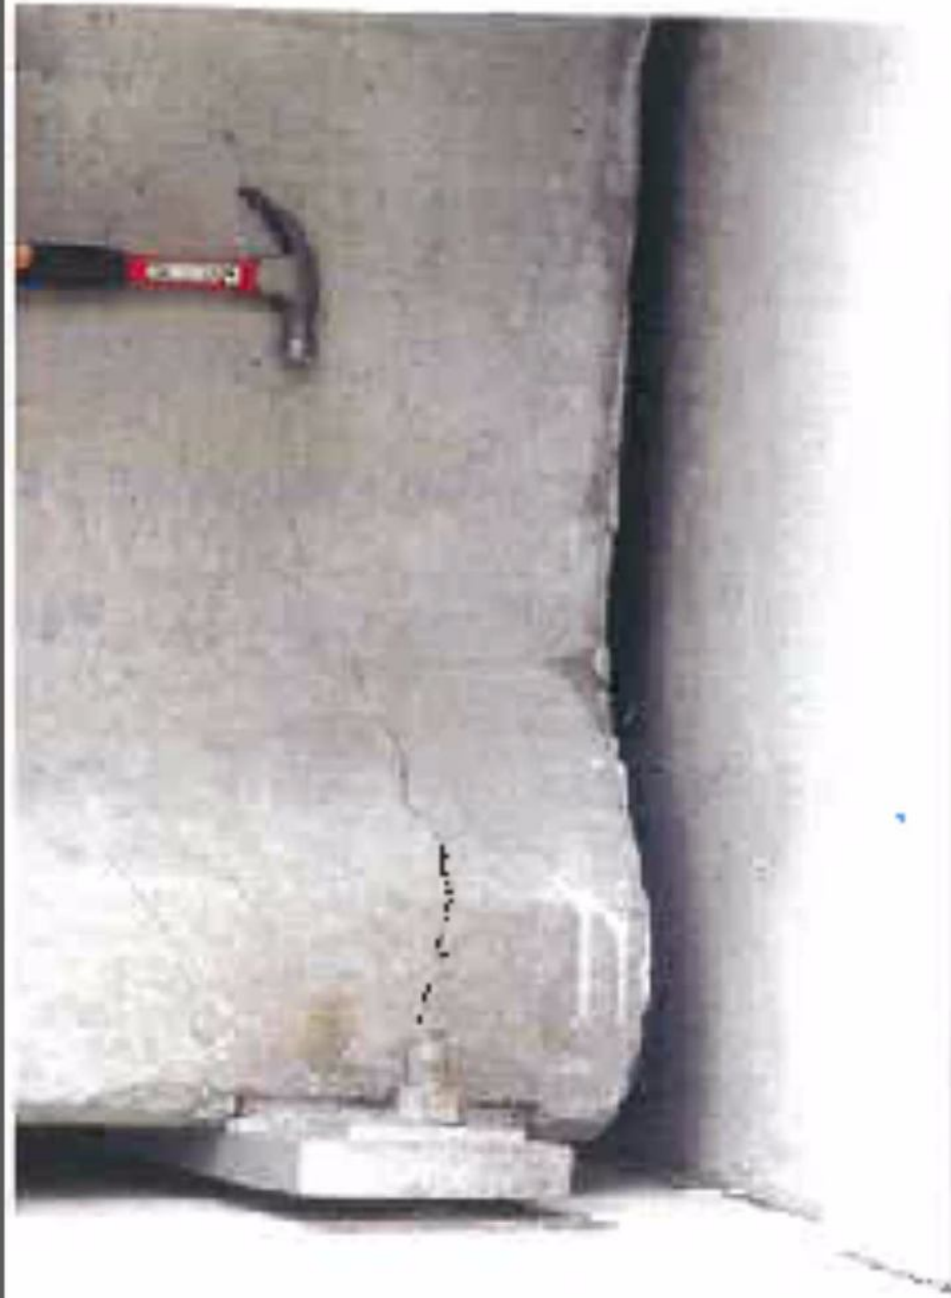
Vertical crack on  
beam web above  
bearing plate

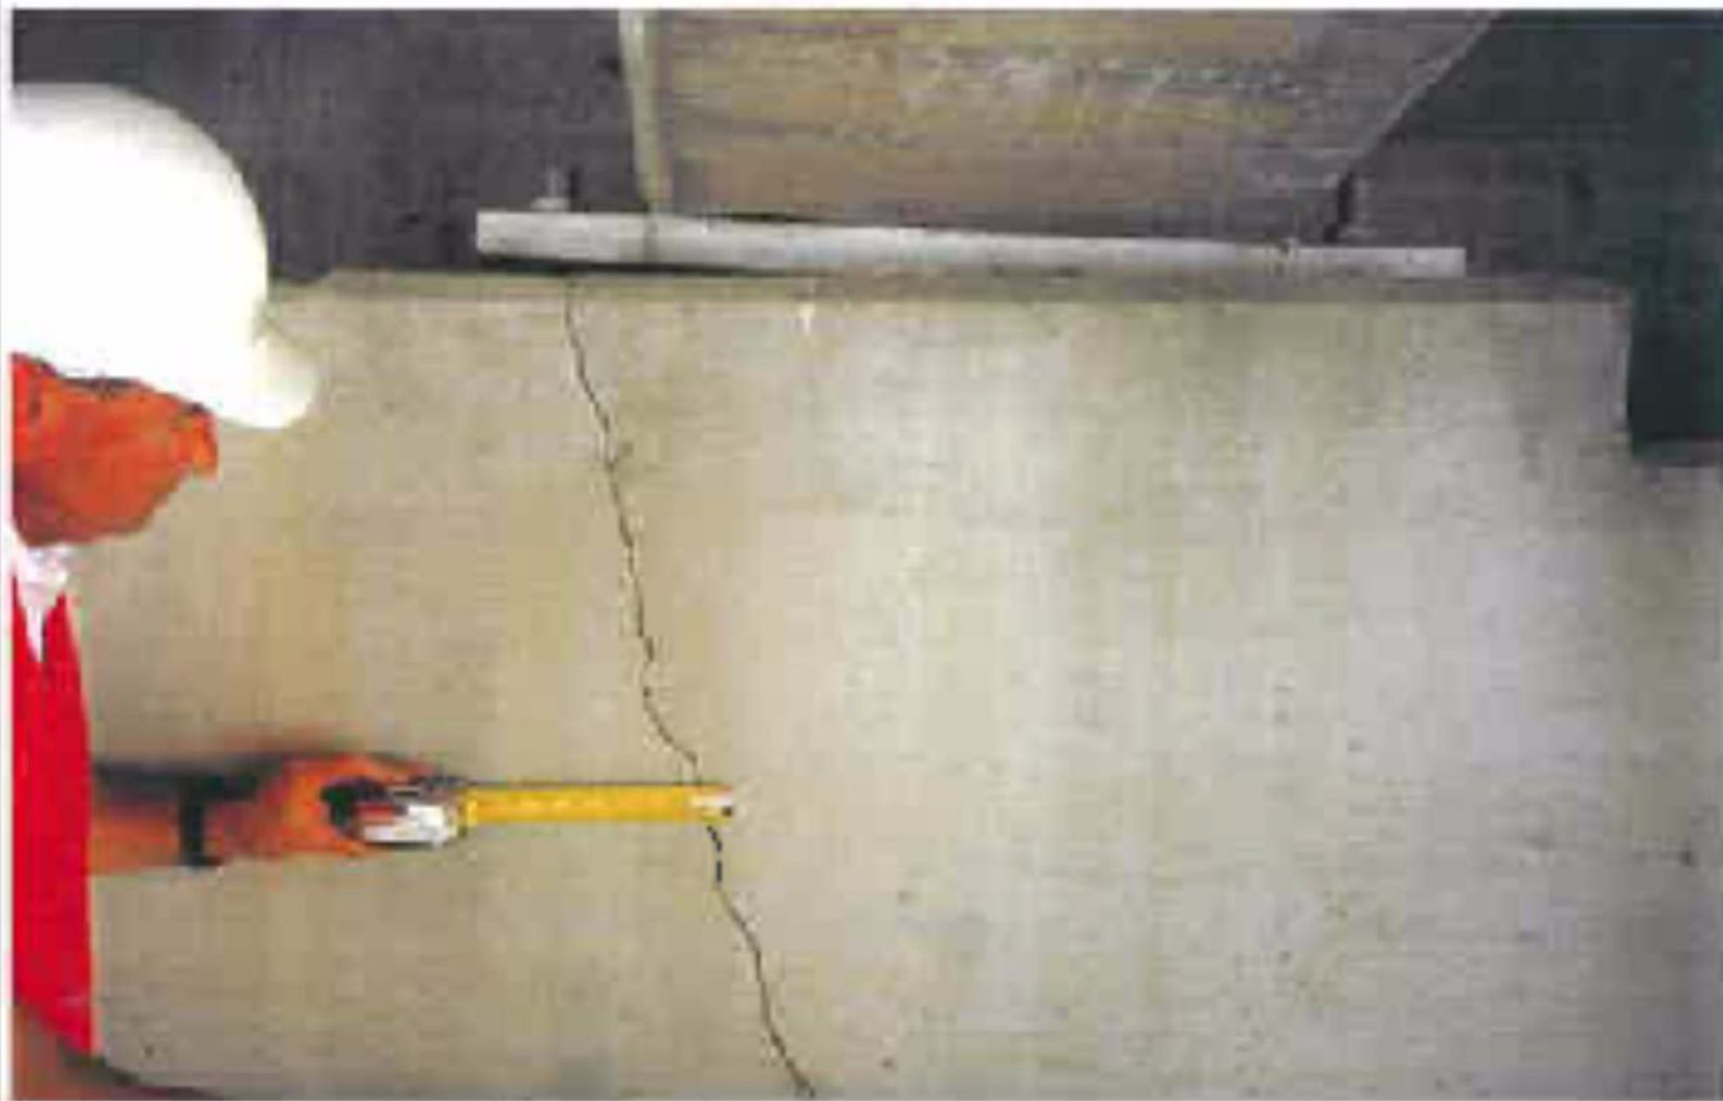
Diagonal Stress Crack in Under Beam

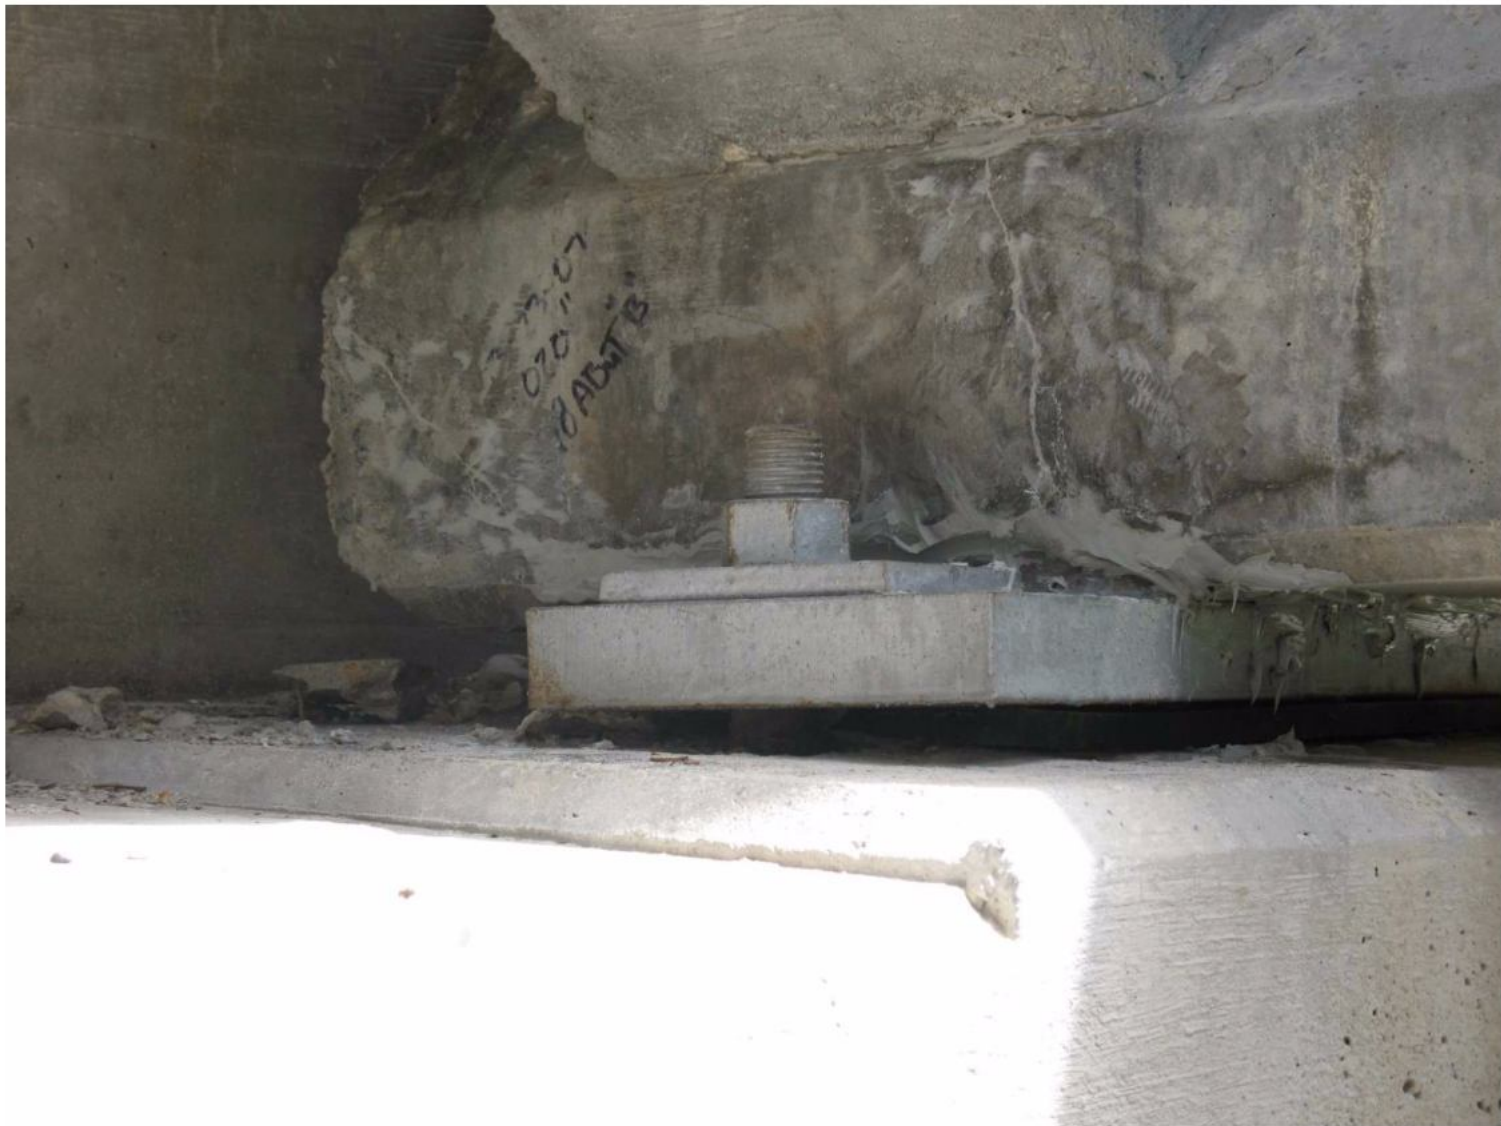
# Cracked and Grouted Beam

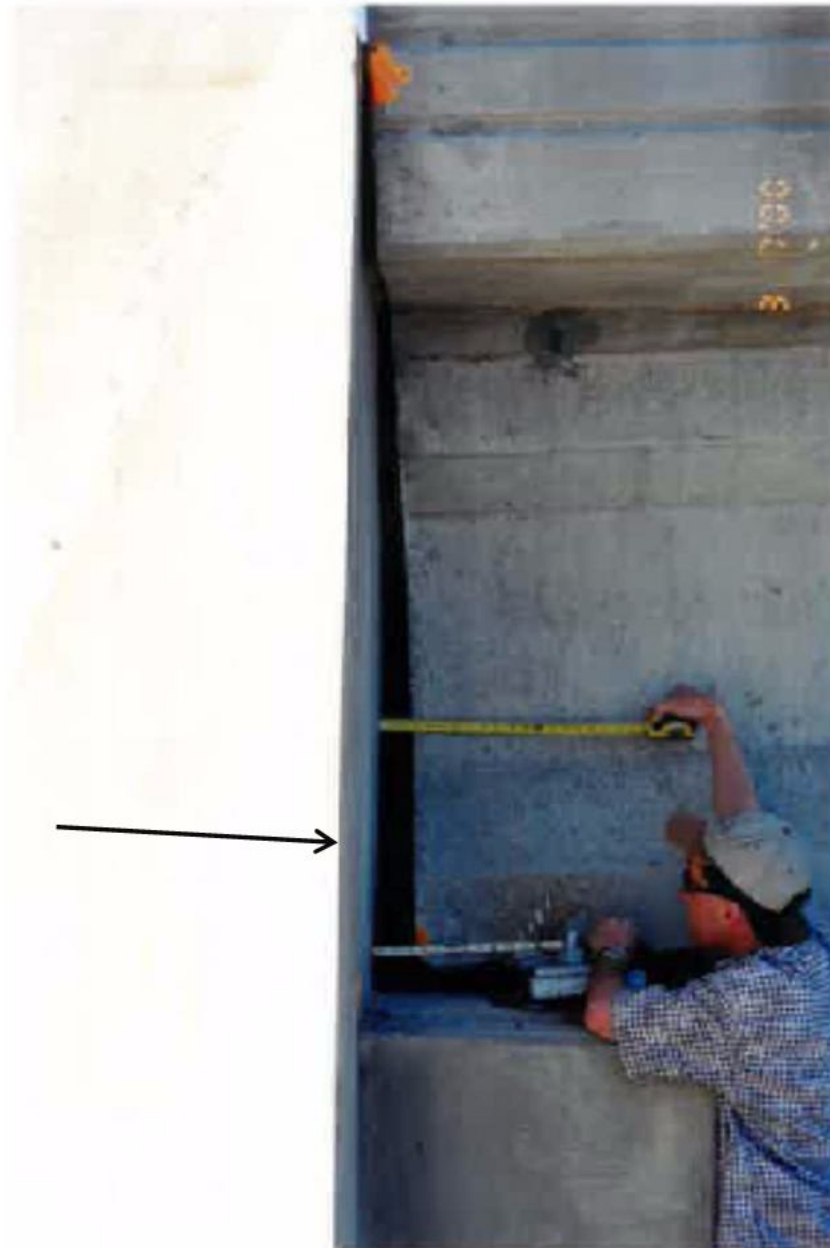
# Rotation of Back Wall

Displacement relative  
to girder

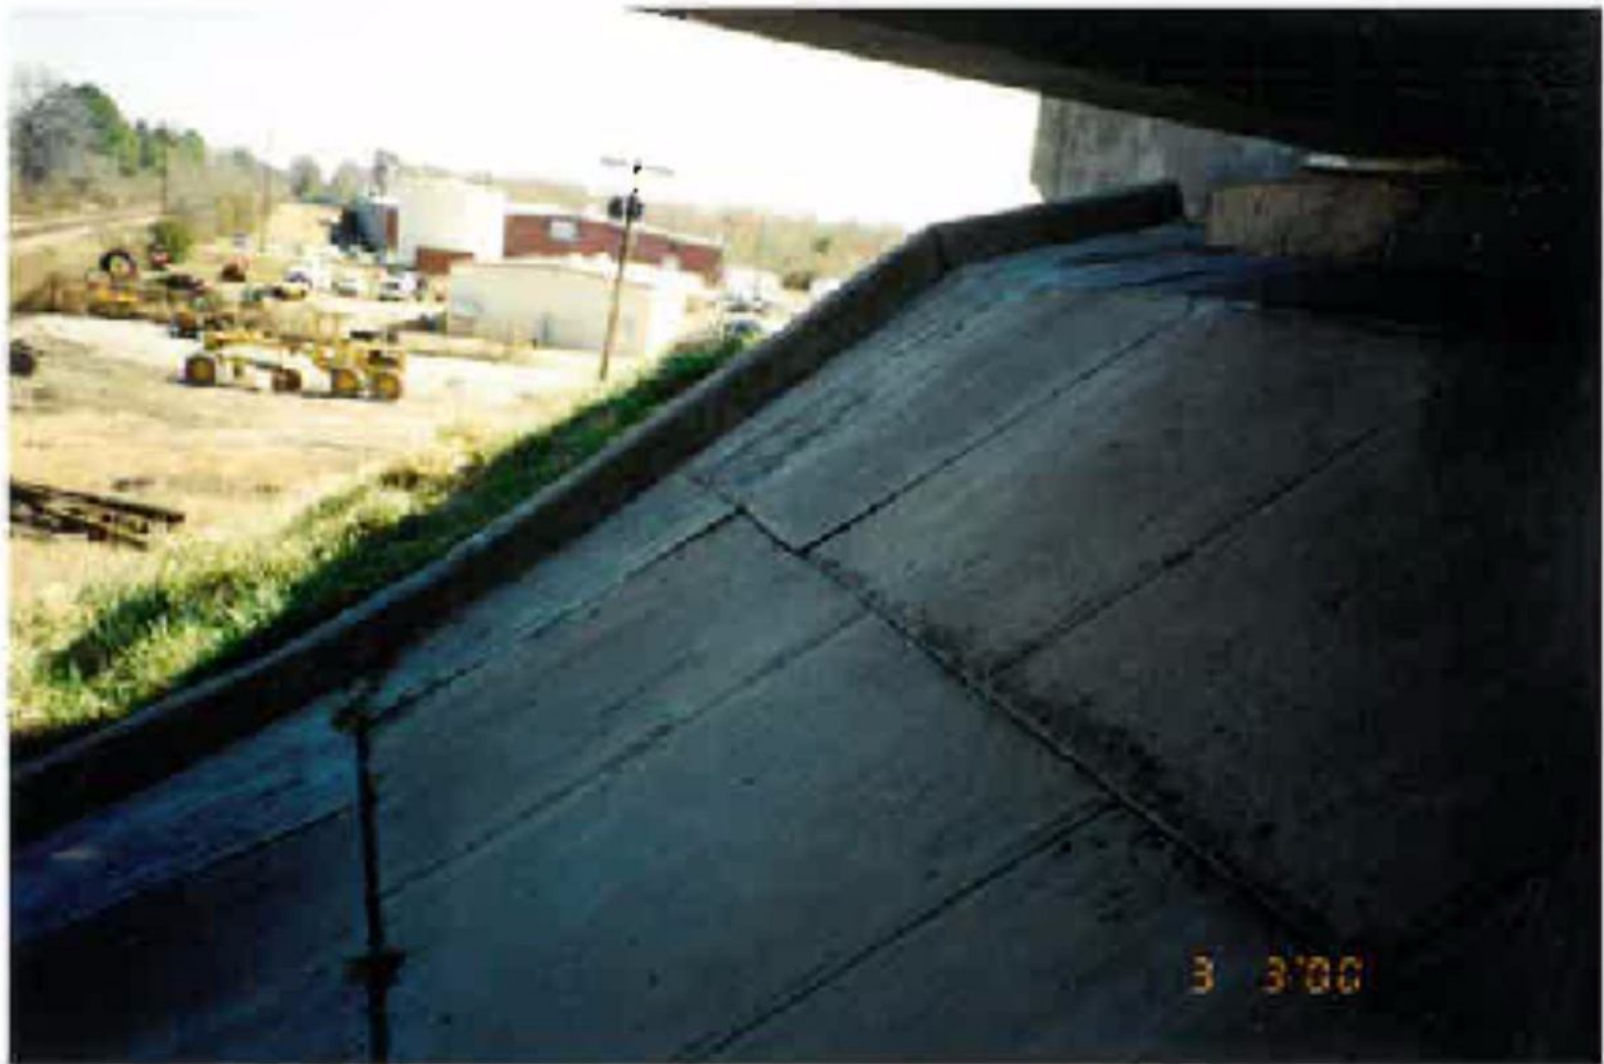
# Buckling of Slope Protection

- Slope indicators showed considerable lateral movement
- Joint displacements of 4 to 6 inches between the slope protection and abutment stem plus abutment tilting
- FHWA rule of thumb criteria exceeded for lateral squeeze (embankment pressure greater than 3 x undrained strength)

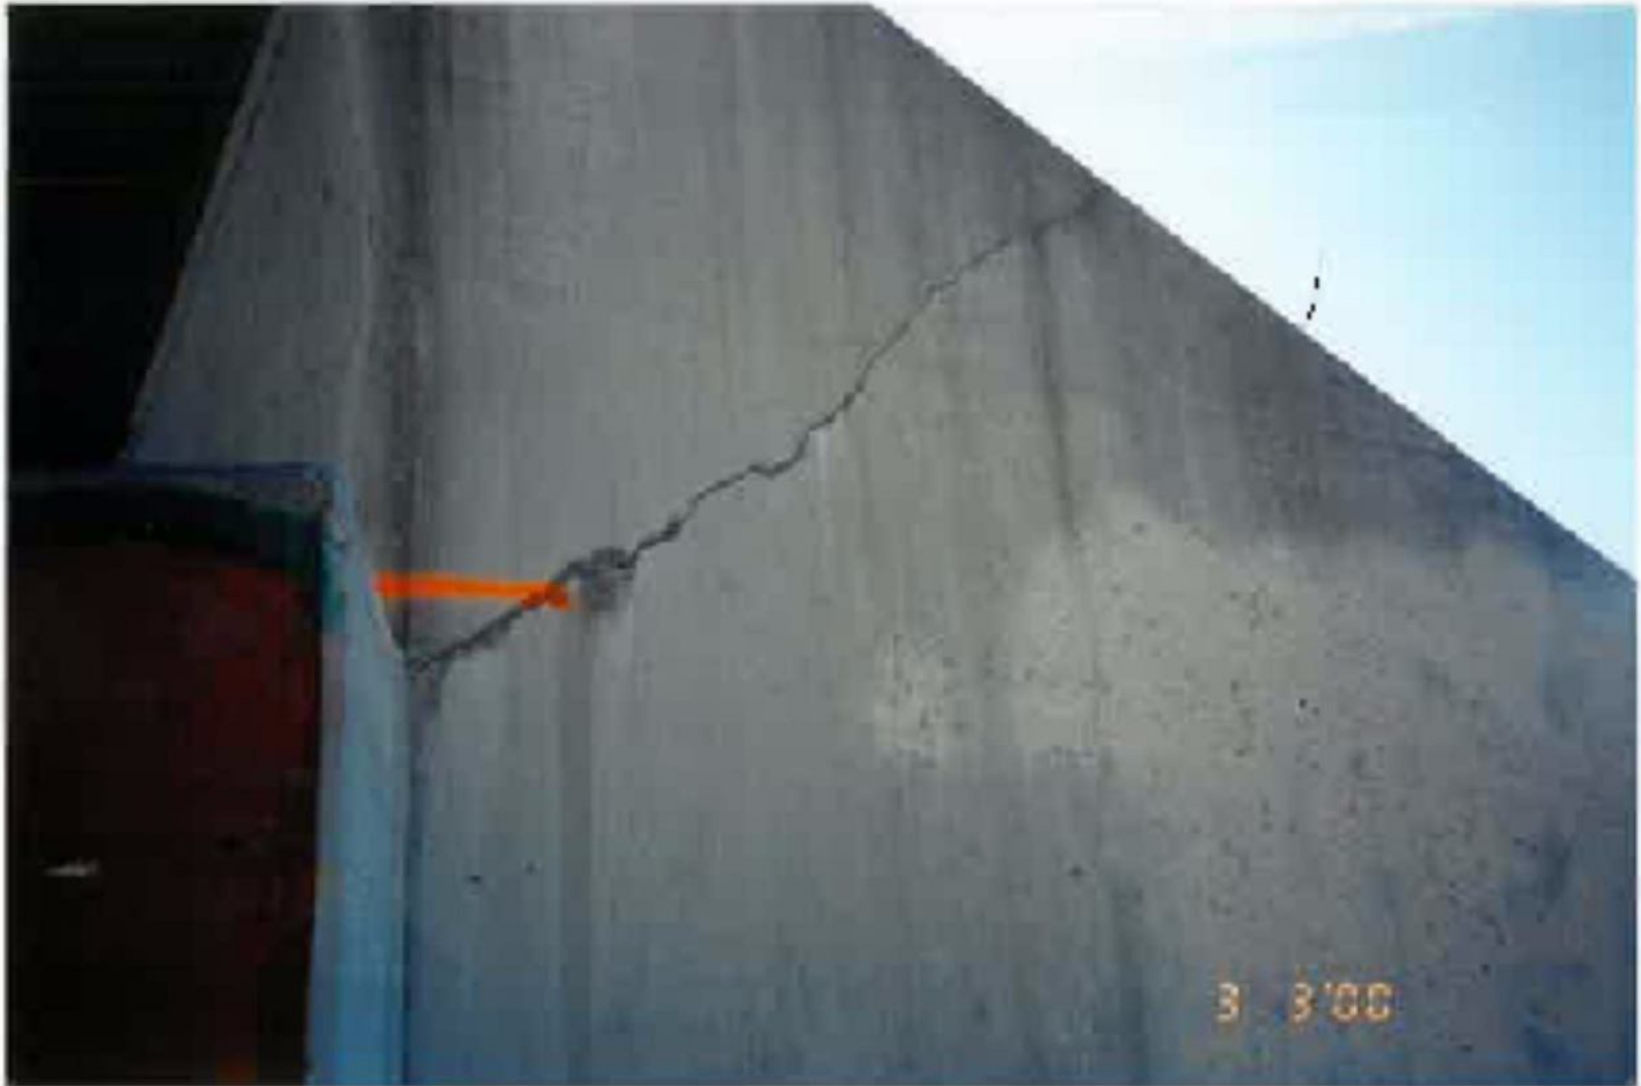
# Diagonal Crack in Wing Wall

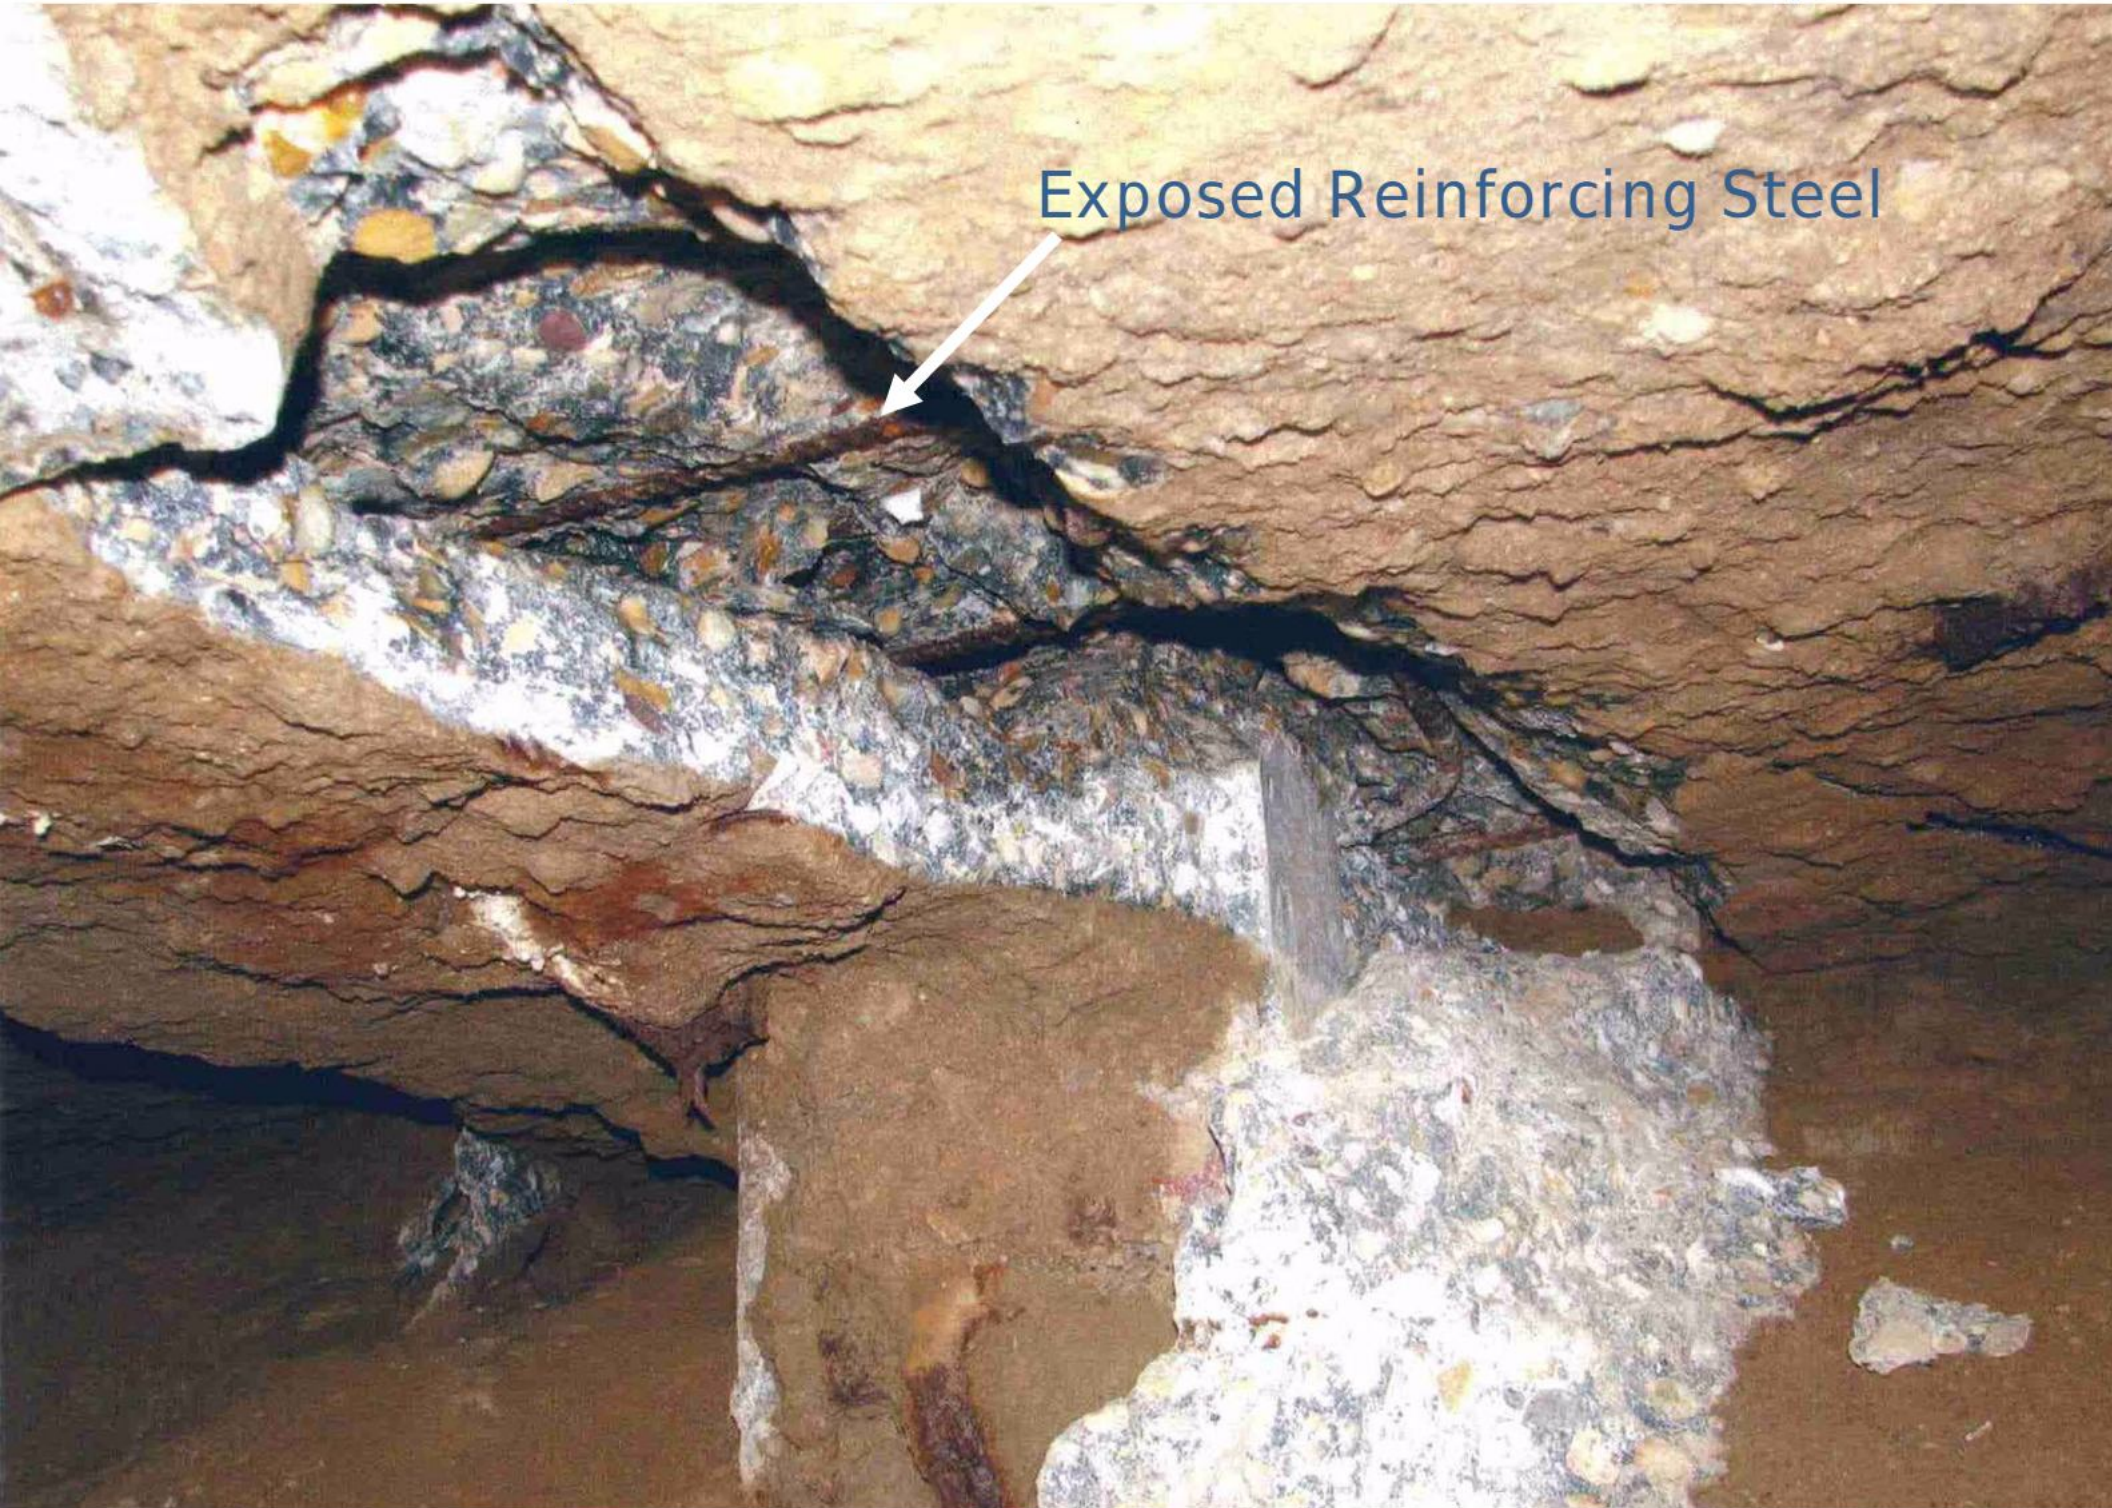
# Concrete Spalled/ Reinforcement Exposed

Exposed Reinforcing Steel

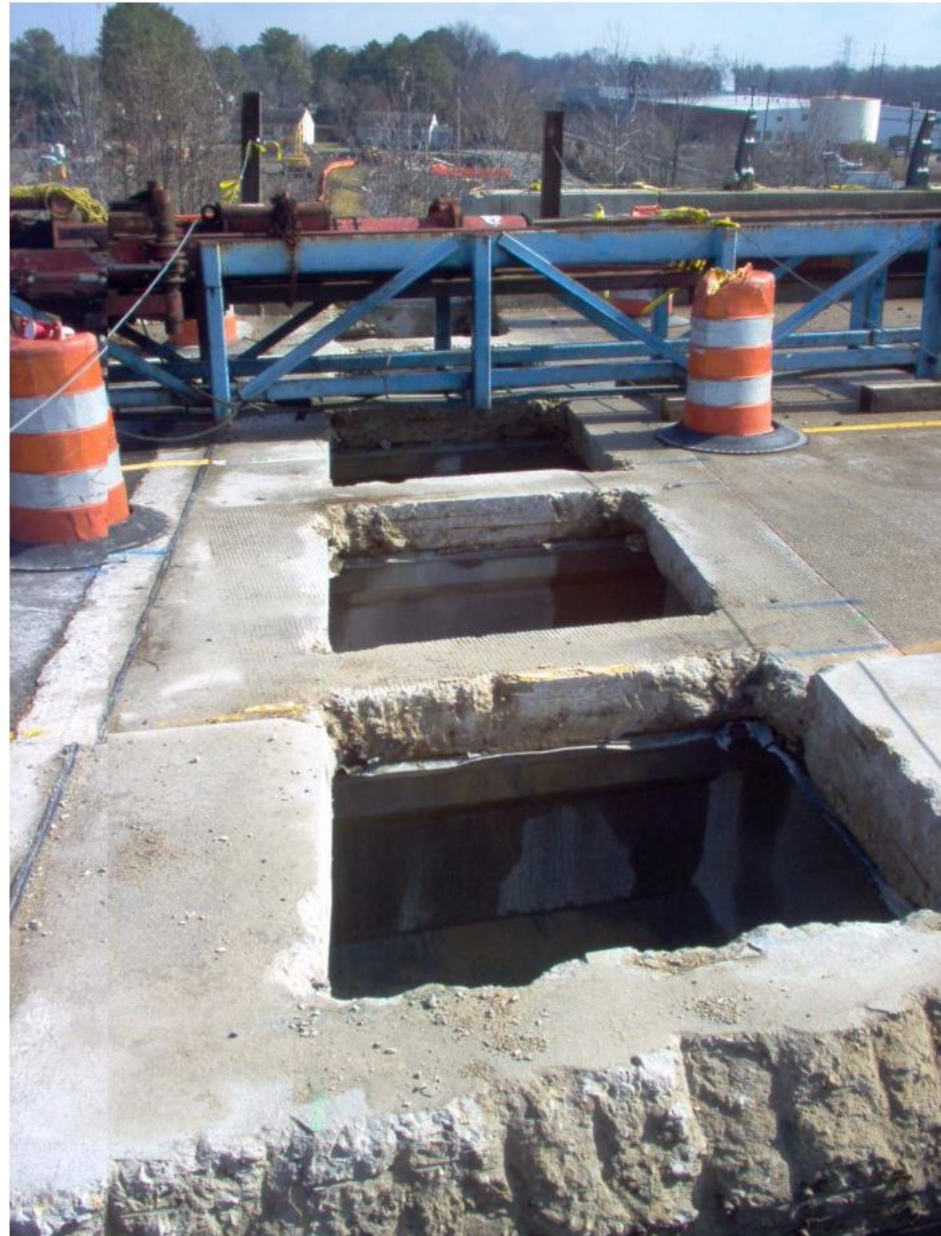
# Access Holes Cut Through Bridge Deck

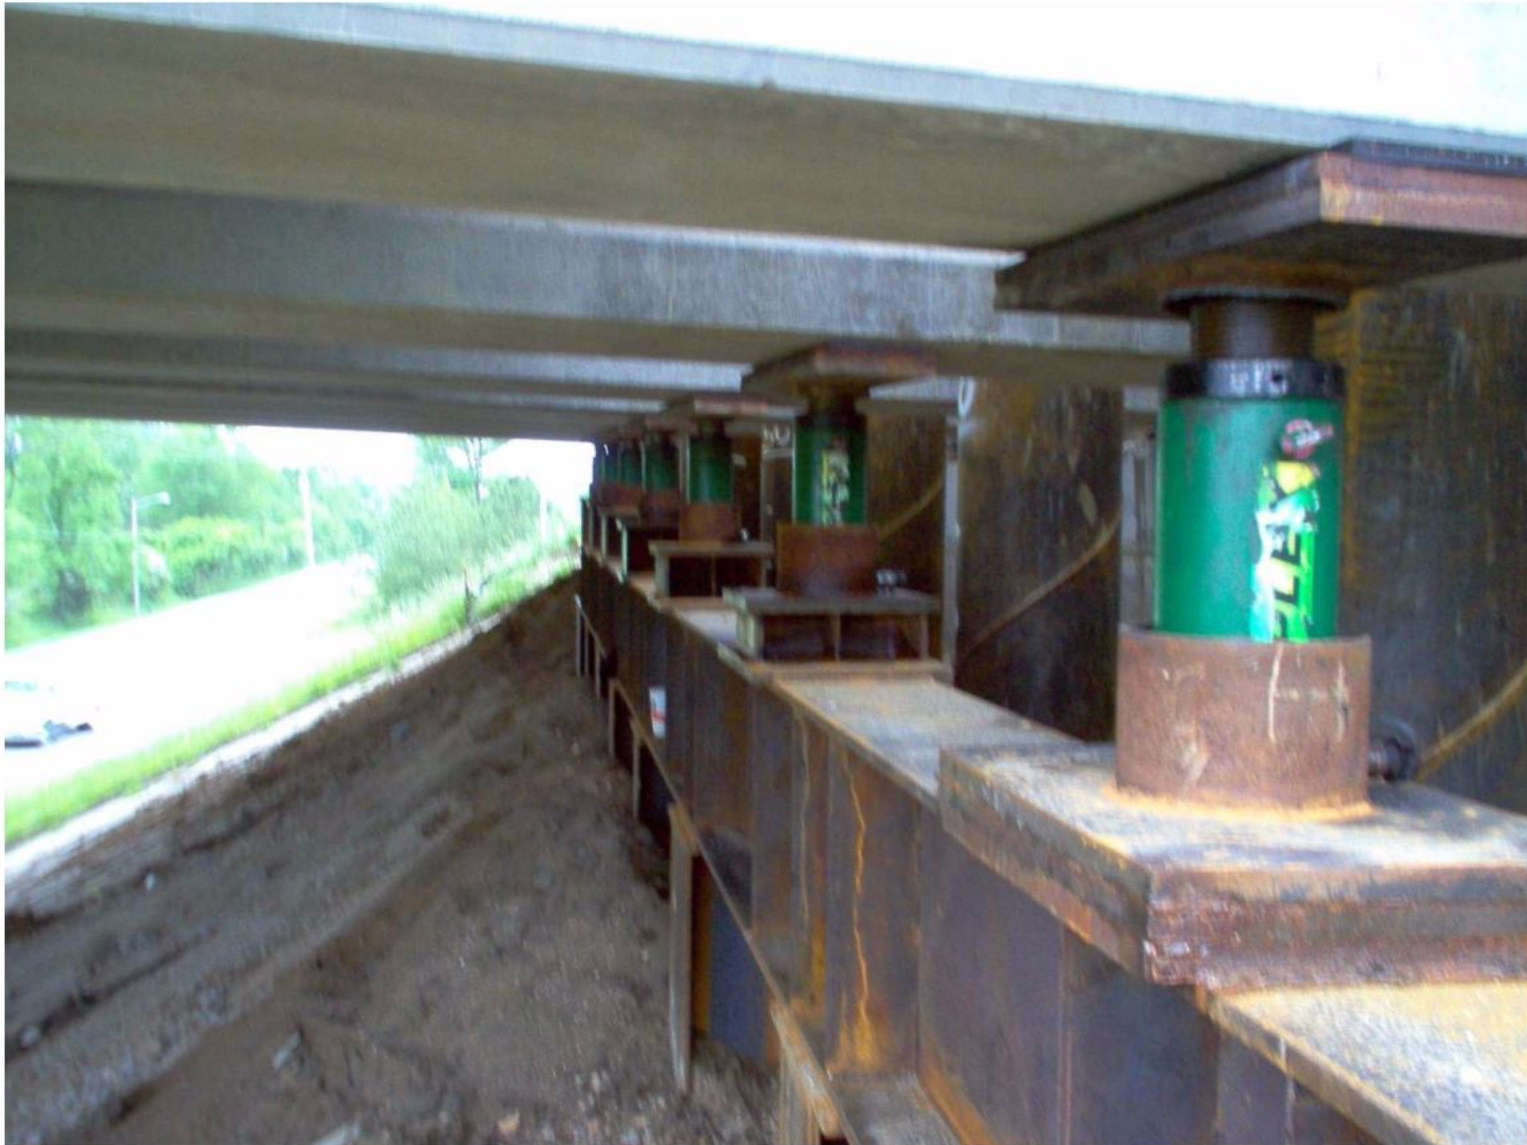
# Jacking Up End Span
