# Lessons Learned from a Bridge Abutment Failure

GeoVirginia 2015

# The Project - Bridge Overpass, Chesapeake, Virginia

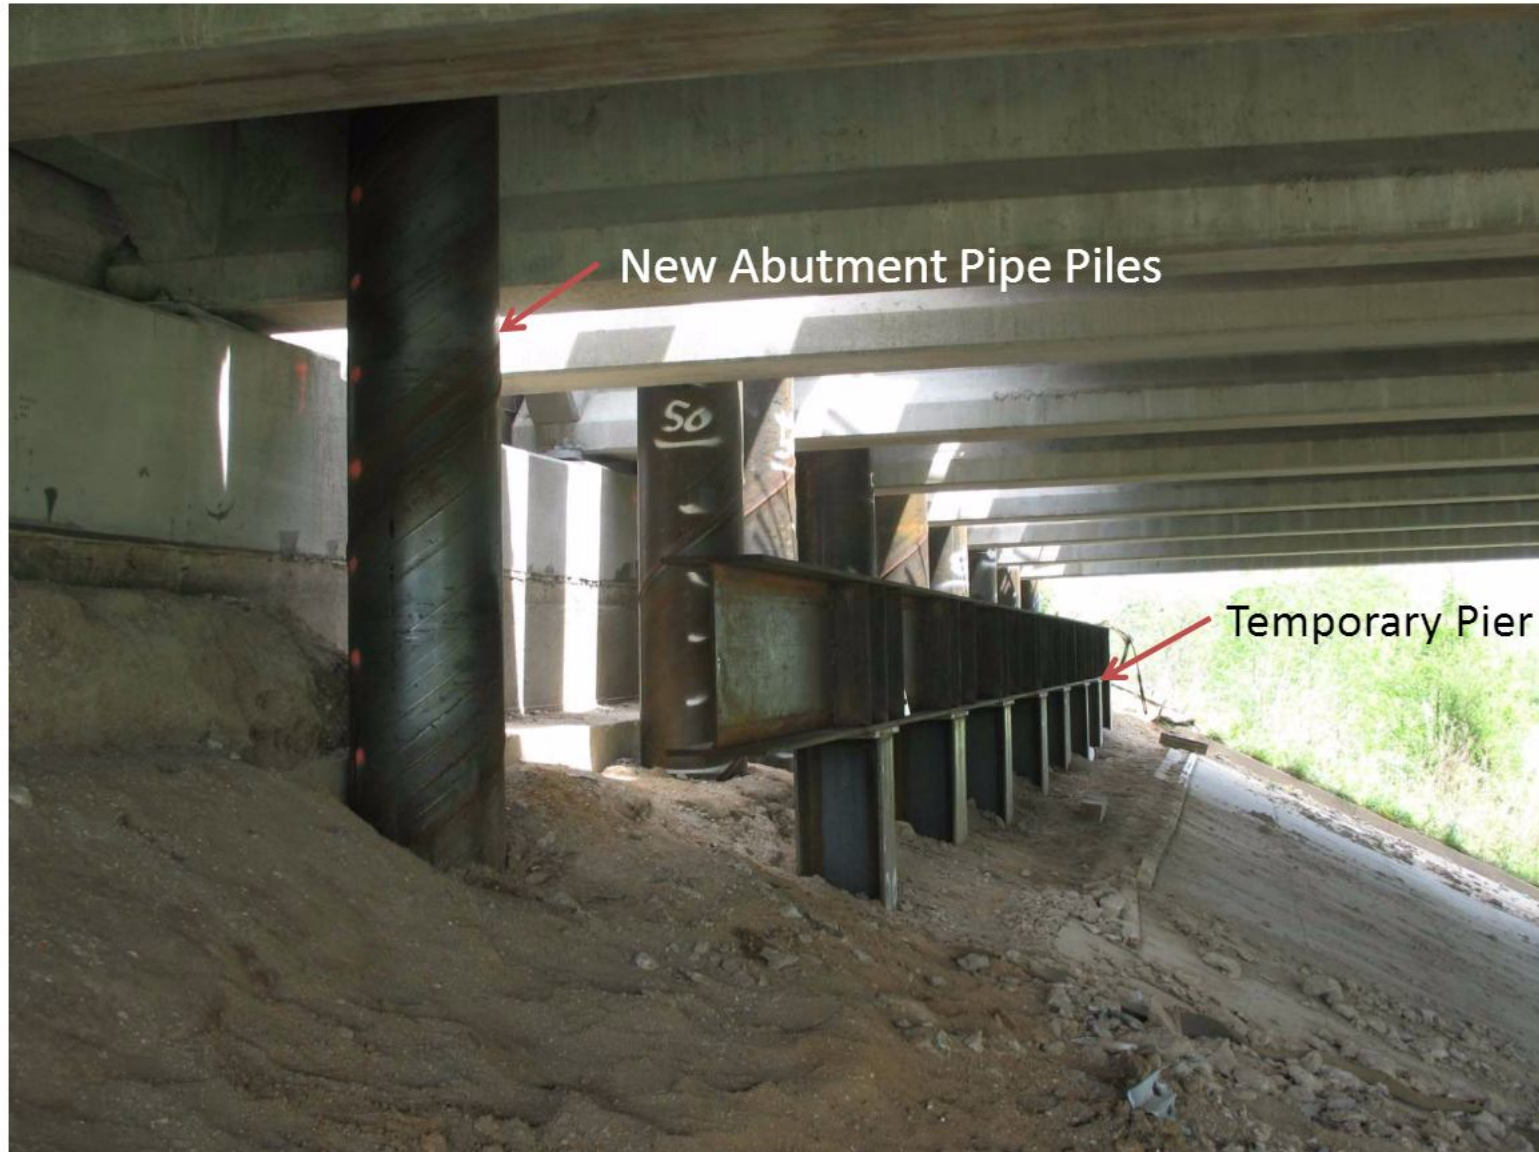
# Temporary Shoring

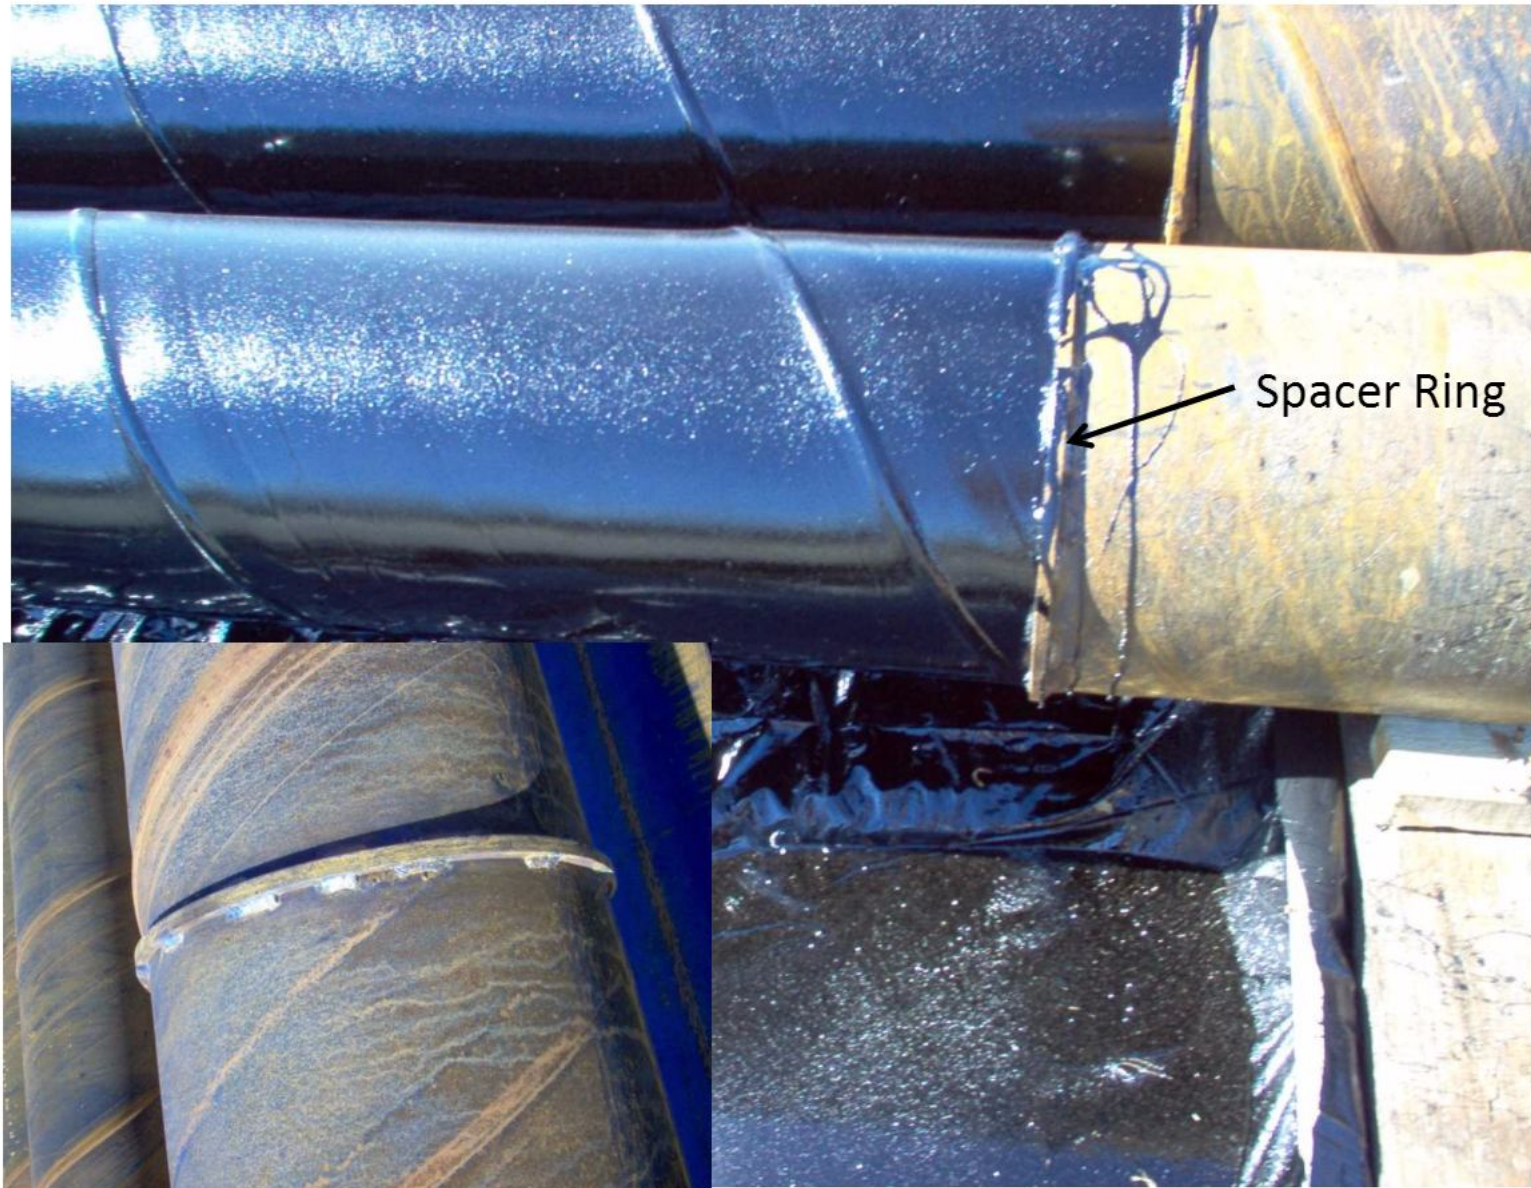
# Pipe Piles with Friction Reducer

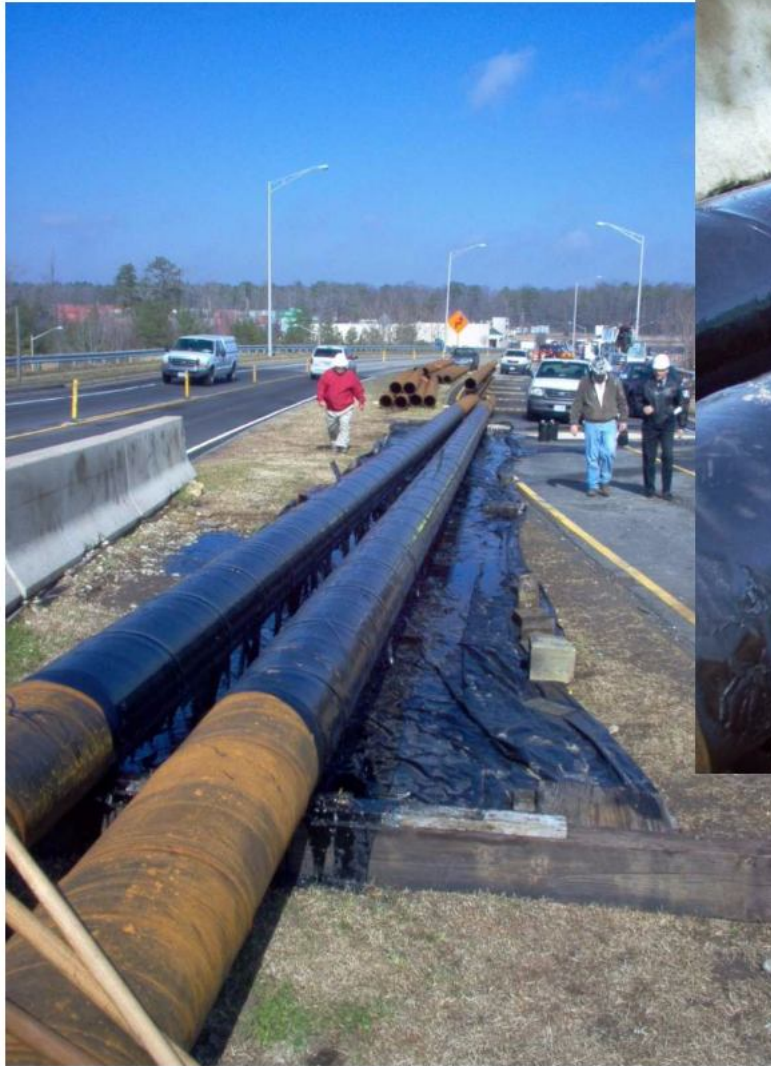
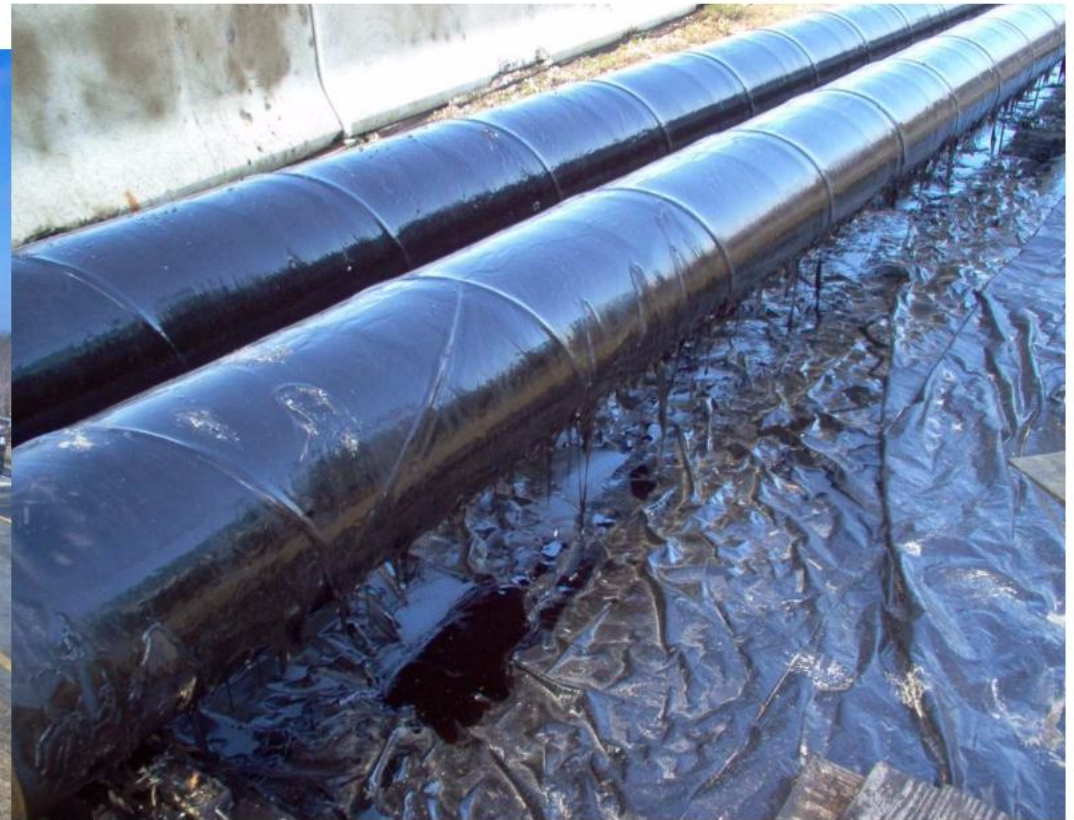
# Pile Coatings Applied

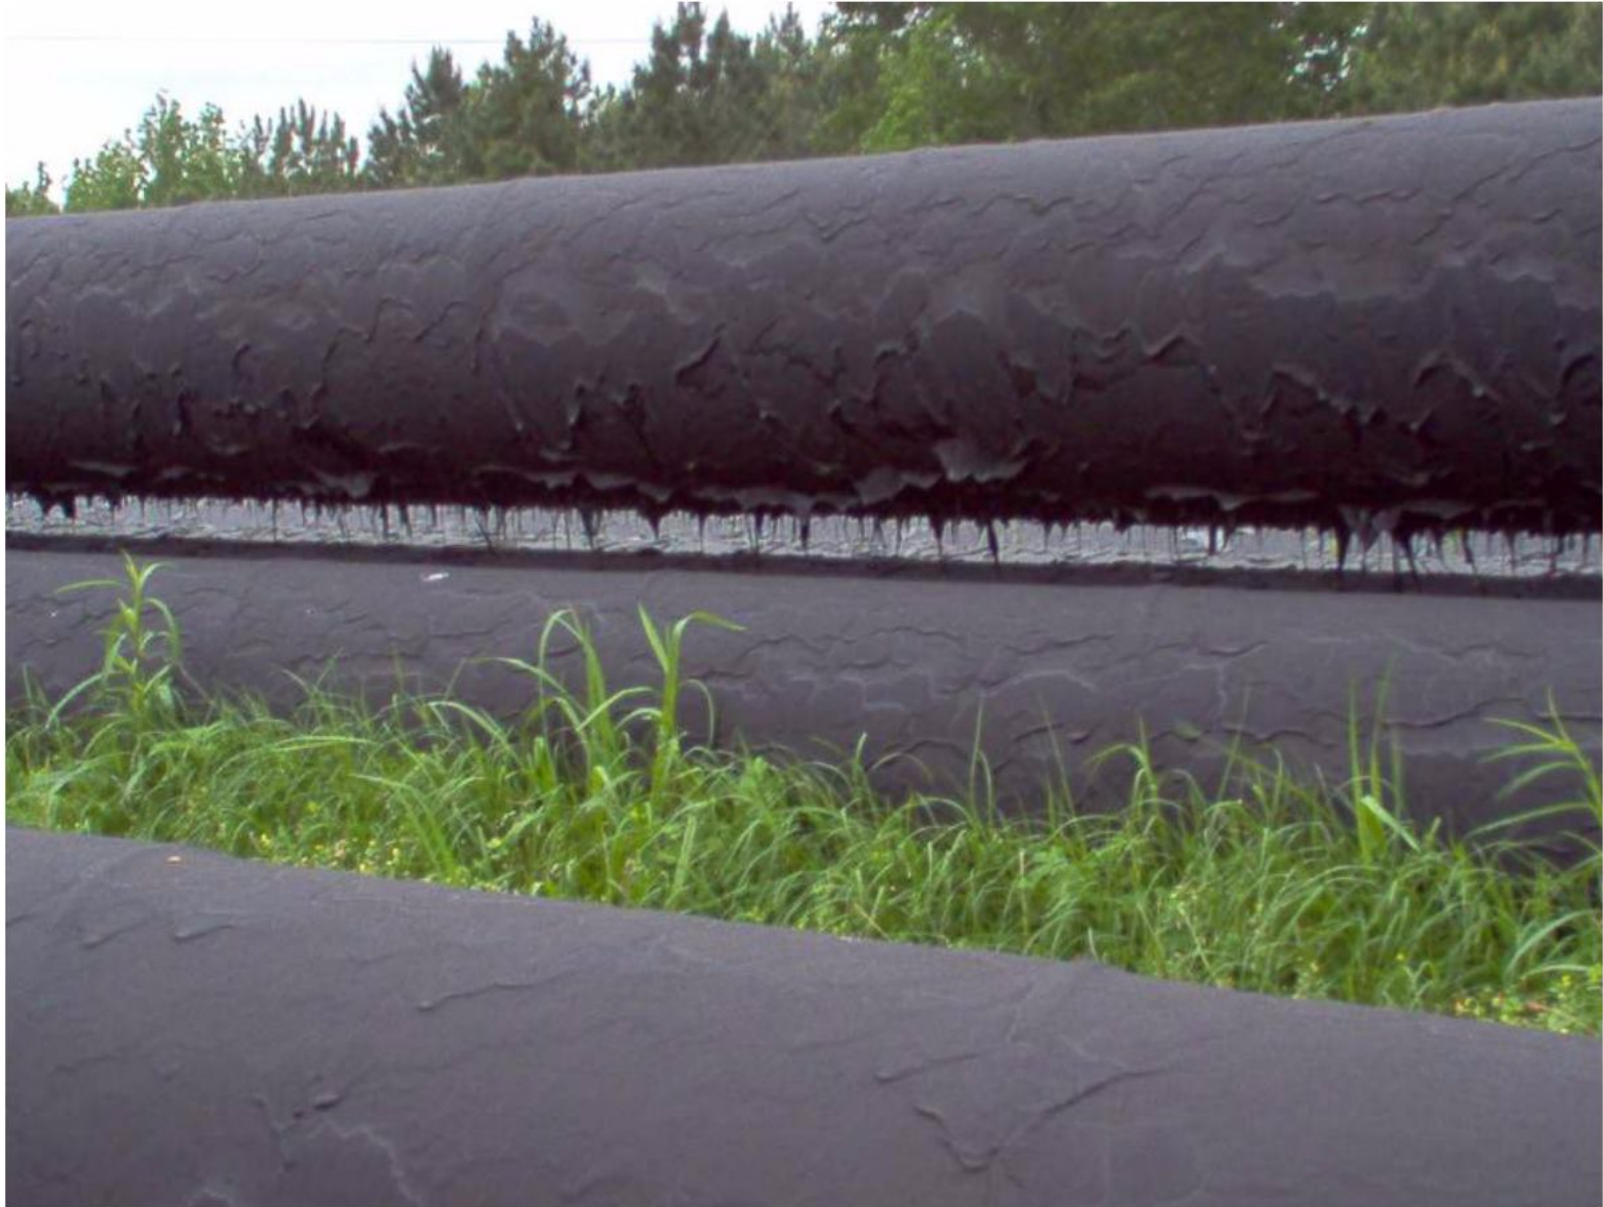
# Hardened Coatings on Piles

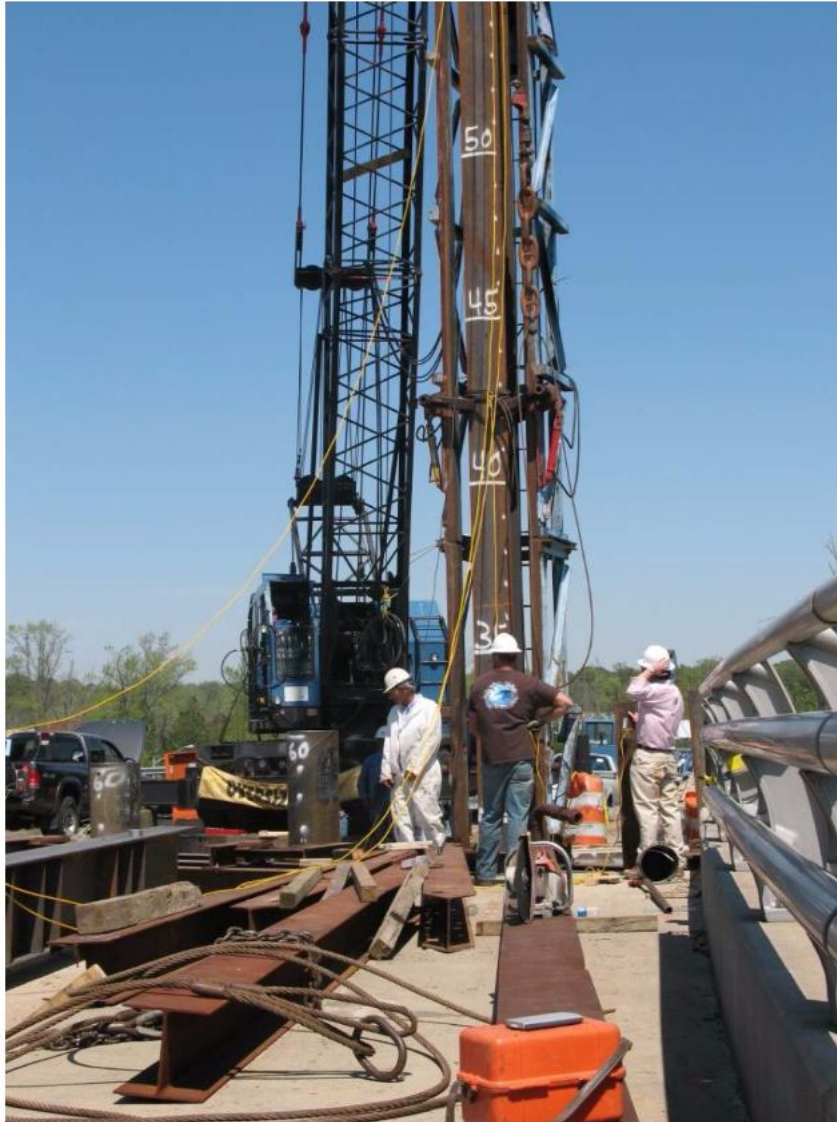
# Control Piles being Driven

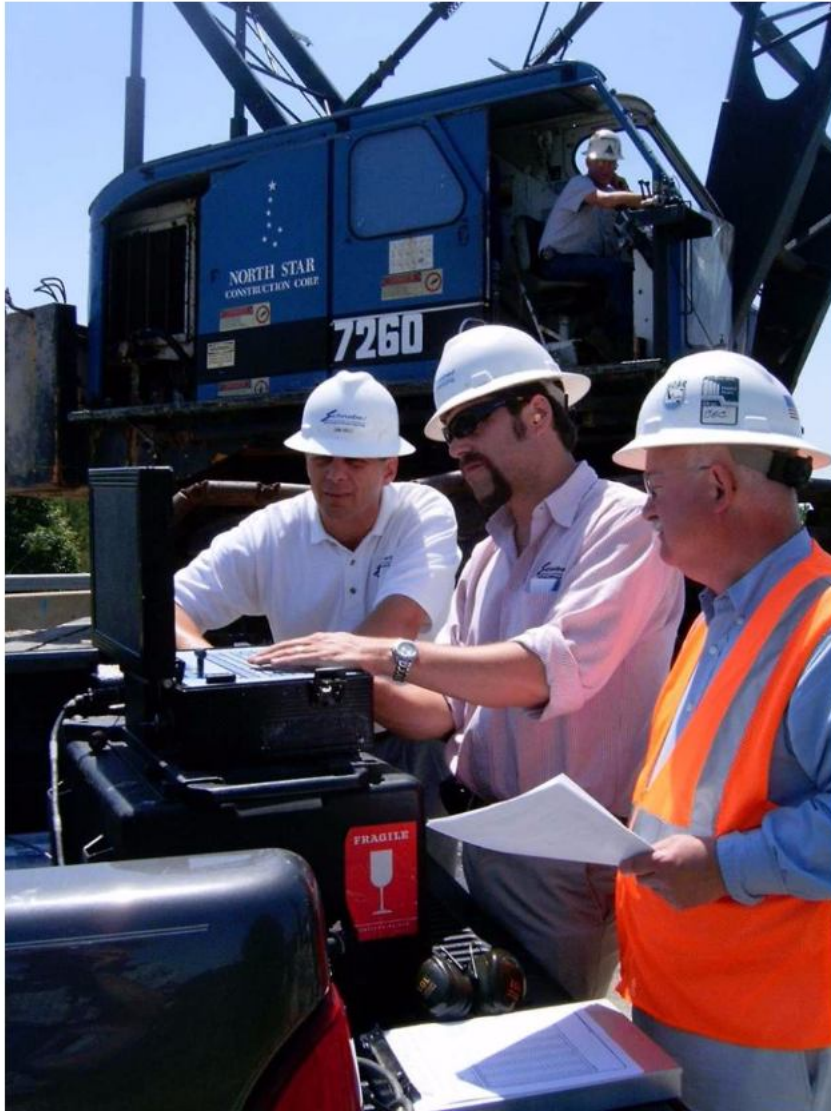
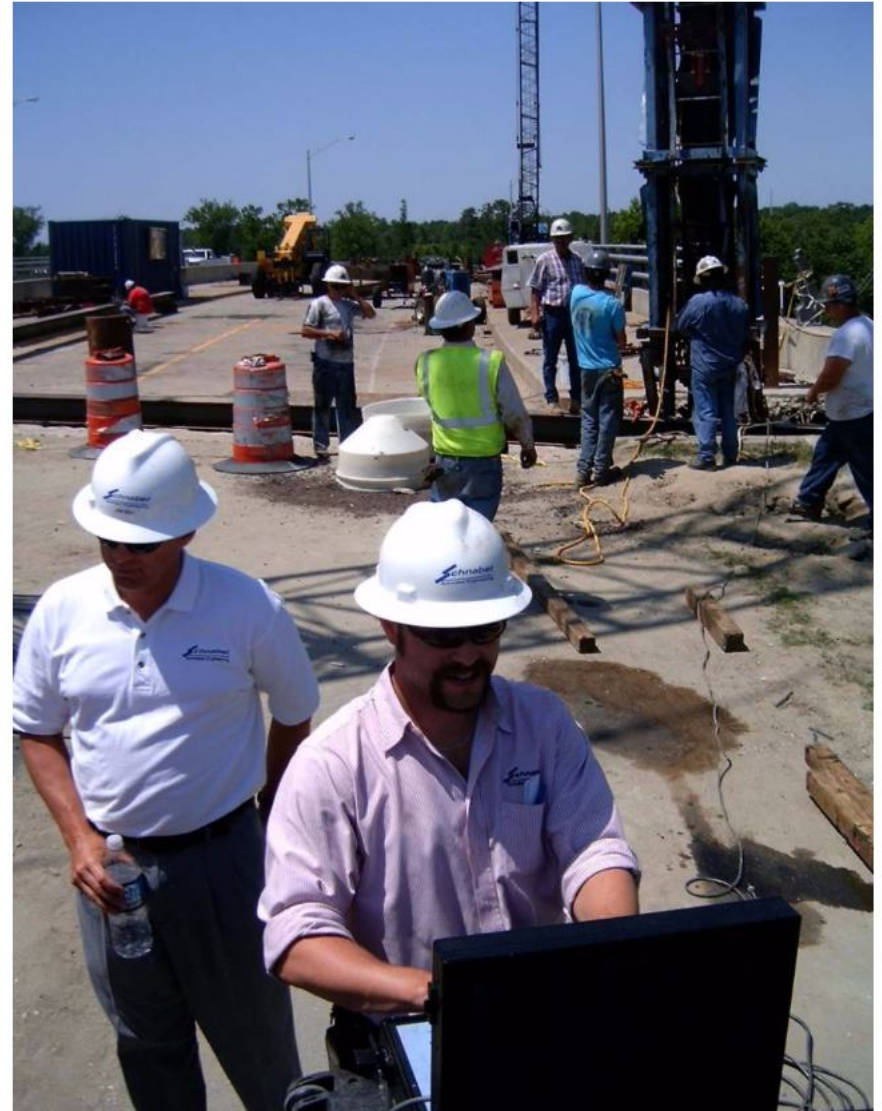
# PDA Testing

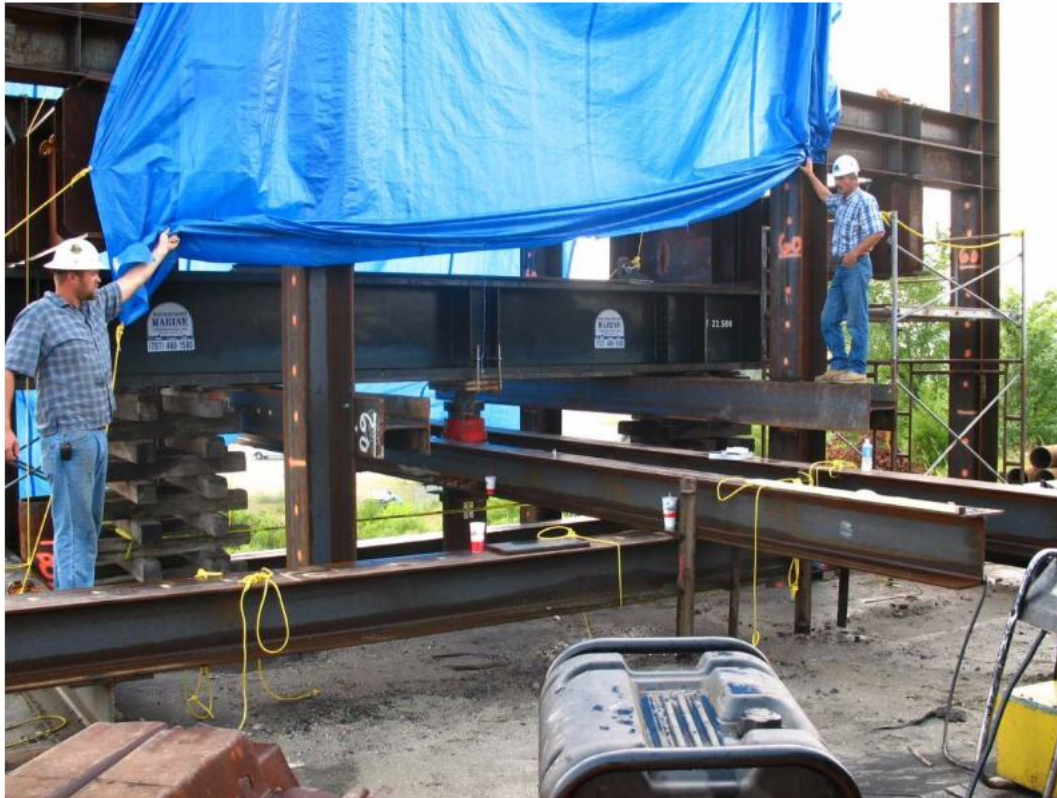
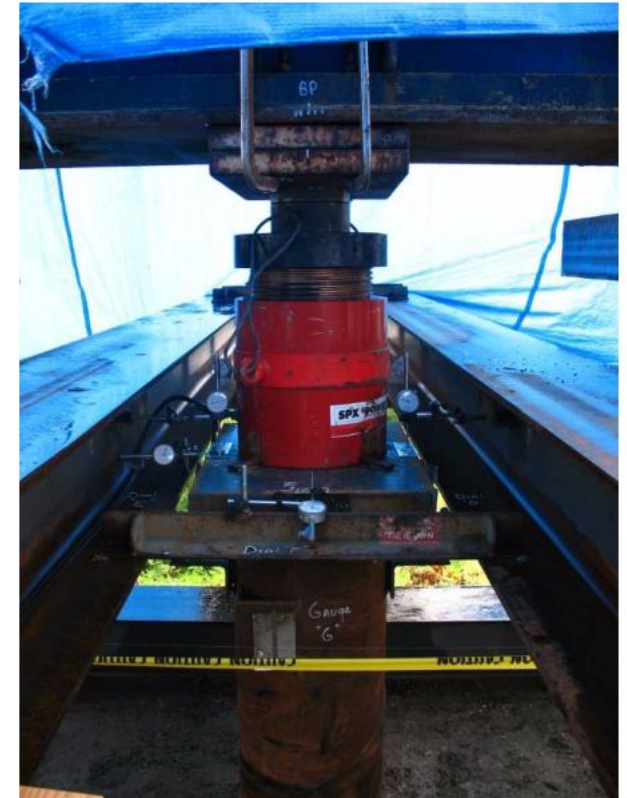
# Pile Load Test

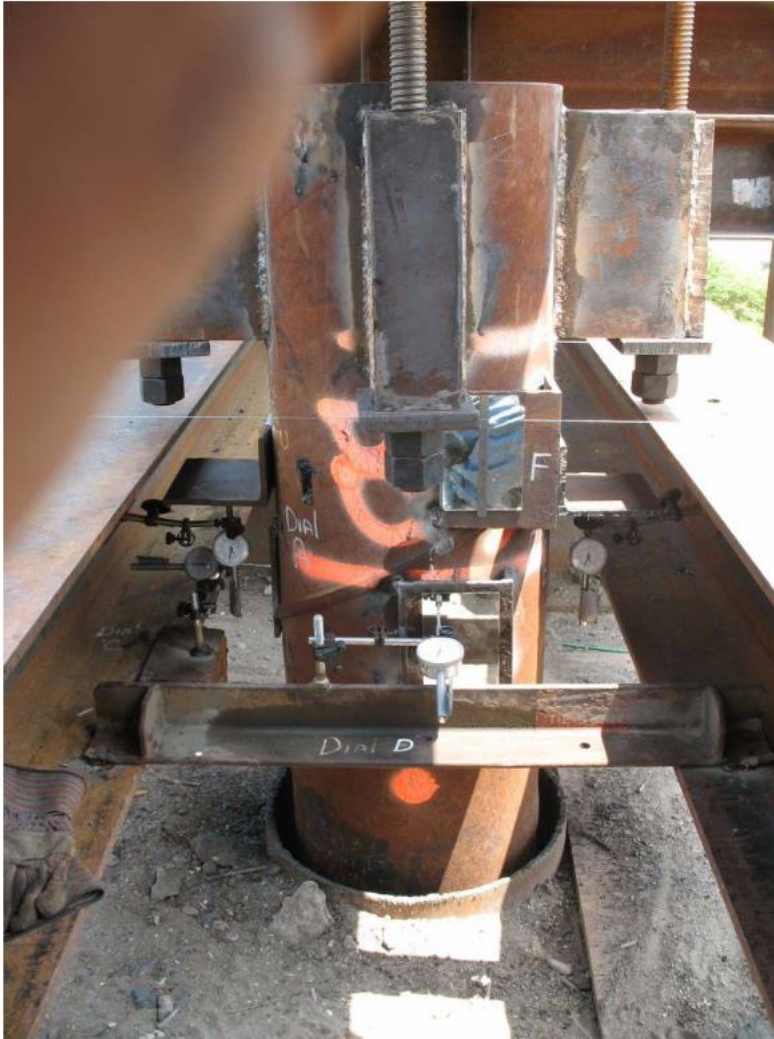
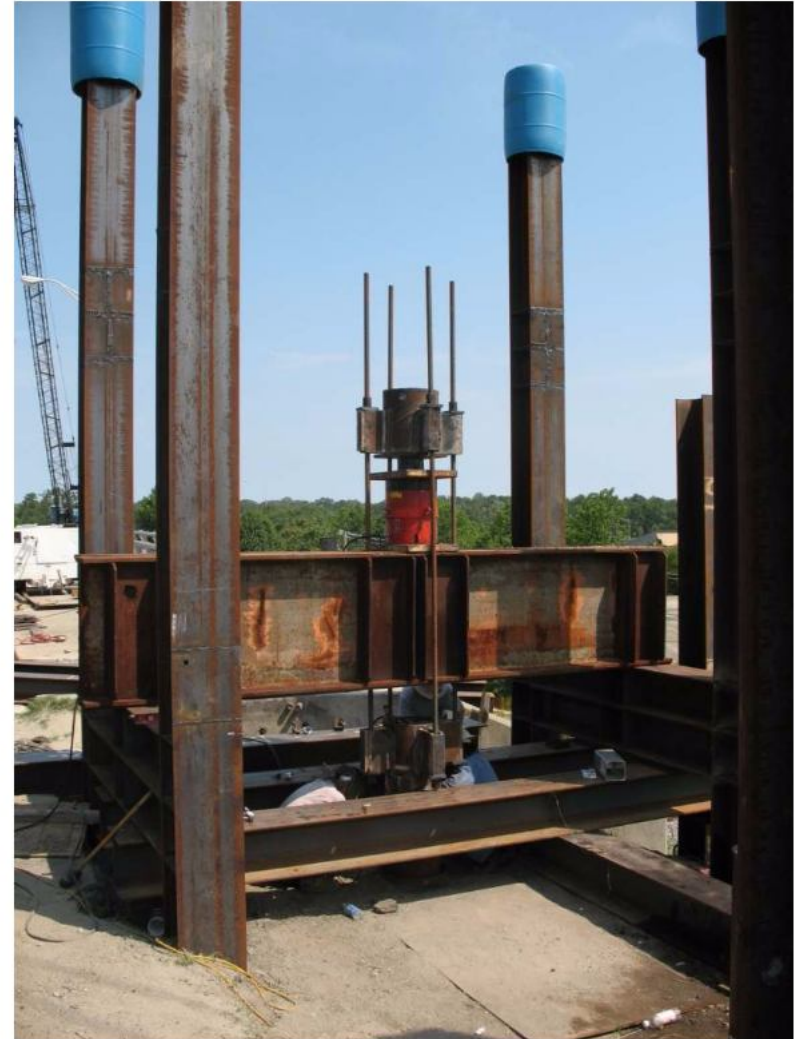
# Pullout Test Setup

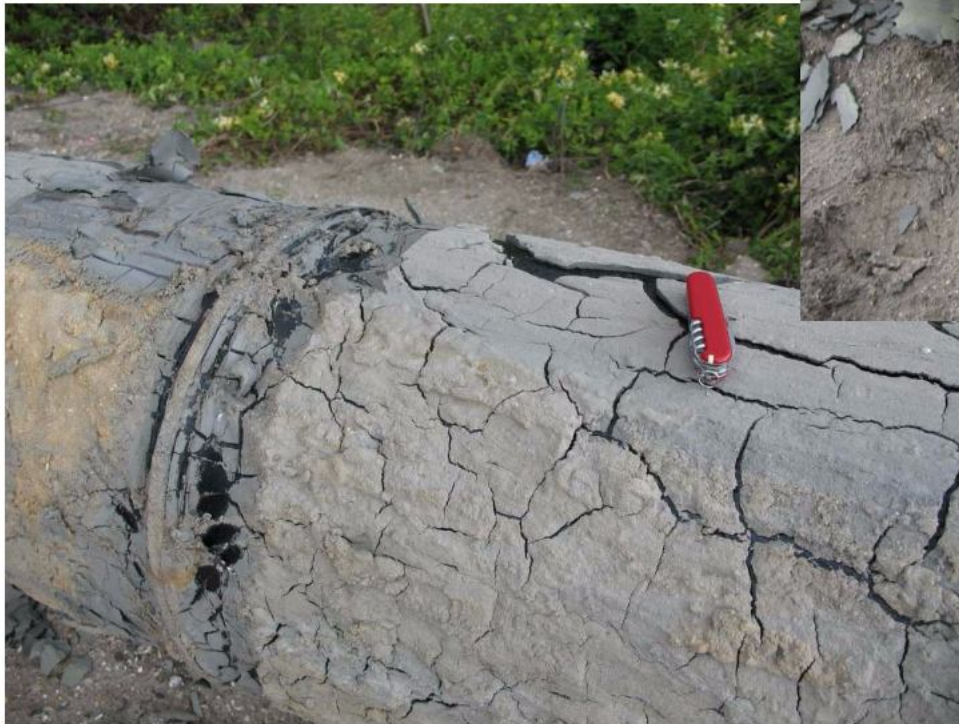
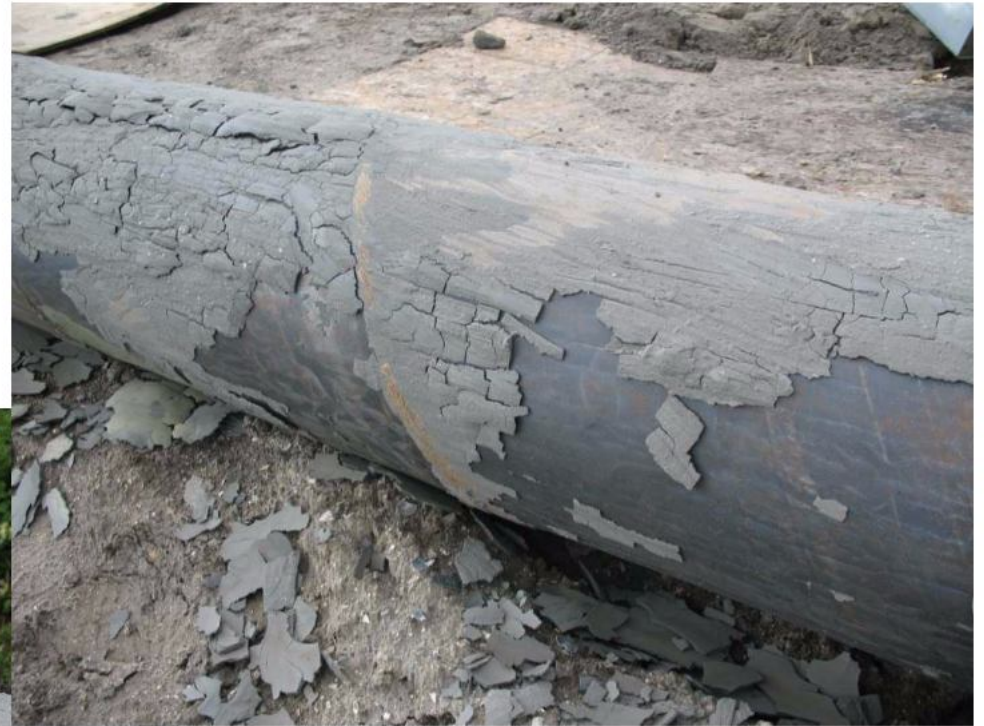
# Shear Failure Appears to be Mostly in Clay

- Observation of construction by people unqualified to do so is a formula for disaster.
- Using pile coatings to reduce pile friction may be dubious, particularly when you're trying to coat a cylinder.
- Don't argue with a contractor while standing above ground on a narrow beam.
- Don't crawl under failing structures (unless you're a bridge engineer).
