# Geotechnical Engineering Implications from Recent Worldwide Earthquakes

James R. Martin (jrm@vt.edu)

Professor, Civil & Environmental Engineering, Virginia Tech  
Director, Disaster Risk Management at Virginia Tech (DRM-VT)

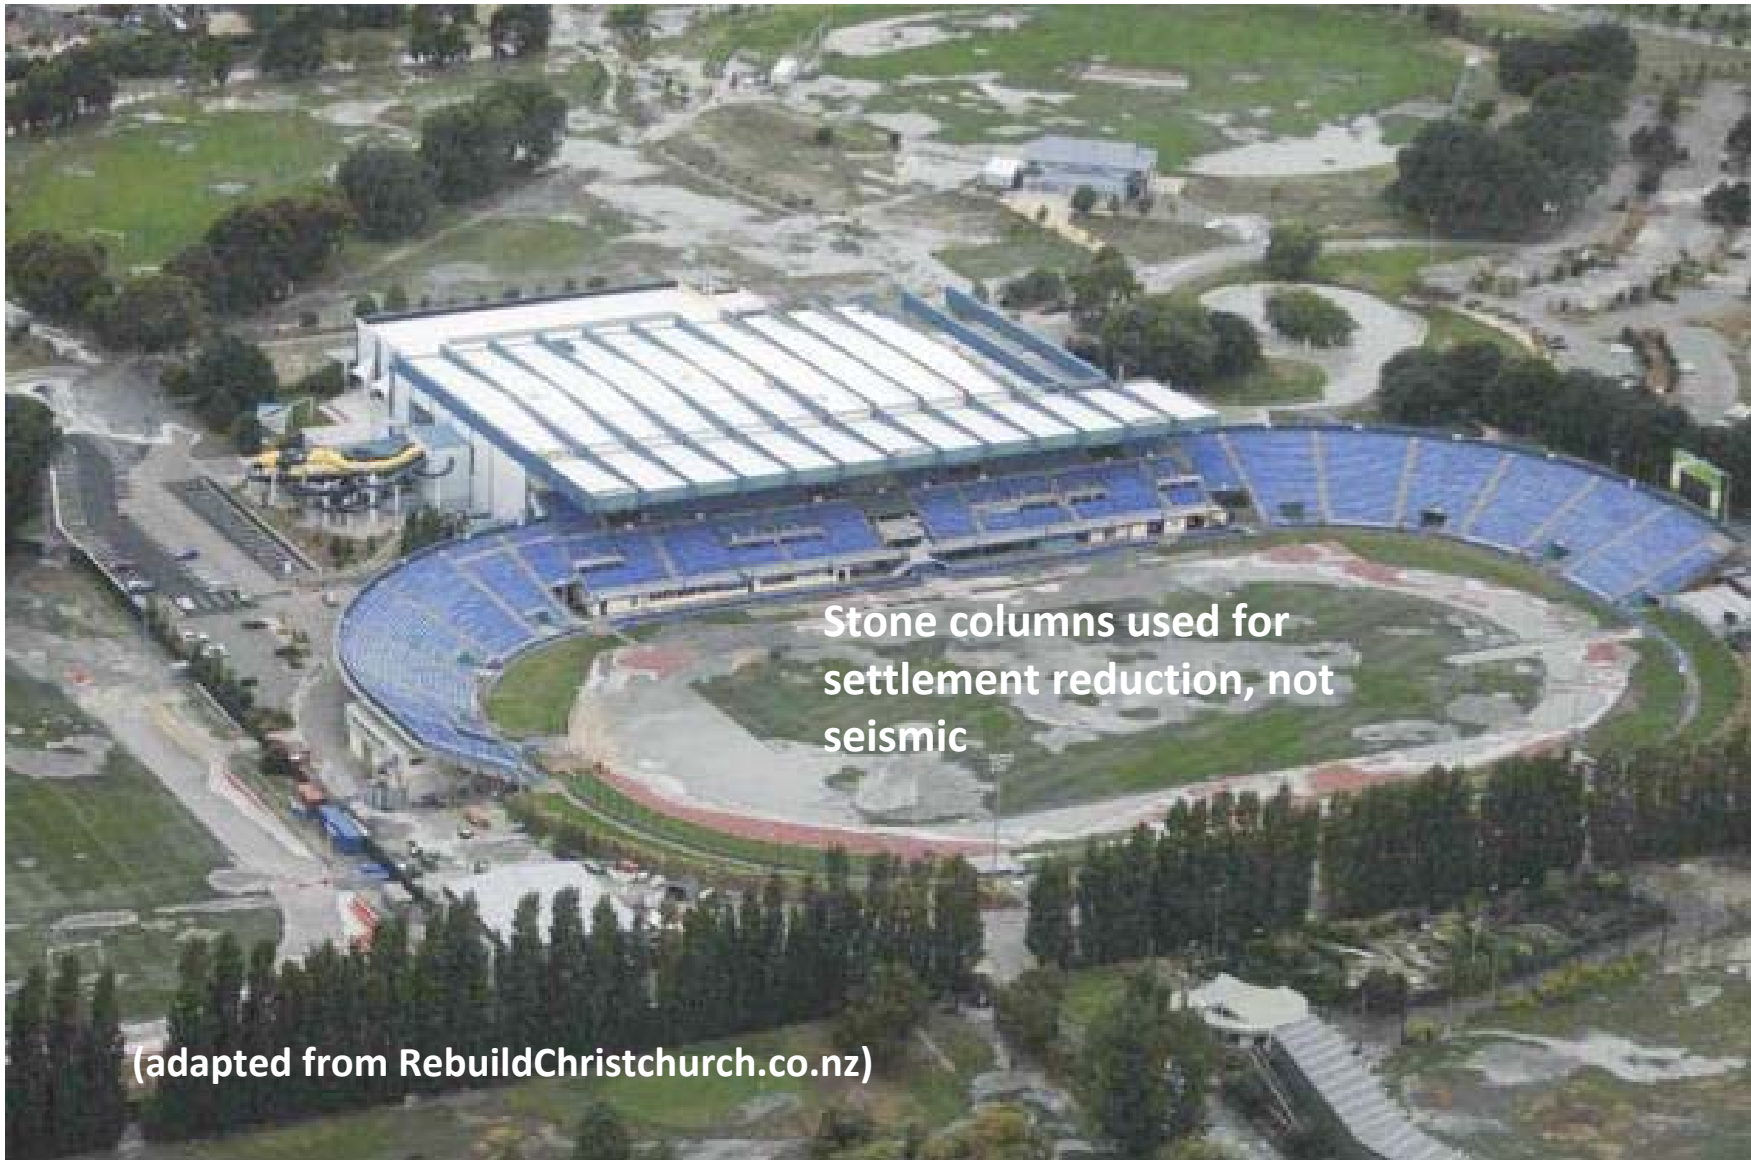
# Liquefaction: 2011 M6.3 Christchurch - QEII Stadium

Stone columns used for  
settlement reduction, not  
seismic

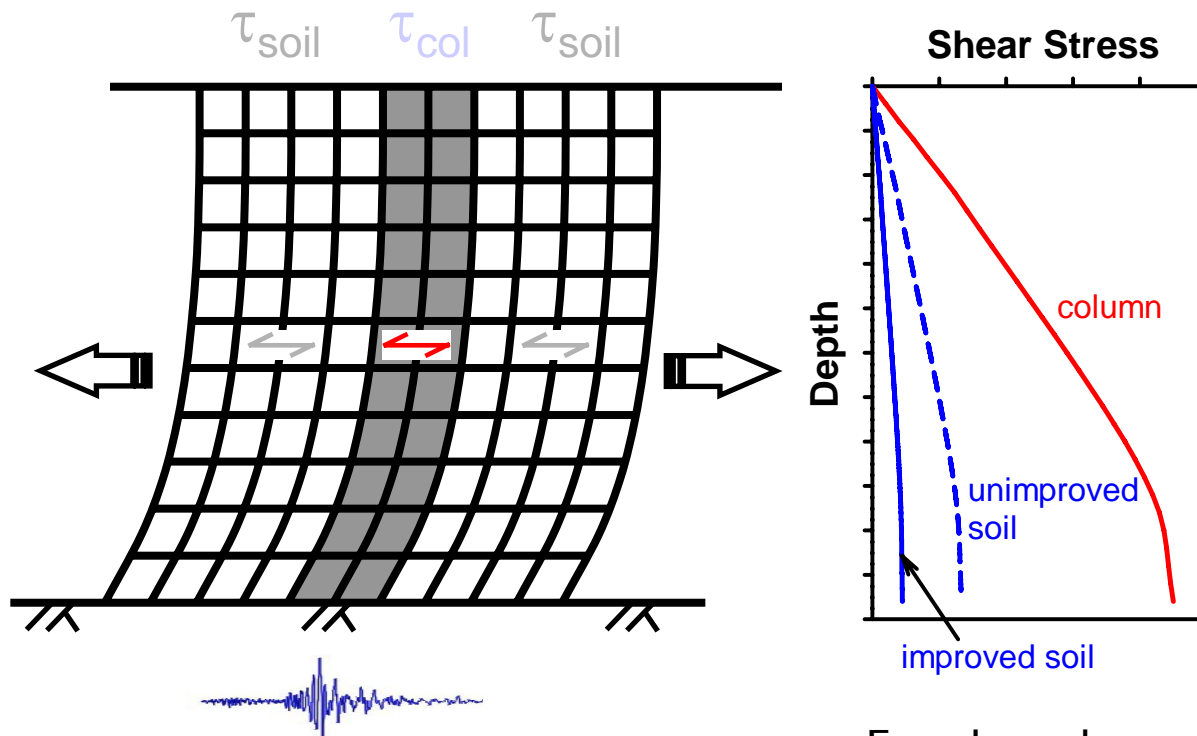
# Shear Stress Reduction

- Column assumed to deform as a shear beam
- $\tau_{\text{column}}/\tau_{\text{soil}} = G_{\text{column}}/G_{\text{soil}}$

$$\text{CSR} = 0.65 \frac{\tau_{\text{max}}}{\sigma'_v} \frac{1}{\text{MSF}} r_d$$

$$\text{CSR}_{\text{treated}} = K_G \cdot \text{CSR}_{\text{untreated}}$$

- $G_{\text{column}}/G_{\text{soil}} = 10$
- Replacement ratio 20%
- 65% reduction in CSR

For shear beam behavior  $K_G < 1$

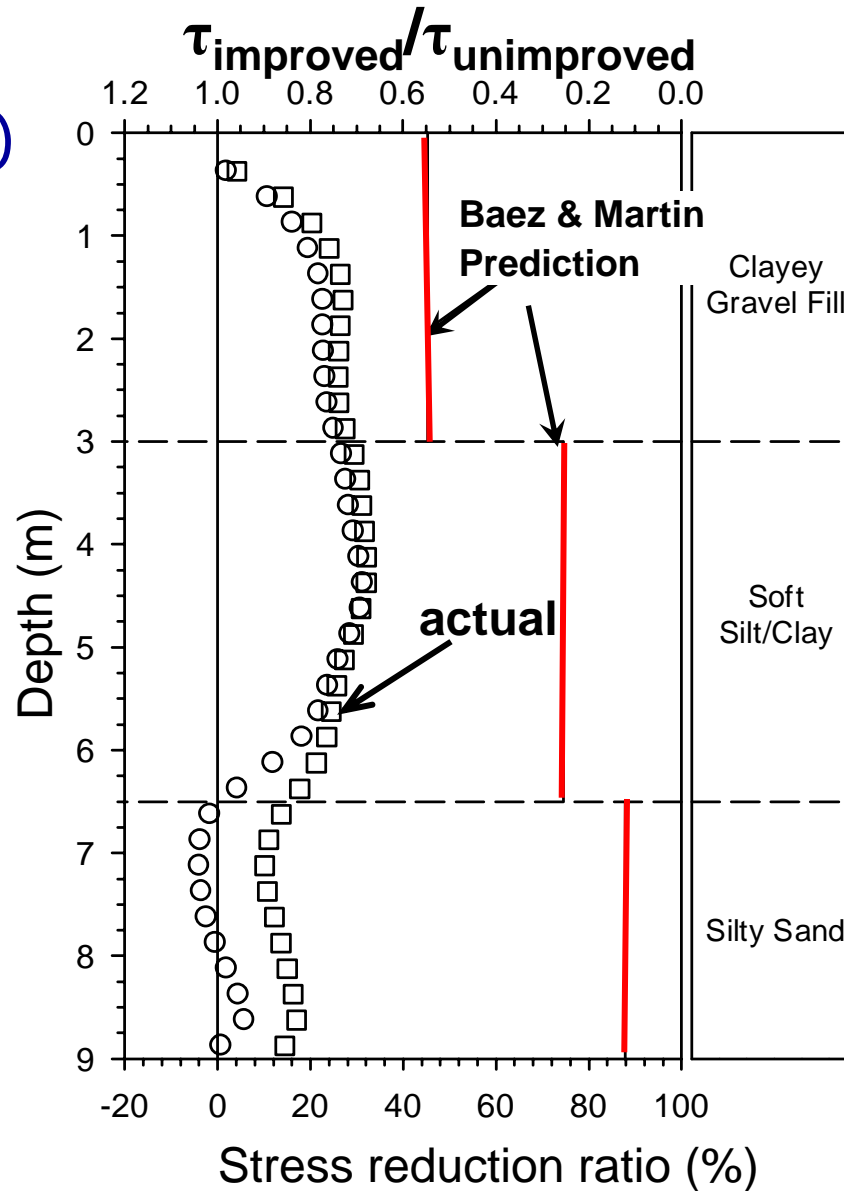
- Soil moves in pure shear, except near the column side and tips (i.e. end effects)
- Apparent flexural deformation of the stiff column within the soft ground - if column stiffer, then more flexure less shear
- Deformation mode of the column investigated in further detail
- Relative values of shear ( $\gamma$ ) and flexural ( $\theta$ ) deformations within the column

Result? Actual shear stress reduction much less than Baez and Martin (1994) Predict:

- $\tau_{zx}$  and  $\tau_{zy}$  for 3-D analysis shown

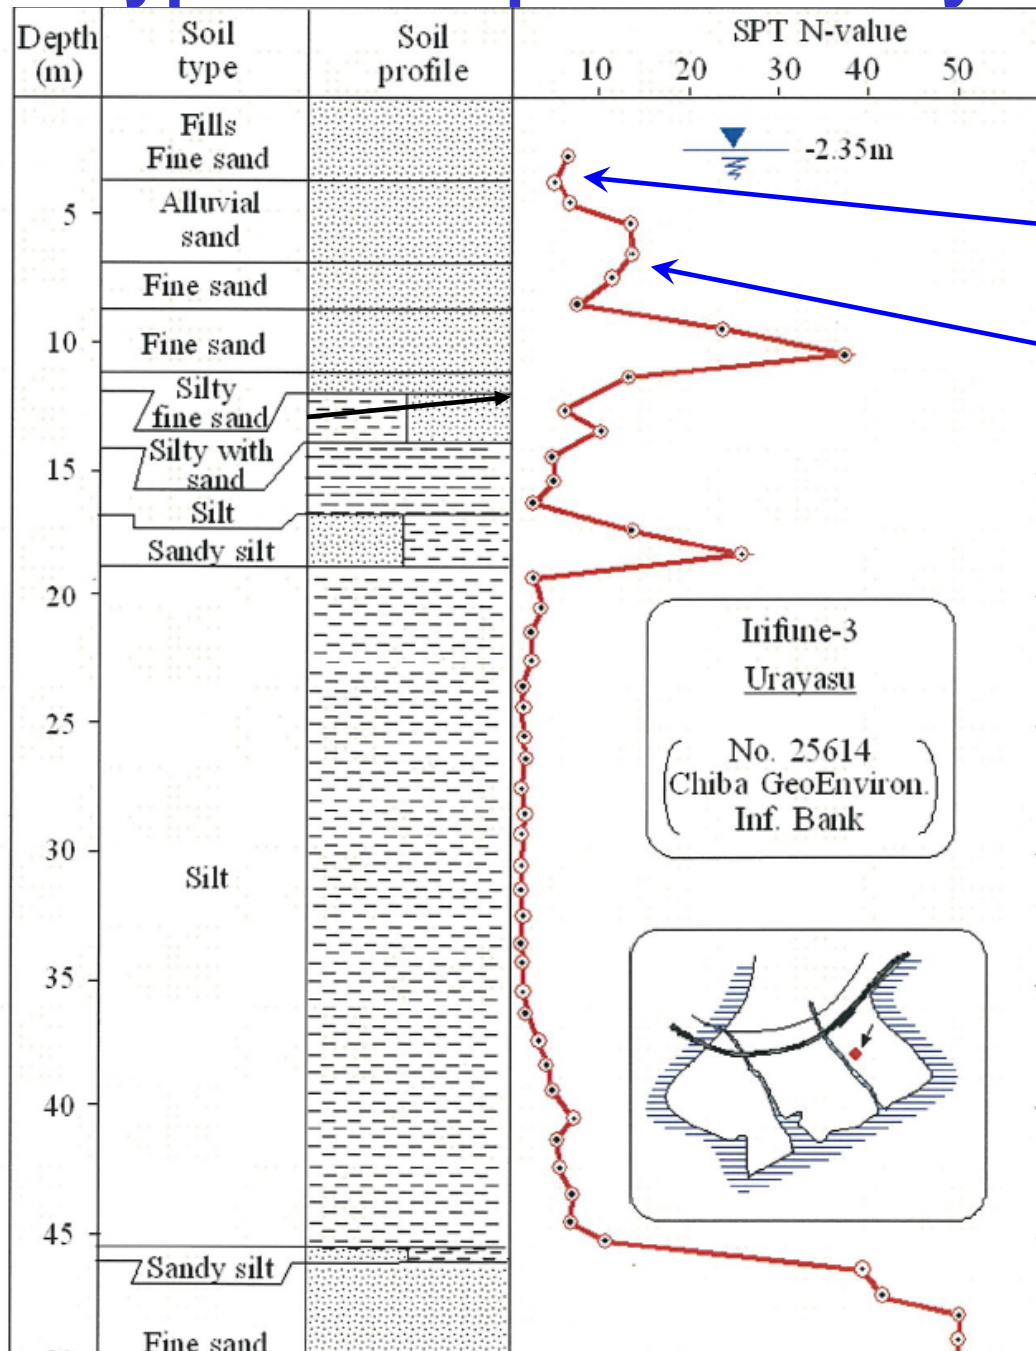
# Typical soil profile – Urayasu - Midtown

Fill commonly liquefied

Alluvium did not; aging due to fines?

- No distress in alluvial soils anywhere
- apparent extra cyclic resistance of alluvial sands not fully reflected by SPTs
- Fills did not liquefy in M7.9 aftershock, only M9

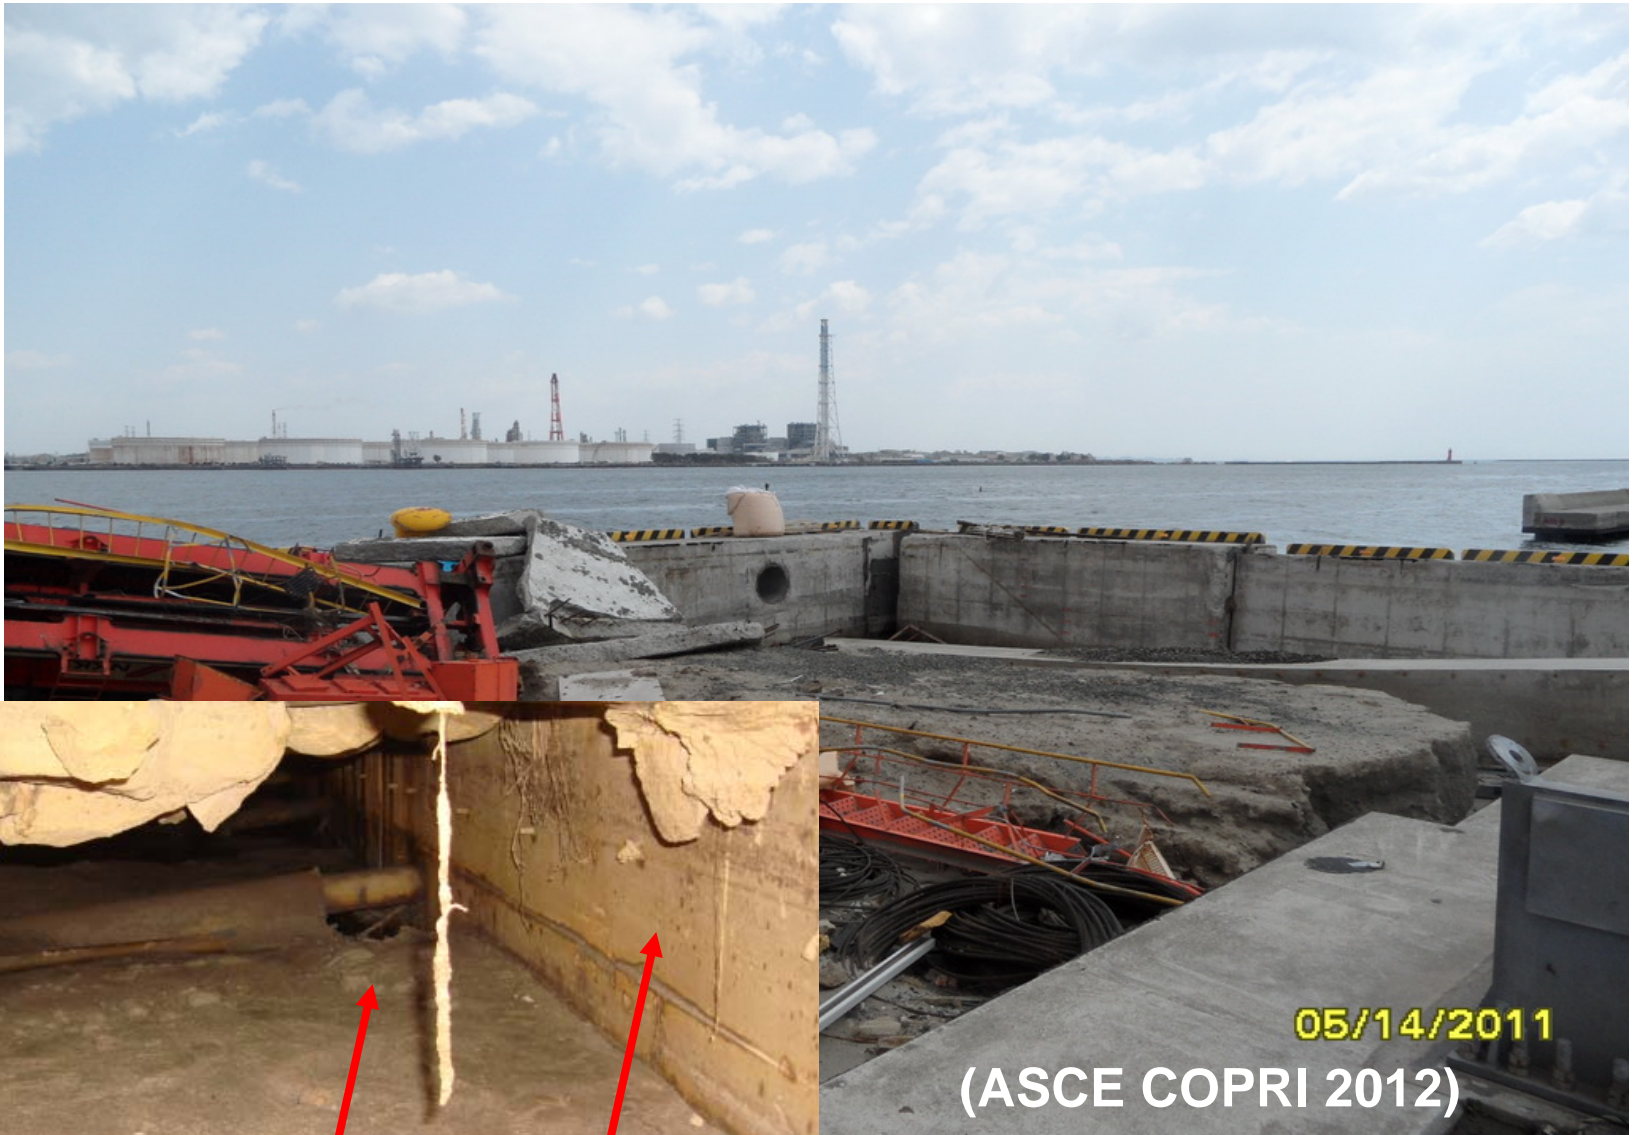
# Sheetpile wall failure in fill section

**Tie rod**

**Inshore face of bulkhead**

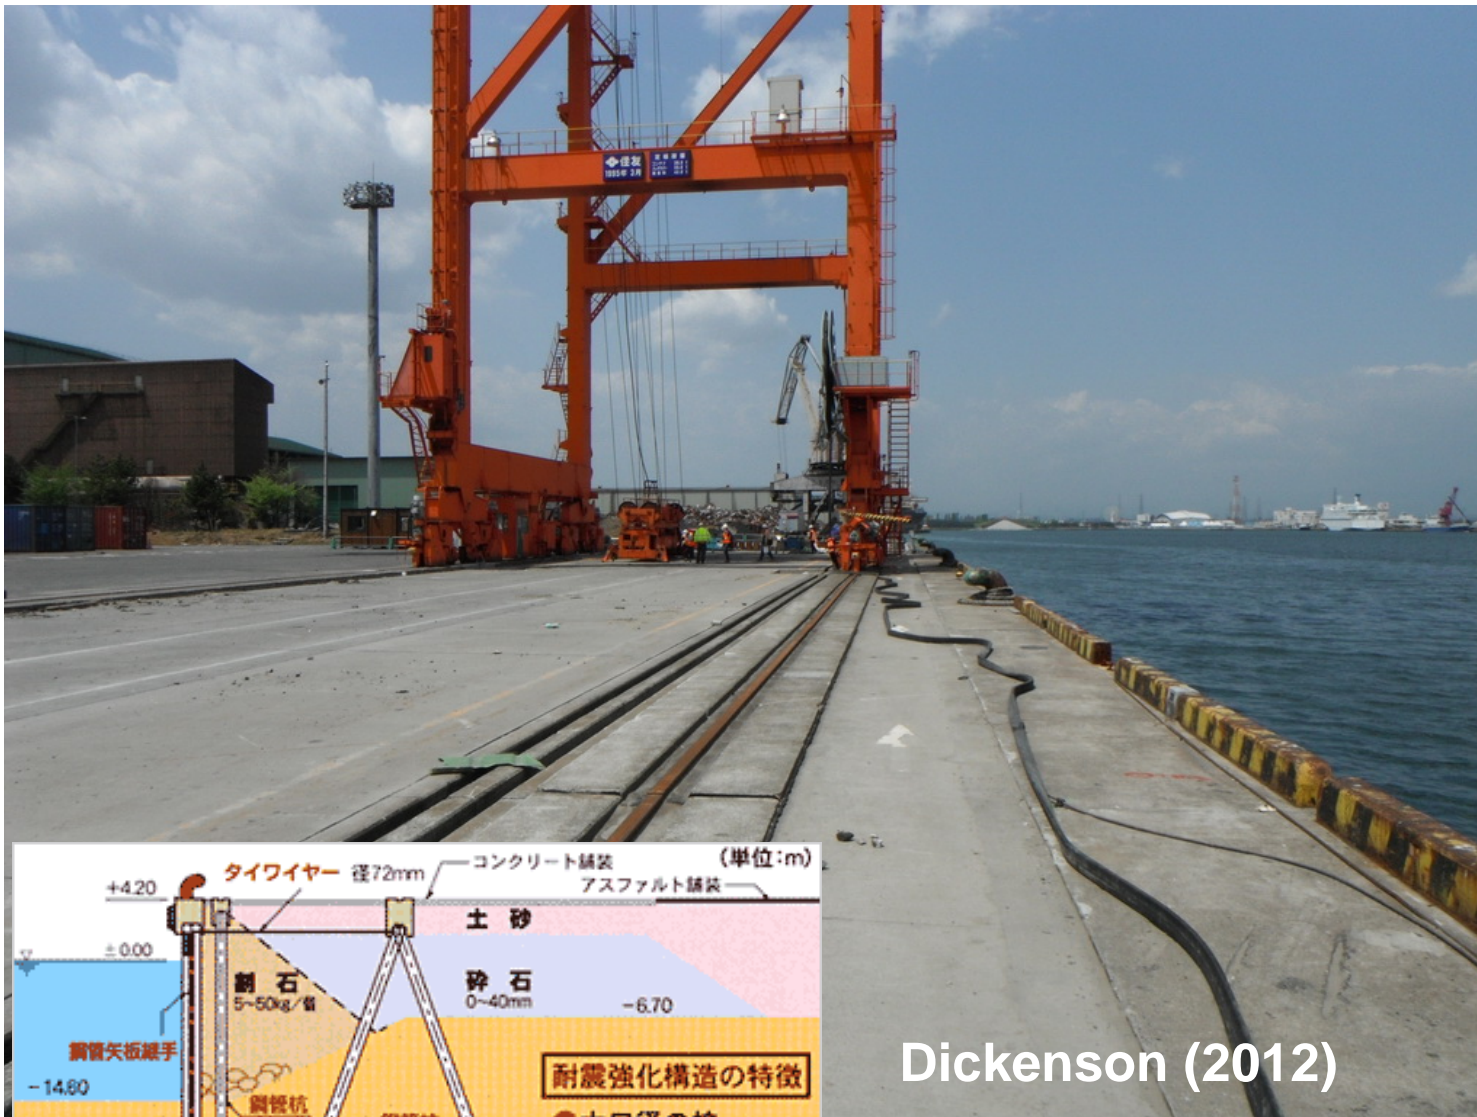
# Undamaged Sheetpile Wharf – natural soil section

- with PGAs of 0.6g, 1.5g, and 2g nearby, current models would predict very large movements
- Why no liq'n?
