# UNINTENDED CONSEQUENCES

## KARST IN SOUTH CAROLINA'S LOW COUNTRY

Stephen Geiger, P.E.  
ECS Southeast, LLP  
April 9<sup>th</sup> to 11<sup>th</sup>, 2018

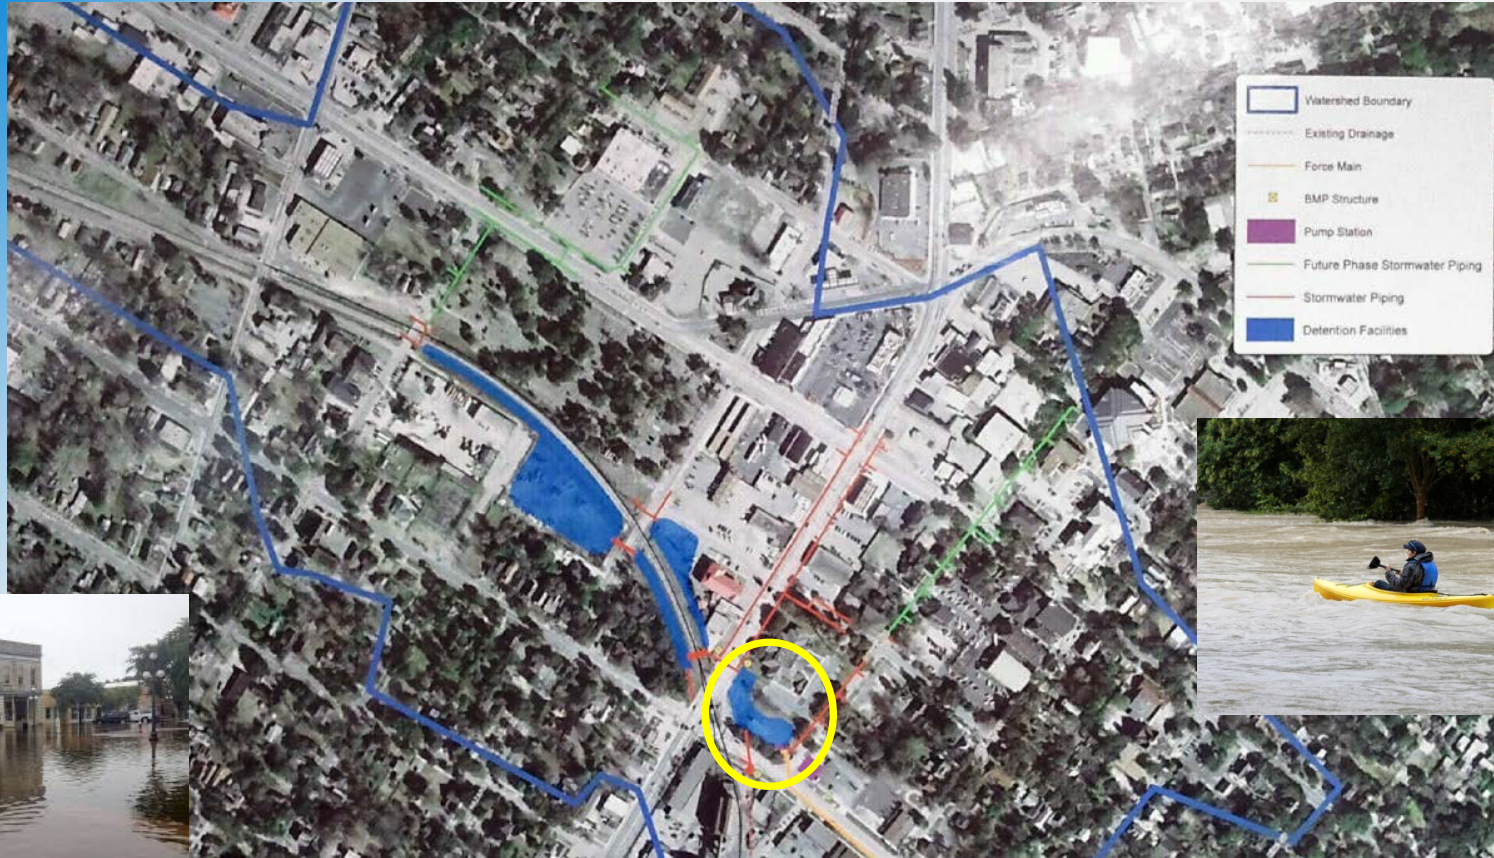
# STORMWATER DRAINAGE PROJECT

Significant Flooding During Heavy Rainfall and High Tide  
Confluence of 2 Major River Systems  
In Area Bounded by Blue Line

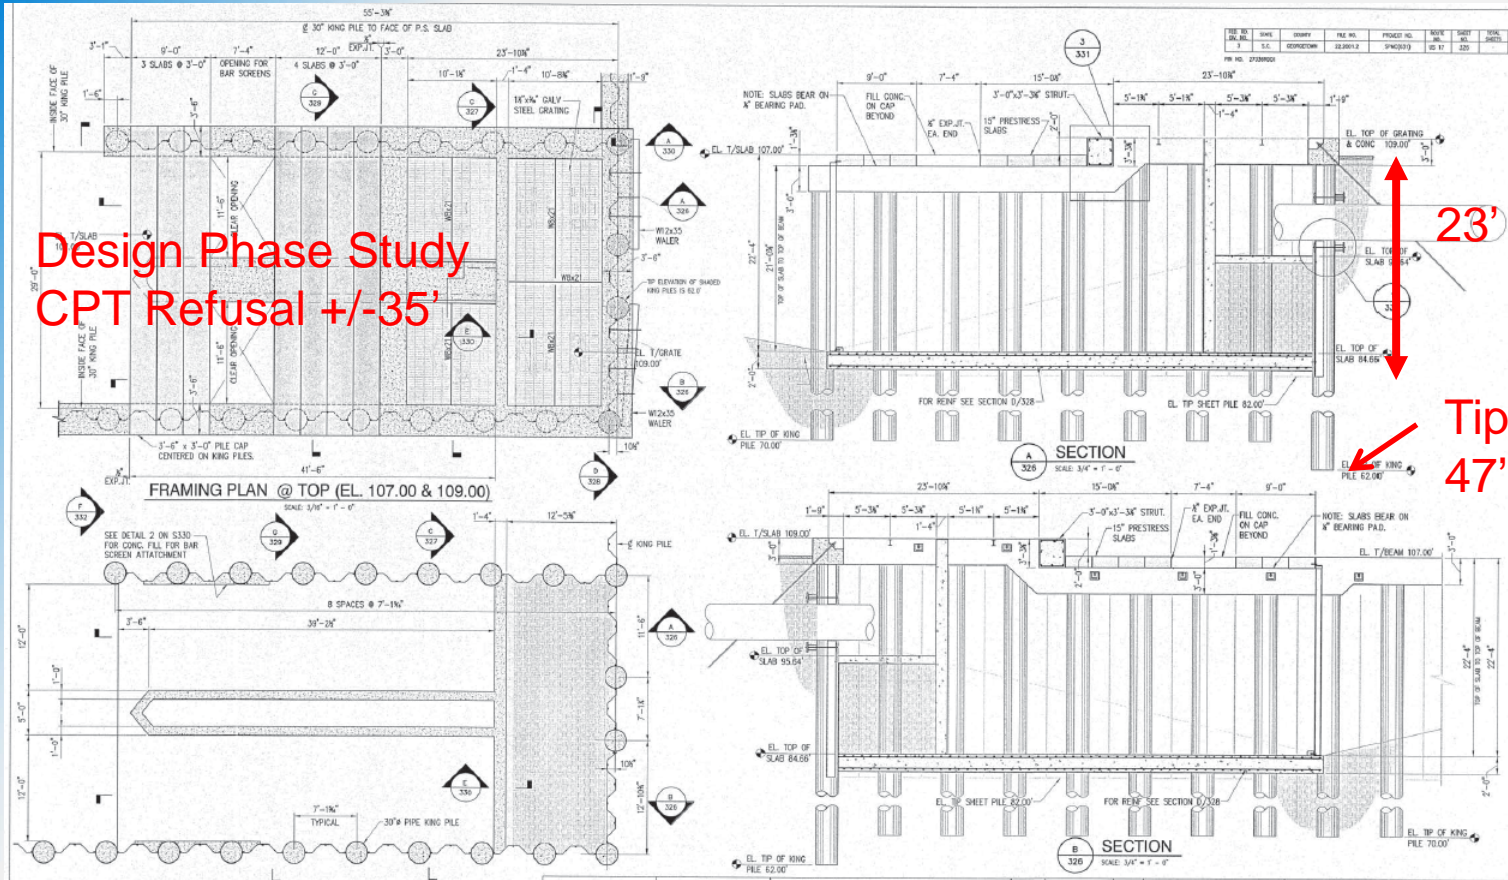
# WET WELL DESIGN KING PILE SYSTEM

Design Phase Study  
CPT Refusal +/- 35'

23'

Tip 47'

30" O.D. @ 7.25' O.C.

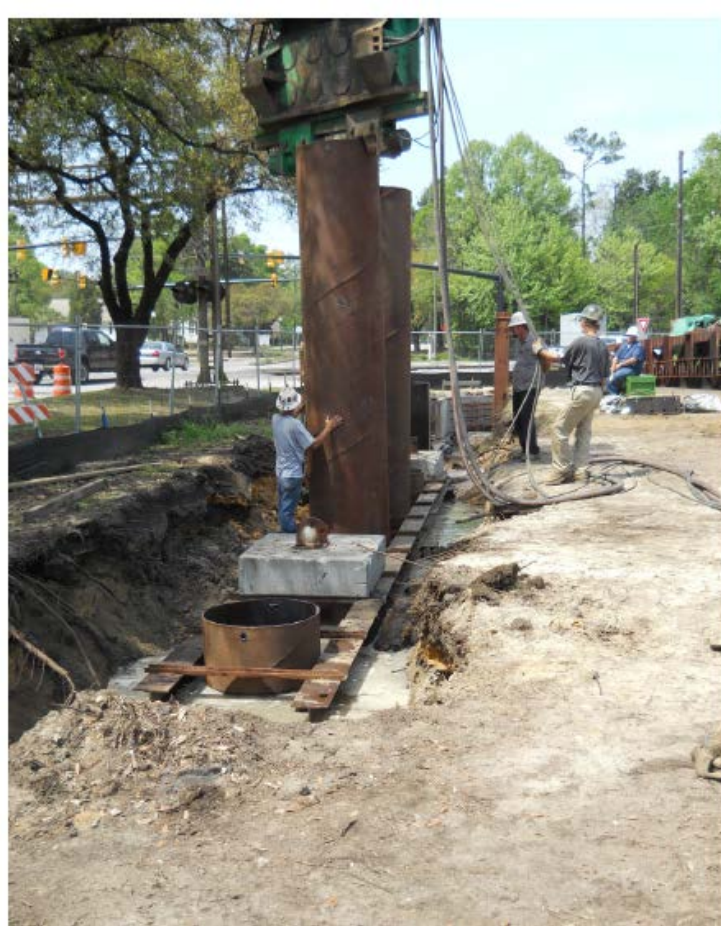
Temporary Steel Casing Installation  
Vibratory Hammer

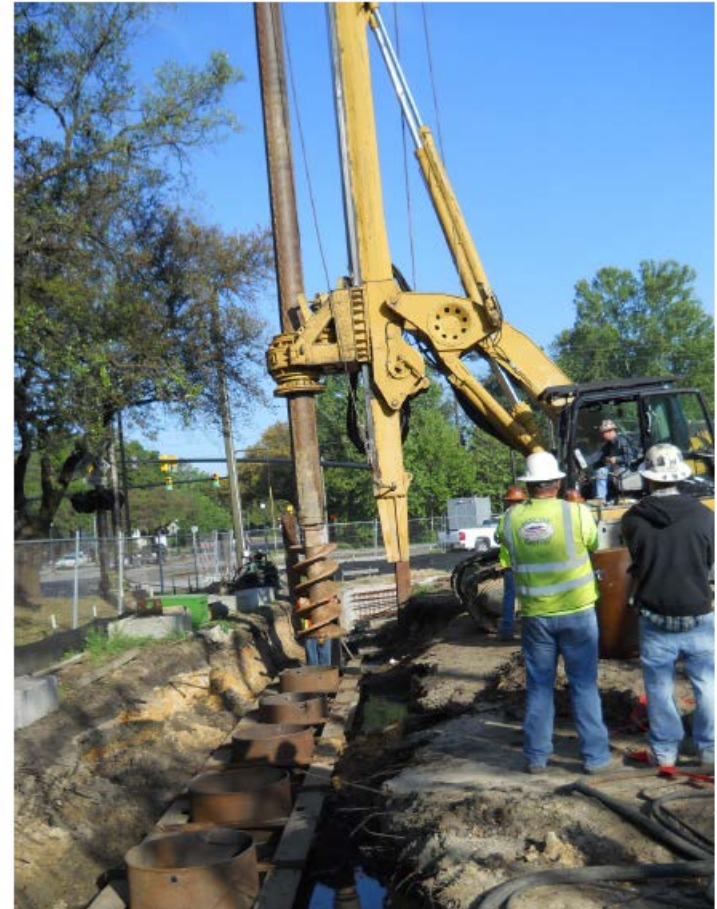
Temporary Casing Clean Out

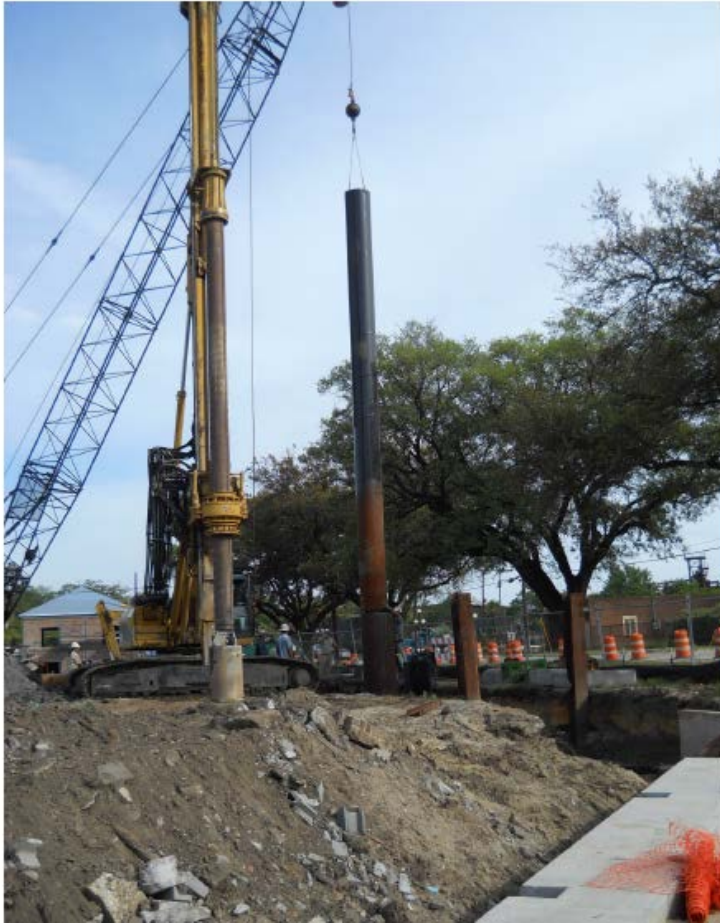
Pile Shell Installation

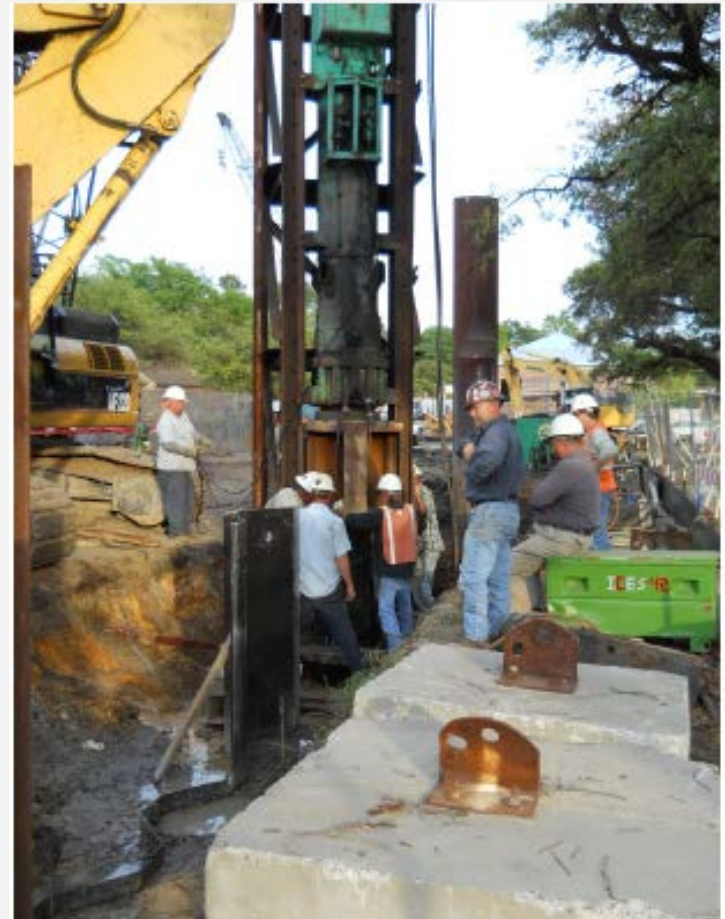
Steel Shell Driven To Design Tip Elevation

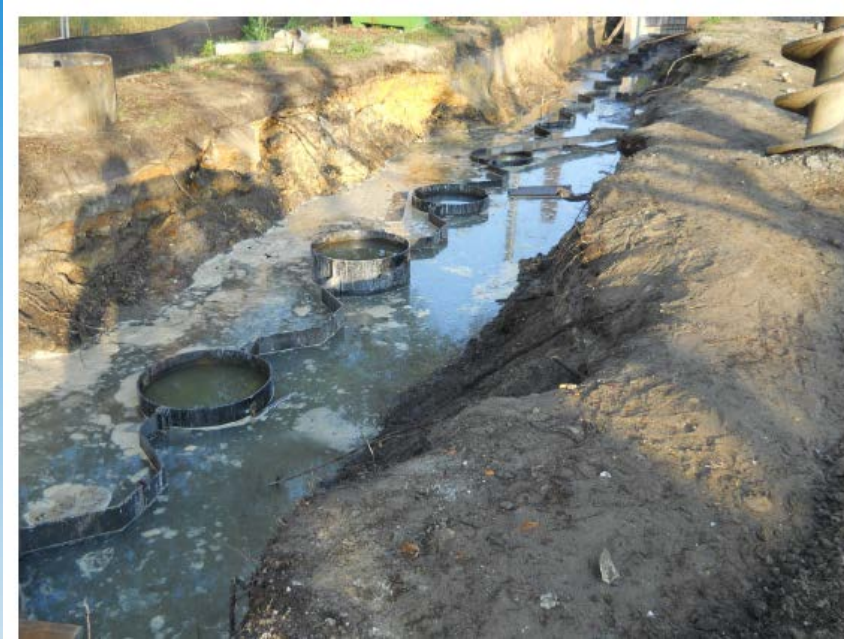
Installed System  
Prior to Concreting and Excavation

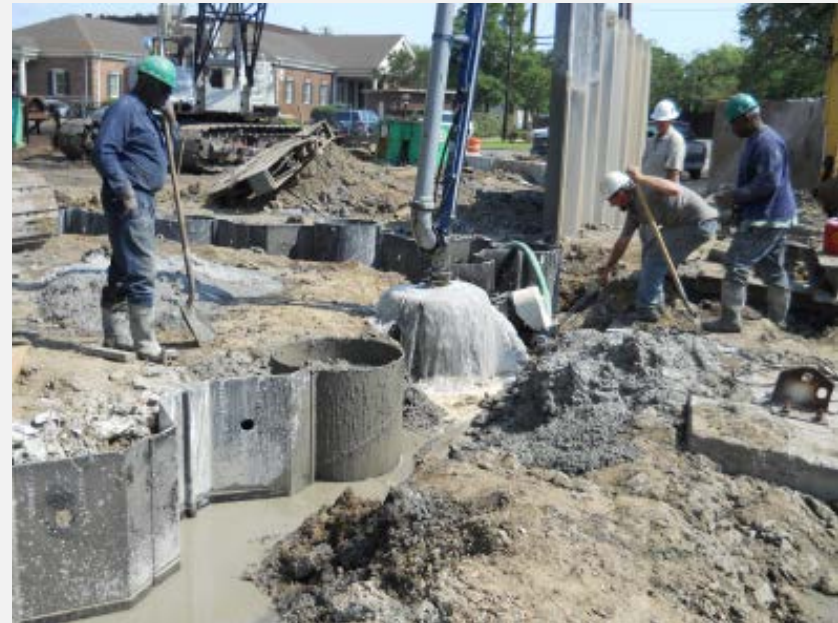
Concrete Placement  
Tremie Method

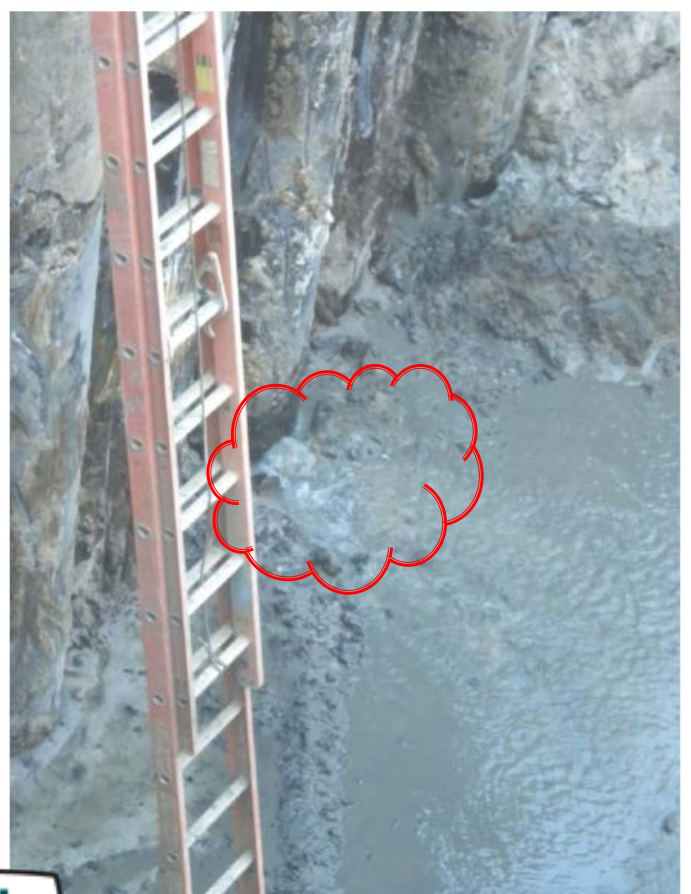
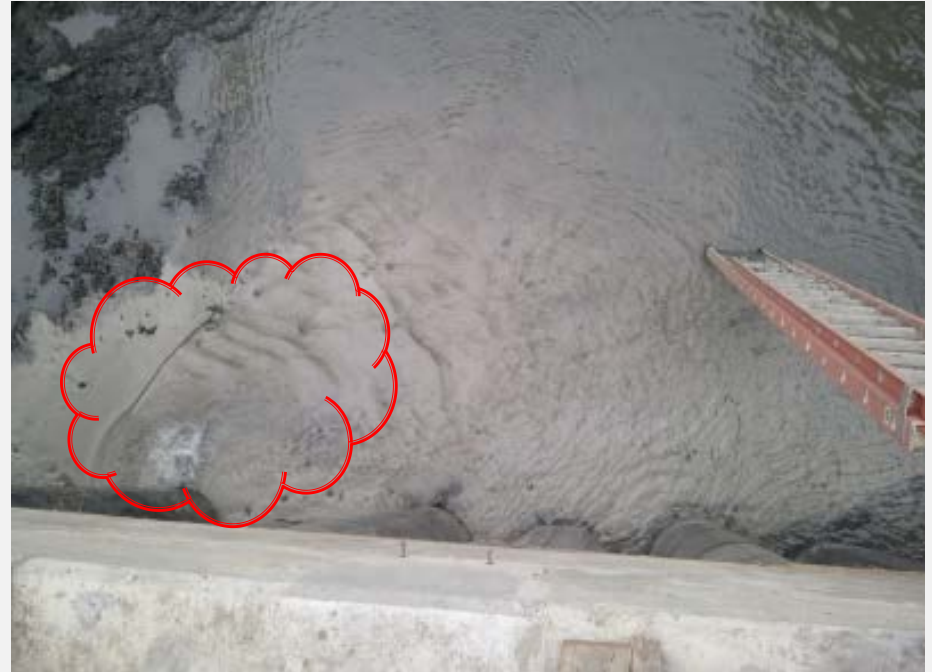
Artesian Conditions At Base of Wet Well Excavation

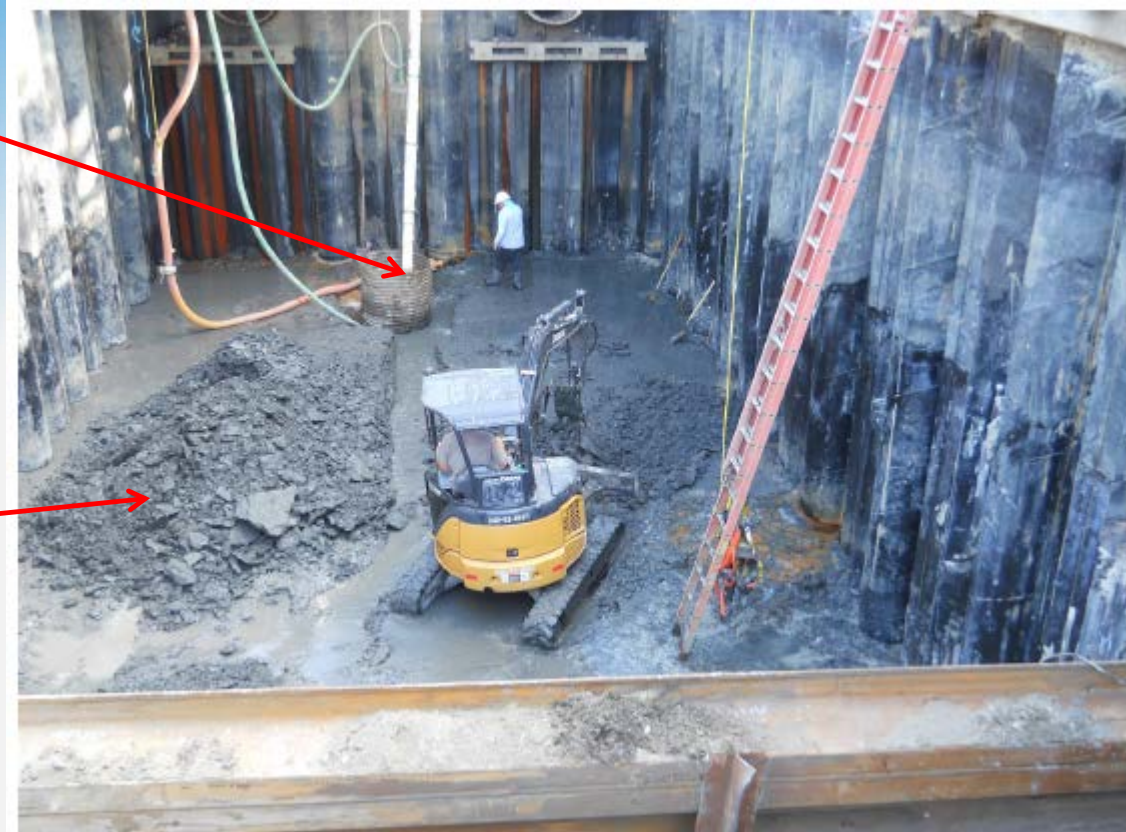
Deep Well

Williamsburg Formation

Finally A Dry Excavation!!

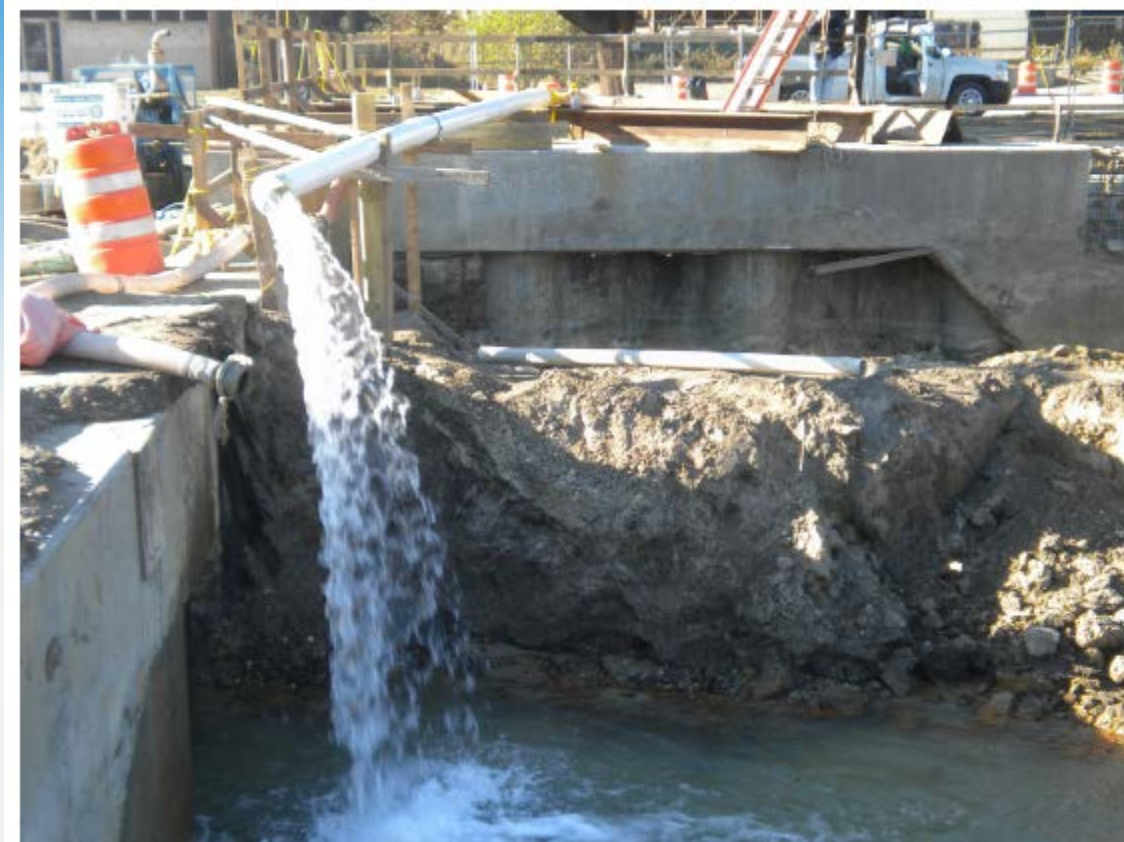
Discharge Rates From Flowmeter  
+/-90,000 Gallons Per Hour  
+/-2M Gallons Per Day

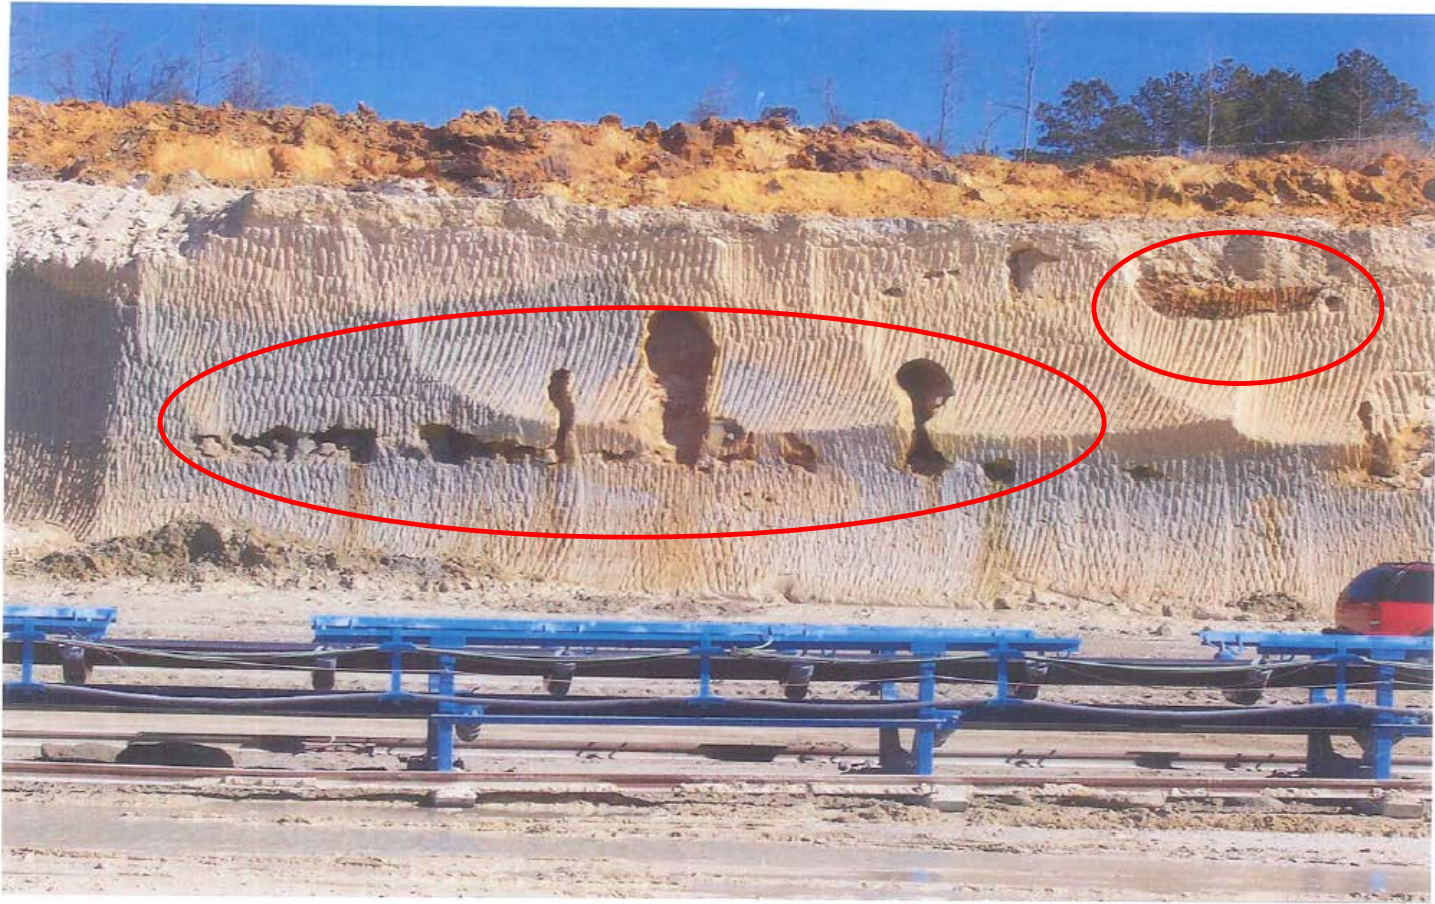
# “REAL” GEOLOGIC CROSS SECTION

Open Pit Limestone Mine – Holly Hill, SC

Open Cut @ Quarry  
< 20 Miles NW of Georgetown

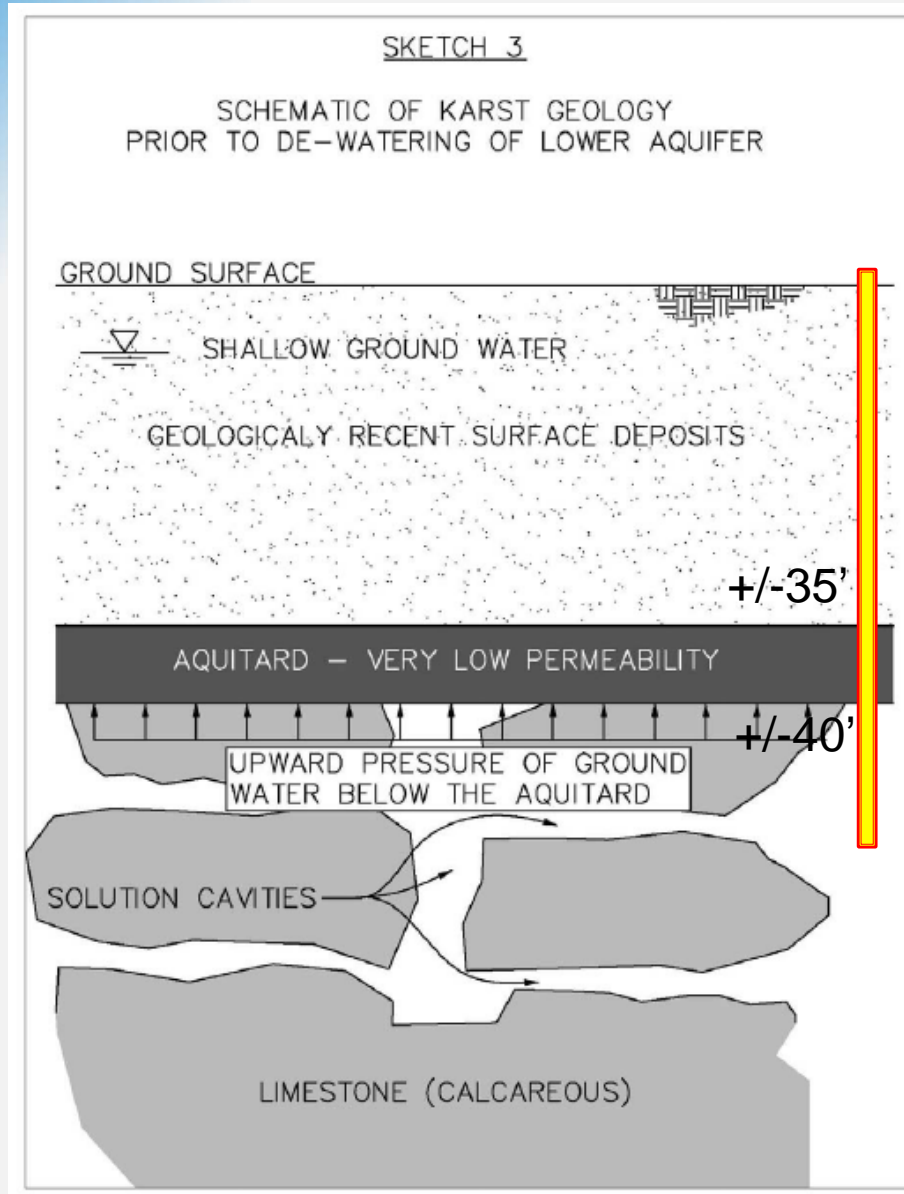
# HYDRO-GEOLOGIC CONSIDERATIONS

Shallow  
Dewatering

March/October  
2011

Deep  
Dewatering

October/November  
2011

King Piles  
+/-47'

Conditions Prior To  
Wet Well Dewatering

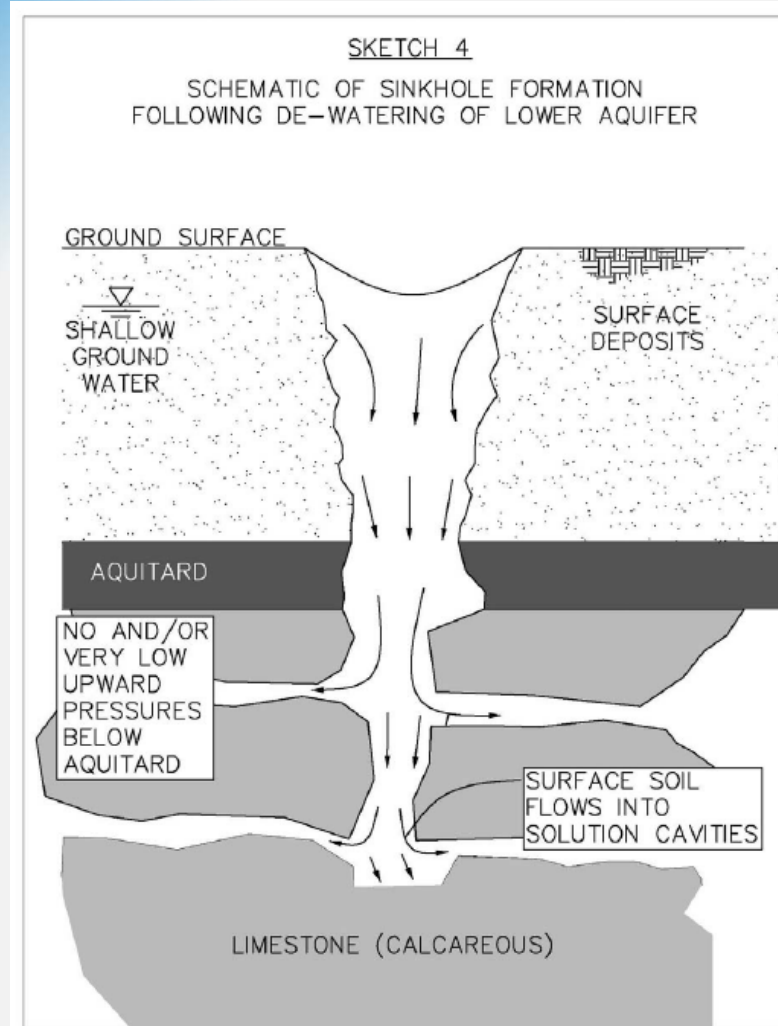
# COLLAPSE/SINK HOLE MECHANISM

Phenomena Documented In Coastal South Carolina Since 1975  
Jamestown Quarry +/-35M Gallons Per Day – Widespread Subsidence

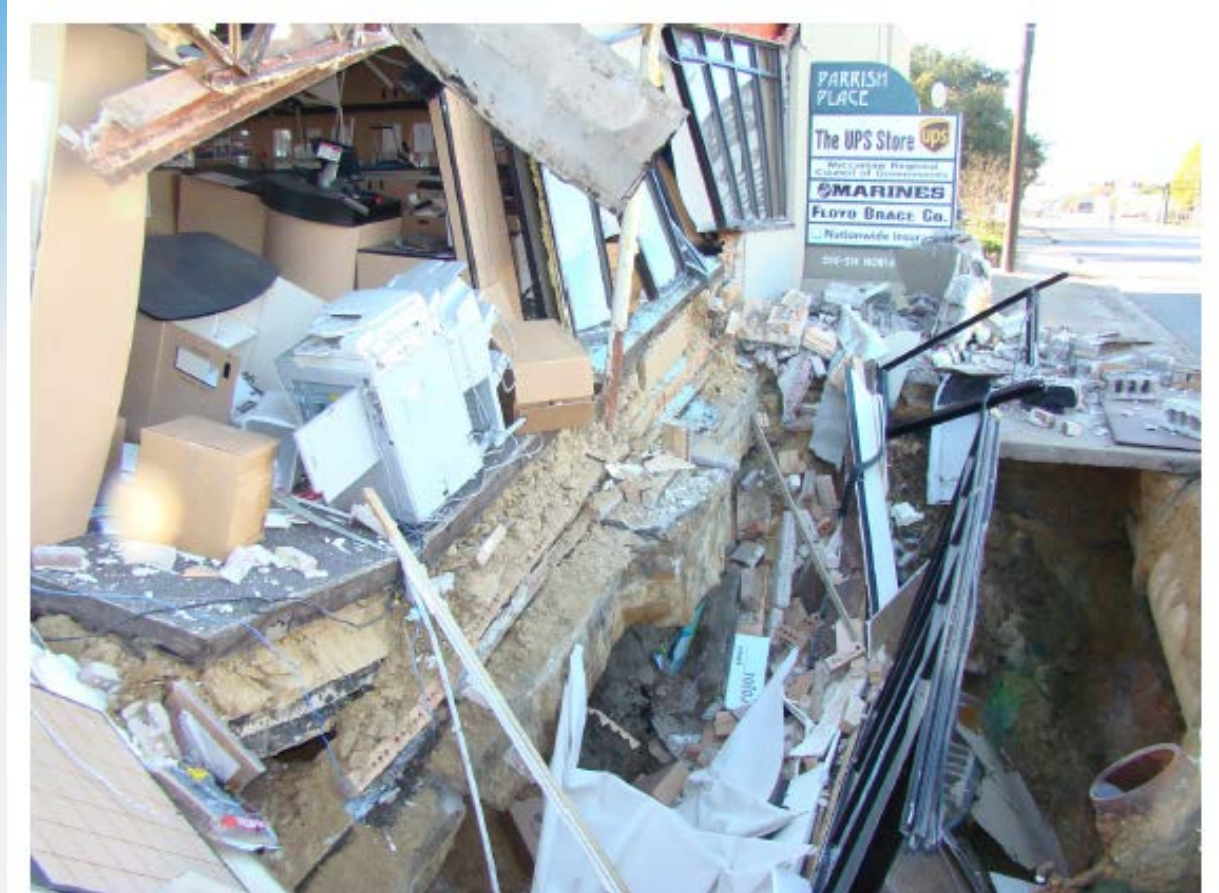
# UPS BUILDING COLLAPSE PARRISH PLACE

Collapse Occurred +/- 10pm November 17, 2011

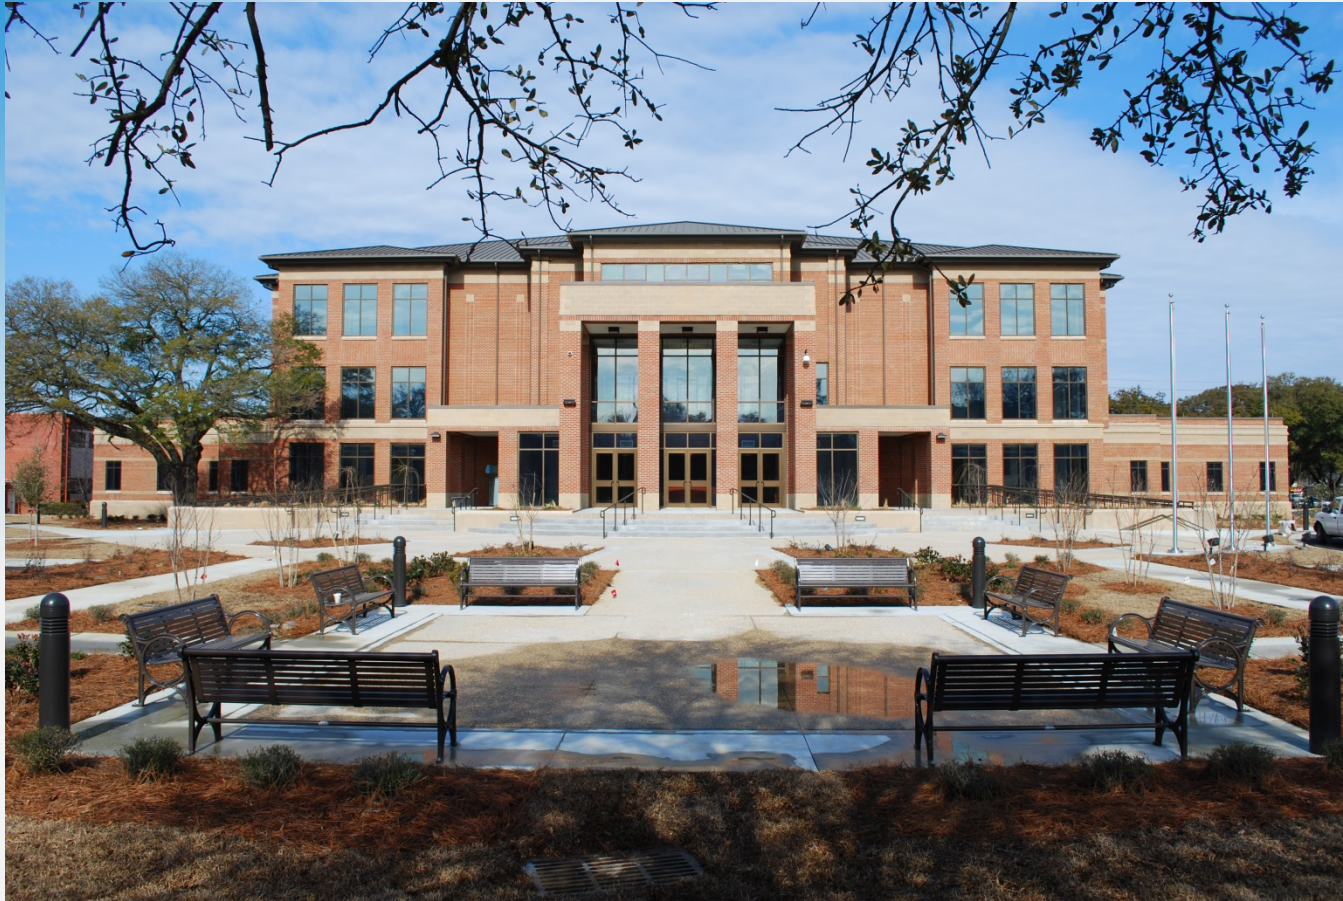
# THE "PROJECT"

Steel and Masonry, 3-Story, 79,300 SF County Judicial Center  
Completed Spring 2008  
Construction Value +/- \$18,000,000

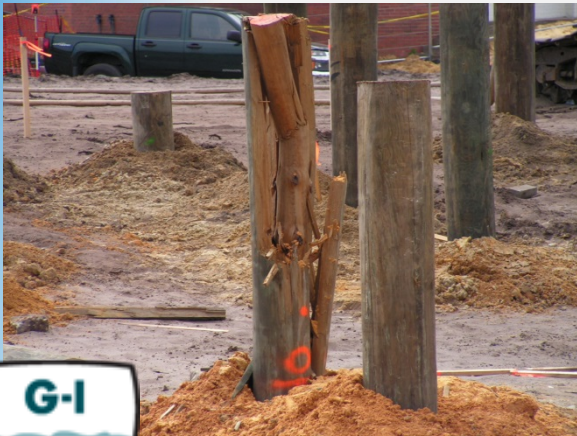
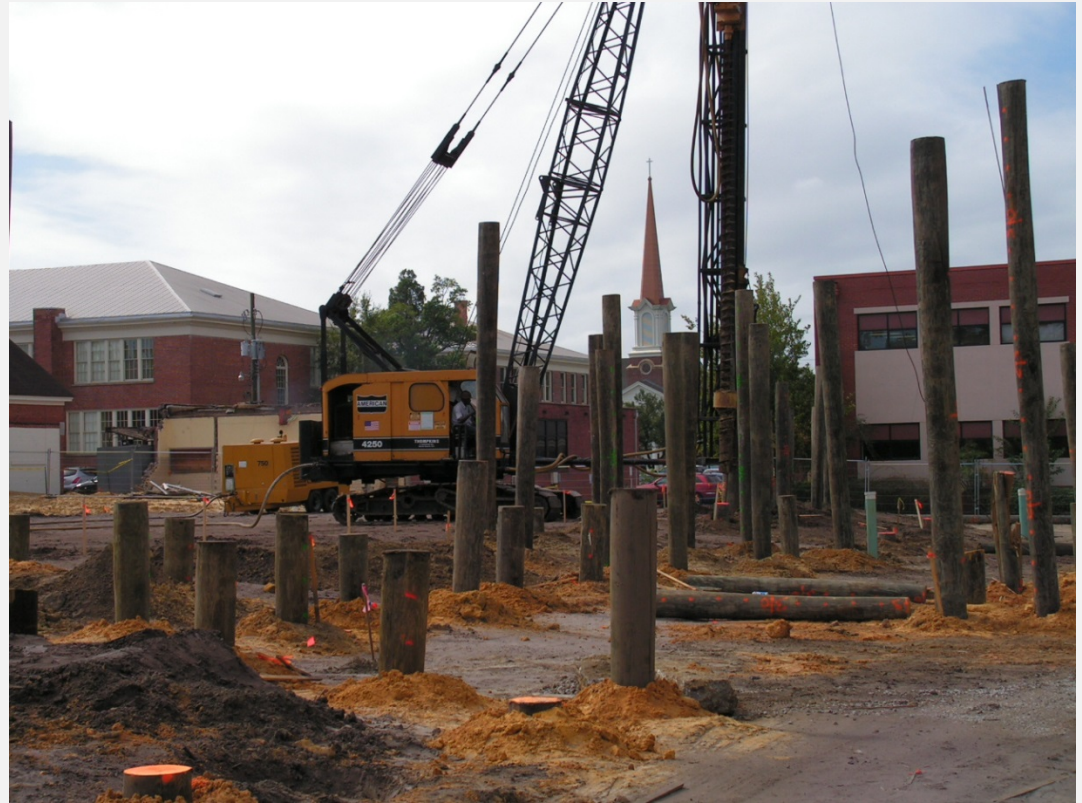
# GEOTECHNICAL CHALLENGES

E.O.D. Resistances: 6 bpf to > 100 bpf
