SLURRY CAISSON PROBLEMS AND CORRECTION IN CHICAGO

Tony A. Kiefer, P.E.
AECOM
Vernon Hills, IL–USA 60061

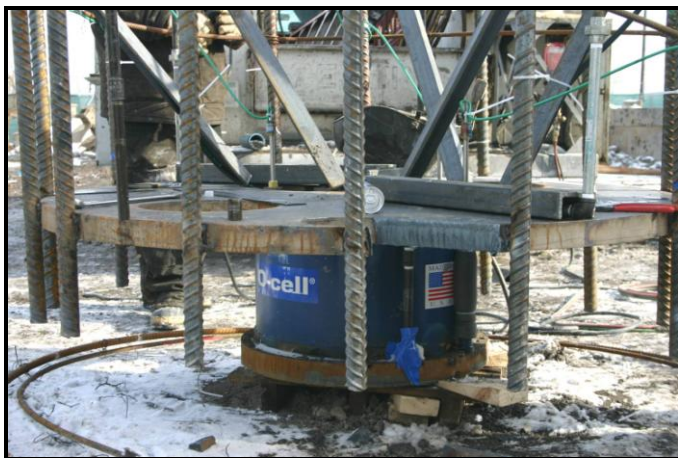
Fig.8. Cage and base plate configuration for a limited base area Osterberg load test on a production caisson.

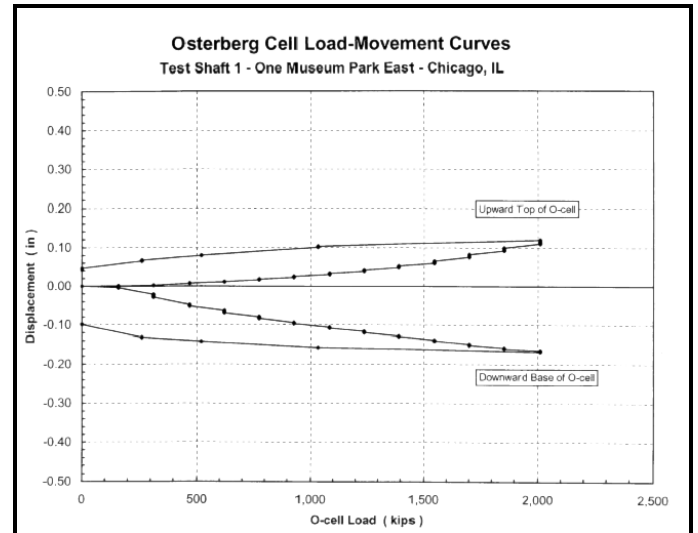
Fig. 9. Load test results for Test Shaft No. 1 at One Museum Park East.

Load Test Results. The load test results from the two test production shafts are shown in Fig. 9 and Fig. 10. These results show that from 1700 to 2000 kips in load was transferred to the base plates resting on the rock surface which proved end bearing pressures of 275 to 320 tsf. Thus, even with the measured friction ignored completely, the end bearing

It is worth noting that while side friction is ignored within the Chicago code, the actual side friction measured within the soft Chicago clay and Park Ridge till were 200 psf and 2250 psf, respectively at movements of less than 1/8 inch. The average value measured over the entire length of the 85 foot long shafts was 950 psf. These values were not ultimate values, but using some judgment of the shape of the load movement curve, we estimate that the ultimate values would have been perhaps 50 percent higher. NAVFAC DM 7.1 recommends adhesion factors less than 0.4 in very stiff clays; however, the results of the load tests justify an adhesion value of at least 0.65 based on the average shear strength of 3500 psf measured

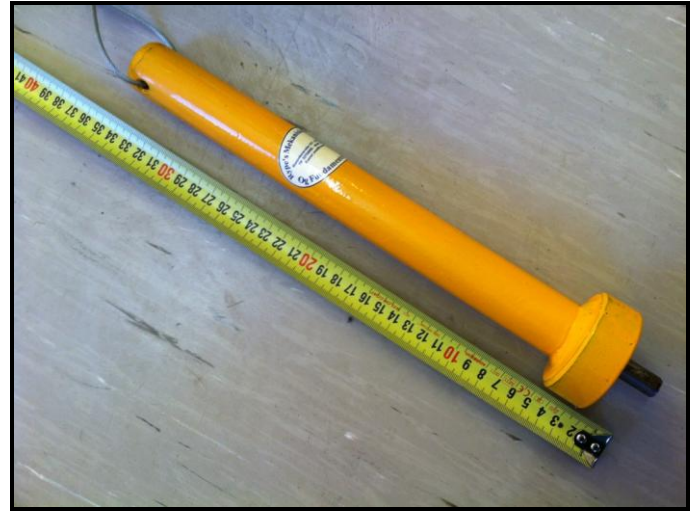
Fig. 11. A hard rock tester similar to the design used on the OMP project.

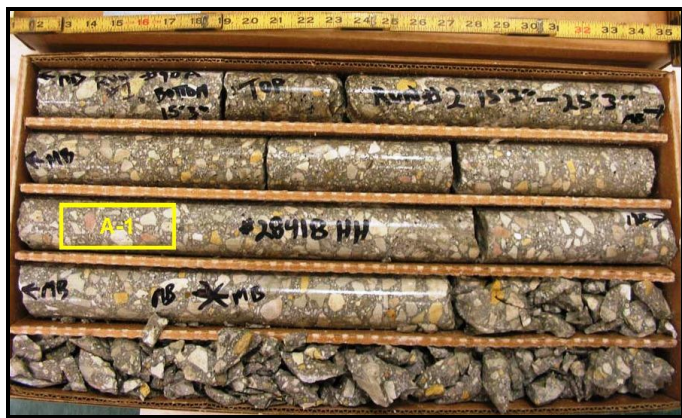
At Caisson 90 an anomaly was detected at about 20 ft below the top of the caisson. Three cores were advanced to 30 ft, but two of the cores showed good concrete. The third core revealed a zone of broken concrete from 22 to 24 feet as shown in Fig. 12. This was unusual in that the concrete appeared to be unsegregated and hard but was nevertheless shattered. The compressive strength of the core above and below the shattered zone was in excess of 9600 psi.

Fig. 12. Broken concrete core from approximately 22 to 24 feet at Caisson 90.

Caisson 90 was a podium caisson that was converted from a belled caisson to a rock caisson due to water problems. The shaft construction record also indicated that a “mudslide” had occurred at a depth of 15 ft while concreting. As a podium foundation, the caisson was not heavily loaded and could easily support the design load even for a worst case assumption that 1/3 the shaft was bad. Despite, this, the shaft was remediated by pressure grouting with 8000 psi neat cement grout as shown in Fig. 13. The grouting could not achieve a high pressure in the bad core hole even though several cubic feet of grout was pumped. We assumed that the grout was exiting the caisson and simply filling the loose fill and soft clay at the level of the anomaly. Subsequent IRS testing after remediation confirmed that the anomaly was gone.

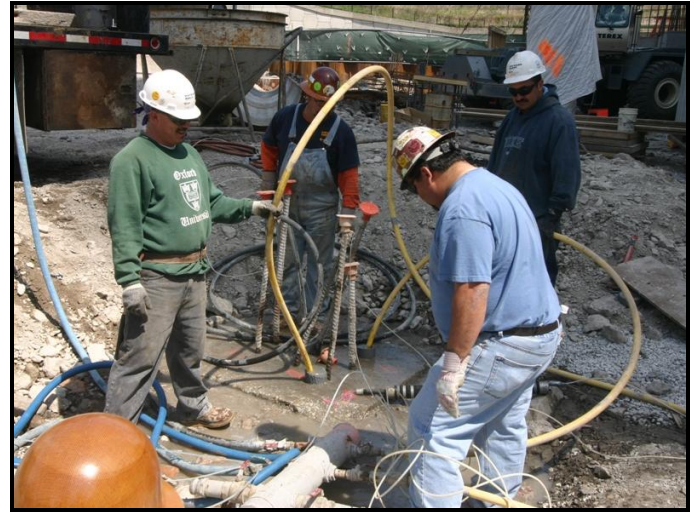
Fig. 13. Remediation pressure grouting of the shallow anomaly at Caisson 90.

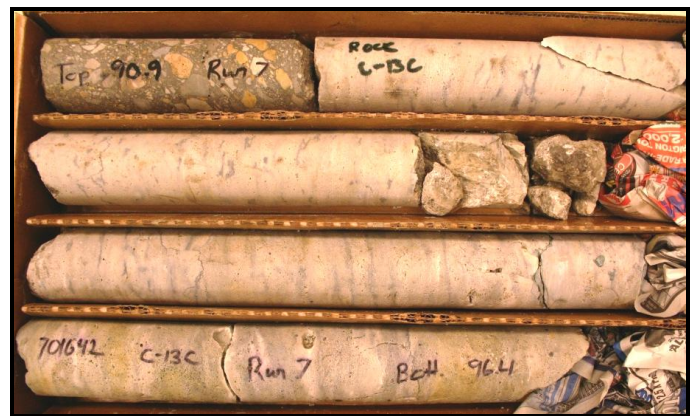
CSL testing at Caisson 13 in the west tower revealed a complete loss of signal in all tube pairs in the bottom 10 ft of the shaft. When an anomaly occurs over all of the tube pairs it is usually an indication of a serious defect. For this shaft, the field construction records provided no indication of a problem. Three cores in this shaft showed segregated and weak concrete in two of the three cores. Though the concrete strengths were considerably less than the nominal 10,000 psi design strength, they were close to the 5000 psi compressive strength needed for a factor of safety of 4.0 on the concrete. Despite the zones of poor concrete, the interface between the concrete and rock was excellent as shown in Fig. 14. At this shaft, side friction as proven in the load tests was considered to estimate the net design stress at depth which reduced concern for this shaft further. Despite the acceptable stress level, this shaft was also pressure grouted through the core holes and 20-foot lengths of 150 ksi, #14 bars were placed in the grout holes to further reinforce the shaft.

Fig. 14. Bottom of concrete core at Caisson 13 showing clean contact between concrete and dolomite bedrock at 91.8 ft.

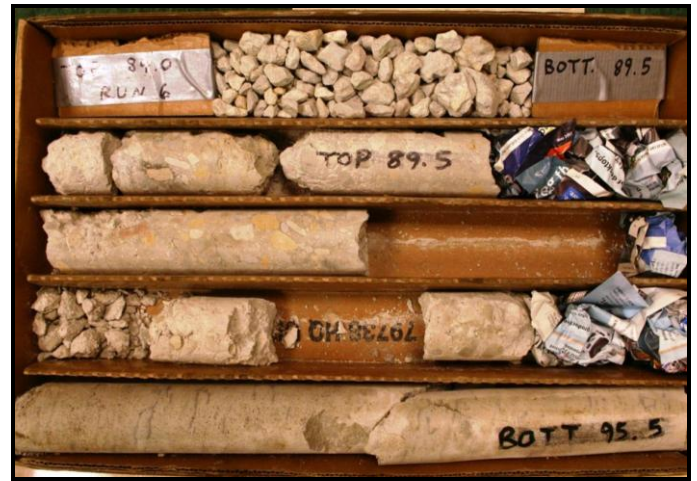
During installation of Caisson 2 at the west tower, our field technician noted that the tremie pour was interrupted and the tremie pipe was pulled out of the concrete twice and reinserted because it plugged. We recommended mucking out the shaft and starting over, but the contractor declined to do so, hoping that the CSL testing results would show that the caisson was good. The CSL results in Fig. 15 show that the concrete was of very poor quality throughout the majority of the shaft. A full length core found weak segregated concrete, washed-out gravel and missing concrete as shown in Fig. 16. Compressive strength tests on intact portions of the core showed that the entire shaft was compromised with compressive strengths between 1700 and 4200 psi. Because of these results, replacement of the shaft was required.

Fig. 16. Concrete core at Caisson 2 showing weak concrete, segregated concrete and gravel zones above bedrock from 84 to 93.5 ft.

Replacement options included two new shafts connected by a grade beam and complete replacement of the shaft. The contractor elected to replace the shaft by drilling out the upper 20 feet and coring the lower 30 ft of the shaft. Thus, a new shaft, 3.5 feet in diameter was cored inside the existing 4.5-foot shaft. This avoided the difficulty of removing the rebar cage and effectively used the shell of the existing shaft as a permanent casing. To make this work, the new shaft was extended one foot into sound rock by coring below the level of the original caisson to increase the allowable bearing pressure to 100 tsf based on Chicago code. A new cage with CSL tubes was cast into the replacement shaft and testing confirmed the integrity of the new concrete.

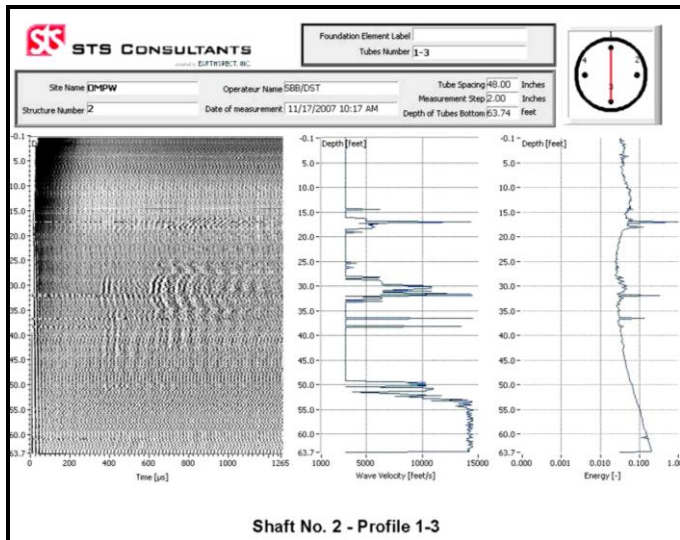
Fig. 15. Cross-hole Sonic Logging results at Caisson 2 showing very low wave velocity (less than 5000 ft/sec) throughout most of the shaft.

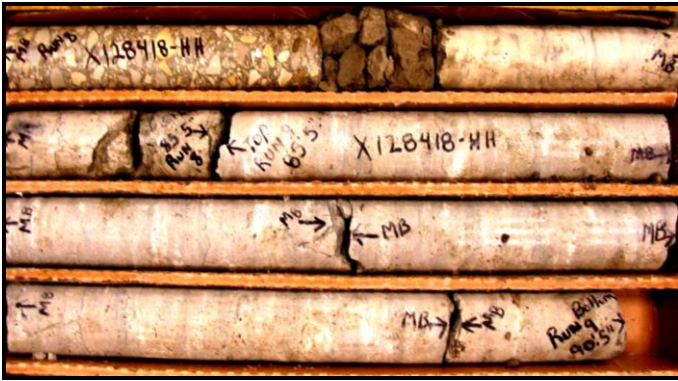
Random concrete cores were planned in both towers to check concrete quality. At the location of Caisson 69 in the east tower, the core encountered about 4 inches of soil between the concrete and rock surface as shown in Fig. 18. Review of the IRS testing at the shaft showed that the bottom reflection could be considered “soft” in comparison to the other shafts tested. Nothing in ordinary was noted in the as-built log by the inspector. It appeared that the soil zone was compressed silt and clay. If this was an isolated zone from a clay lump which fell into the shaft prior to concreting it might not be a concern. However, if the zone extended across the entire base, it appeared that more than 2 inches of settlement could occur before the caisson “fetched up” on the rock. To check this,

Fig. 18. Core at Caisson 69 showing 4-inch clay zone (top row) between concrete and dolomite bedrock at 84 ft.

three more cores were attempted, but all of them drifted out of the shaft before reaching the base of the shaft. With no other options, we chose to perform a full scale dynamic load test on the shaft. Because of the relatively rapid performance of this test, we were able to also perform a dynamic load test on Caisson 79, a good shaft with a hard bottom that was also cored. By testing both shafts, a comparison between the two could be made to help interpret the results.

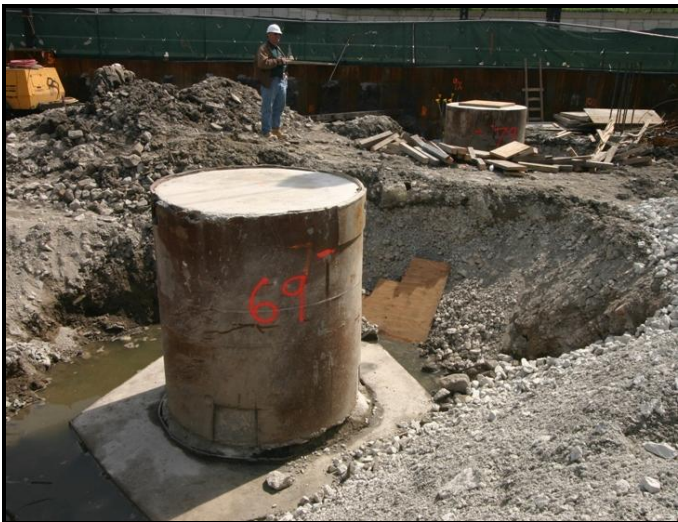
Fig. 19. Top of Caisson 69 (and Caisson 79 in the background) prepared with a high-strength, cased concrete cap for dynamic load testing.

To test the caissons, high strength cased caps had to be cast on top of the two shafts as shown in Fig. 19. To achieve a test load greater than the design loads which were about 5500 kips, it was necessary to use an Apple IV tester as provided by GRL. The test setup consisted of a 40 ton weight which was dropped from a height of as much as 3 feet onto the shafts. The test load is about to be dropped on Caisson 79 in Fig. 20. We estimated that the test setup was capable of applying a 4000 ton test load which would allow the caissons to be tested to a factor of safety approaching 1.5 which would be acceptable for confirming the performance for a specific shaft.

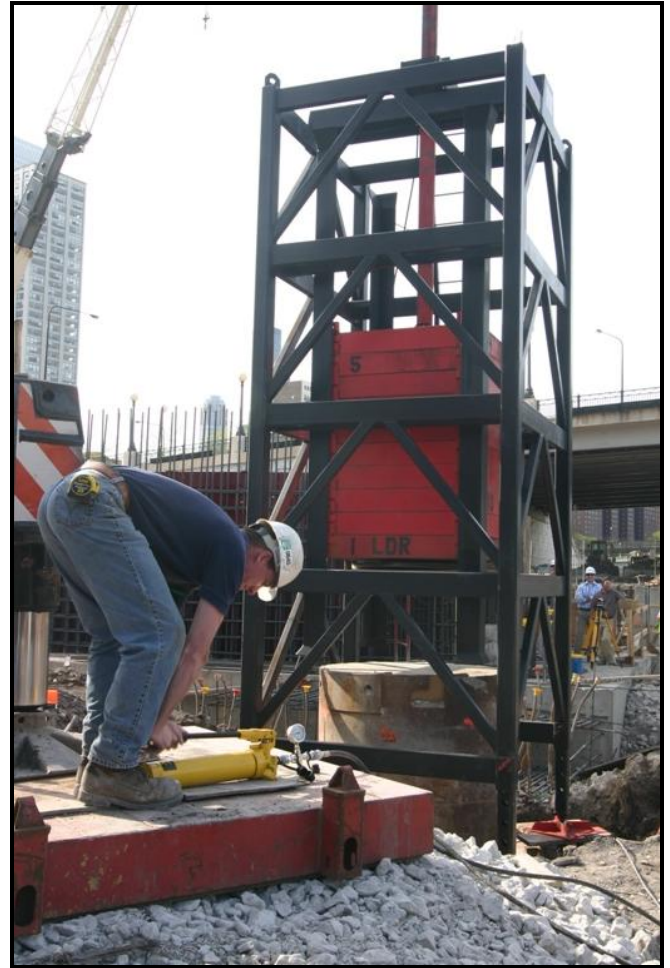
Fig. 20. Forty-ton weight about to be dropped on Caisson 79 to perform a 4000 ton dynamic load test.

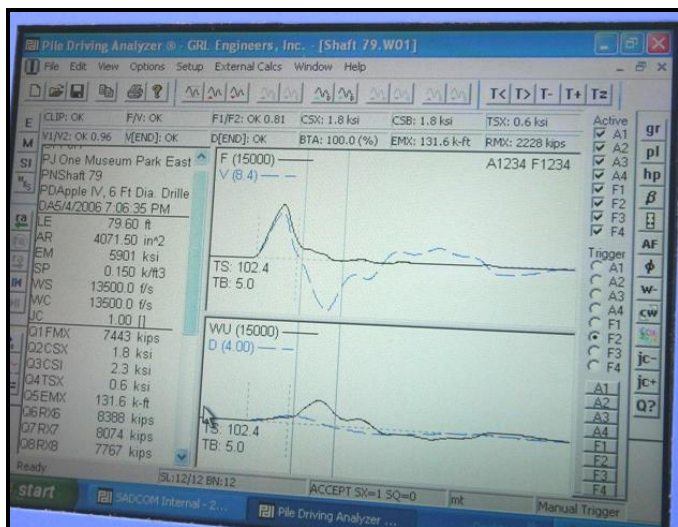
The on-screen results from the load test on Caisson 79 are shown in Fig. 21. These results showed a load impact of about 7400 kips while monitoring the tensile stress in the shaft from the rebound which approached 600 psi. At Caisson 69, a total of four hits were performed which permanently pushed the caisson down ½ inch. Each successive hit was stiffer than the previous hit. The testing confirmed that the reaction of Caisson 69 was about ½ the stiffness of Caisson 79 and confirmed that the clay layer appeared to extend over the entire shaft base. Based on the measured stiffness response from the dynamic load test, we estimated Caisson 69 was likely to settle an additional 1 inch as the building load was applied. While we felt this was acceptable, the structural engineer added a grade beam between Caisson 69 and two neighboring caissons to distribute the load and control the possible differential settlement.

Fig. 21. In-the-field computer display of the response of a 4000 ton dynamic load test on Caisson 79.
