# Lessons Learned in Geotechnical Engineering

- 1) Excess Pore Water Pressure
- 2) Pyritic Sulfur

Presented by: George C. Webb, P.E.  
Terracon - Cincinnati

Landslide due to  
Excess  
Porewater  
Pressures

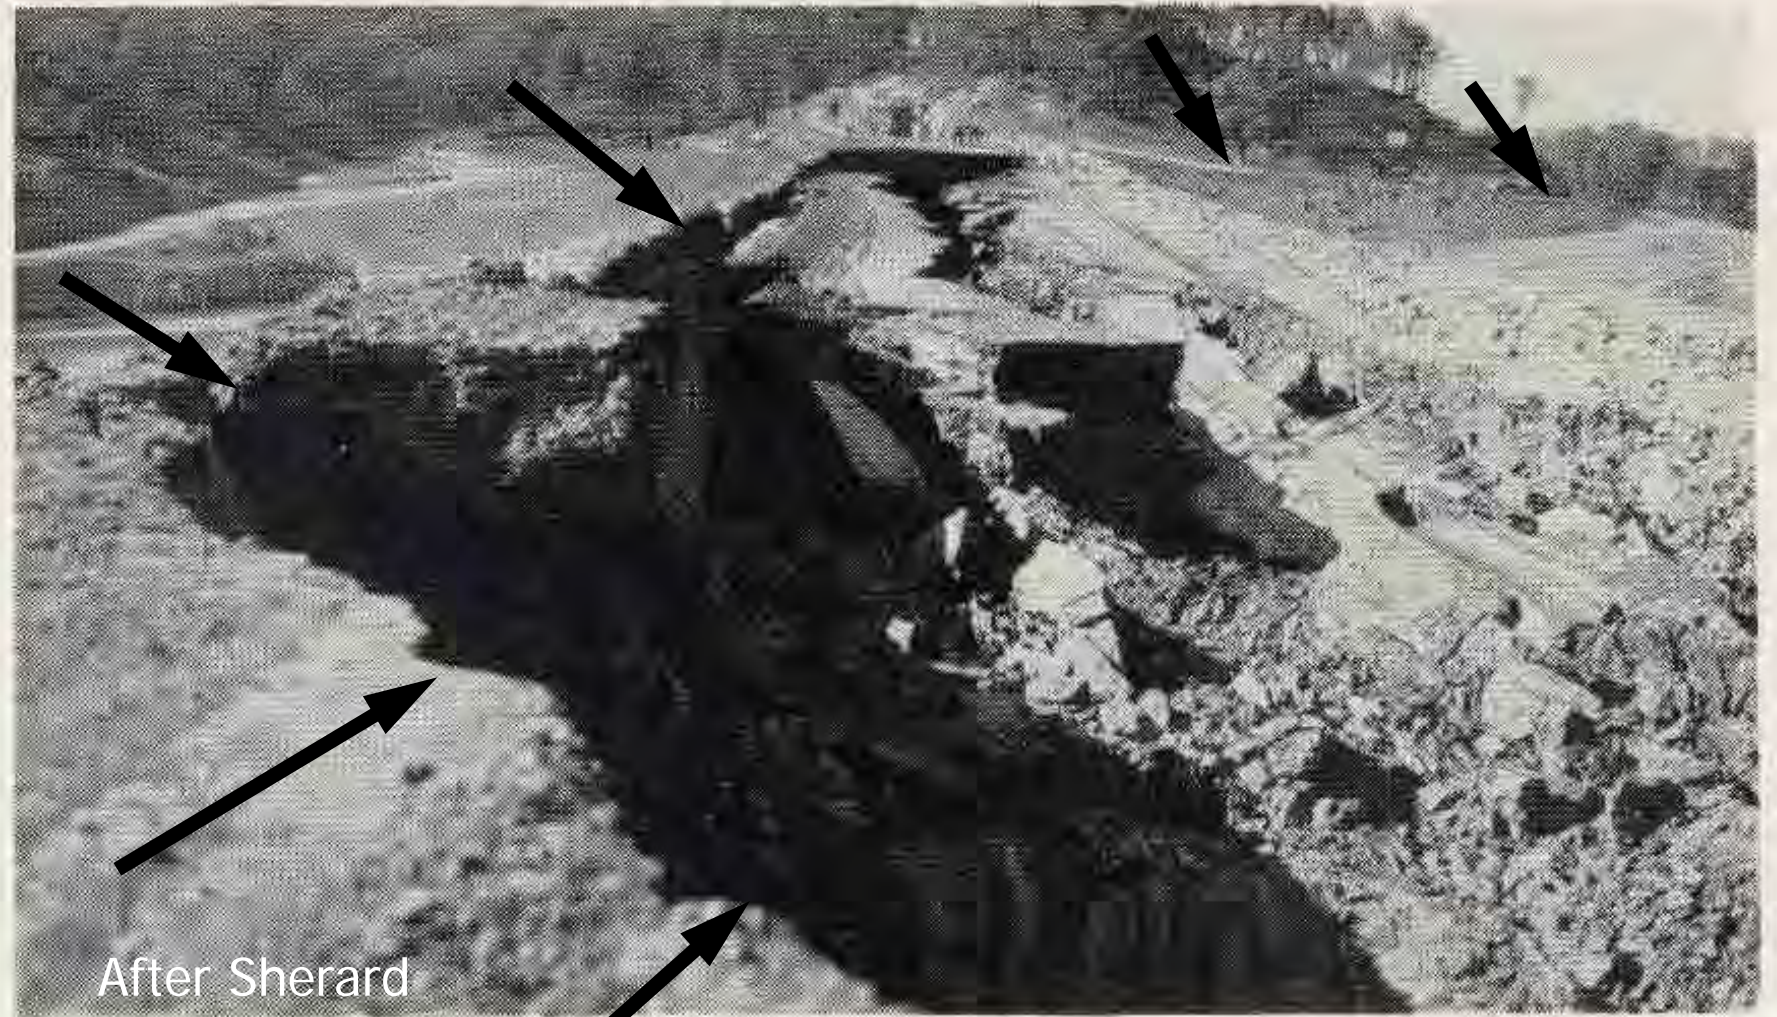
After Sherard

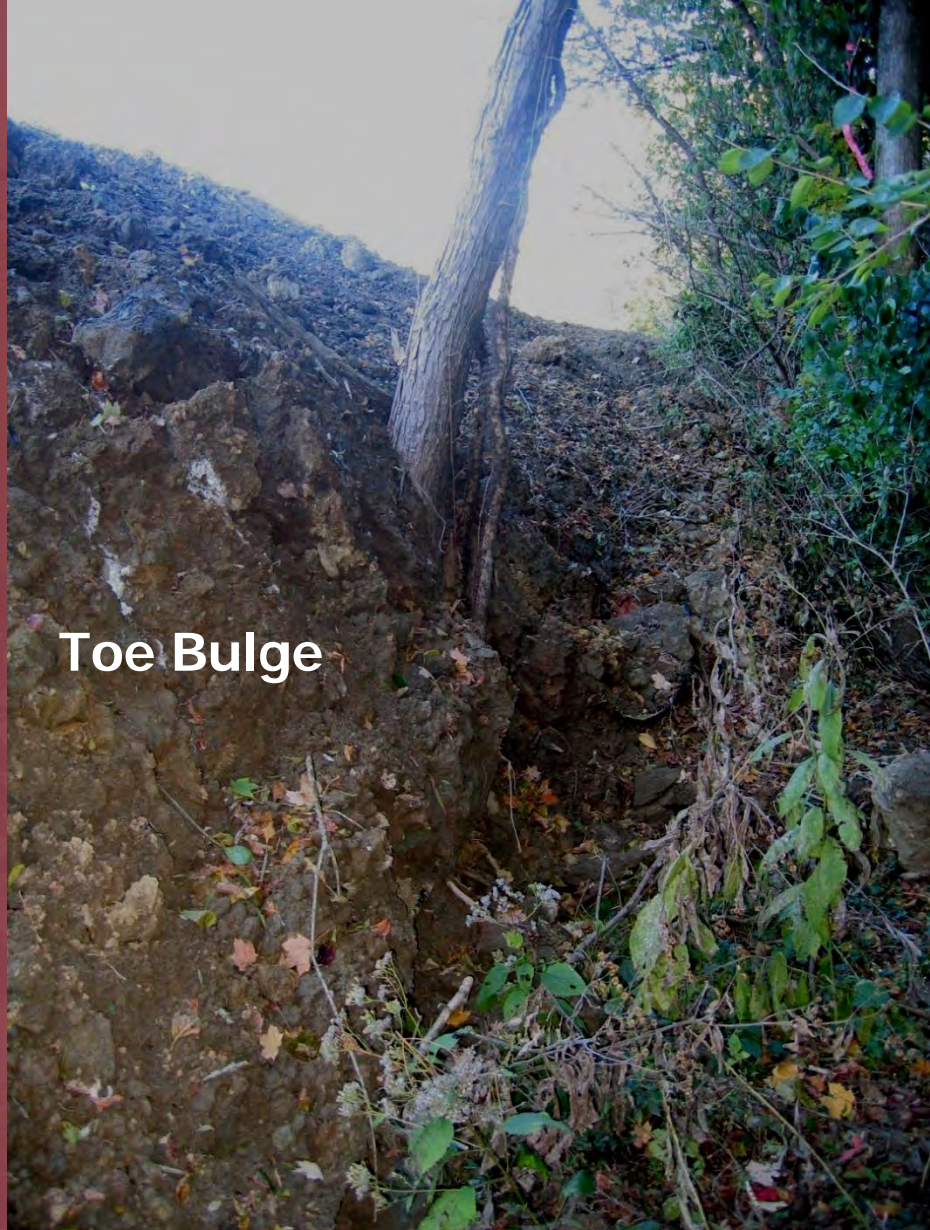
Toe Bulge

The Day After the Landslide Occurred

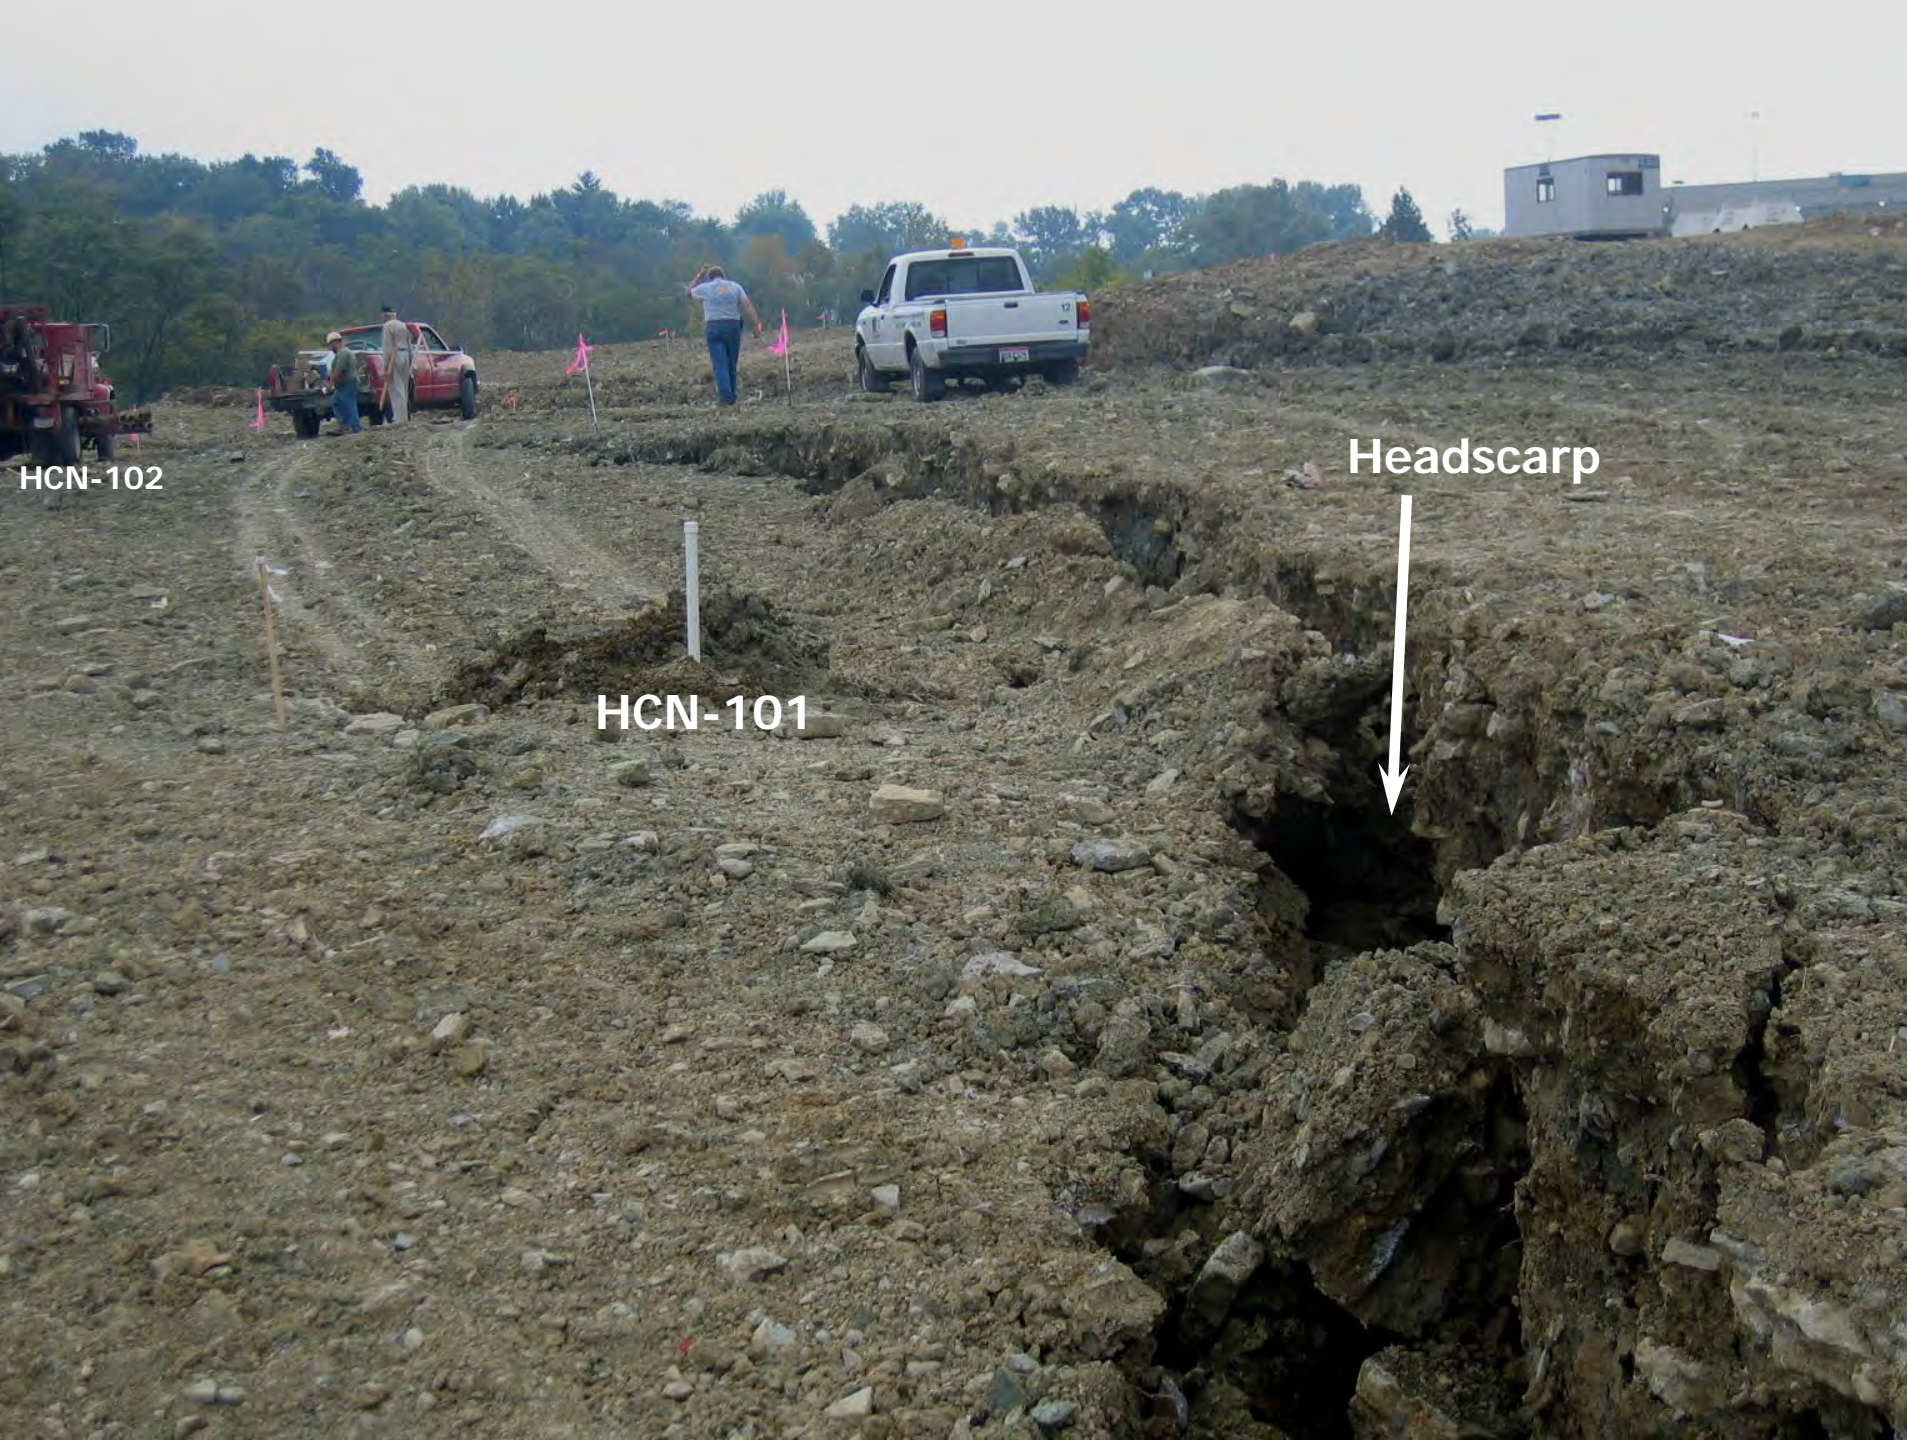
Two Days after  
Landslide  
Occurred

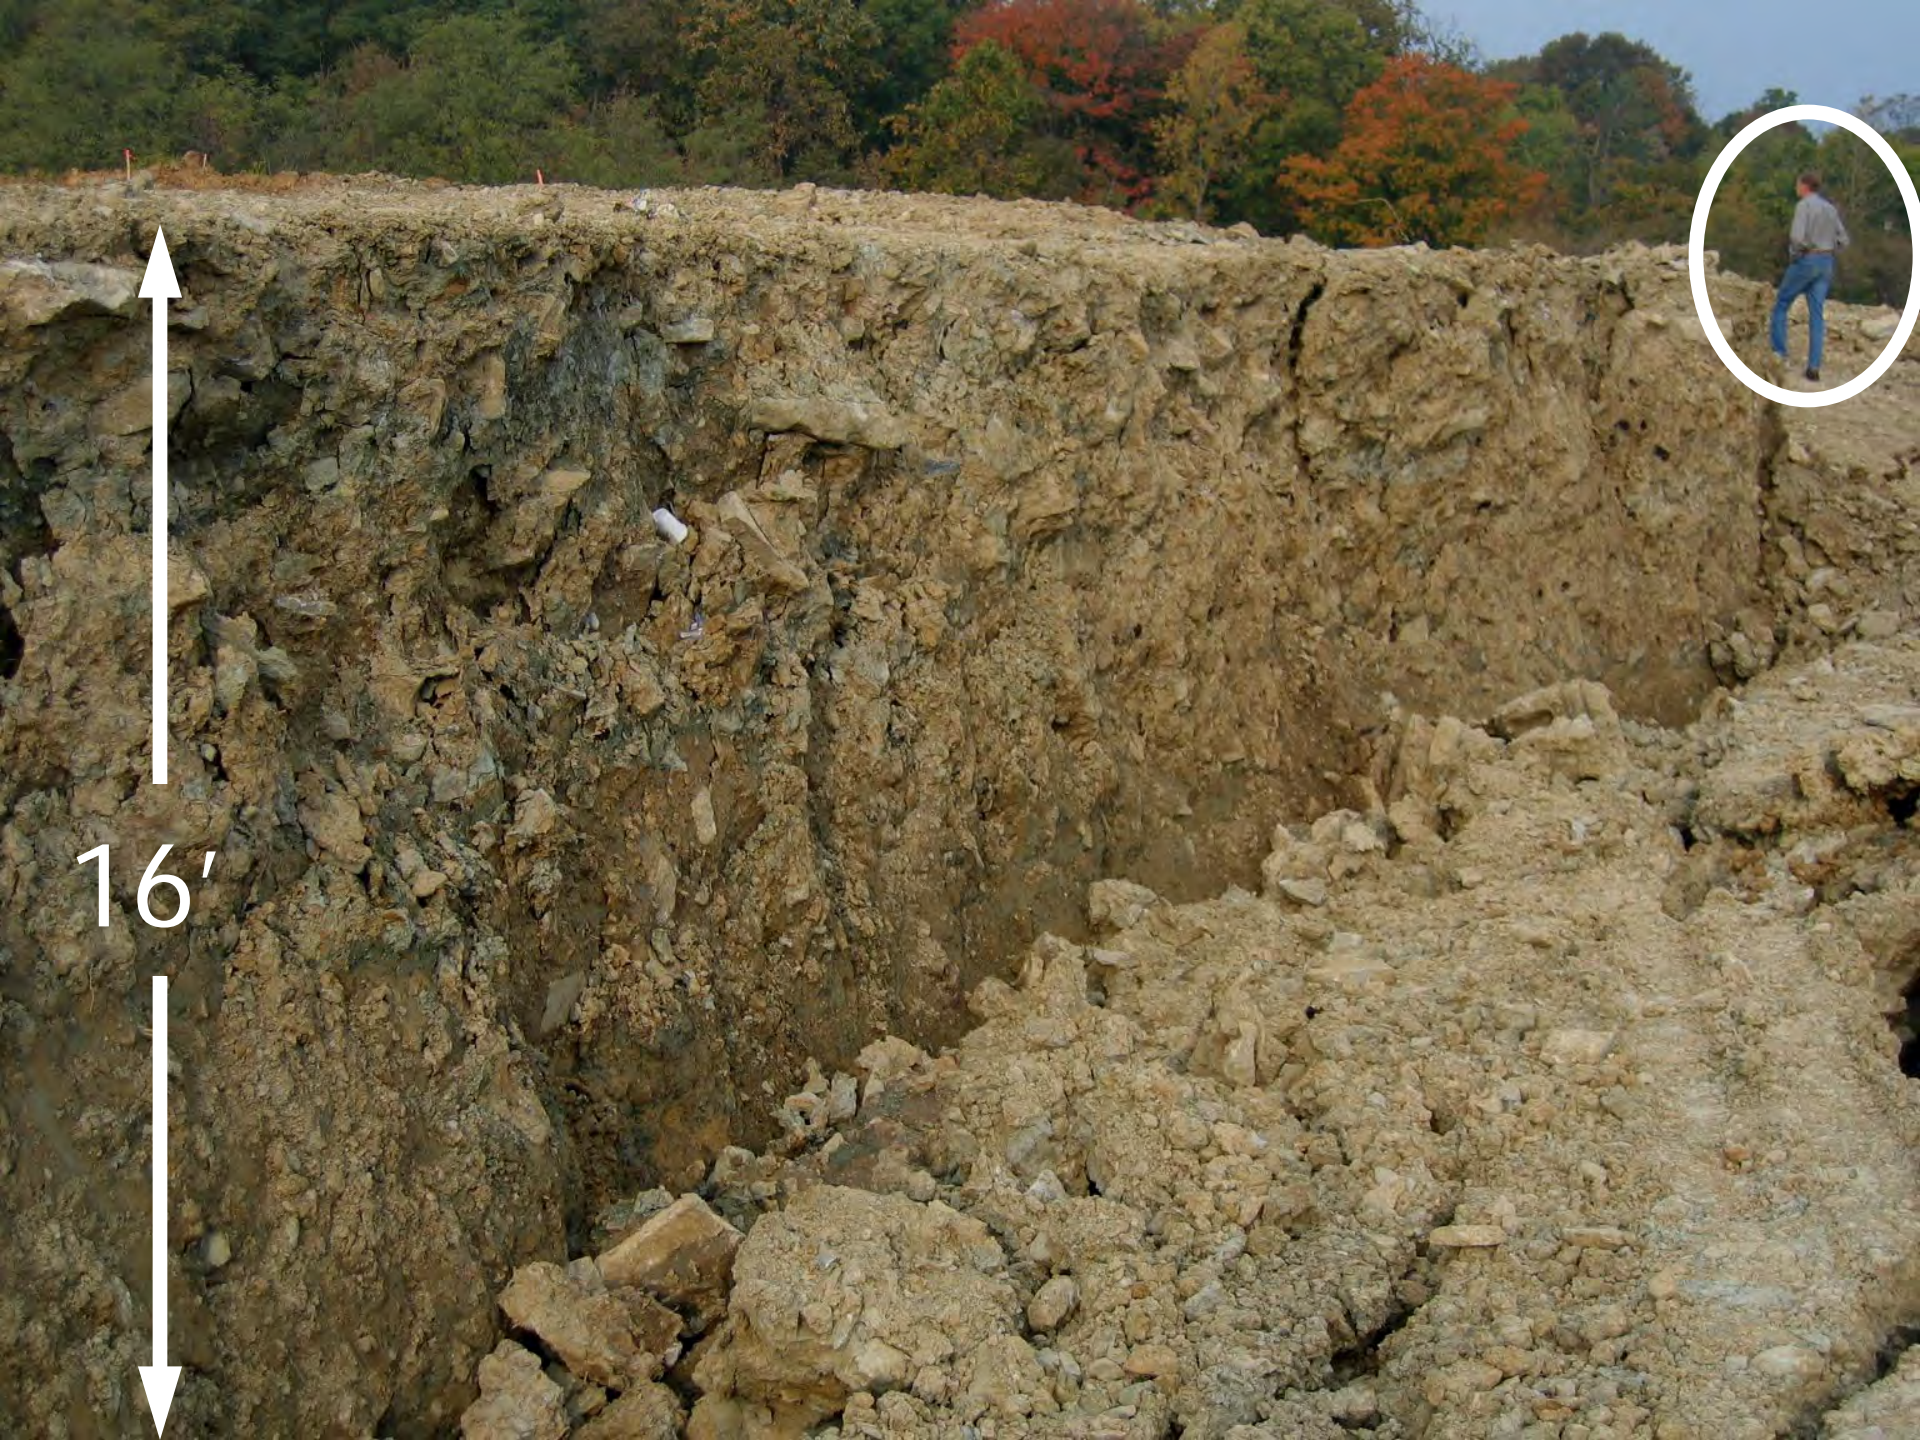
Fill - Well  
Compacted

16'

18 Days After  
the Landslide  
Occurred

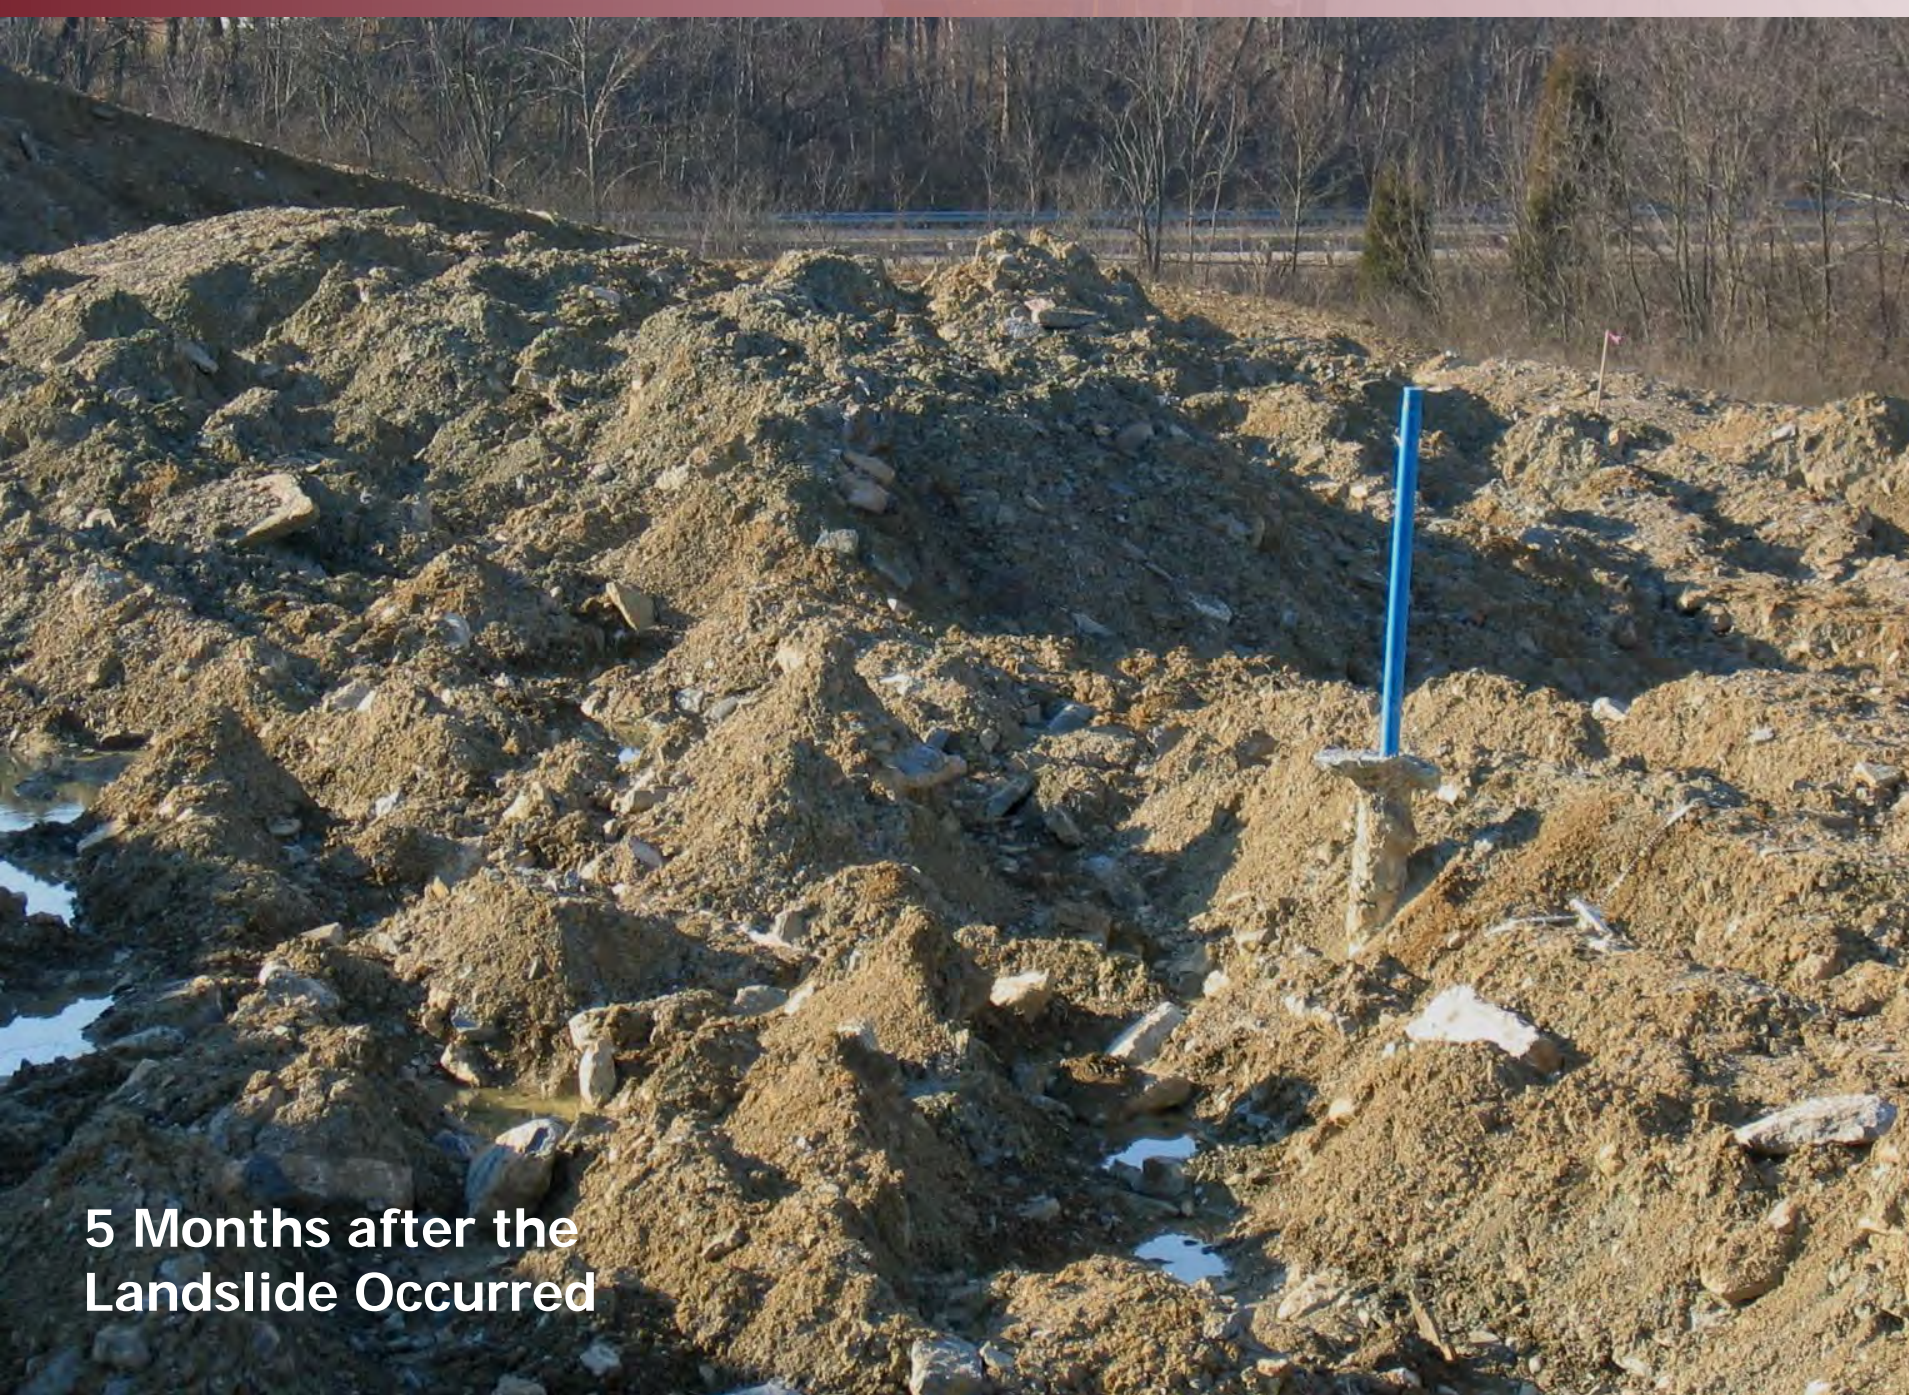
5 Months after the  
Landslide Occurred

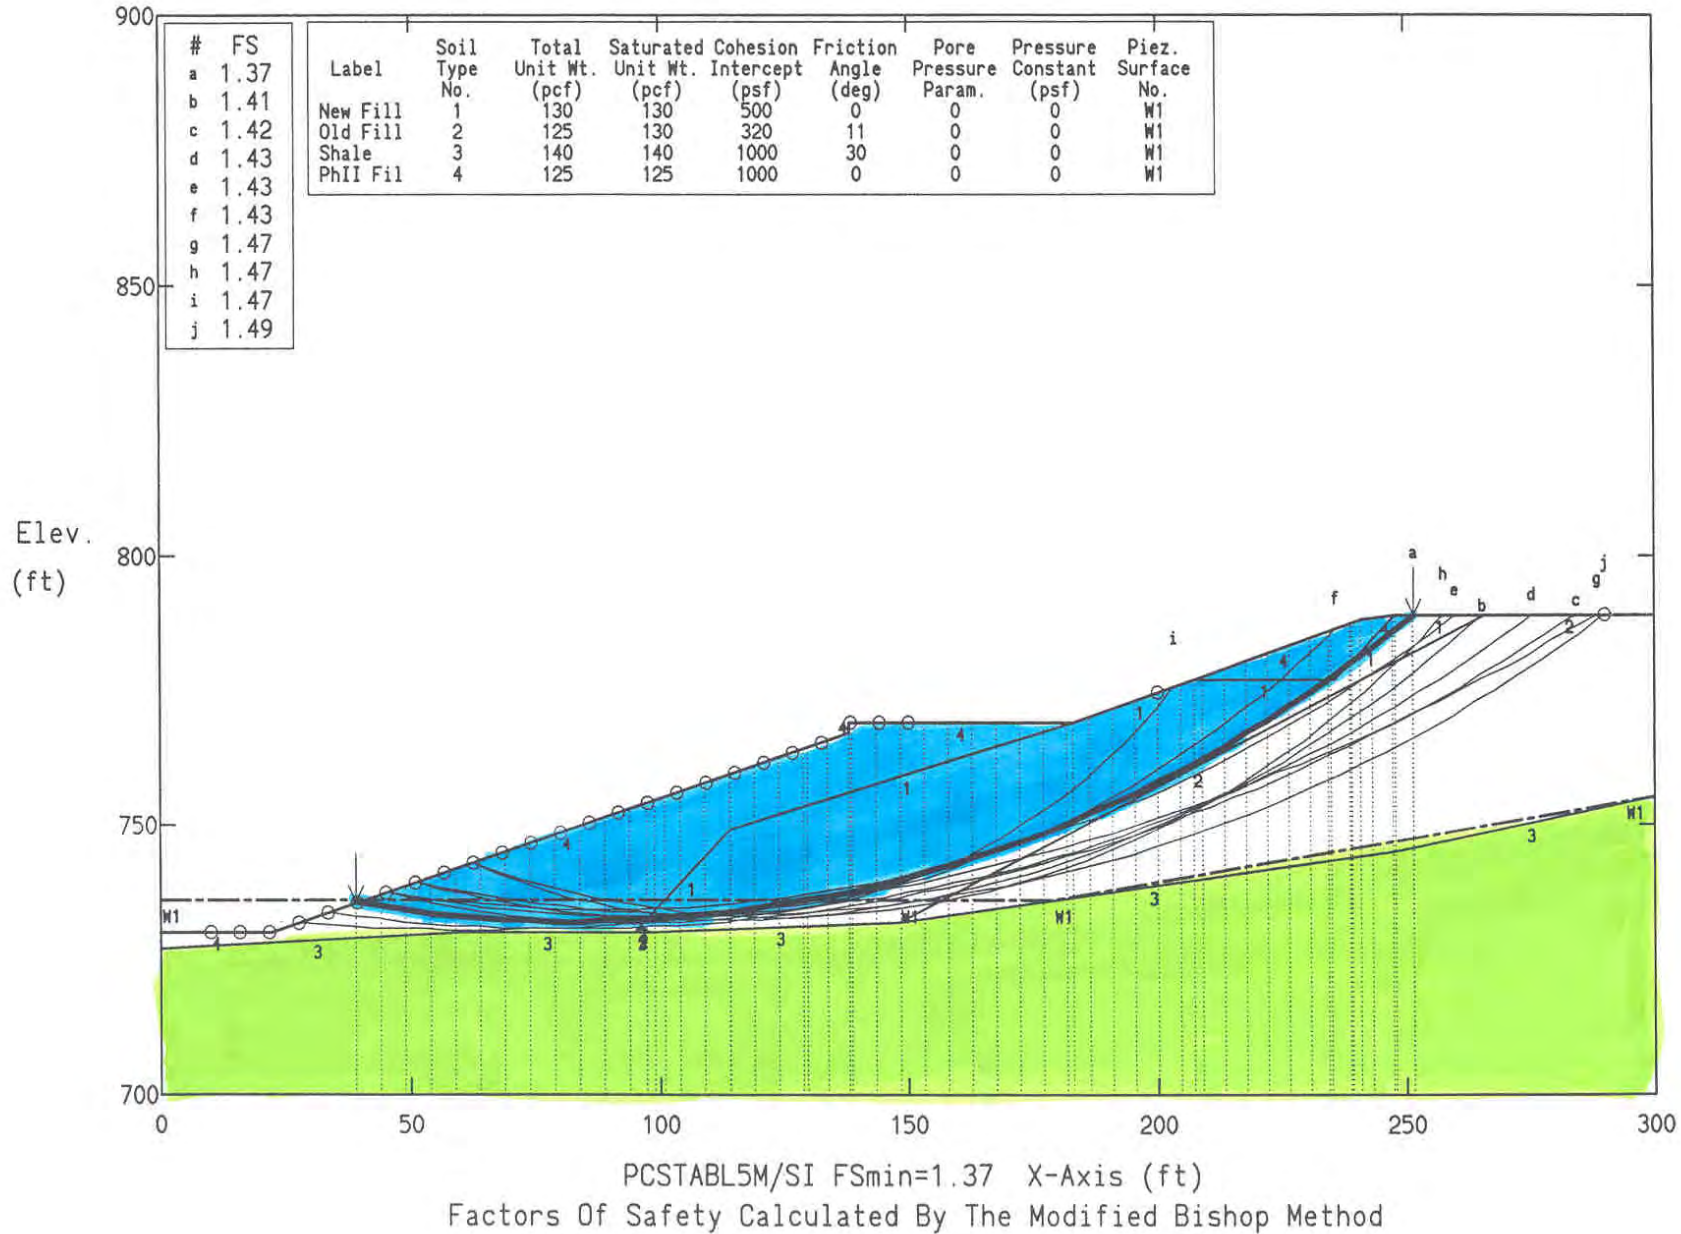
Anderson Park-n-Ride (W.O. 00096.800) Section B-B (Phase II - Short-term)

Ten Most Critical. C:FPRBST.PLT By: H.C. Nutting Company 11/02/2004 1:05pm

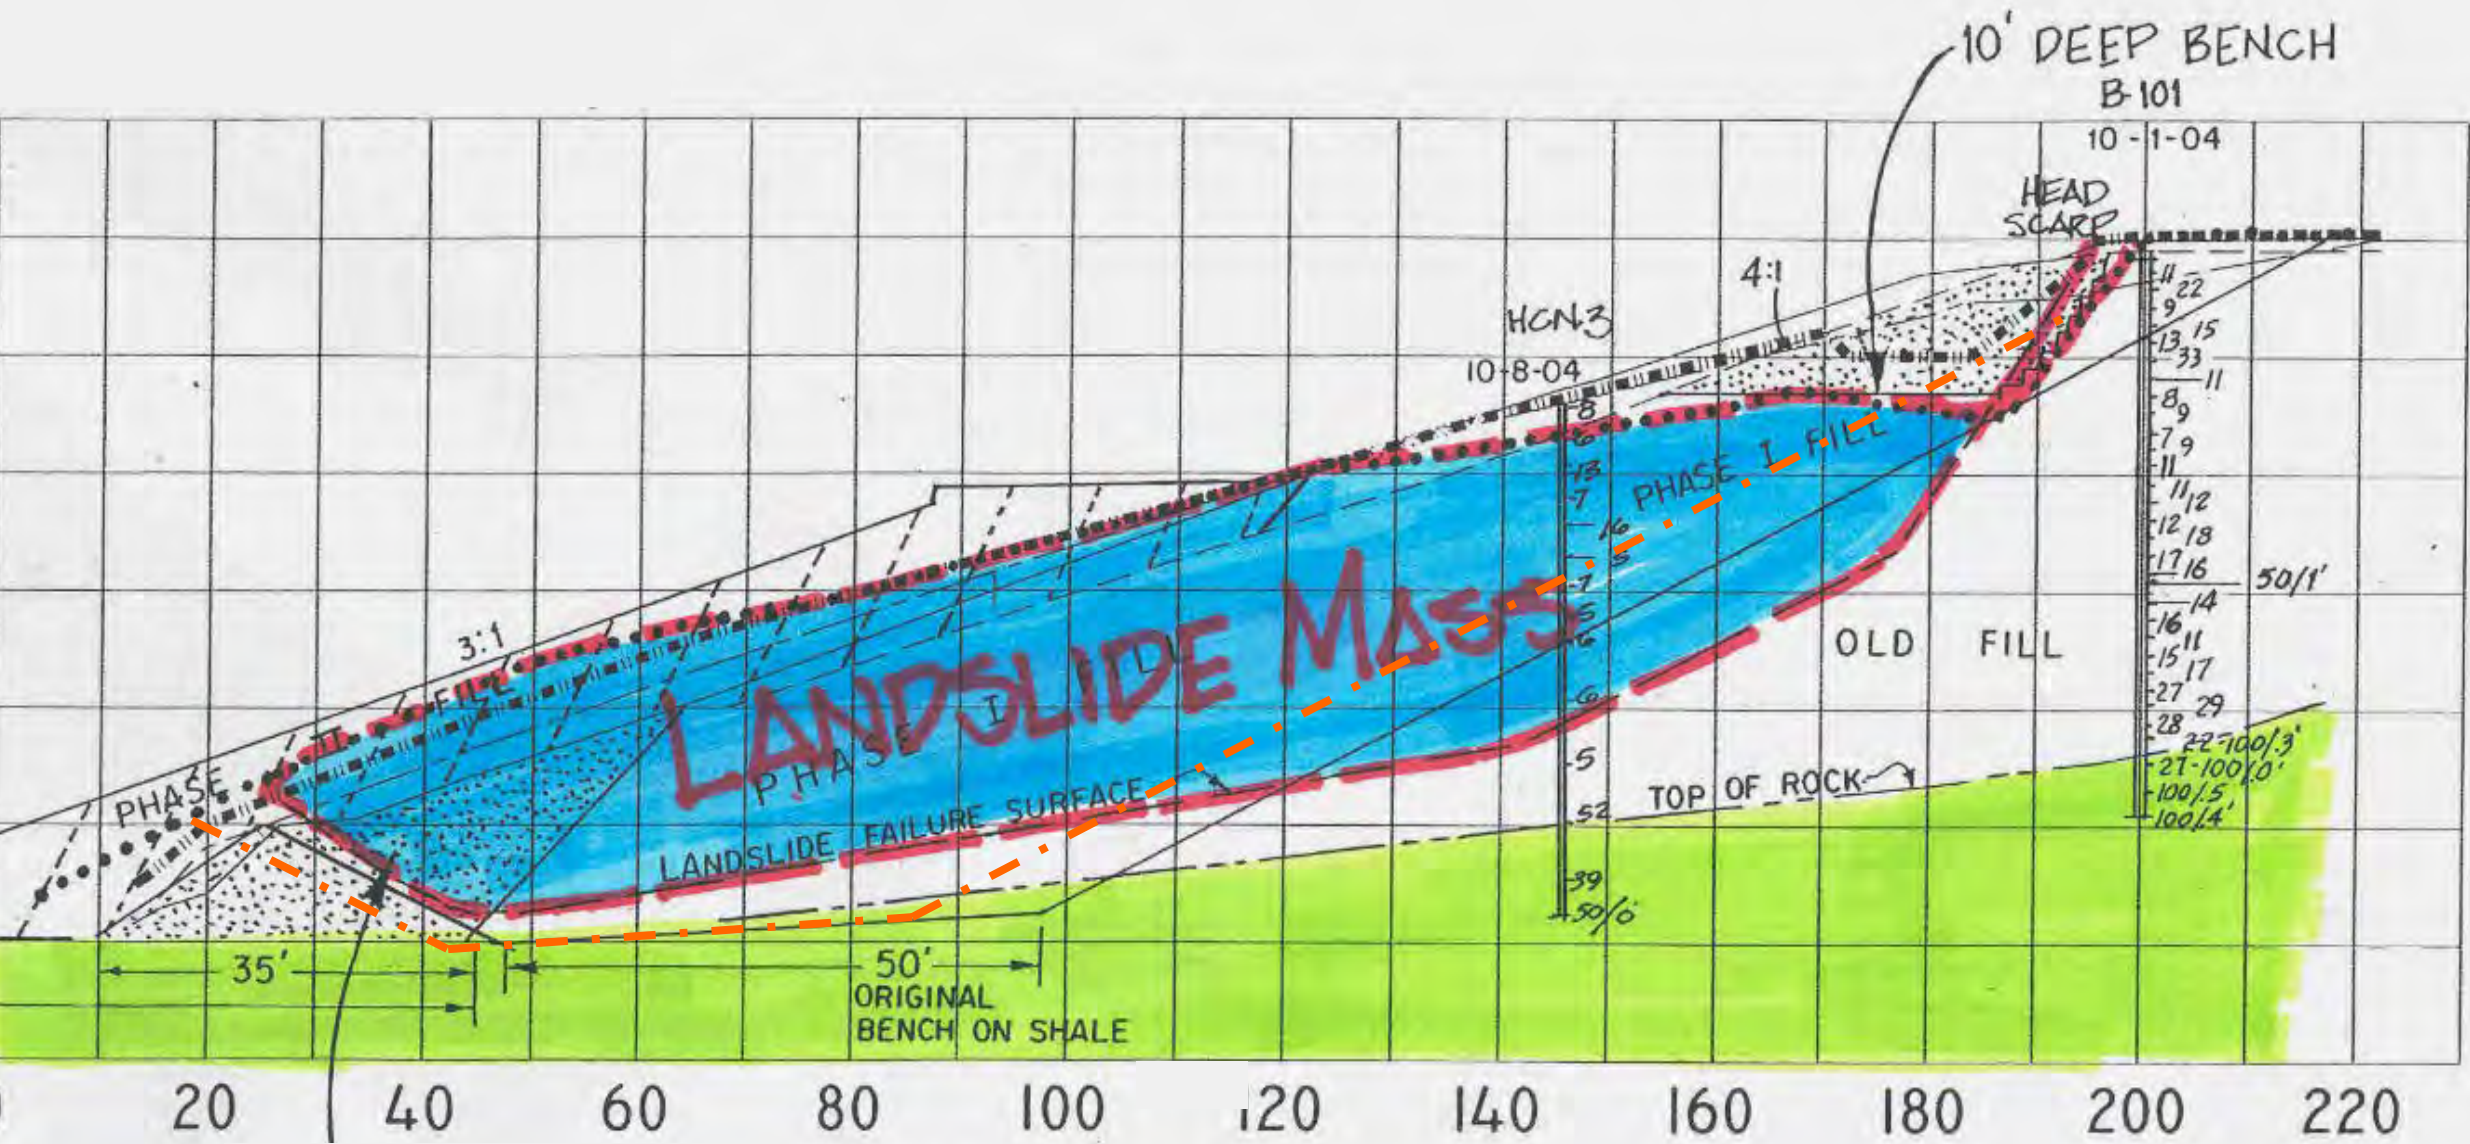
**CROSS-SECTION B-B'**

SCALE: 1"=20'

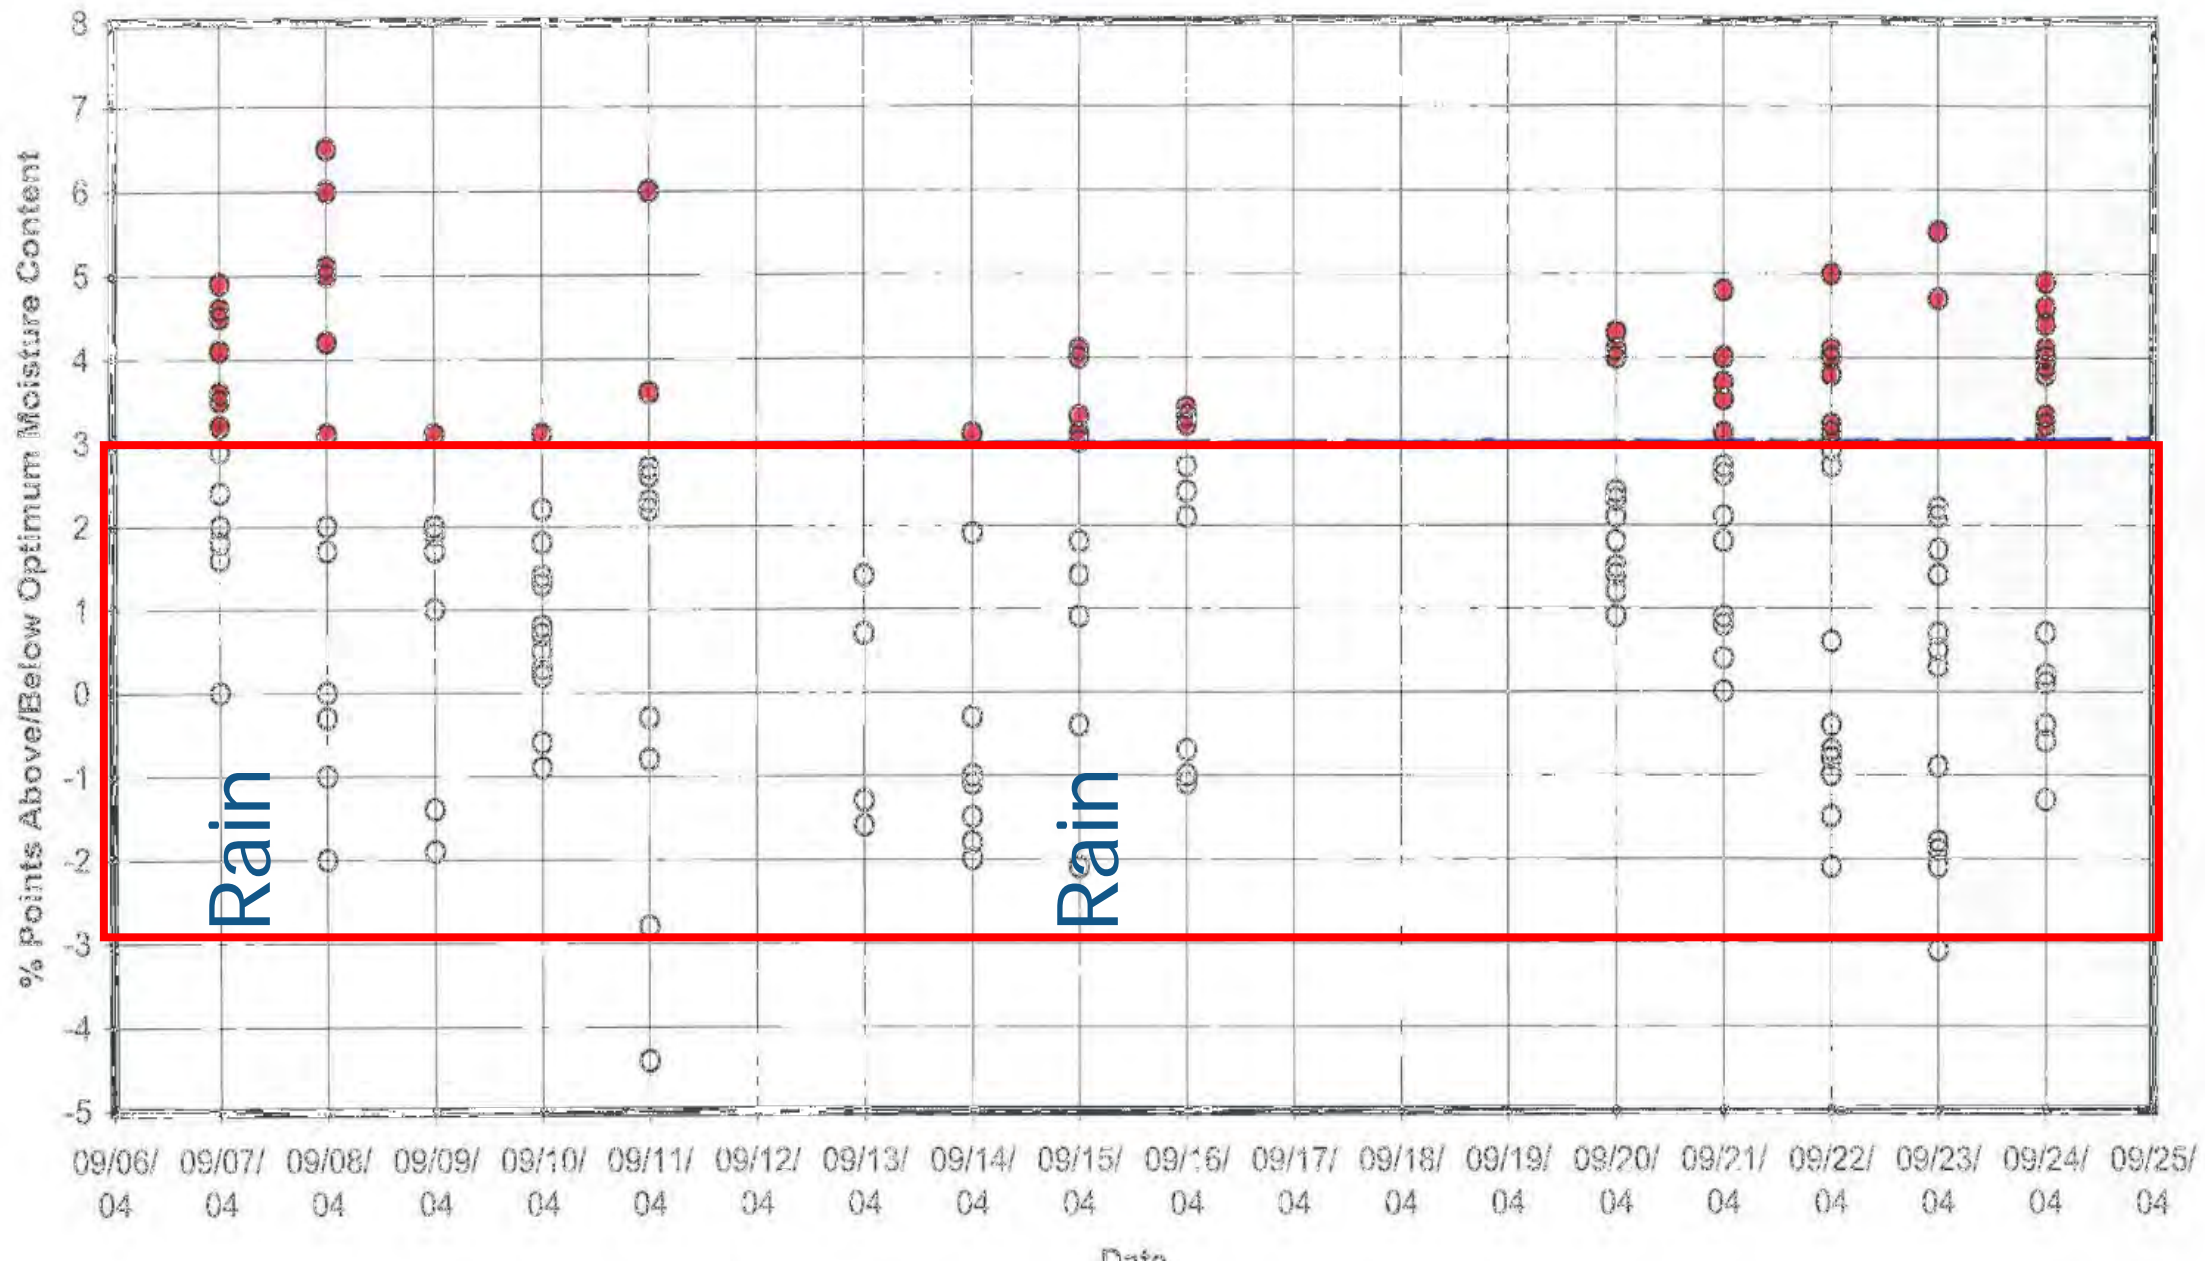
# Fill Moisture Contents

FTD Moisture Content vs. Time  
WO# 00096.800  
Anderson Park-'N-Ride

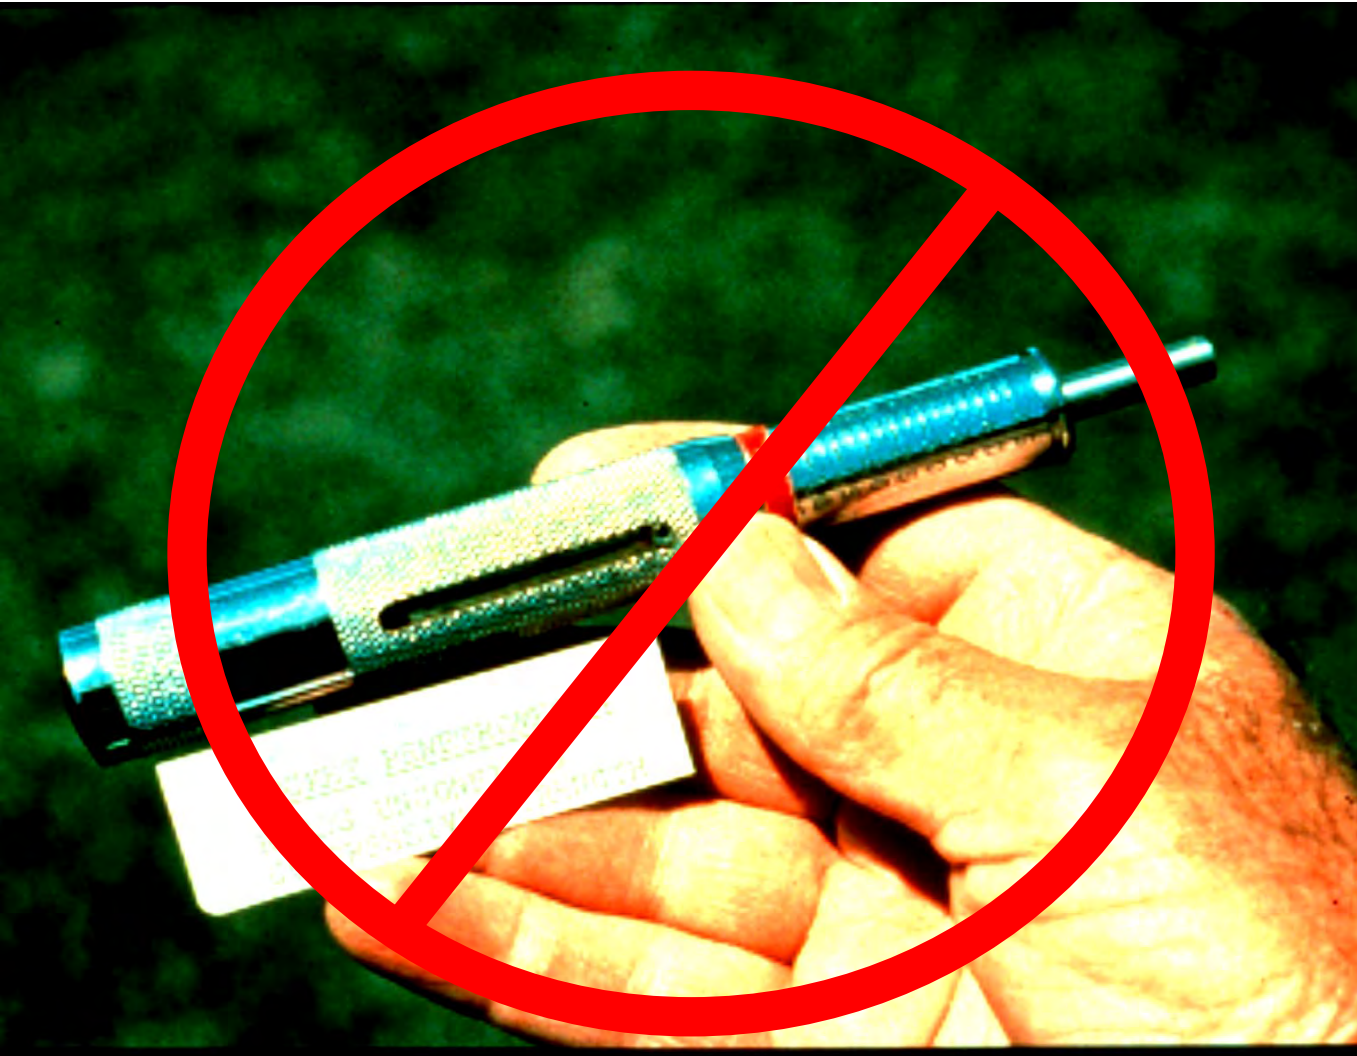
Undrained Shear  
Strength

Not for evaluating  
controlled fill

(false sense of security)

1. Recognize importance of proper control of moisture content of fill soil
2. Do NOT use undrained shear strength to control fill placement
3. Consider excess PWP for all embankments greater than 30 feet high

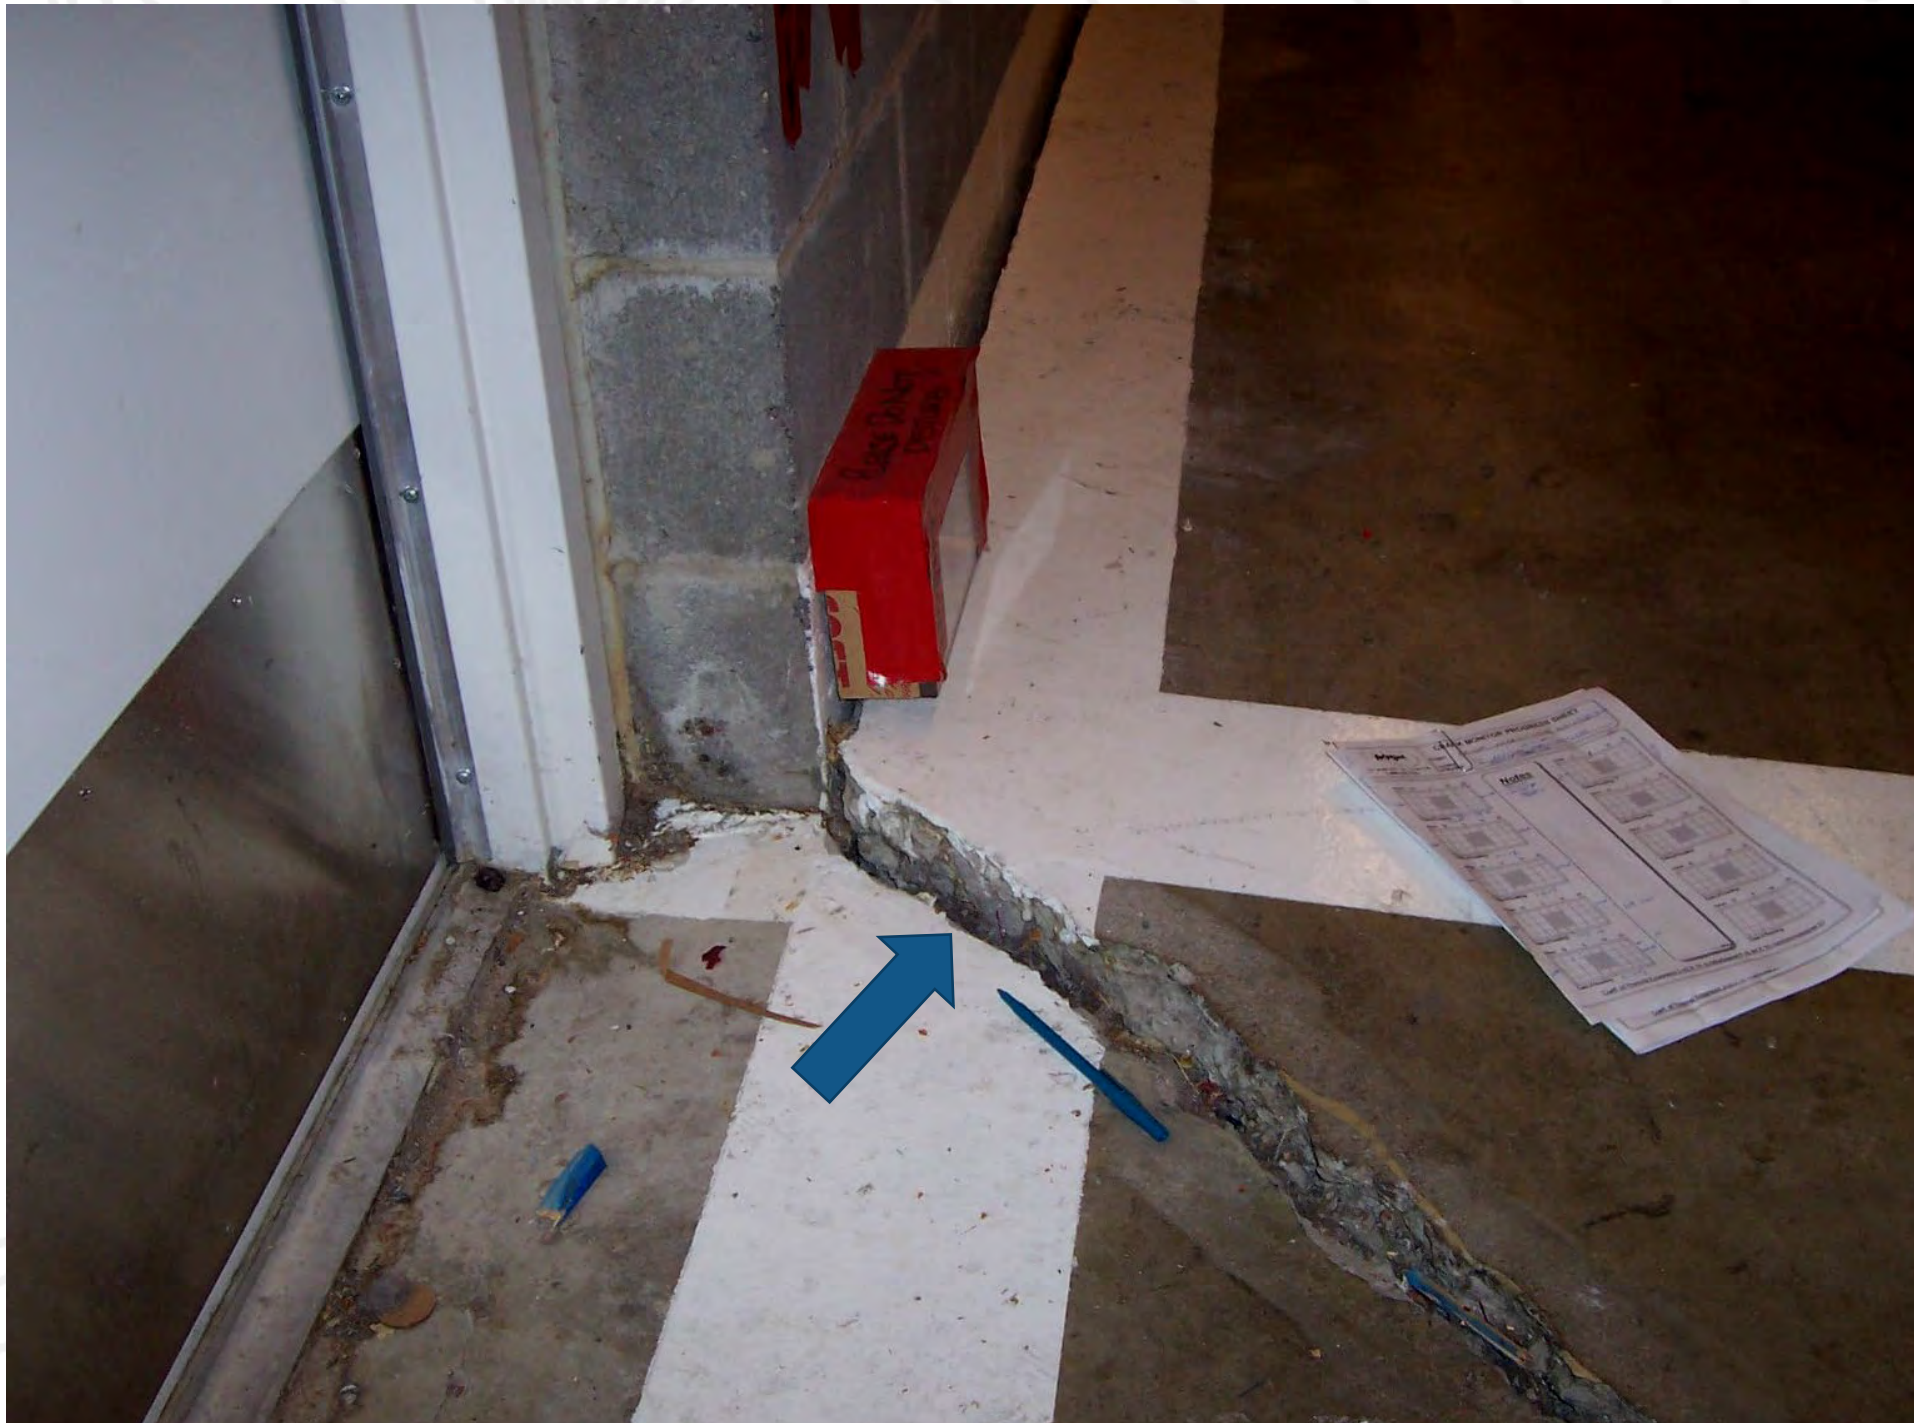
**Floor Slab  
Heave in  
'Back Room'**
