# Lessons Learned in Geotechnical Engineering

- 1) Excess Pore Water Pressure
- 2) Pyritic Sulfur

Presented by: George C. Webb, P.E.  
Terracon - Cincinnati

Landslide due to  
Excess  
Porewater  
Pressures

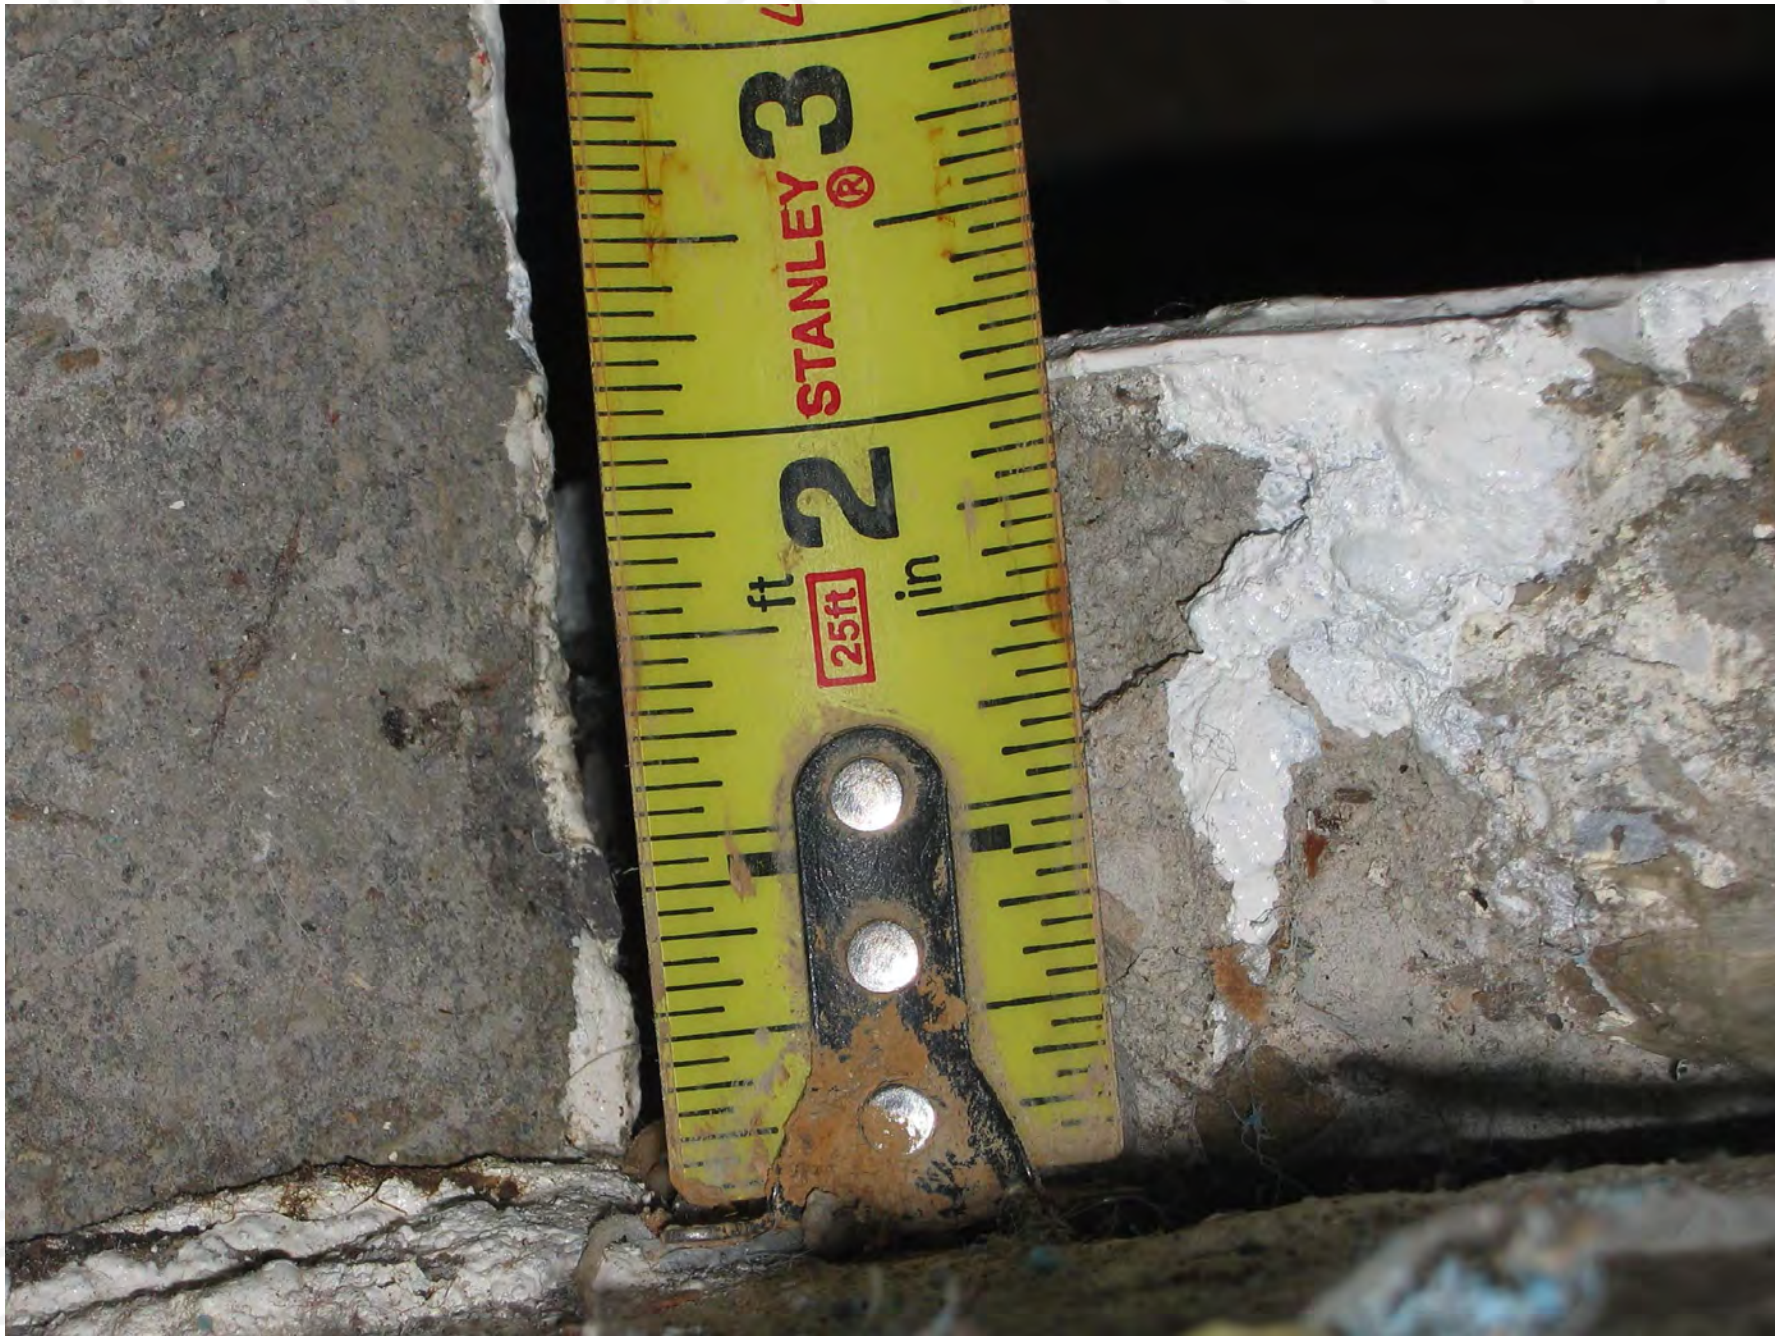
2  $\frac{1}{8}$ " Heave  
In 2006

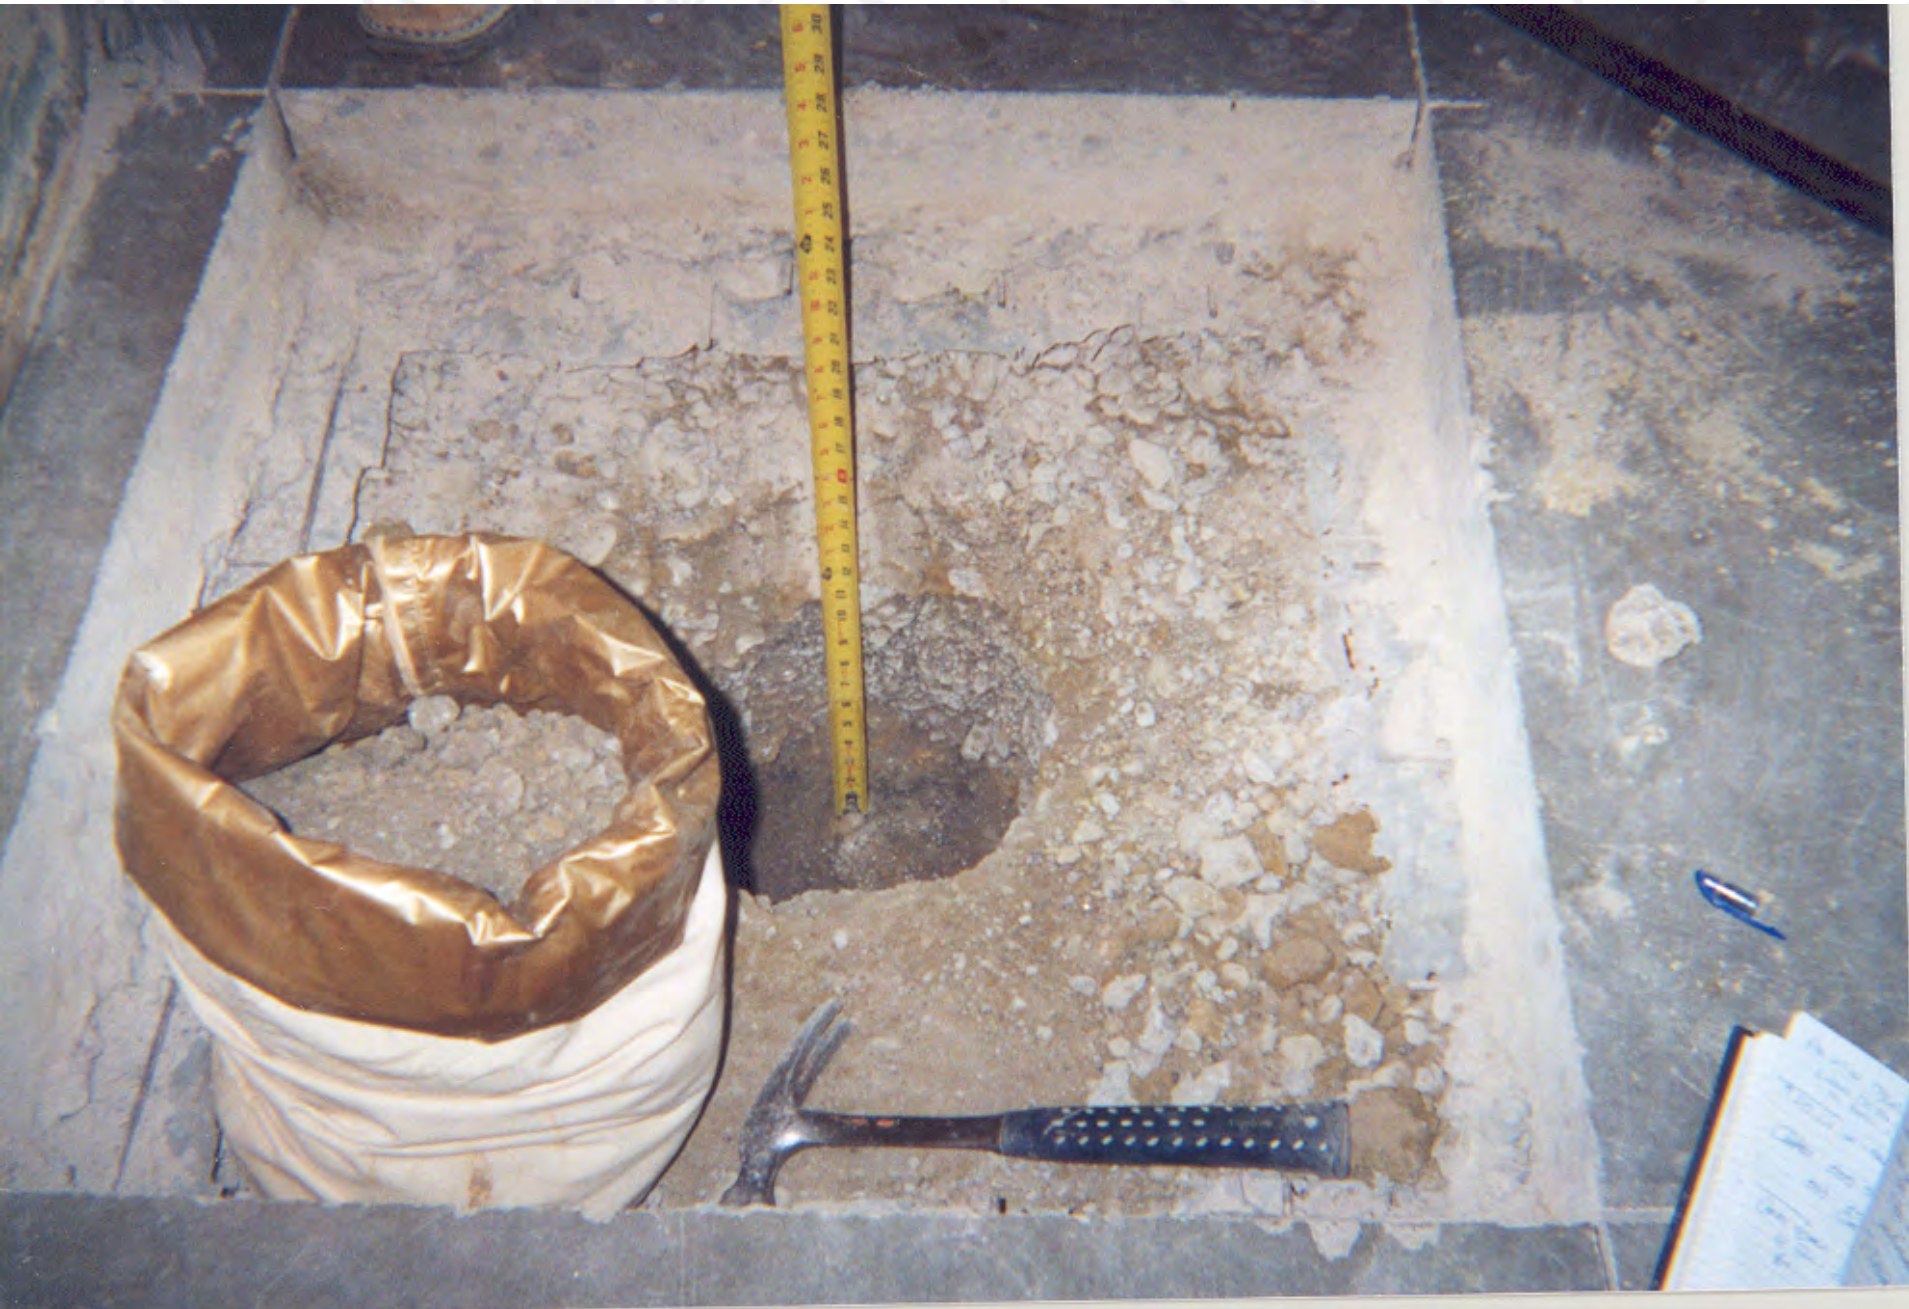
Test Pit  
Bag 4

- **Five Samples Tested for Pyritic Sulfur.**
- **Results varied from 0.17 to 0.21% Pyritic Sulfur (Sulfide Sulfur).**
- **Tests confirmed presence of Pyritic Sulfur below the slab.**
- **Performed X-Ray Diffraction tests which showed the presence of Basaluminite ( $\text{Al}_4(\text{SO}_4)(\text{OH})_{10} 5\text{H}_2\text{O}$ ) from the oxidation of Pyrite ( $\text{H}_2\text{S}$ ).**

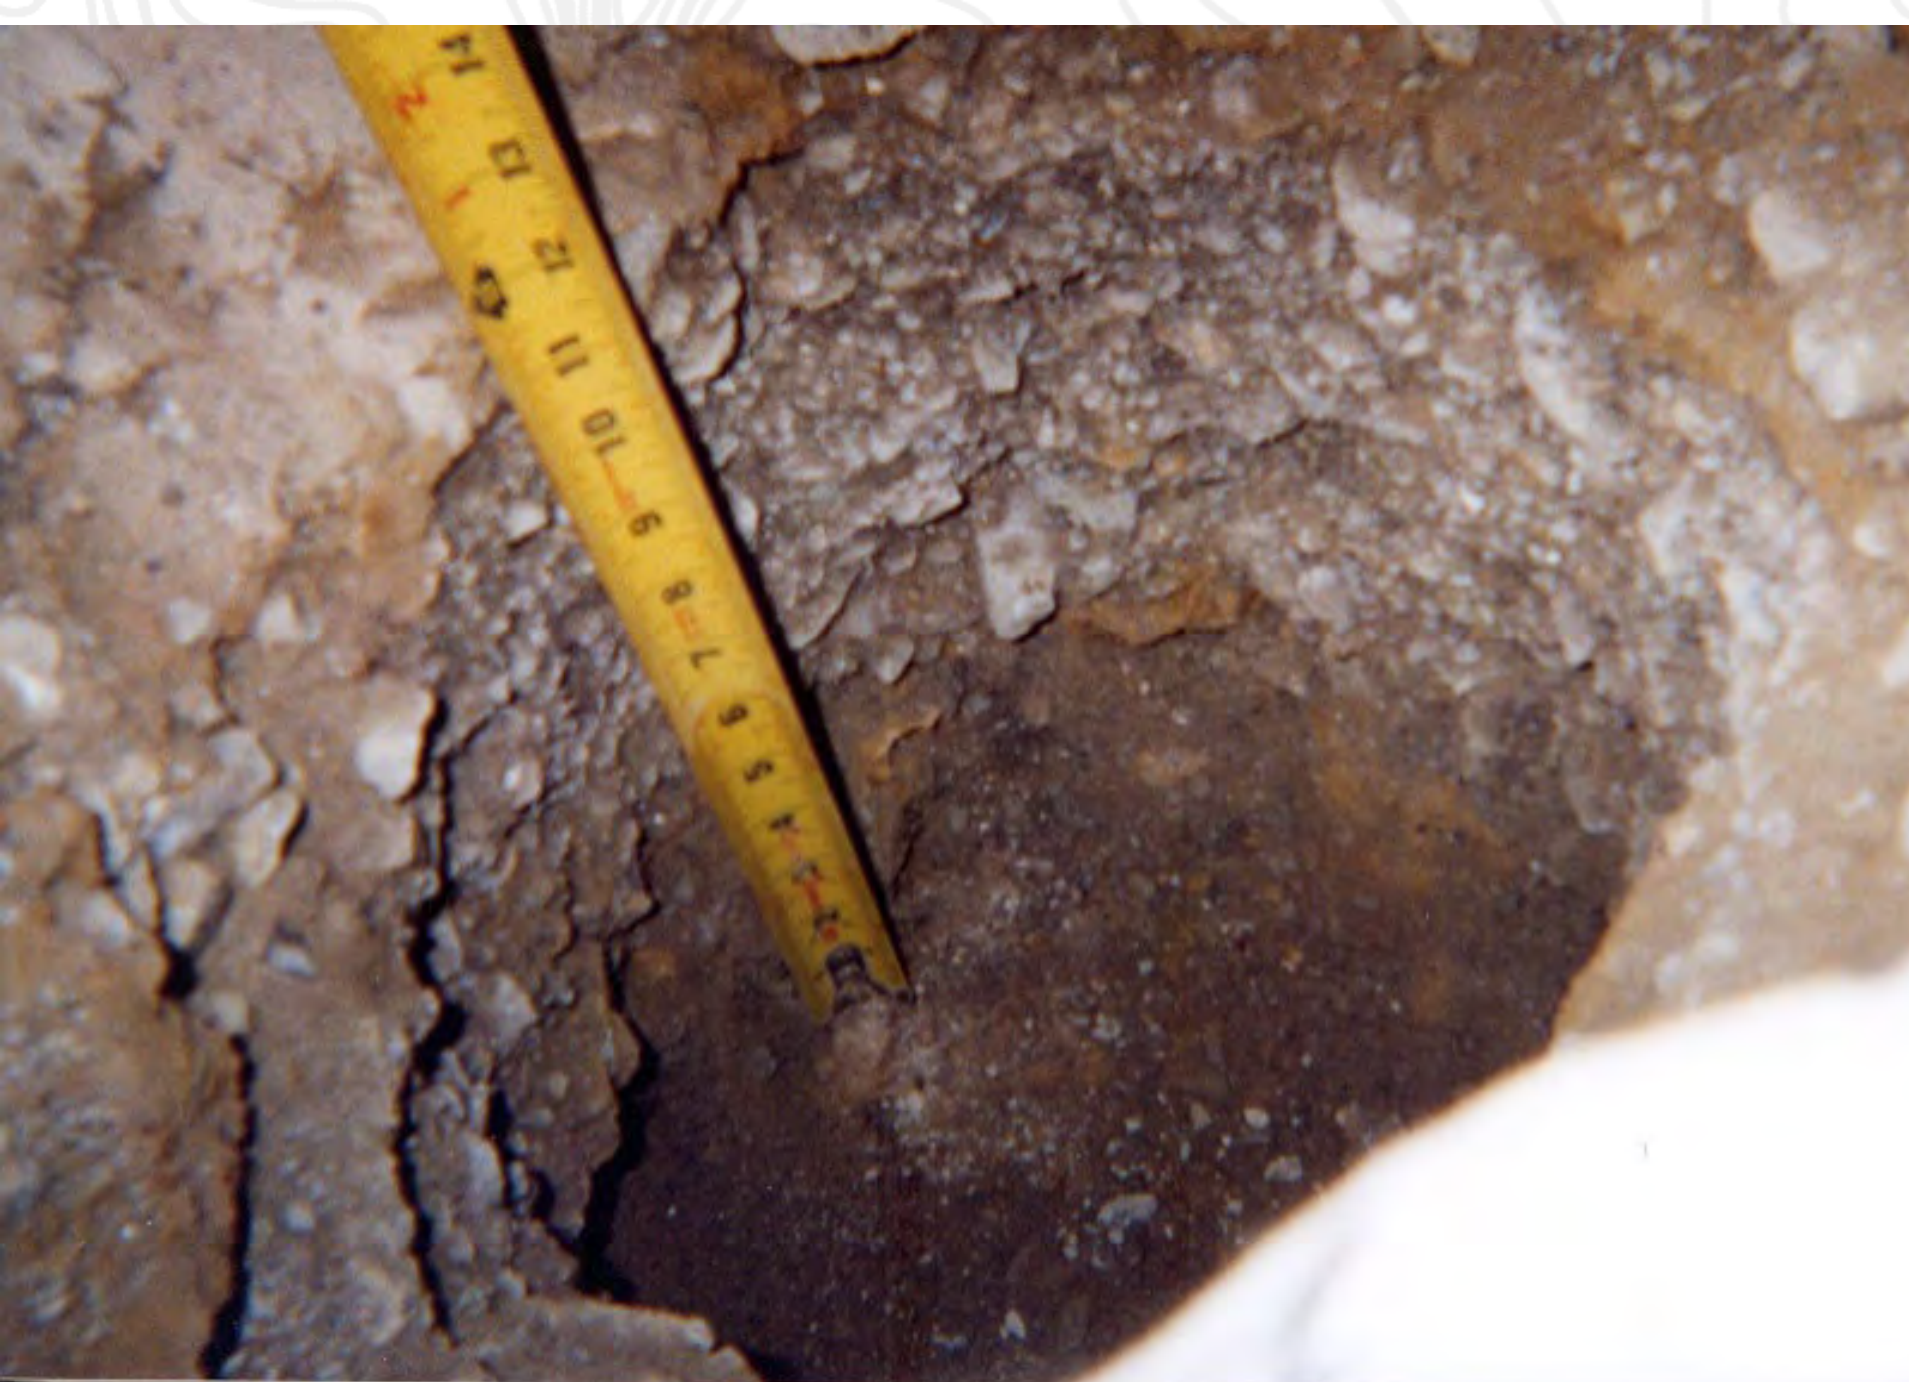
Very Densely  
Compacted  
Trench Backfill

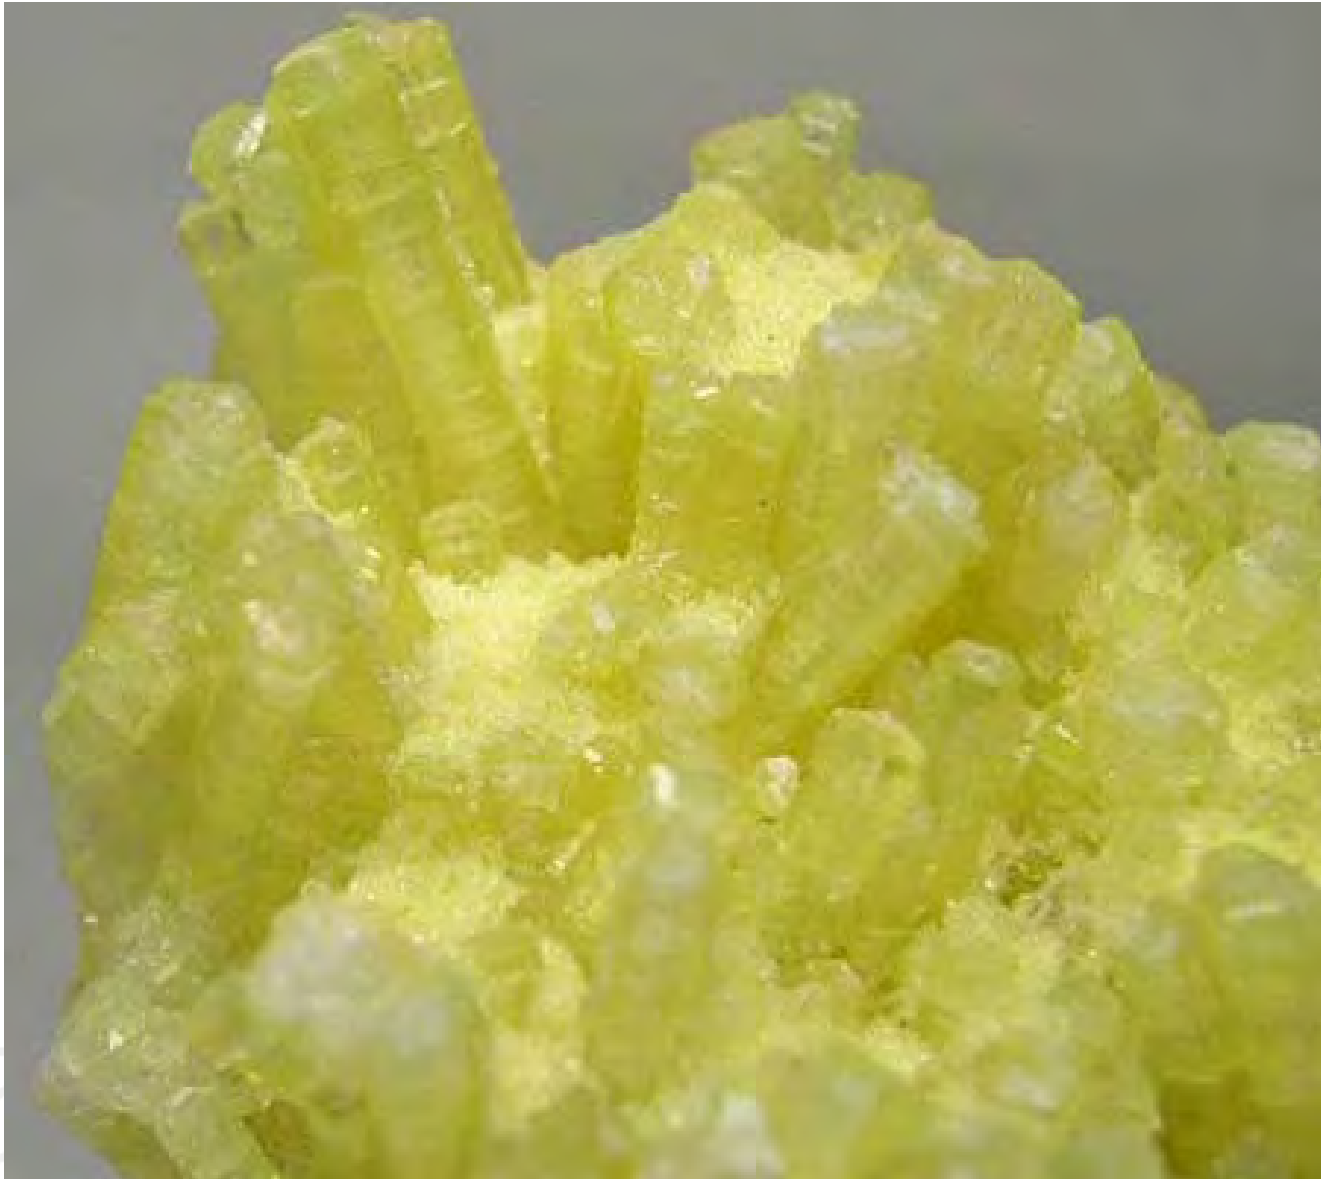
# Ettringite Crystals

- **Gypsum and Ettringite Crystal Growth**

- 1. Know the materials you are recycling.**
- 2. Never use slag or cinder materials inside of a building.**
- 3. Heave pressures from secondary mineral growth are significant.**
