Geotechnical Lessons Learned from Construction of a Tire Plant in Karst

The NS2 Case History – A Tire Plant over Karst conditions

▶ NS2 Tires, White, Georgia

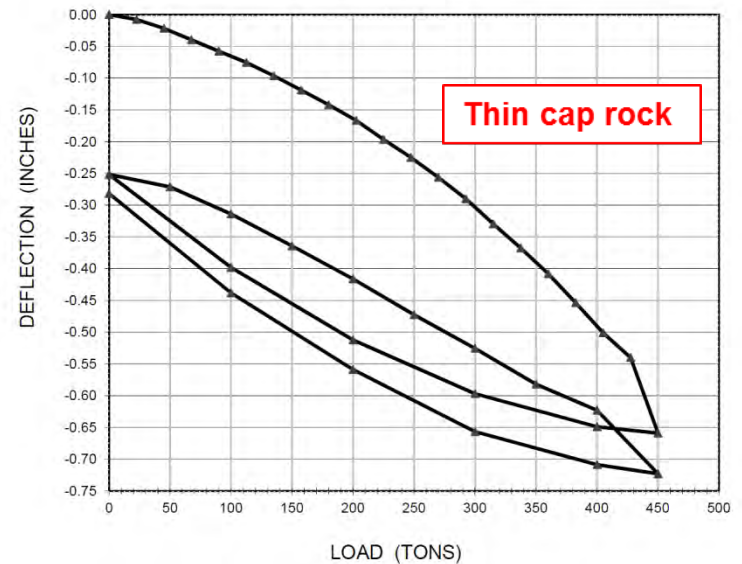
Pile # 6079 (18-inch Dia Compression Test)
Pile Length - 44.5 feet

Test Pile Number	Maximum Applied Test Load (tons)	Creep at Maximum Load		Actual Test Pile Length	Depth to Top of Rock*	Est. Thickness of Rock Below Pile Tip*
		Initial Load Cycle	Rapid Reload Cycle			
6023	450	0.049"	Apparent breakage at full load	39'	41'	7'
6027	450	0.042"	0.002"	65'	70'	19'
6049	382.5	Test stopped for safety reasons	No reload attempted	44'	42'	7'
6073	450	0.014"	0.017"	66'	50'	3'
6079	450	0.081"	0.042"	44.5'	45'	2'

- ▶ During installation of the probe, reaction, & test piles several lessons were learned:
 - As production progresses, grout takes were expected to lessen.
 - **Earliest piles tend to seal upper rock surface & reduce number of open passages into lower voids in rock.**
 - Supporting a pile on thin rock seams 2 to 3 feet thick is practical (see piles 6073 & 6079).

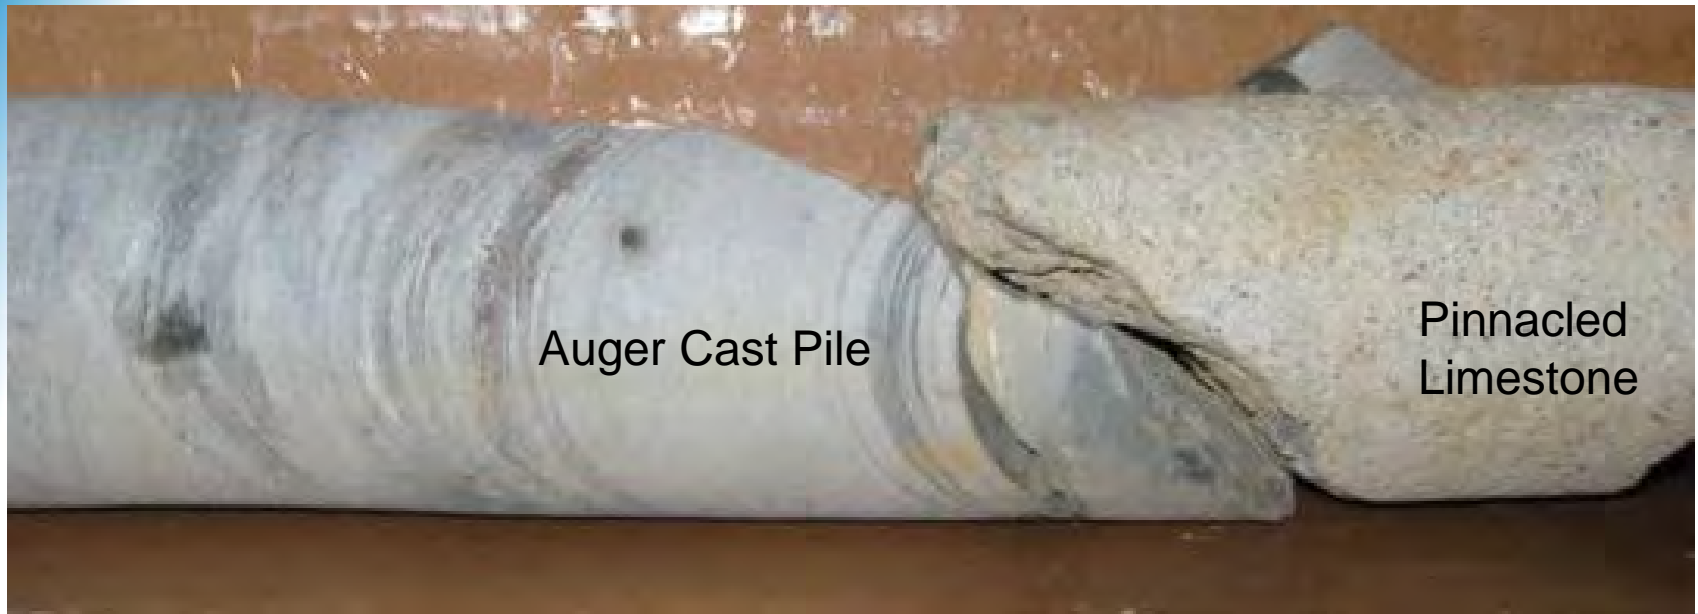
NS2 Tire Phase 3 – Test Piles

Client requested coring of TP # 6049 to inspect interface between pile & pinnacled rock

Pile Contractor said coring the pile couldn't be done. **We did it!**

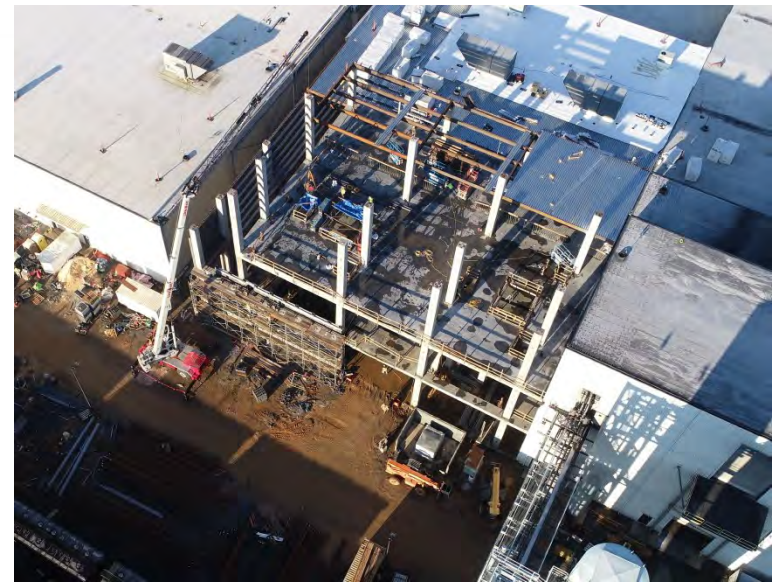
Example of pinnacled rock in carbon black pit excavation

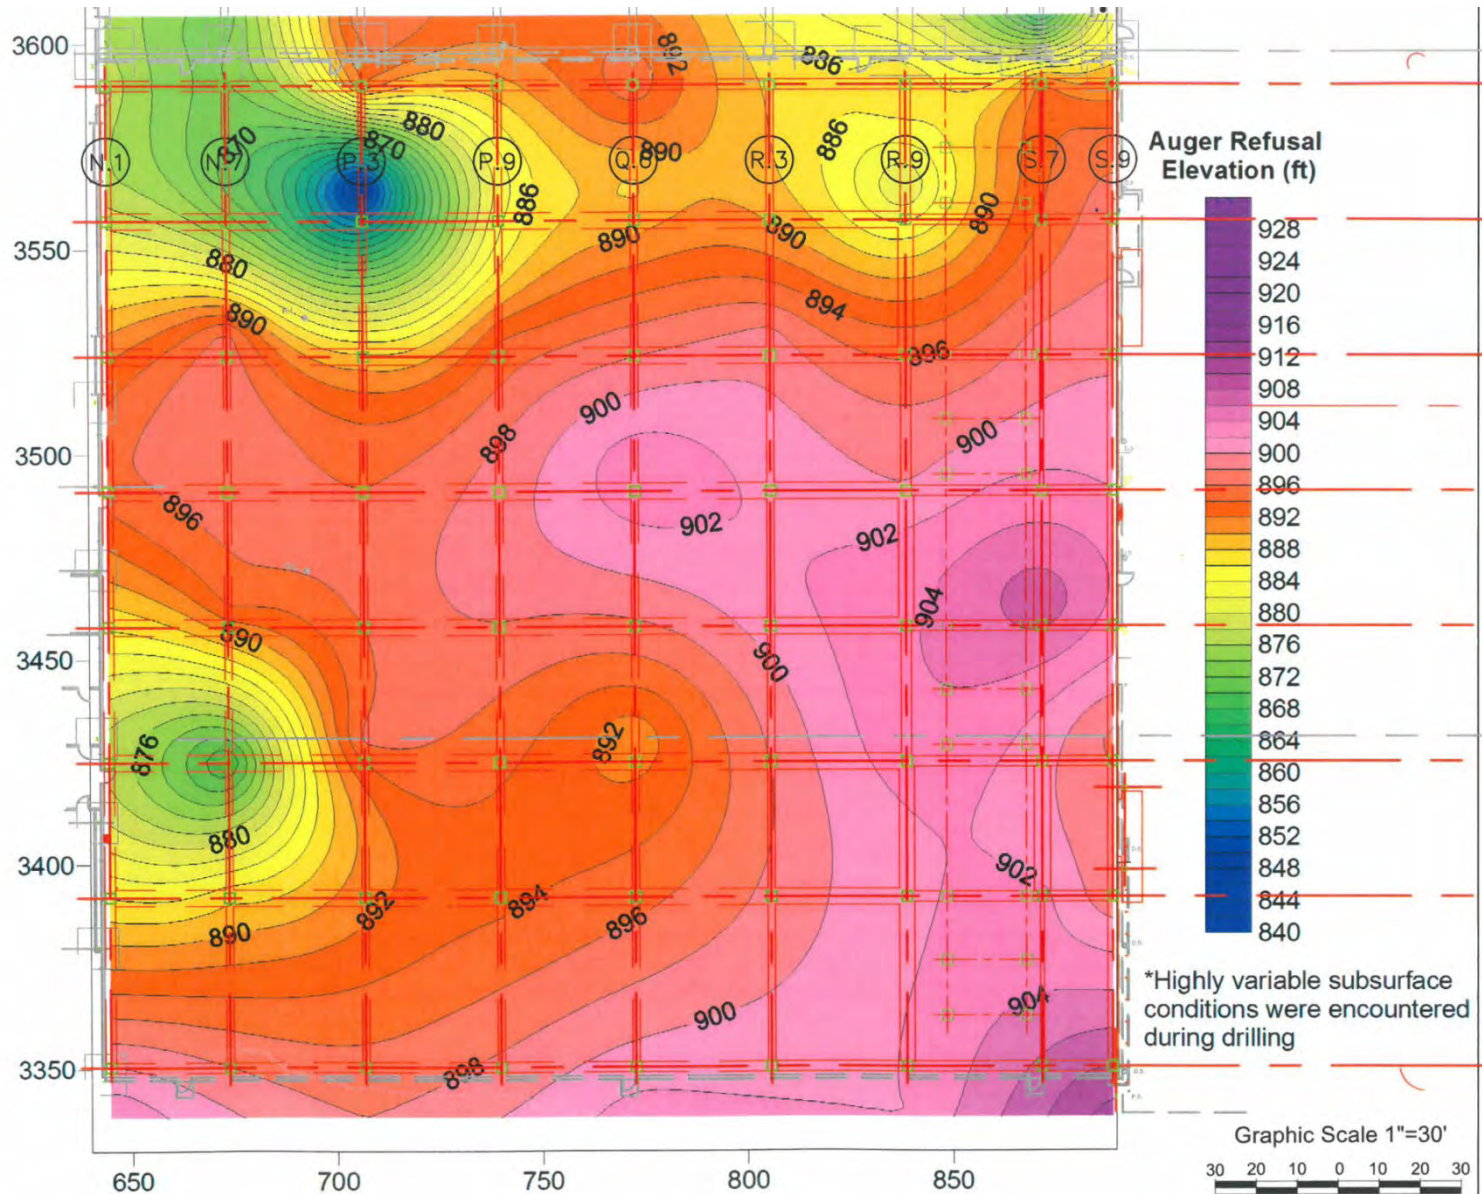
Variability in rock surface – Phase 4 Mixing Tower

- ▶ Phase 4 drilling found shallower rock than Phase 3 in mixing tower & silo.
- ▶ Some very shallow pinnacled rock was found at depths of 5 to 10 feet below grade near equipment pits.
- ▶ Phase 4 earthwork included deep fill (30+ feet) in existing detention pond to support warehouse.

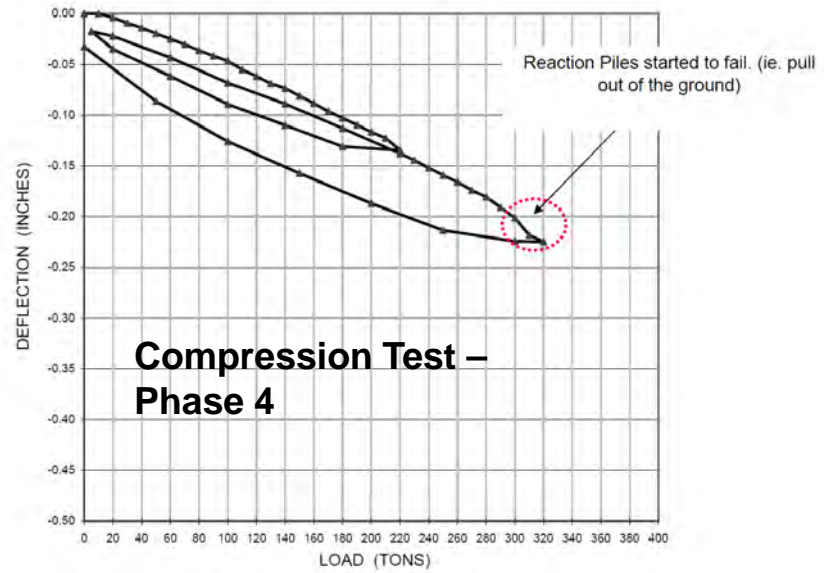
Test Pile #3 (18-inch Diameter Compression Test)
Pile Length - 23 feet
ECS Project Number: 10-7543

Test Pile Number	Type of Test	Maximum Applied Test Load (tons)	Gross Deflection (in)	Design Allowable Load (tons)	Actual Pile Length
TP#1	Compression	400	0.286	110	27'
TP#2	Tension	52*	0.974	20	29'
TP#3	Compression	310	0.218	110	23'

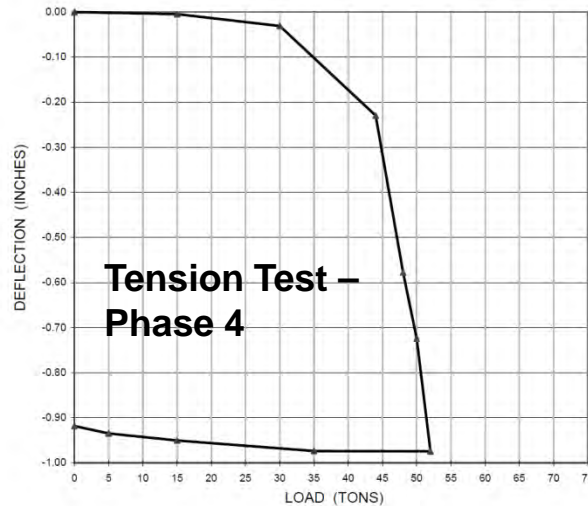
Test Pile #2 (18-inch Diameter Tensile Test)
Pile Length - 29 feet
ECS Project Number: 10-7543

*Load test stopped due to anchor pile pullout.

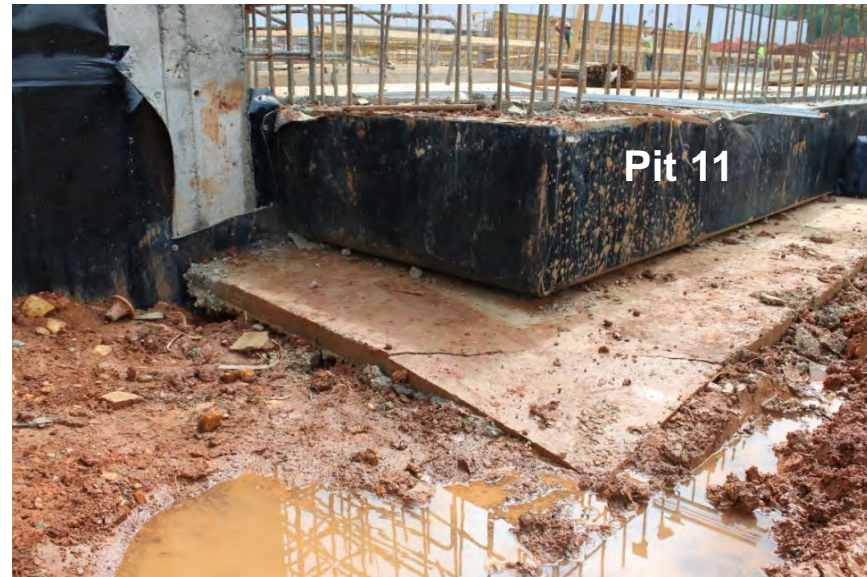
**Distress at Equip.
Pit 11 after 3" rain**

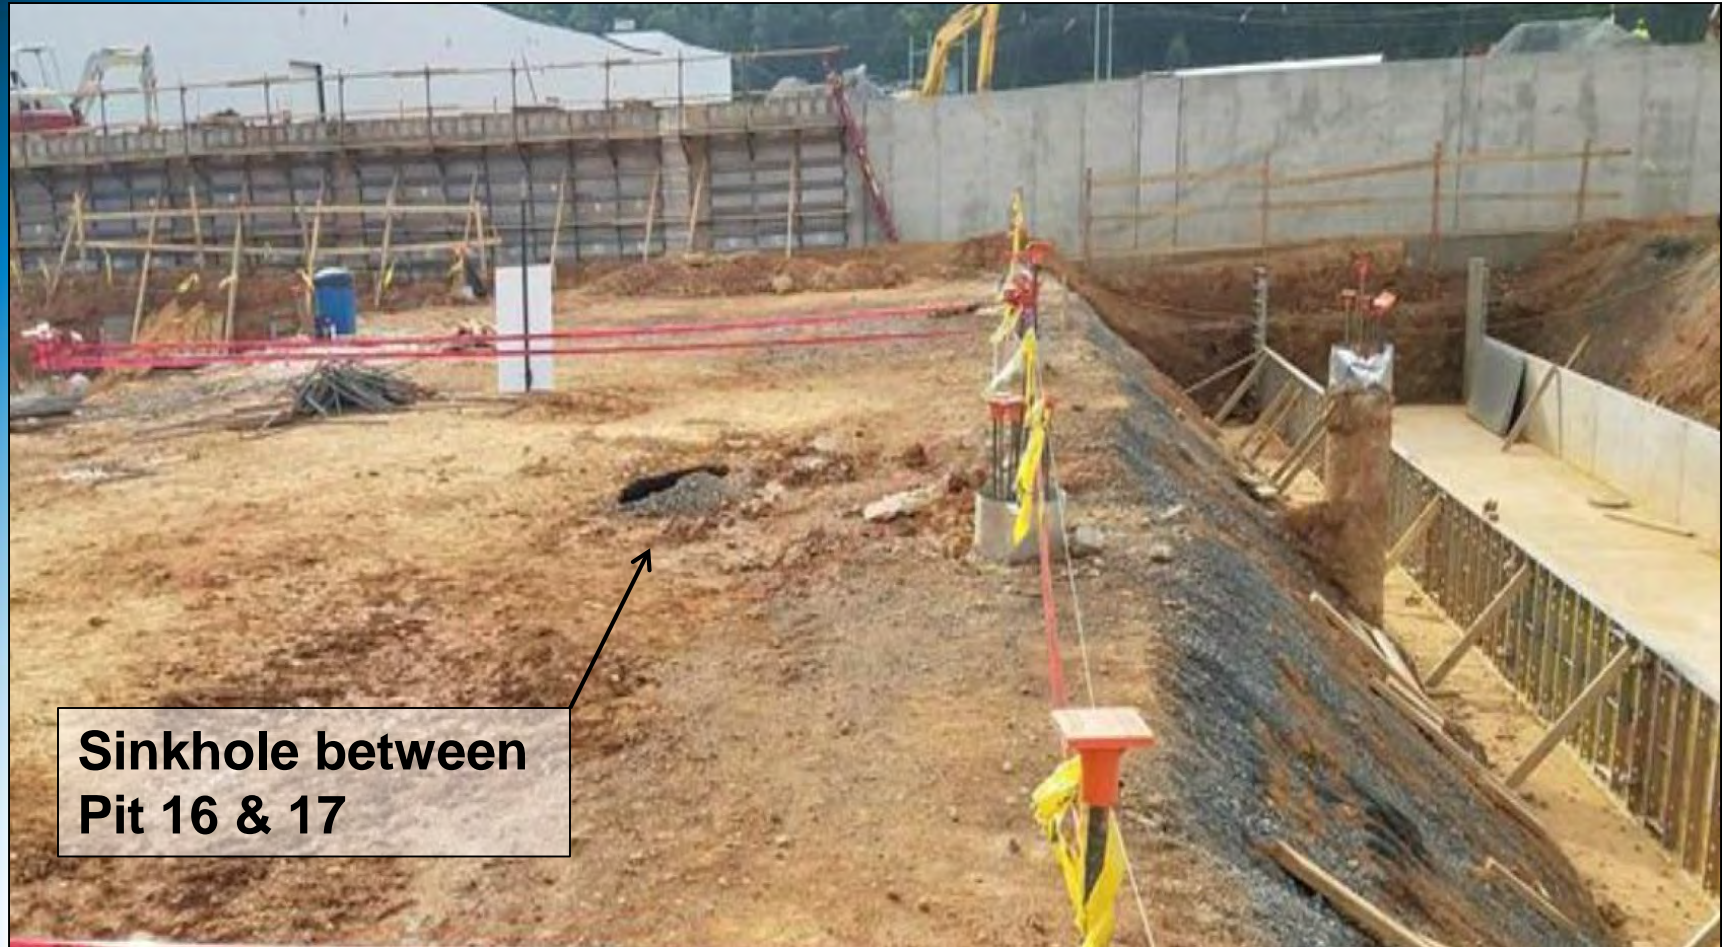
Phase 5 Equip. Pits – Sinkhole

**Sinkhole between
Pit 16 & 17**

Grout Injection No.	Initial Casing Depth (ft)	Total Grout Take (cy)	Ave. Grout Take (cf/LF)	Remarks
1	17.5	NA	NA	Refusal at 17.5', Point not grouted.
1A	52	7.28	3.8	
2	64	30.54	12.9	
3	72	15.29	5.7	
4	61	48.40	21.4	
5	67	69.74	28.1	
6	57	10.10	4.8	
7	72	27.40	10.3	
8	59	15.70	7.2	
9	71	15.05	5.7	
10	70	23.70	9.1	
11	52	5.86	3.0	
12	55	9.02	4.4	
13	71	15.32	5.8	
Totals	823.0	293.4		
Average	63	22.6	9.4

- ▶ Even when you try & mitigate risk of ground relaxations & damage, surprises can happen.
- ▶ After ACIP piles went in w/no issues a sinkhole formed less than 5 feet from a pile.
- ▶ Moderate to high grout takes were experienced after ACIP installation.
- ▶ Sinkholes can appear when least expected...
