REHABILITATION OF THE CENTRAL MACHU PICCHU HYDROELECTRIC PLANT

**CONSTRUCTION OF GALLERIES
CONNECTING THE POWERHOUSE TO THE
TAILRACE TUNNEL**

OCTOBER 1, 2013

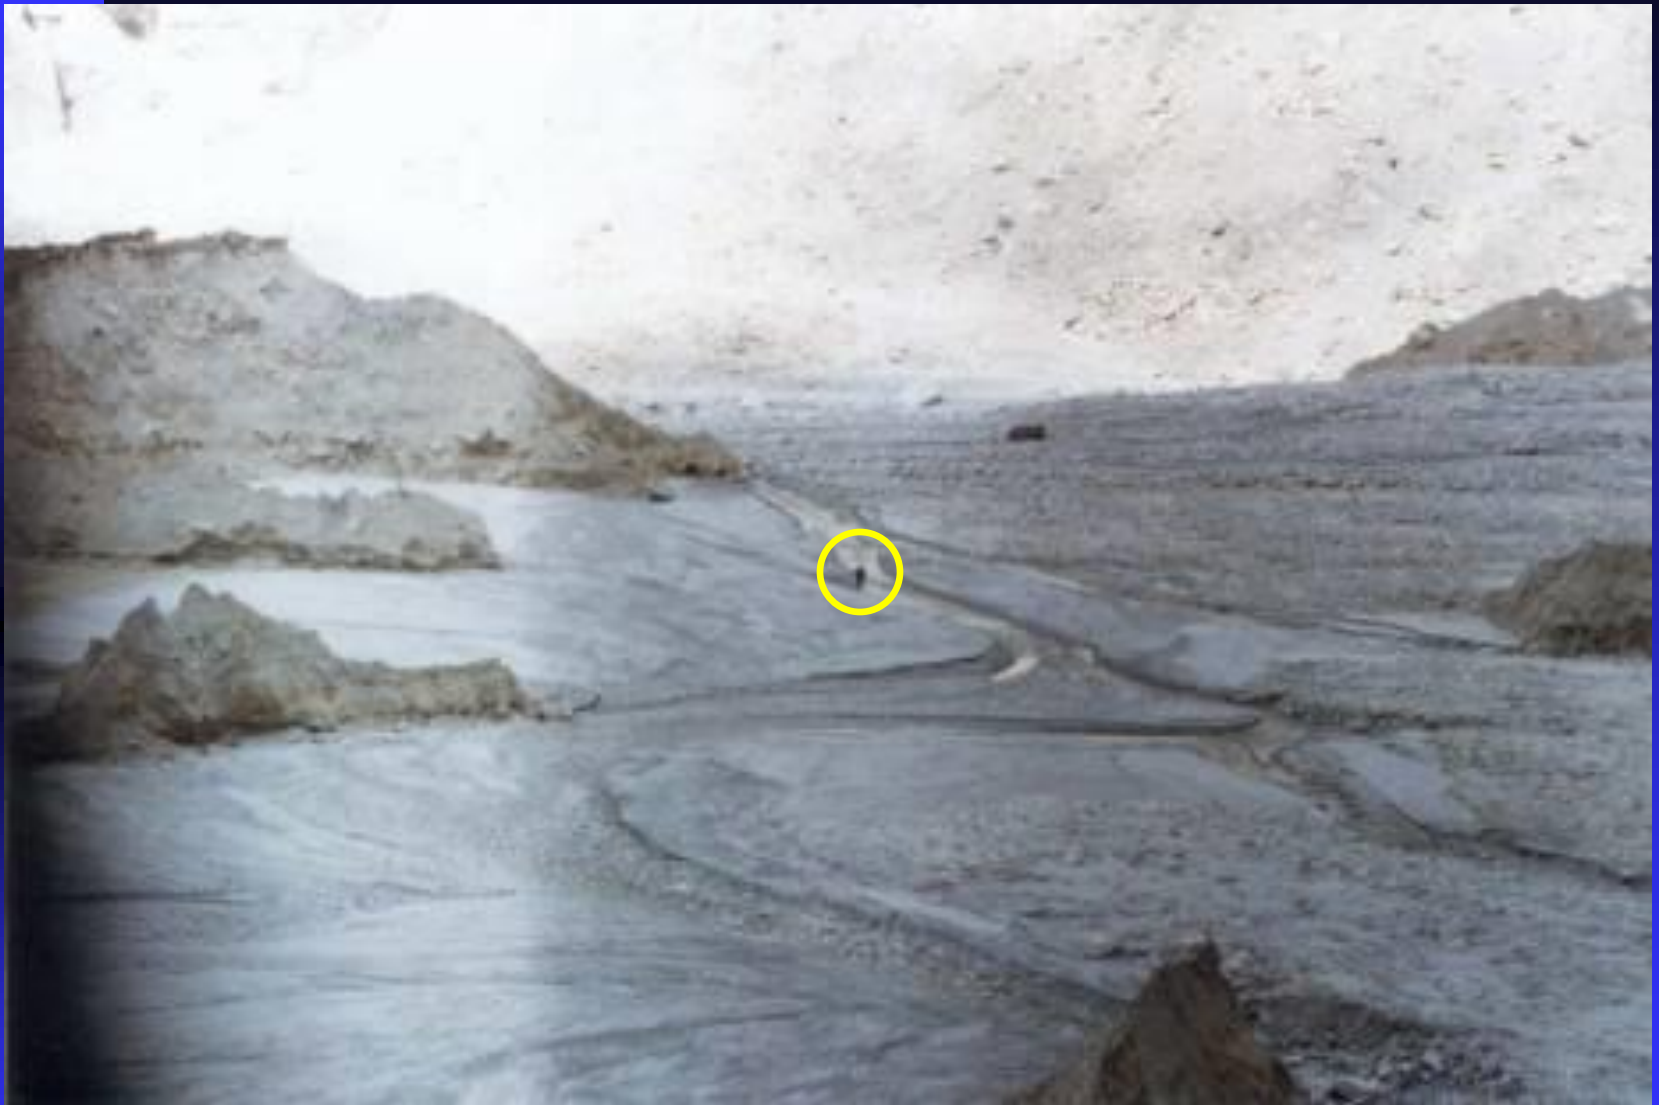
MUDDY GROUND AT THE BOTTOM OF THE LAGOON OF THE GLACIER AFTER THE FLOOD

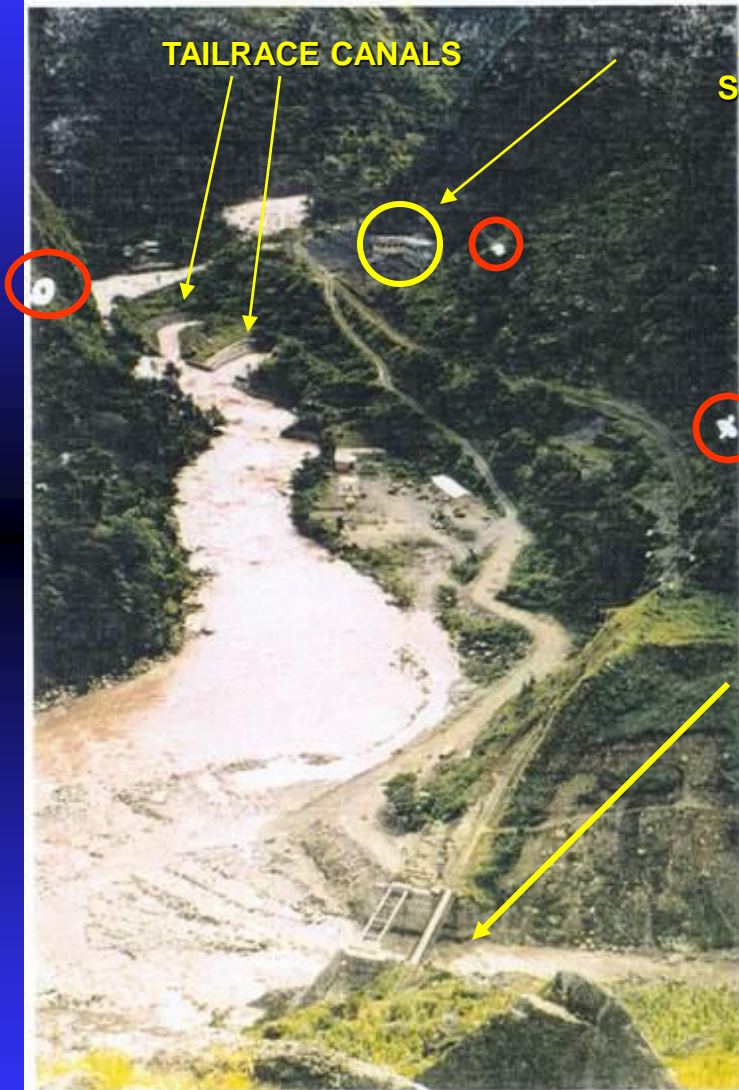
VISTA PANORAMICA DE LA CENTRAL
(ANTES DEL SINIESTRO - ENERO 1998)

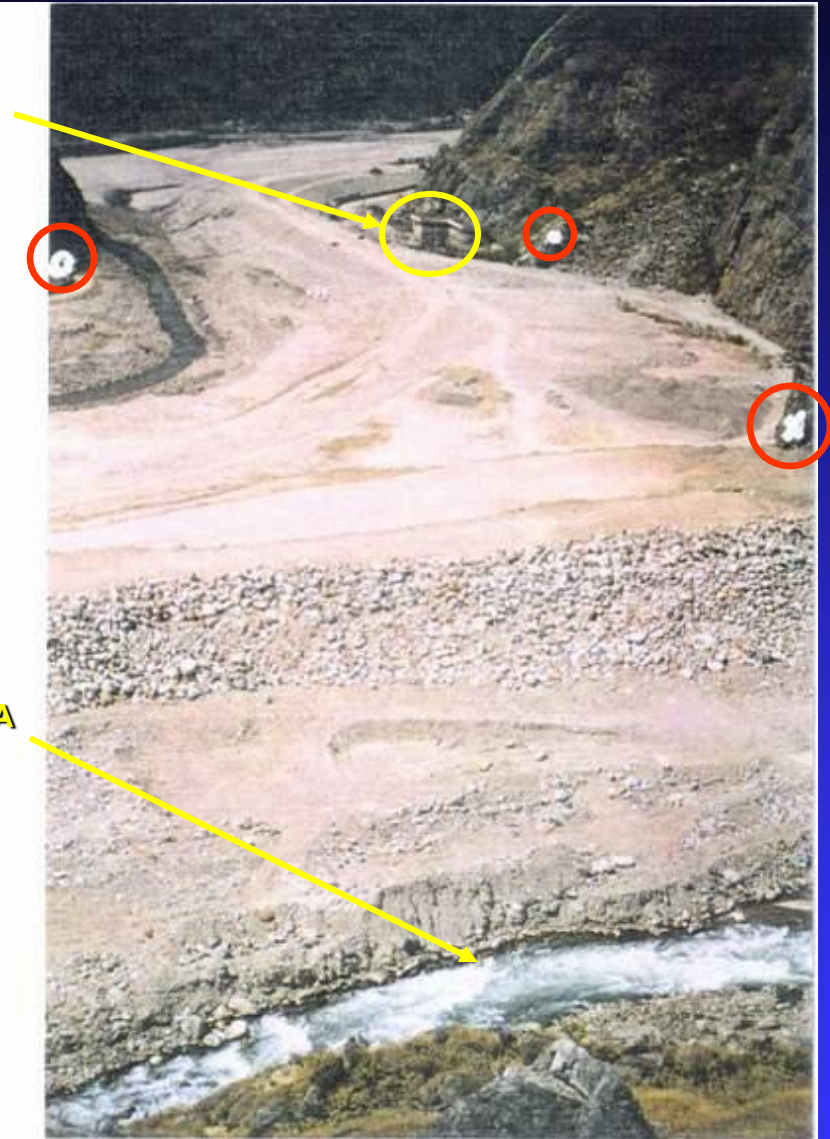
VISTA PANORAMICA DE LA CENTRAL
(DESPUES DEL SINIESTRO - AGOSTO DE 1999)
