# **Geosynthetic Reinforced MSE Wall Failures and Their Remediation**

**Bob and George Koerner  
Geosynthetic Institute**

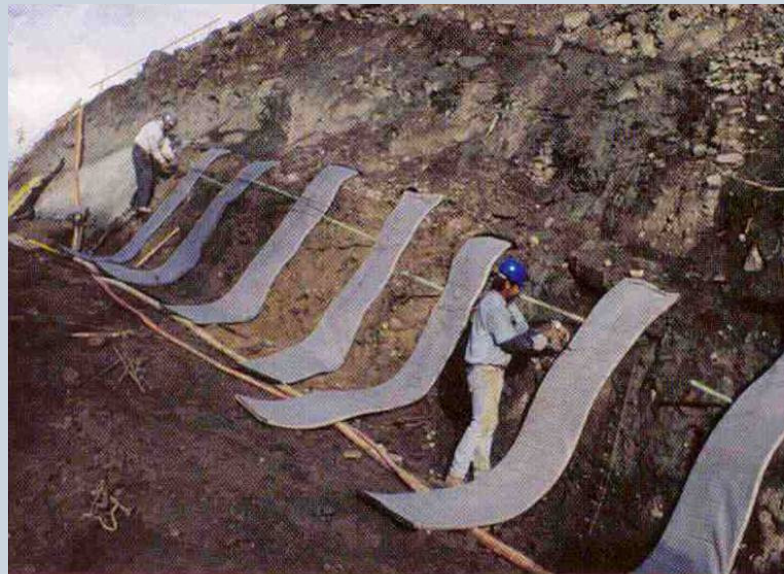
- use of on-site soil is compelling
- cost savings (vs. imported) is 40-70%
- appears incapable of being stopped
- so, use it, but circumvent the poor drainage by external routing as follows...

Use of continuous and intermittent geocomposite back drains when using fine grained soils in the reinforced soil zone (compl., TenCate Geosynthetics, Inc.)

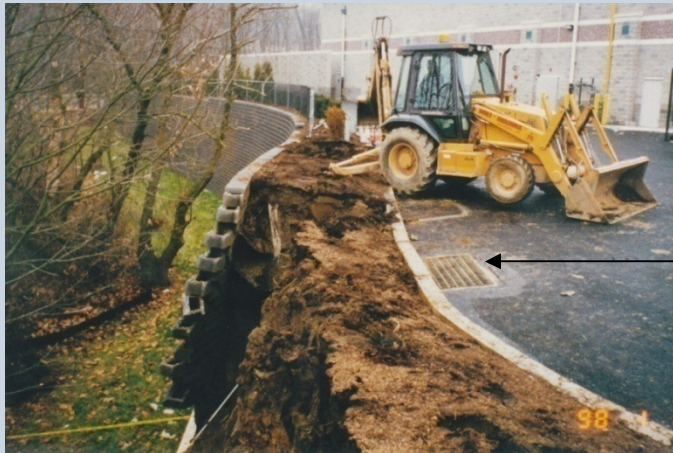
# Common Problem of Capturing and Transmitting Roof Runoff and Paved Surface Water Flow Within Reinforced Soil Zone

Surface water  
drainage inlet
