Failures of Helical Pile and Helical Anchor Projects and Associated Lessons Learned

Howard A. Perko, Ph.D., PE
Magnum Geo-Solutions, LLC

Abstract

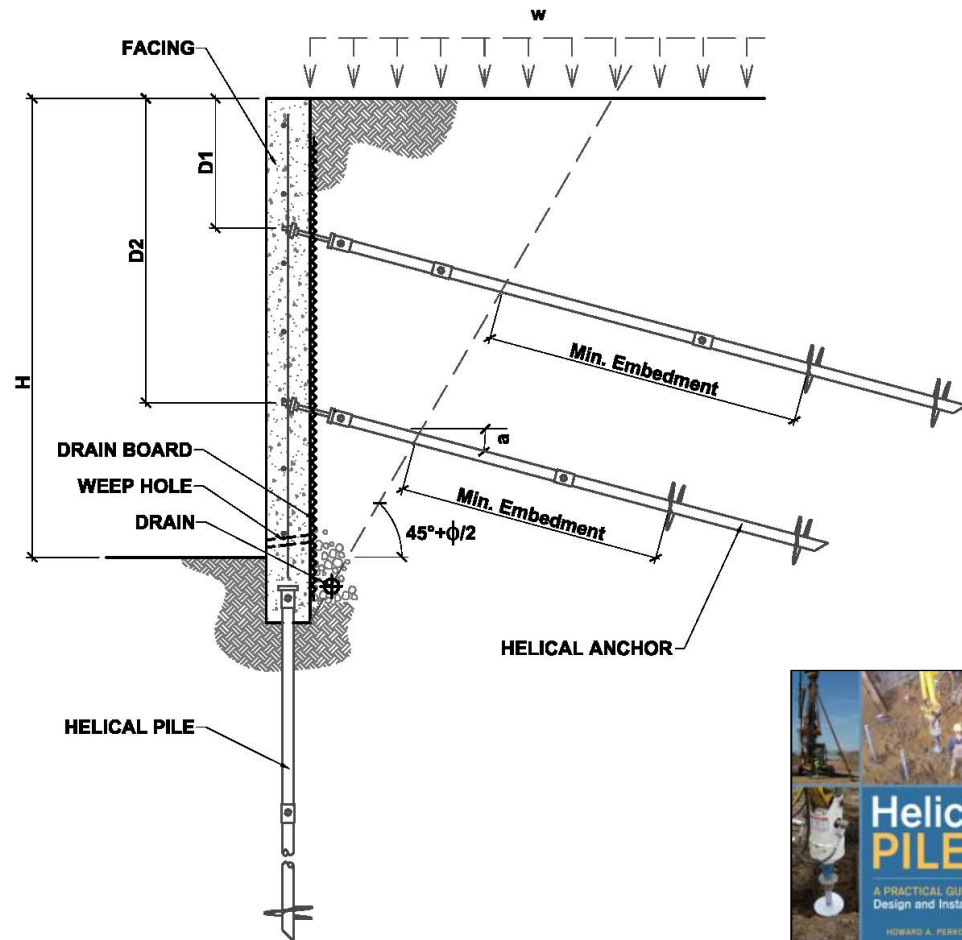
Typical soil “anchor” wall

- Misunderstanding between anchored wall and soil nail wall
- Bearing capacity failure
- Improper reinforcing steel

- Purpose of anchors is to hold back facing
- Rigid facing spans between anchors
- Post-tension anchors
- Helical bearing plates located far outside active plane
- Helical bearing plates located far outside active plane
- Anchors at angle from horizontal
- Foundation resists downward component of anchor force
- Large anchor spacing
- Higher capacity, longer anchors
- Drainage behind wall

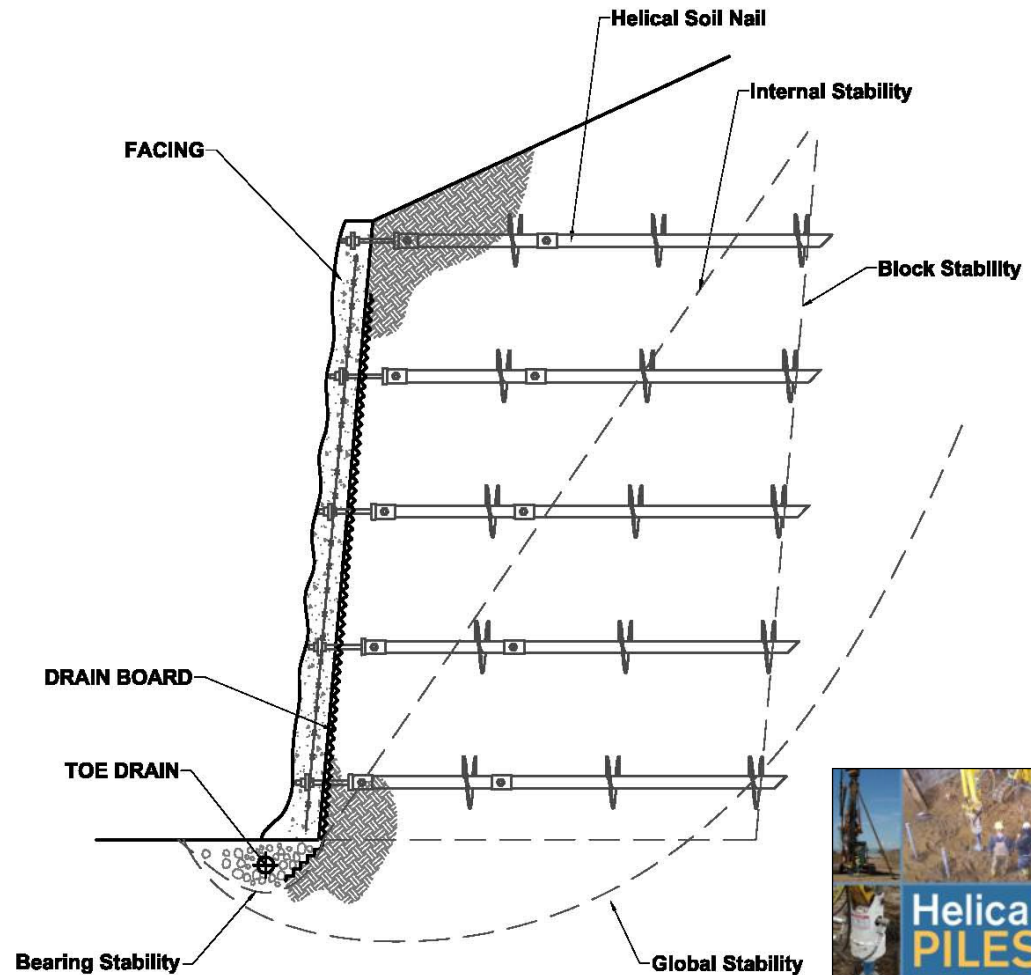
- Typical soil “nail” wall
- Purpose of nails is to reinforce soil block
- Minimal facing that simply resists raveling
- Generally not post-tensioned
- Helical bearing plates located within failure plane
- Anchors often horizontal
- Minimal foundation
- Small anchor spacing
- Low capacity, short anchors
- Drainage behind wall

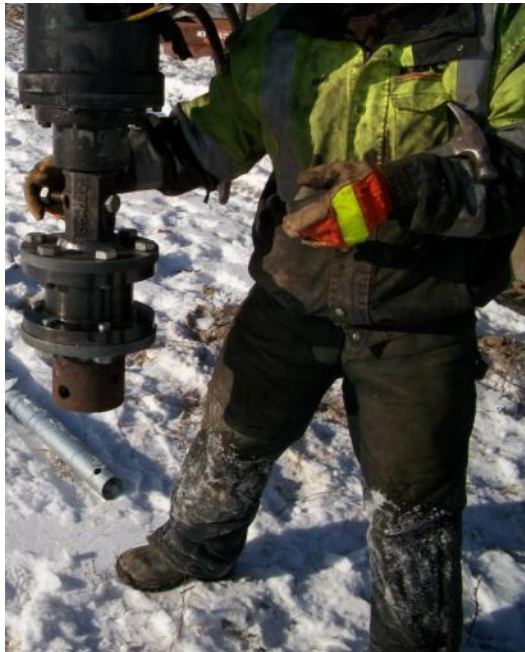
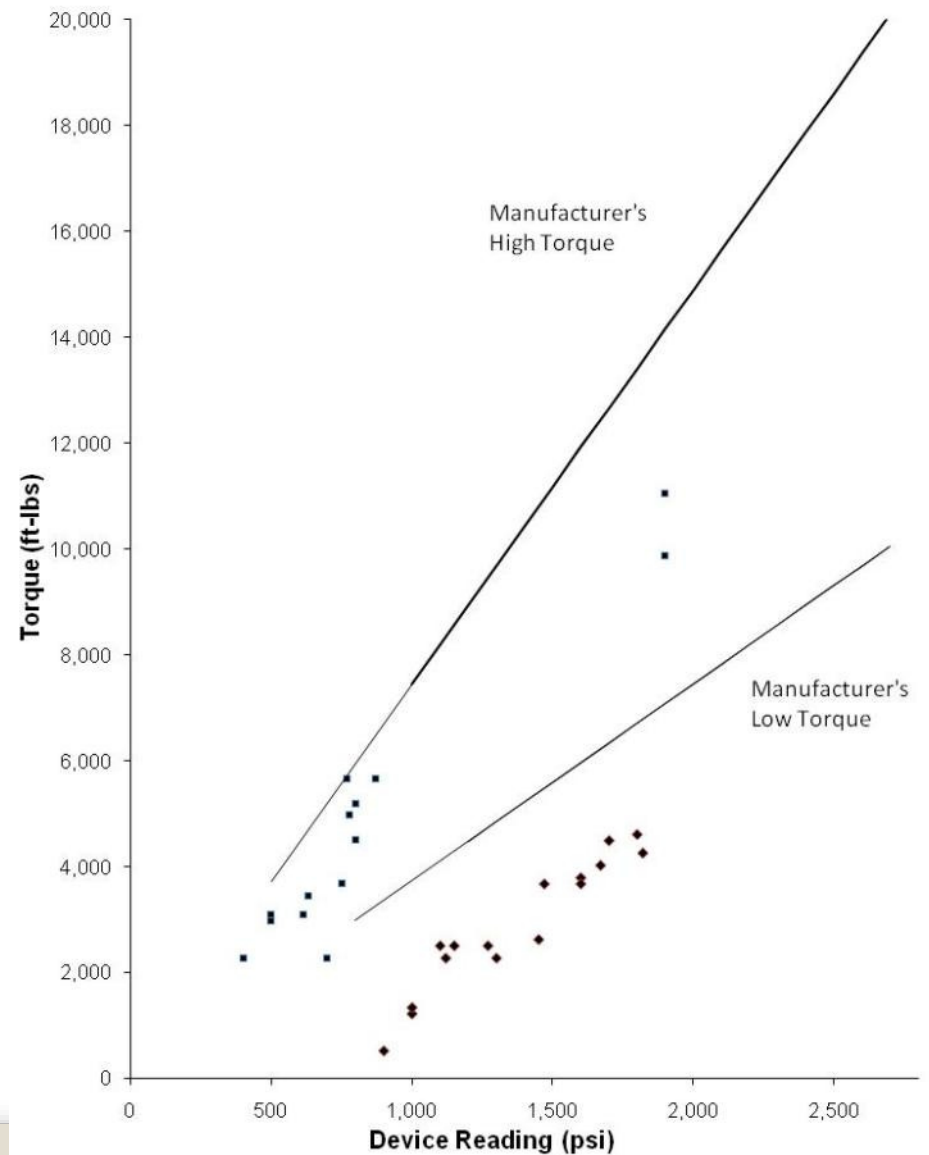
Potential Cause of Failure

- 1 row of approximately 35' long helical tie-backs
- Continuous torque readings during installation
- Approximately 15-foot cut to removed failed timber crib wall
- All 18 helical anchors failed proof test
- Supplemental anchors based on same design methods, installed by same crew using different torque motor passed proof tests

- Flawed torque motor calibration

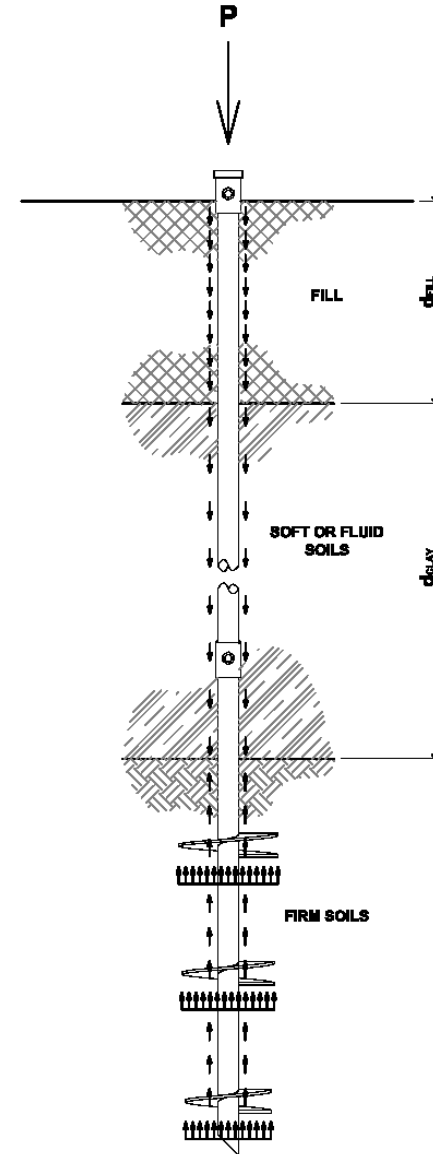
Potential Cause of Failure

- Grouted pull-down piles
- Houses settled several inches
- Approximately 7-feet of site grading fill
- Piles bottomed in soft clay, grouted full depth

- Down-drag of site grading fill on grouted pile

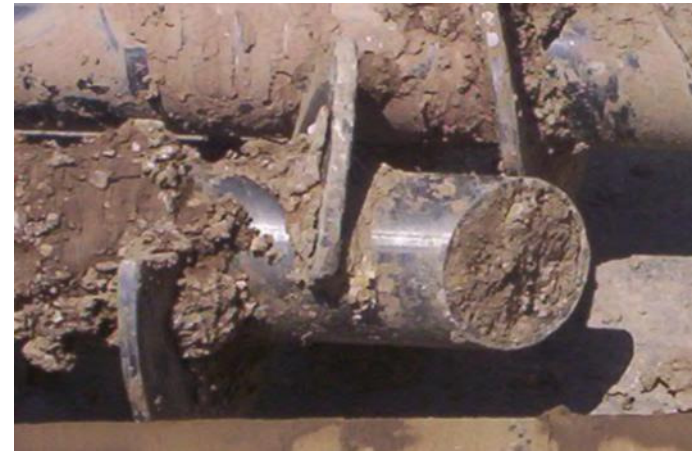
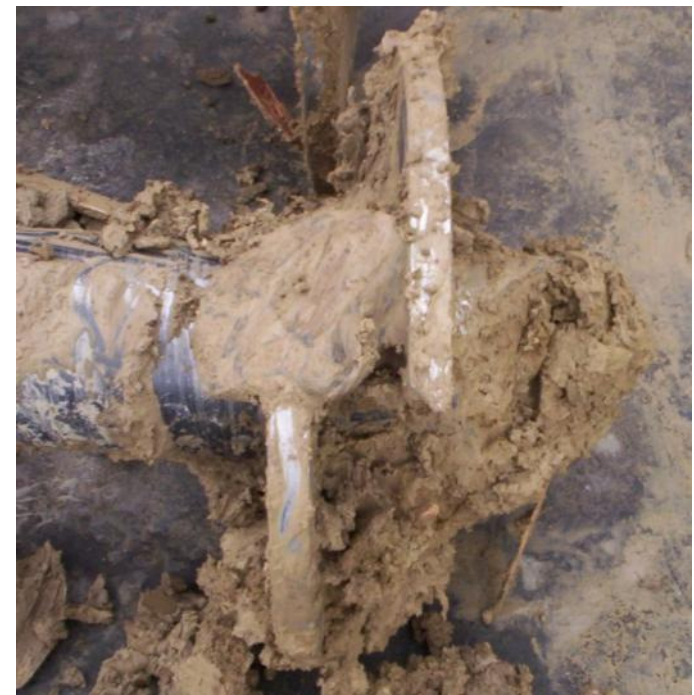
Potential Causes of Failure

- Approximately 140 helical piles installed to support several 5-story apartment buildings
- Design load of helical piles= 45 to 65 tons
- Immediately after construction, several of the buildings exhibited settlement on the order of 4"
- Three of the buildings had to be demolished and re-built. The others were repaired by underpinning.

- Non-conforming helix invalidates capacity to torque readings
- Insufficient bearing area; relied on torque alone and did not check theoretical bearing capacity
- Over-reliance on load tests

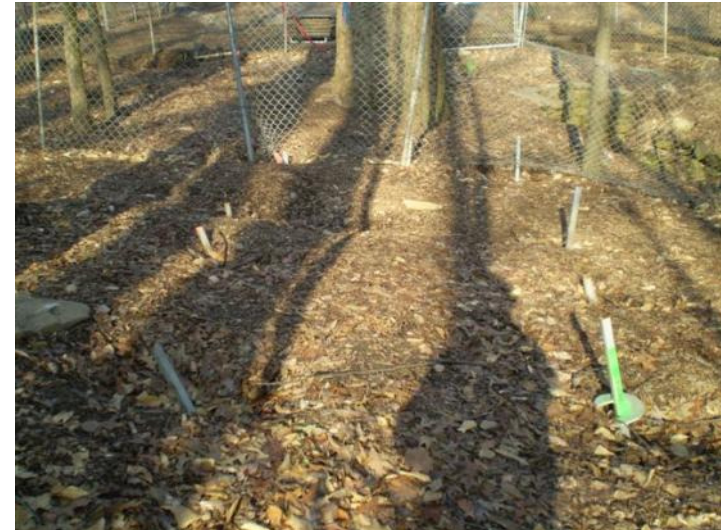
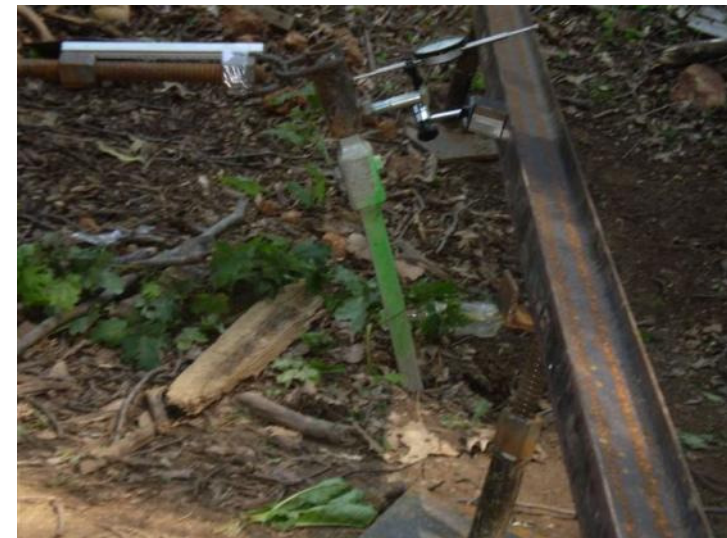
Potential Causes of Failure

- Example Frame Scaffolding
(Note: This is not the actual scaffold that collapsed. Due to confidentiality, actual scaffold cannot be shown.)
- Approximately 4-story tall, temporary, stand-alone scaffold towers were erected to construct an elevated concrete walkway
- Each scaffold tower was supported on 8 helical piles
- During concrete placement, scaffold gave-way killing one worker and injuring 18 others

- Structural issues associated with scaffold design
- Lack of lateral stability
- No lateral capacity specification for the piles
- Square-shaft helical piles have negligible lateral capacity
