Schnabel
ENGINEERING

Emergency Repairs to the Jefferson Memorial Seawall

Dr. Jesús Gómez, P.E., D.GE

Geo Virginia 2012. Williamsburg, Virginia

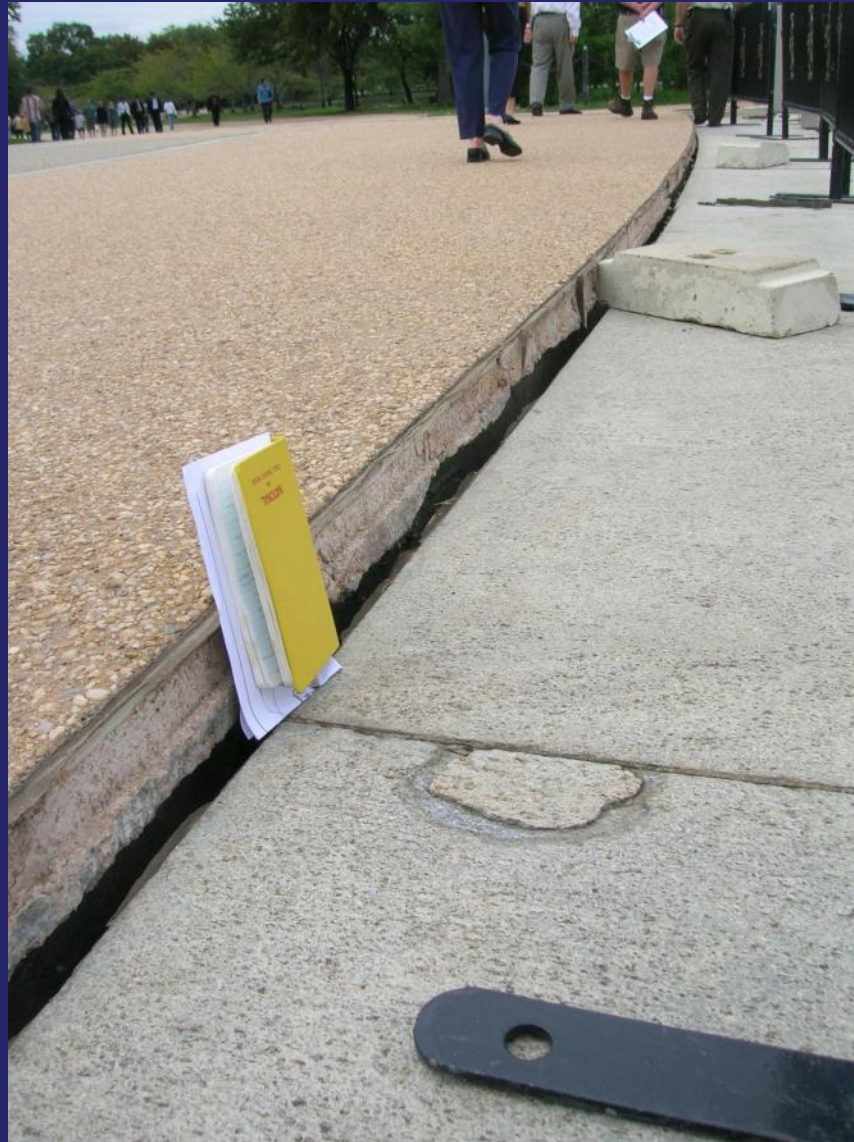
- 2005-2006
 - “Sudden” noticeable seawall settlement
 - North Plaza pulling away from Steps
- October 2006, NPS commissions investigation of movements

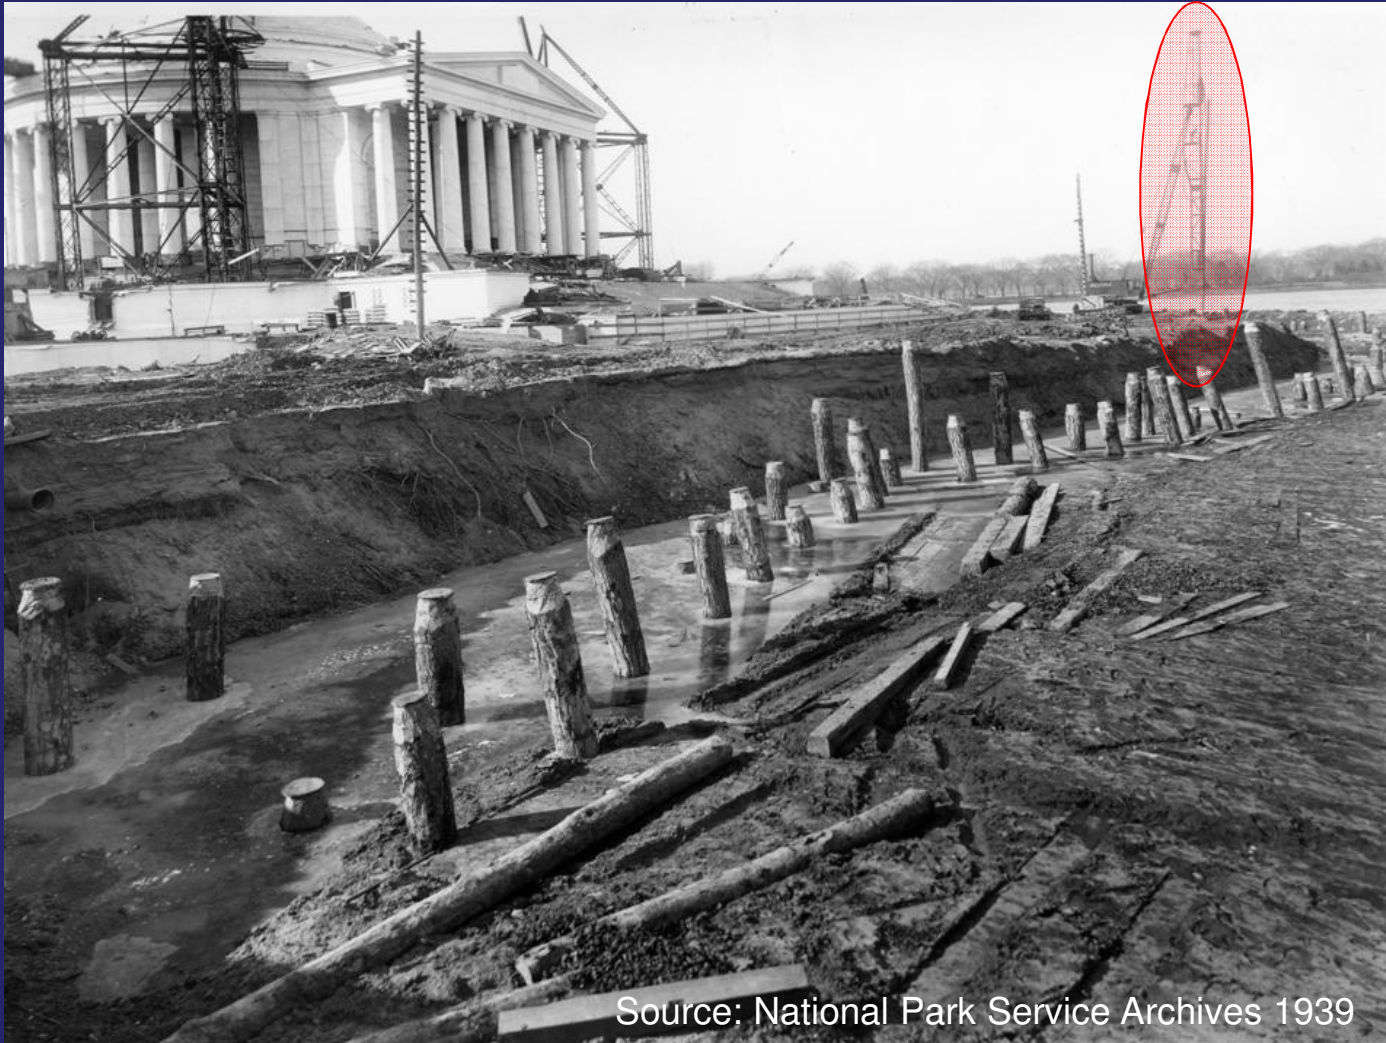
Was seawall on piles?

- Seawall
 - No records on its construction
 - Original design was reinforced concrete wall on vertical and battered precast piles
 - Needed to investigate this further
- North Plaza, Perimeter Wall and Ring Road on Grade

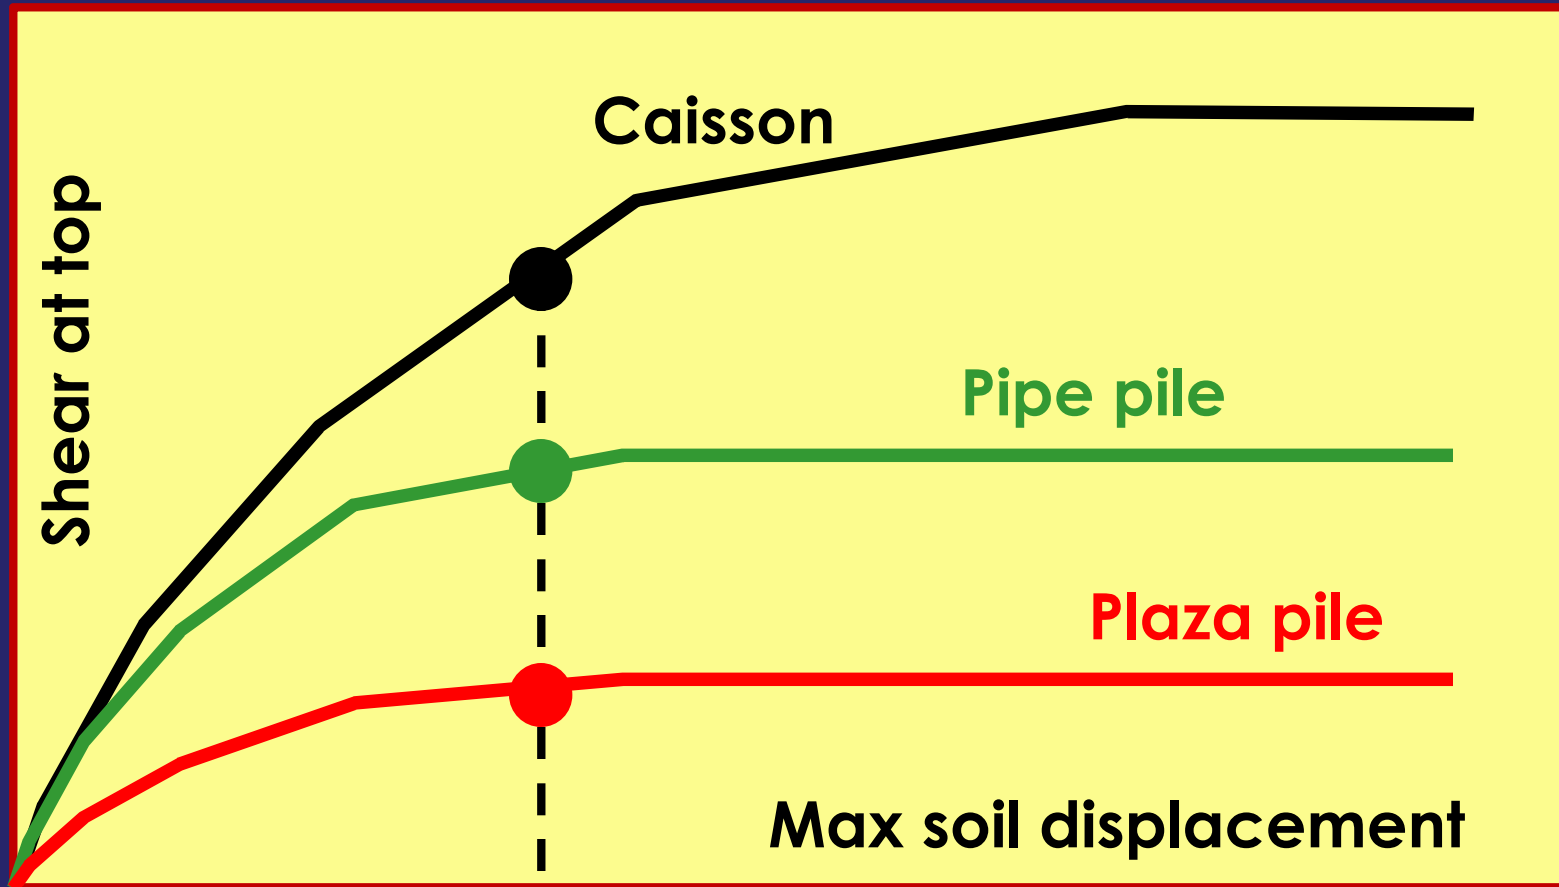
Lateral Analyses

- Modeled caisson and pile separately in Lpile Plus
- Applied various magnitudes of soil movement around foundations
- Movement profile scaled from inclinometer data
- Maximum settlement estimated from present pore pressure distribution
- Maximum lateral movement scaled from settlement based on Plaxis analyses
