Series of mistakes leading to the collapse of a small dam in Colombia.

Jaime Suarez-Diaz Msc, PE
Distinguished Professor
Universidad Industrial de Santander, Colombia.

GEOVIRGINIA 2018

Lessons Learned in Geotechnical Engineering

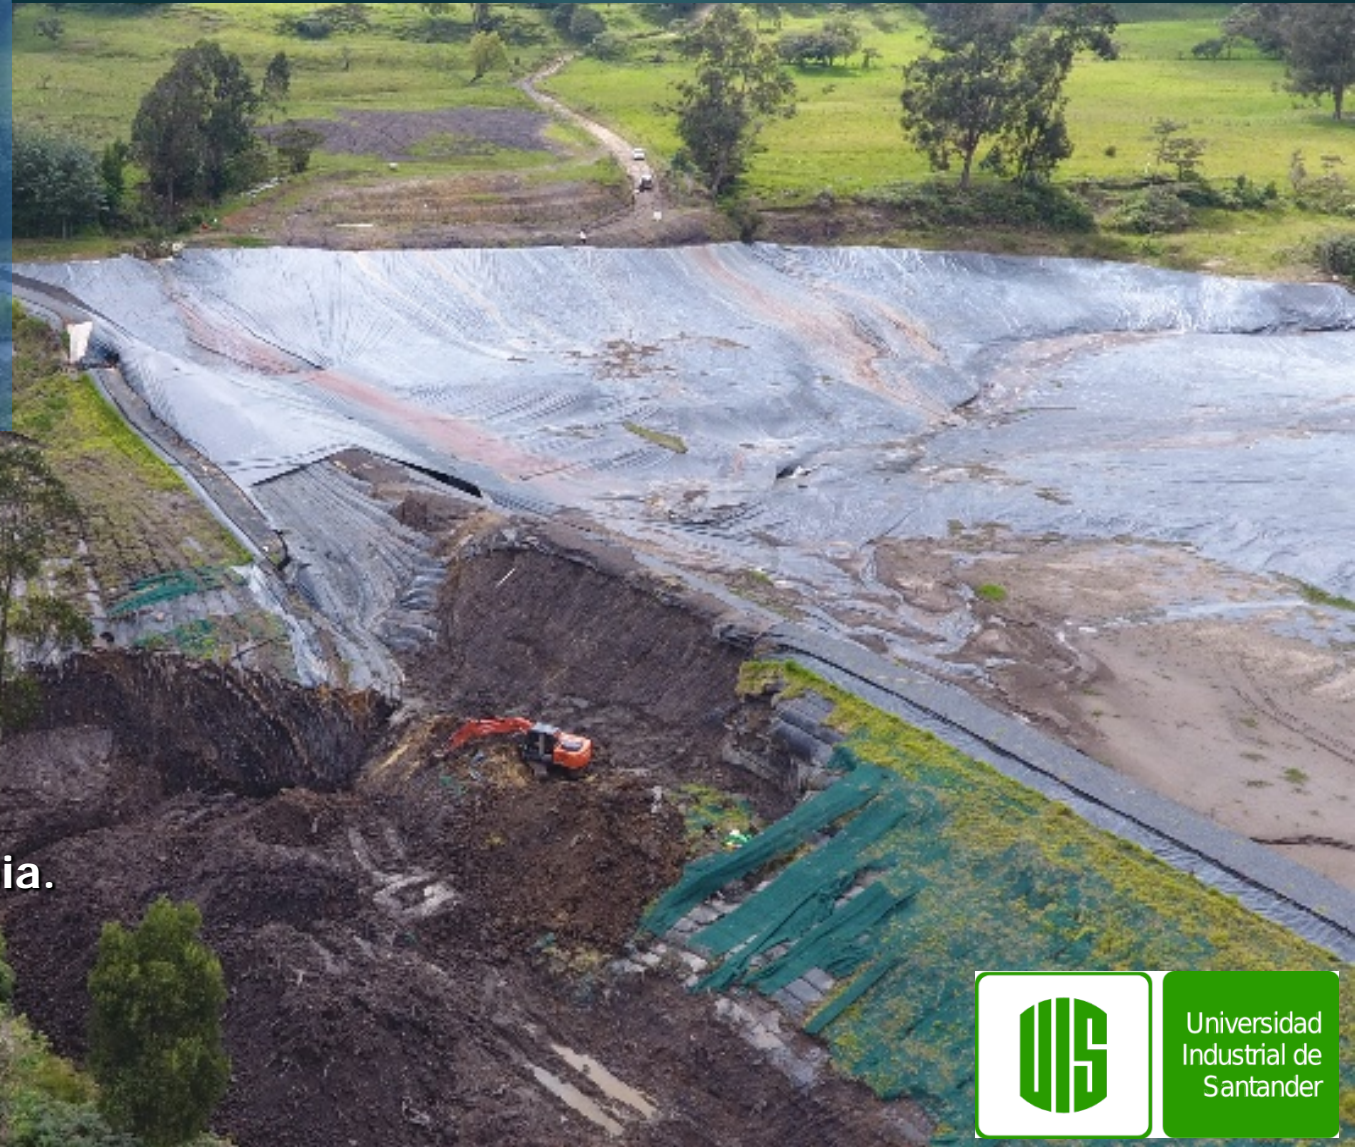
**The dam failed 7th June 2016
two weeks after filling up the reservoir.**

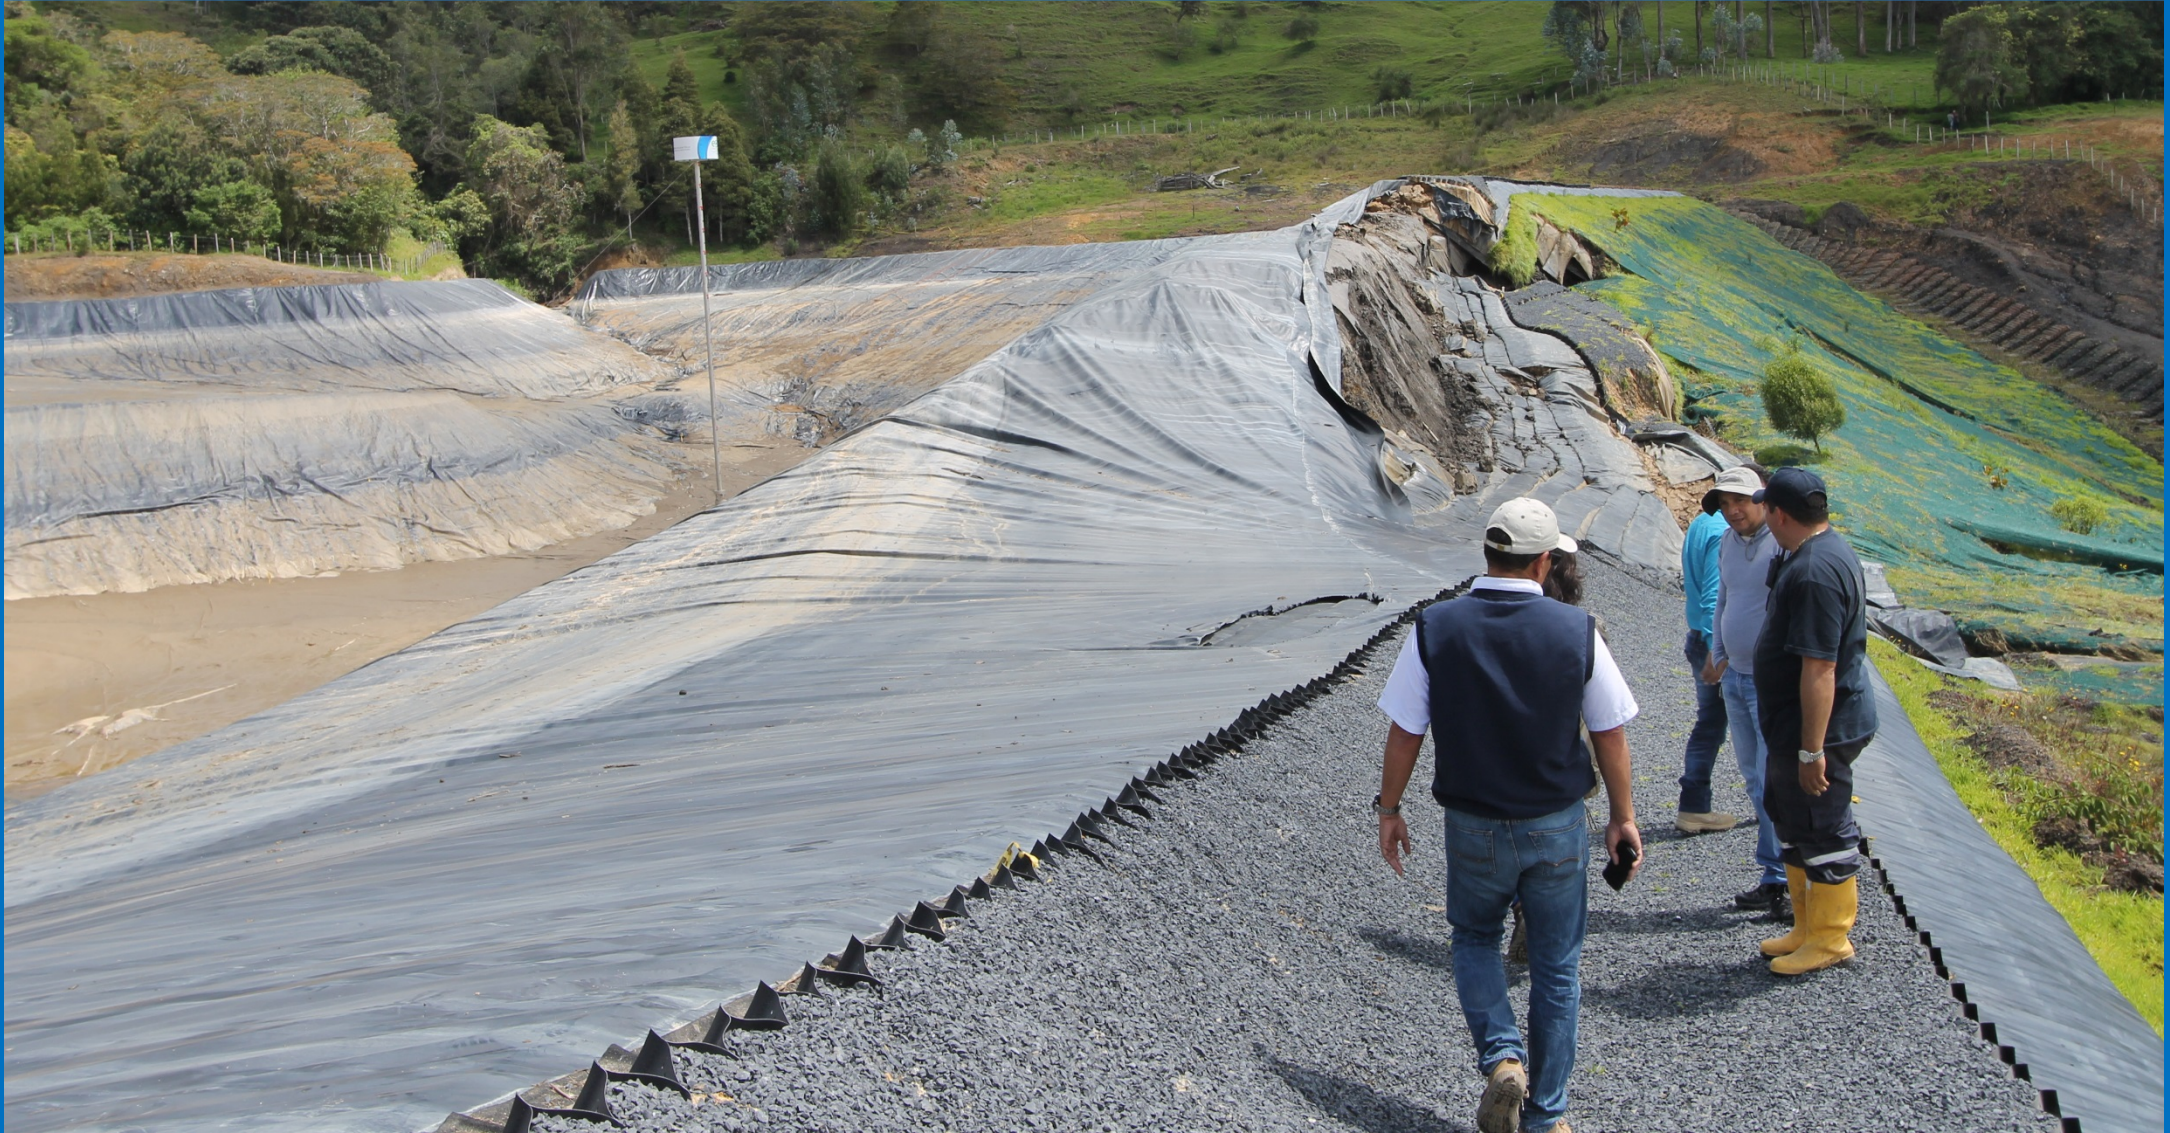
Design Investigations did not detect the presence of caverns of dissolved limestones under the reservoir.

When we got to the site, for the first time, after the dam failure, we were not aware of the presence of cavers under the reservoir.

Caverns were detected using a combination of geo-radar, geo-electric tomography and seismic MASW.

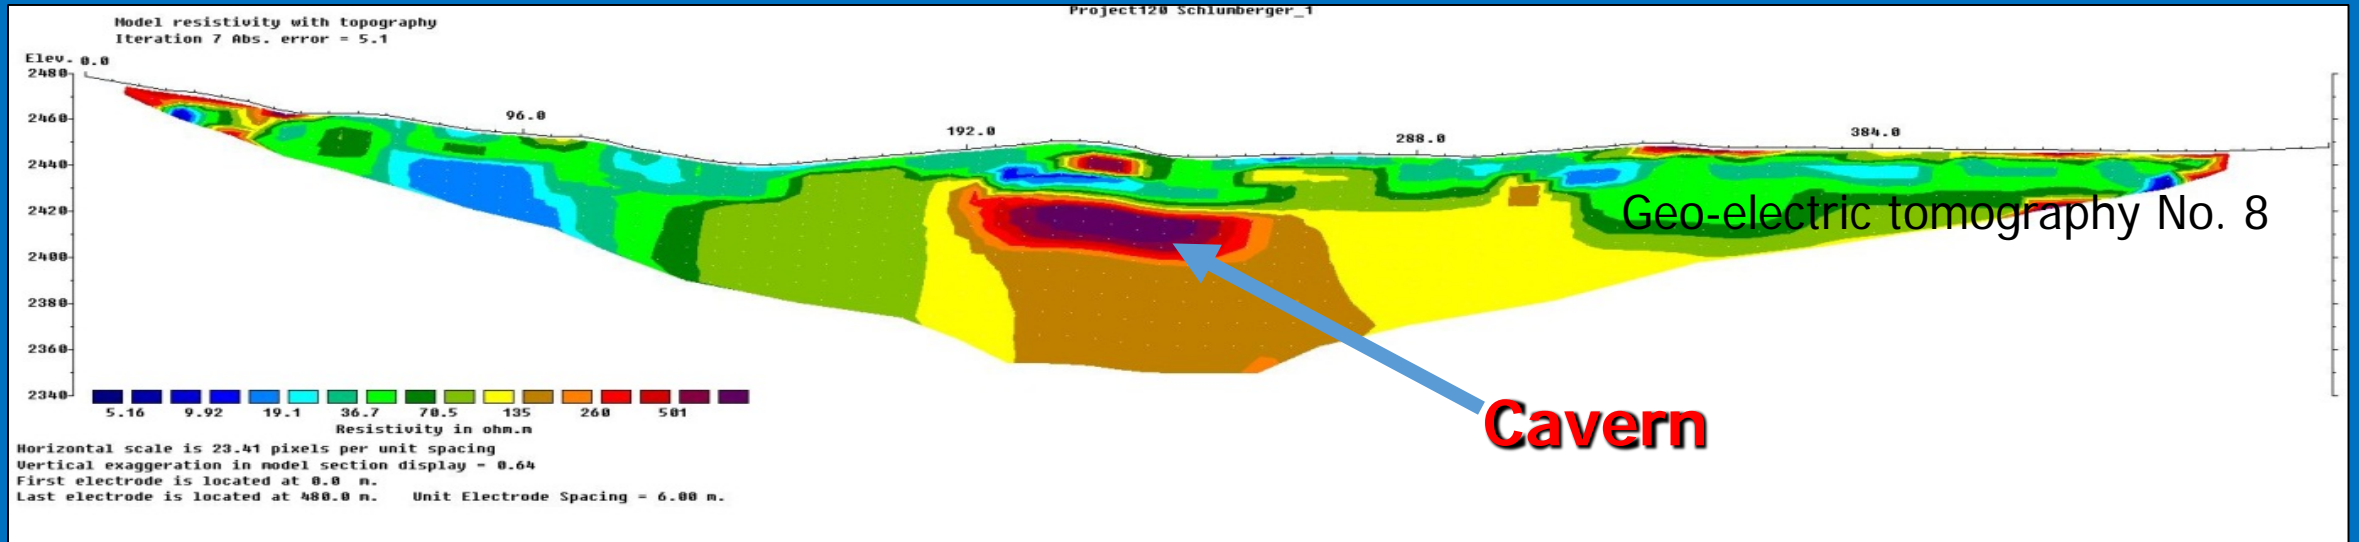
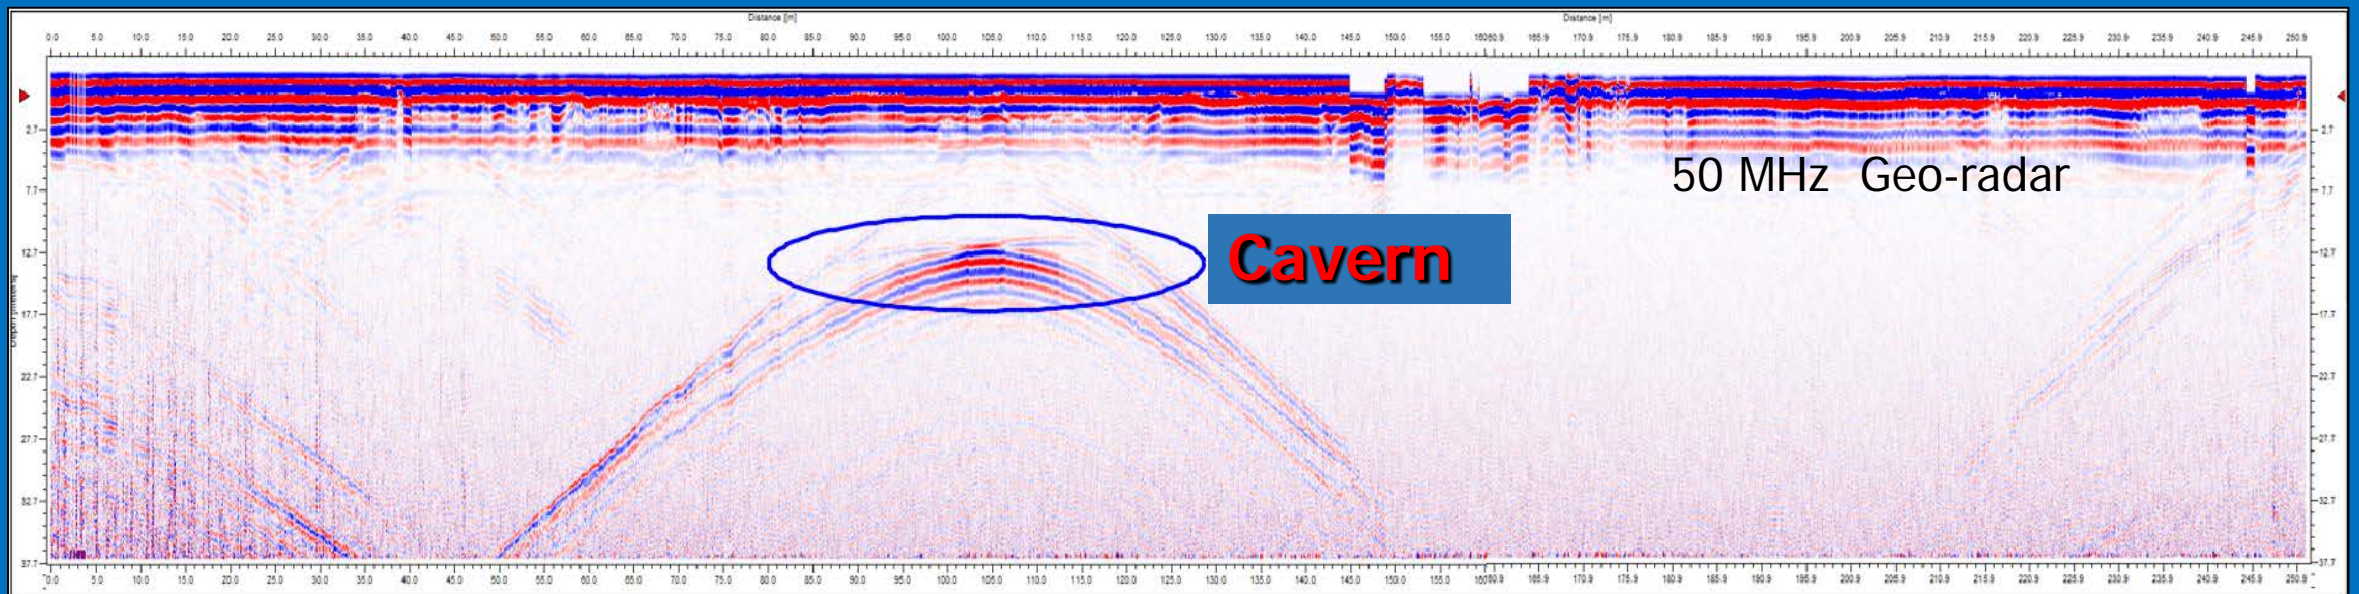
The 50 MHz geo-radar was especially effective.

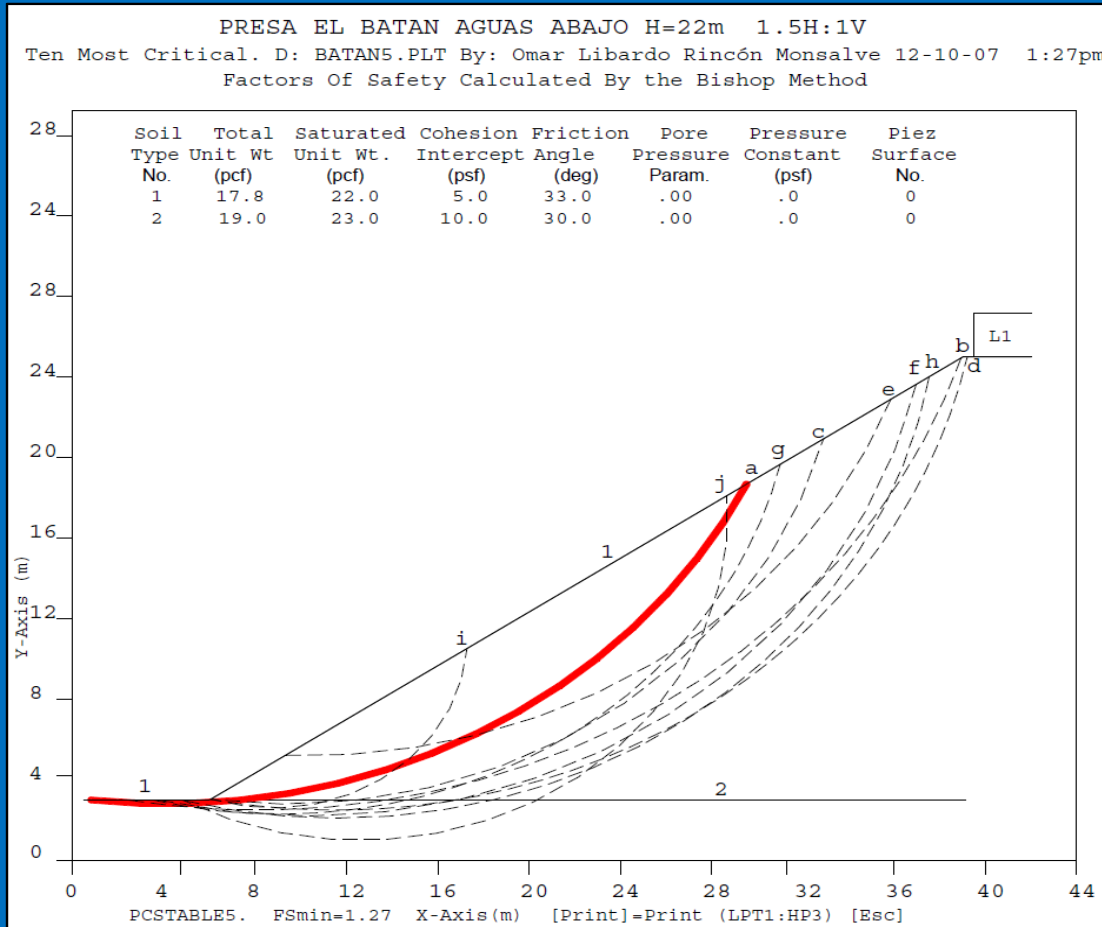
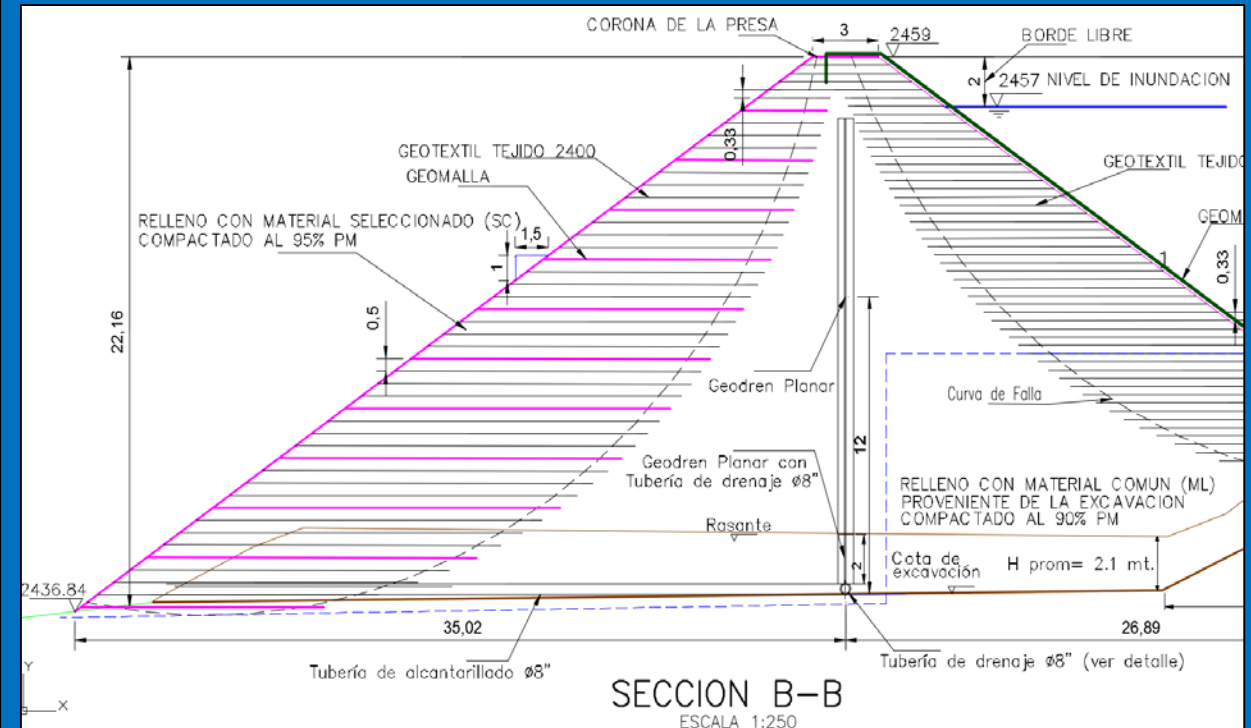
Deep slope failure was not considered in the design

Length of reinforcements was not enough to control deep slope failure

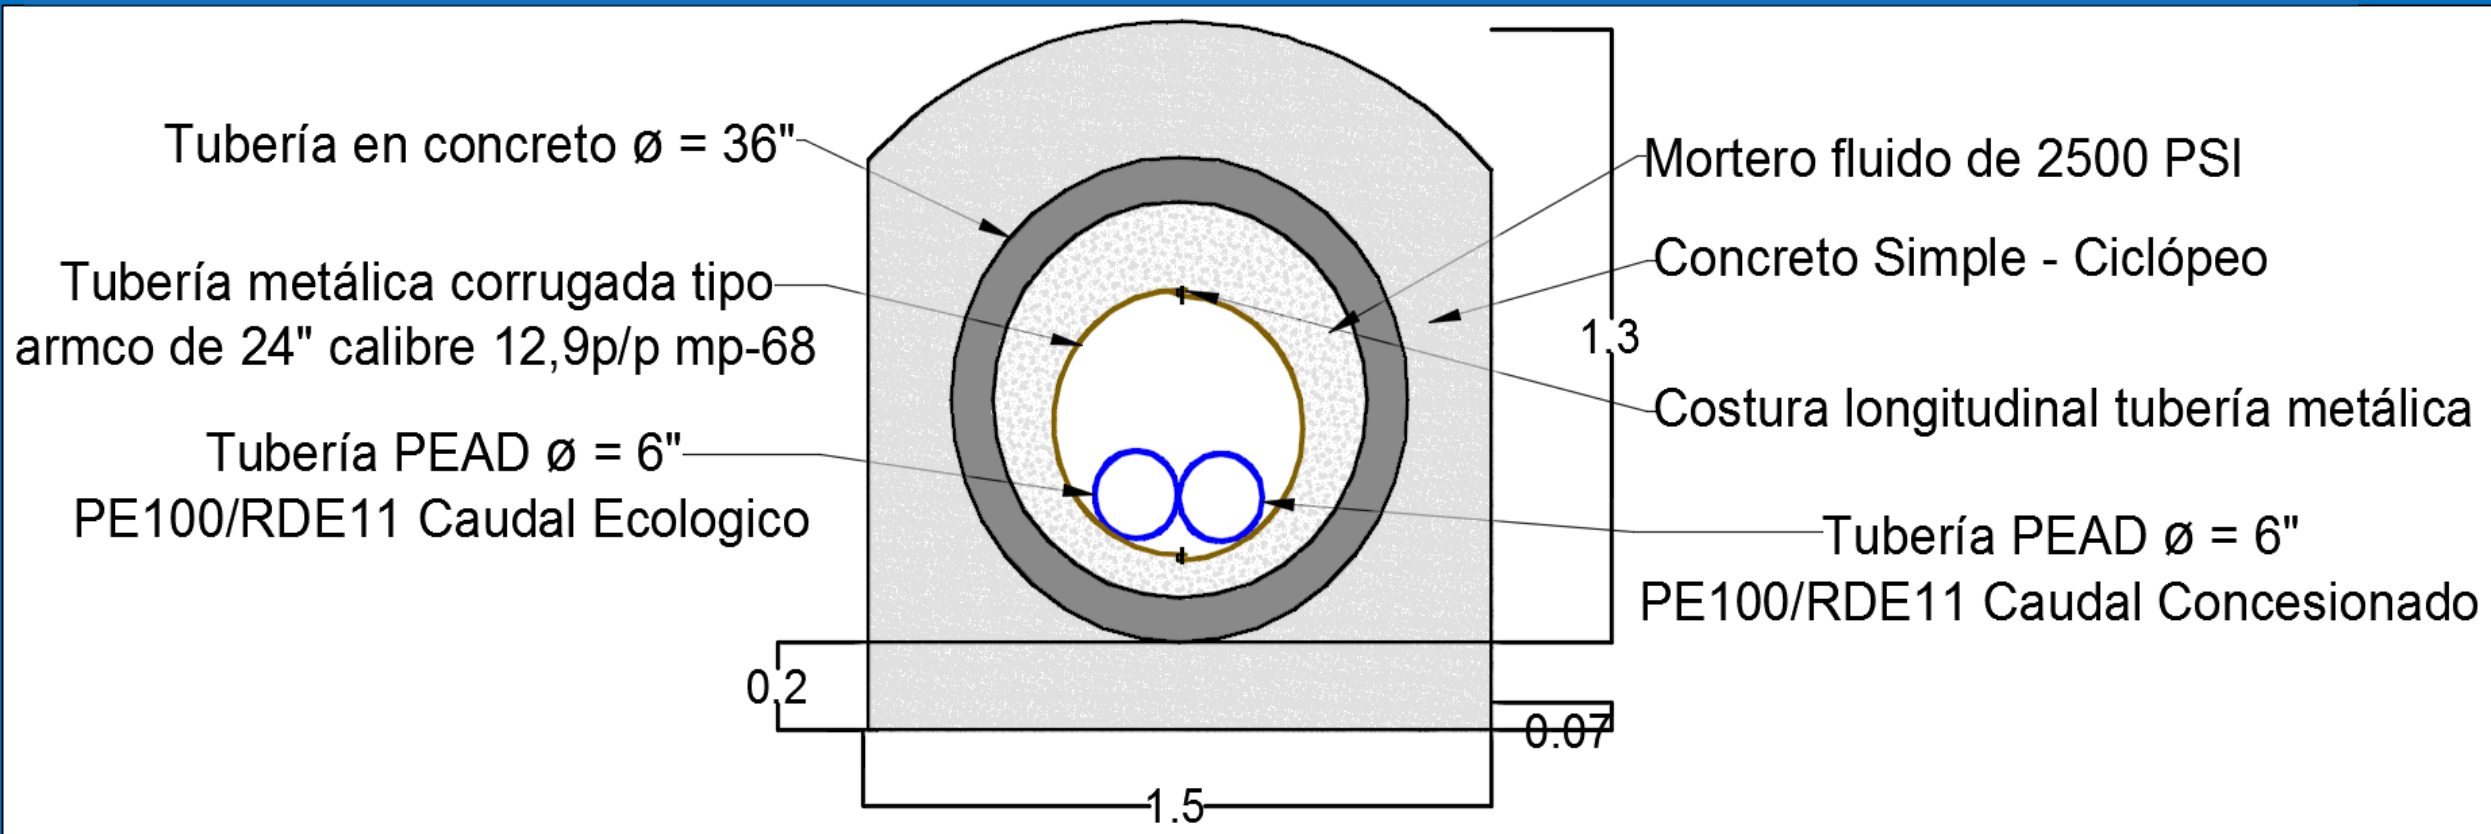
The contractor introduced an additional smaller metallic conduit with fluid concrete between the two tubes

Concrete cover

36 inches reinforced concrete conduit

Injected fluid mortar

24 inches Metallic conduit

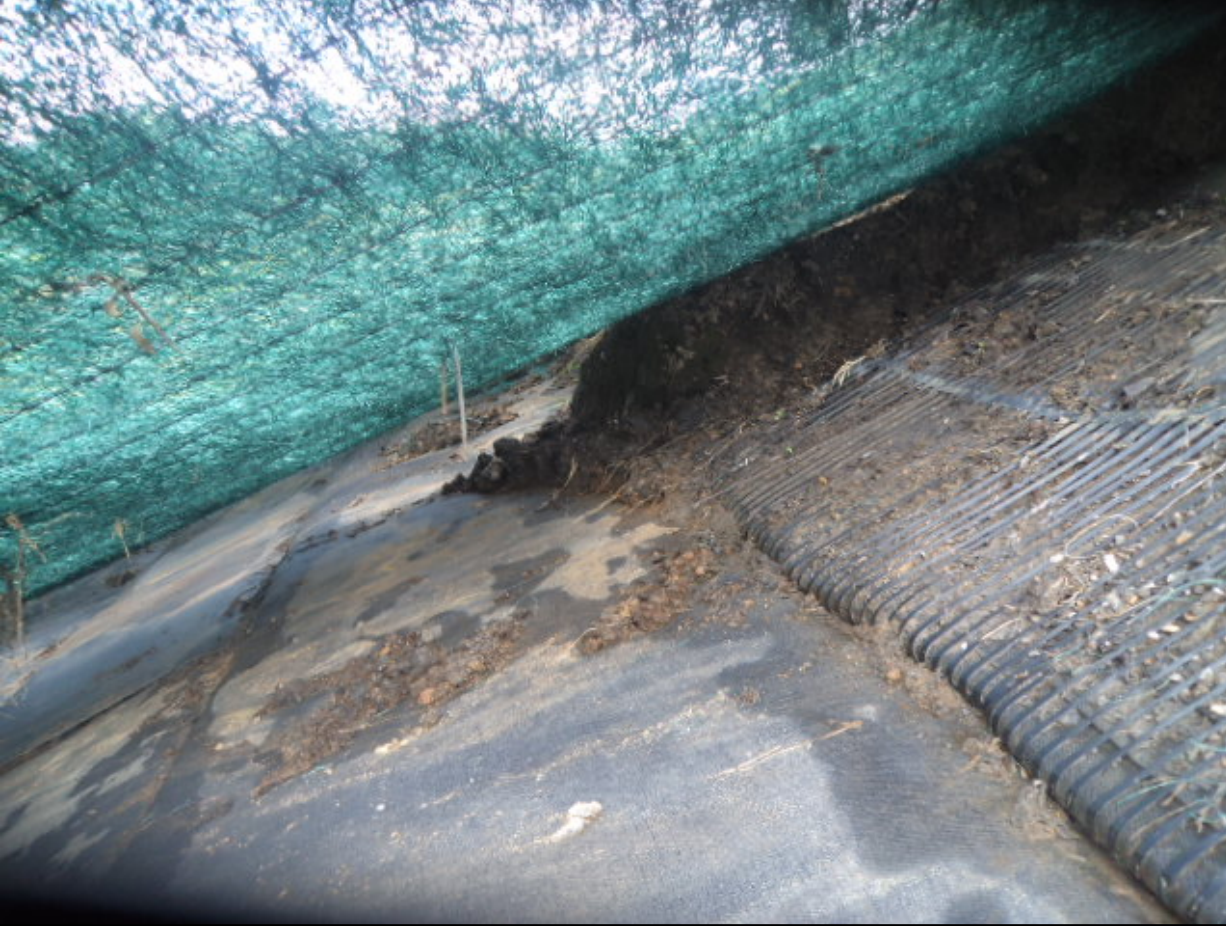
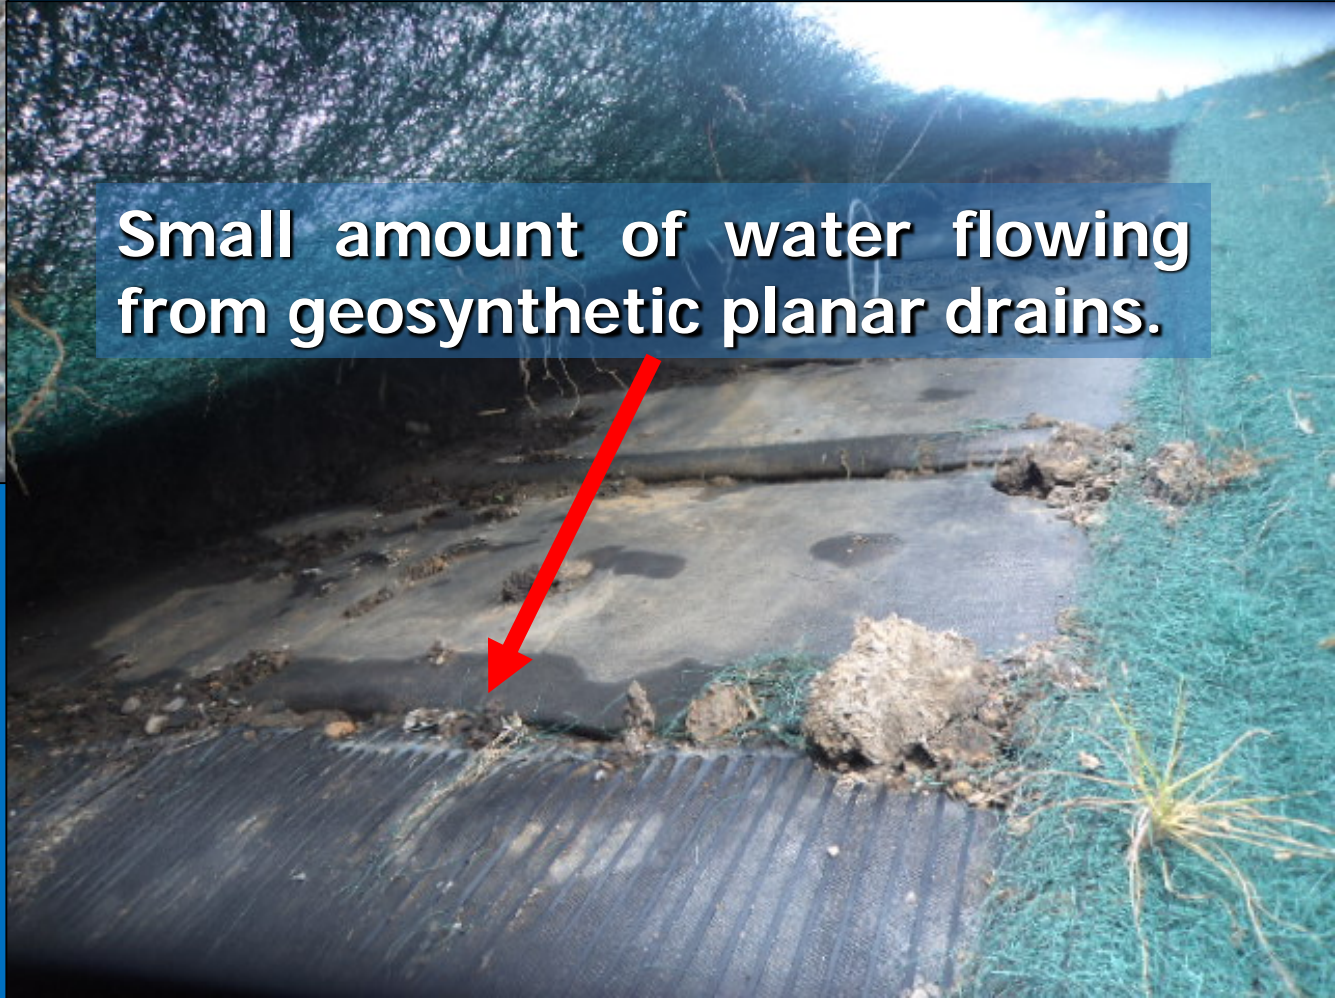
Small amount of water flowing from geosynthetic planar drains.
