Dams and Reservoirs; Lessons Learned

Ray E. Martin, Ph.D., P.E., D.GE

Outline of Case Histories

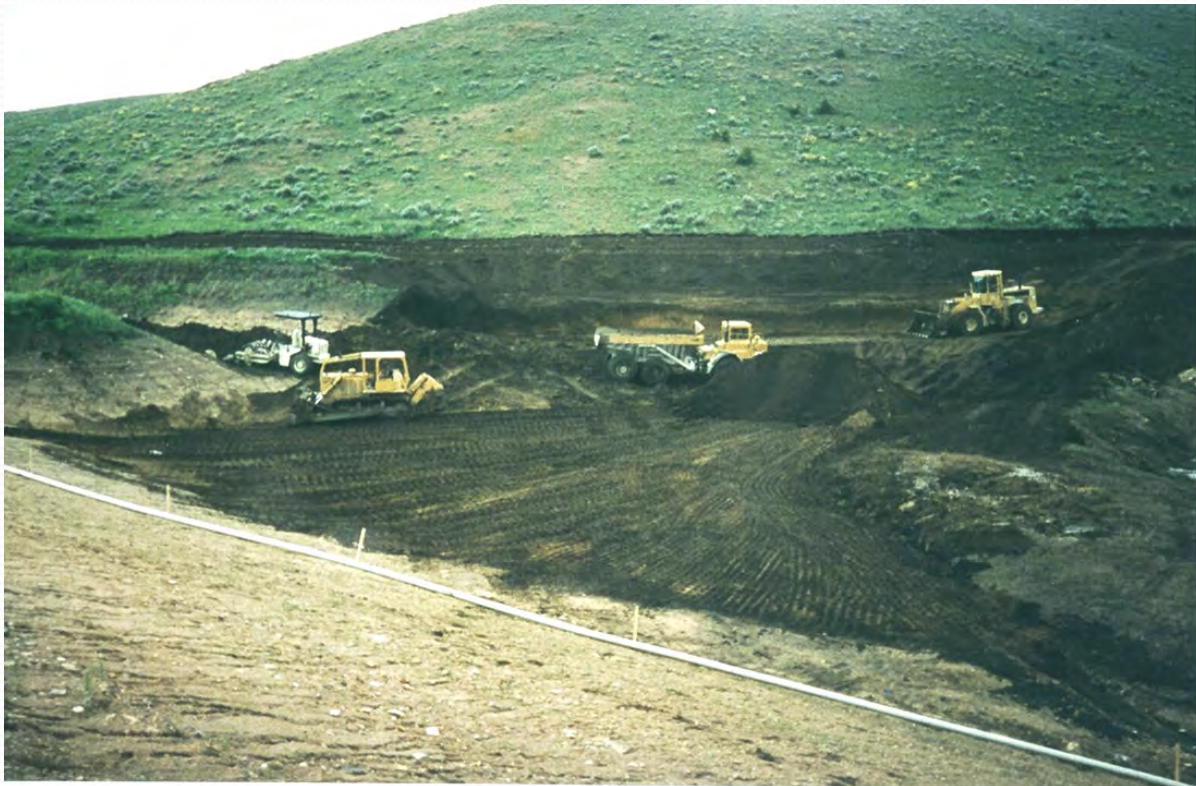
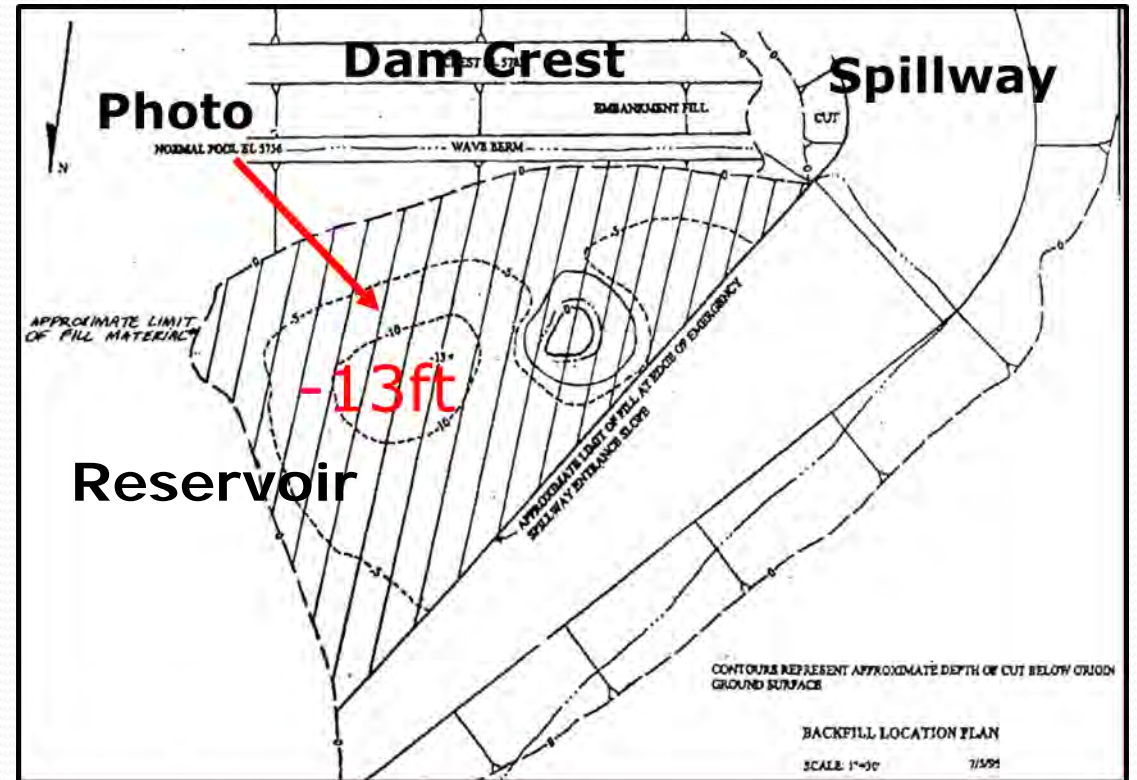
Repair

After Reservoir Filled – Urgent Call

- Ranch manager called: “seepage flowing from toe of dam on right side of outfall pipe”
- Ray: “Drain the lake ASAP”
- What caused the seepage?

- Backfill excavation with compacted fill from borrow pit
- Construct inverted filter-drainage blanked over seepage area

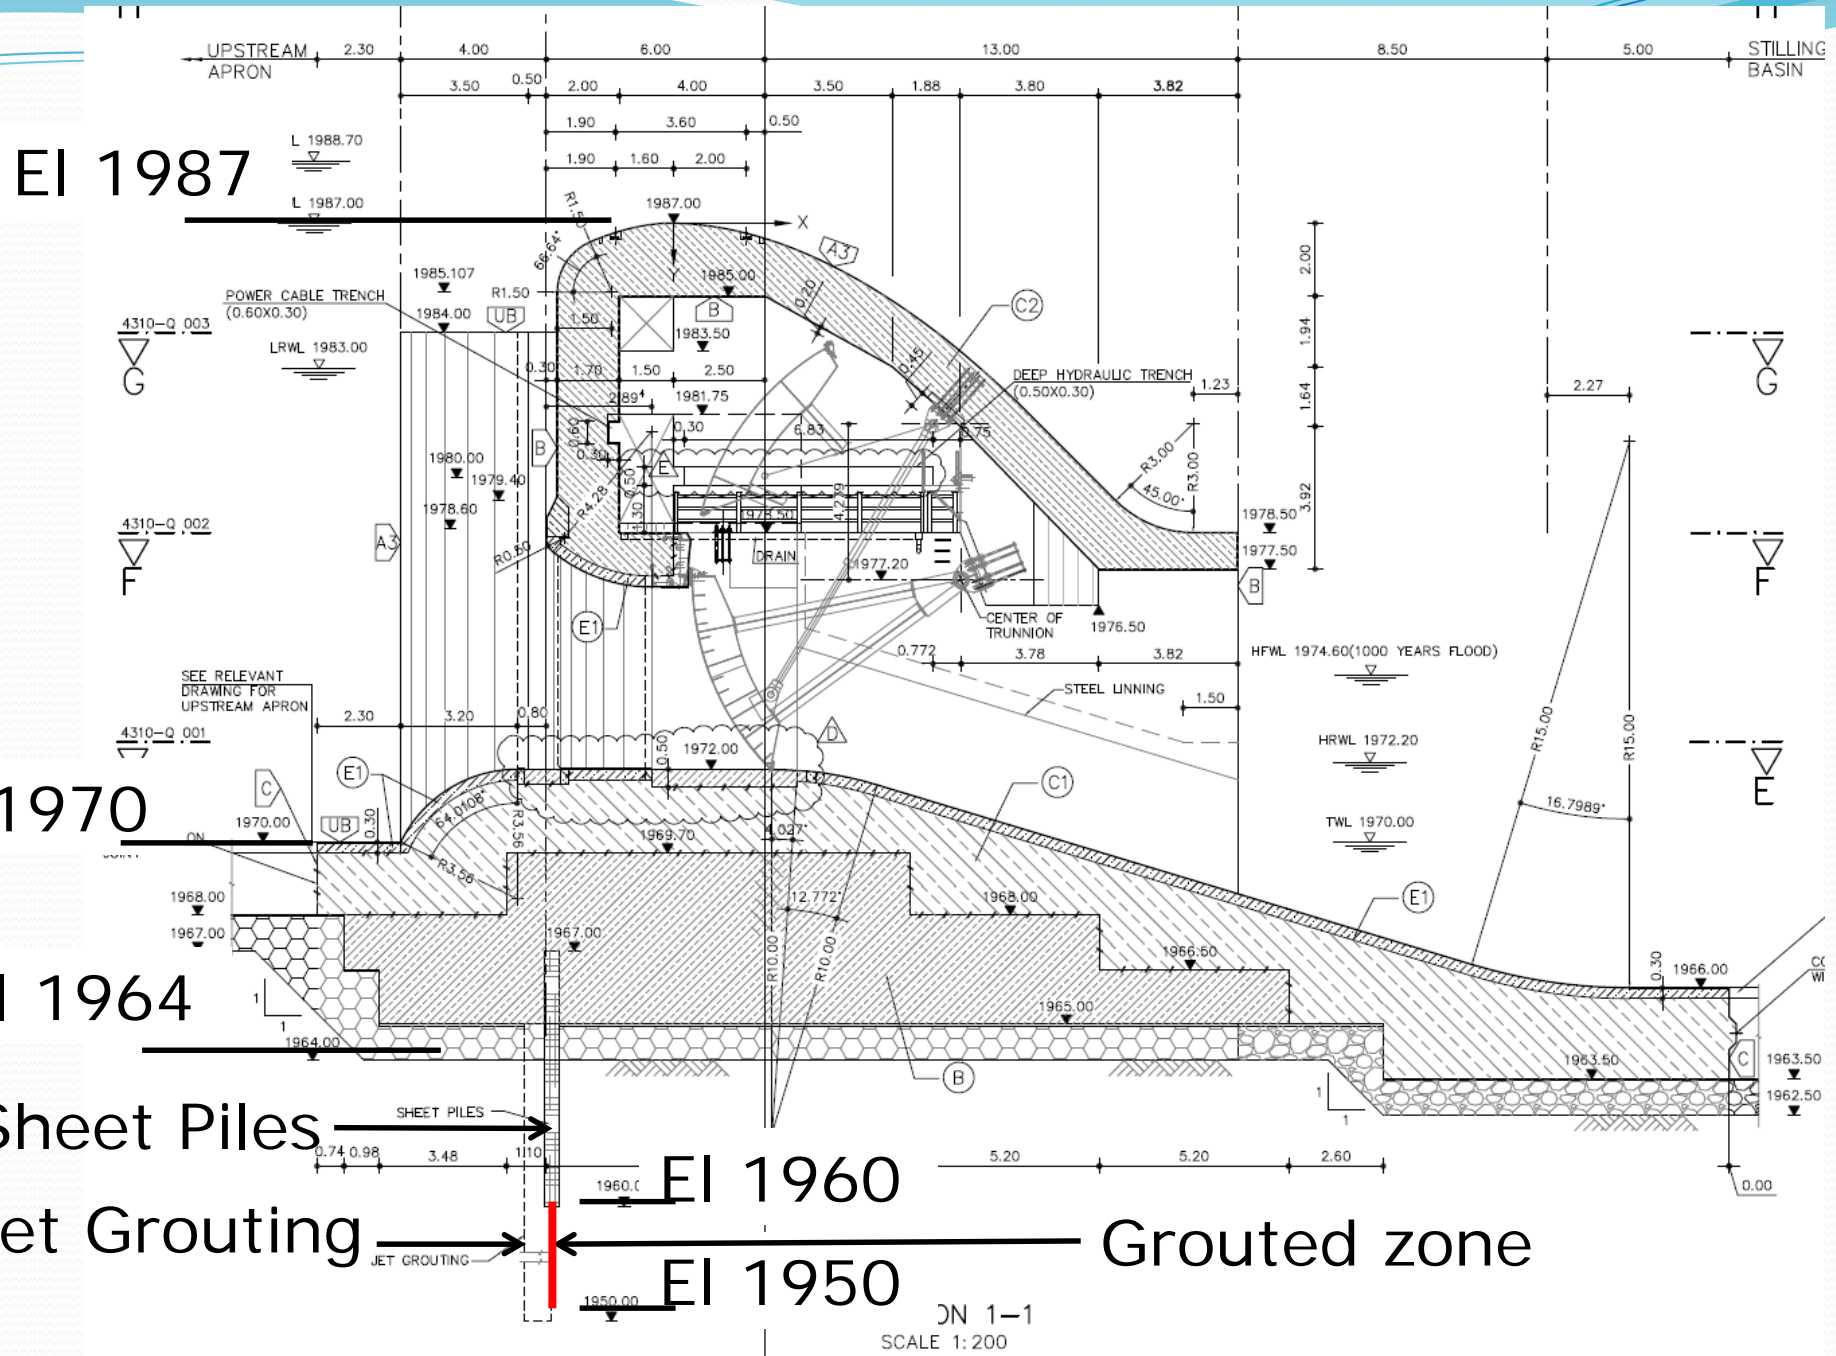
Cross Section

Spillway and Inlet Monoliths supported on compacted fill from about EI 1964 to 1959

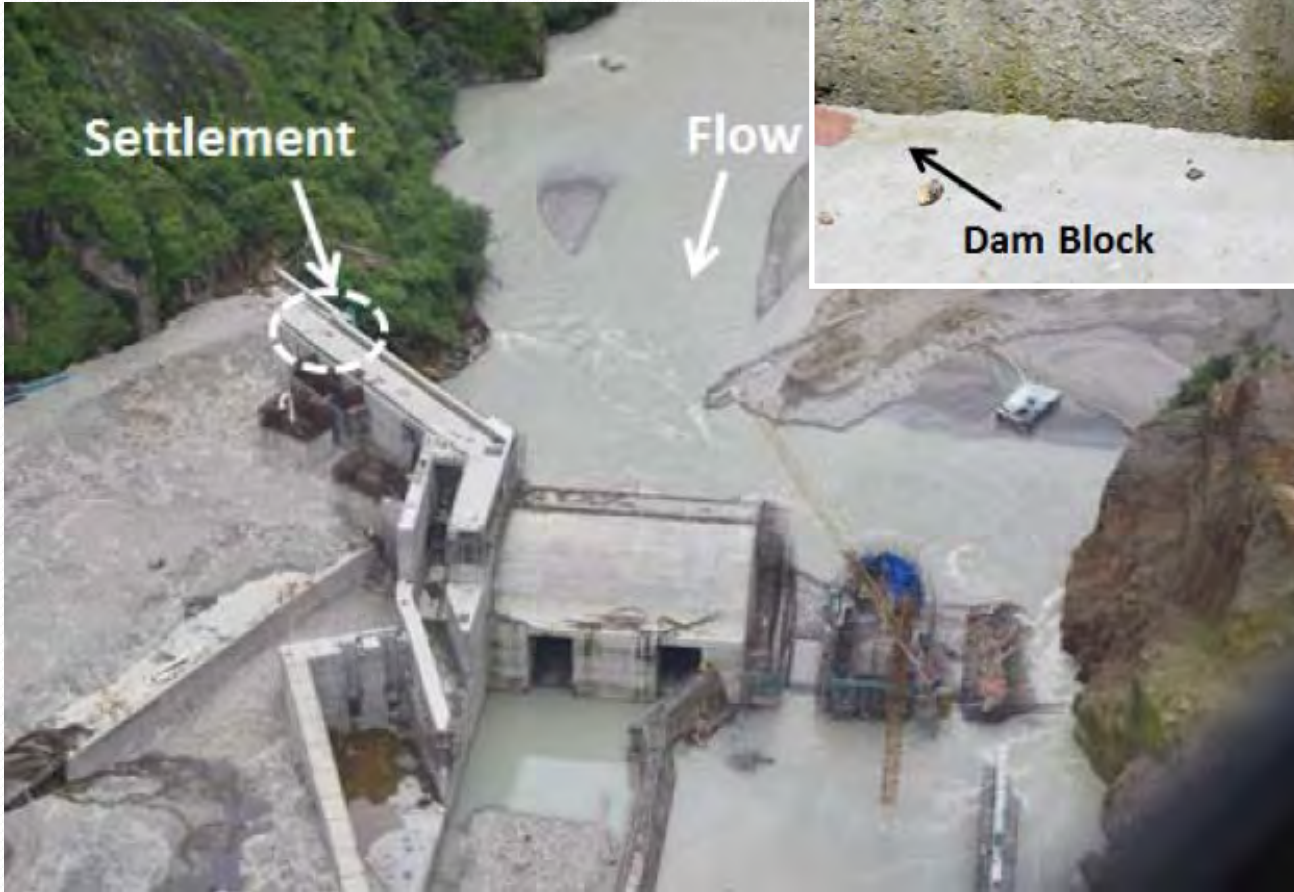
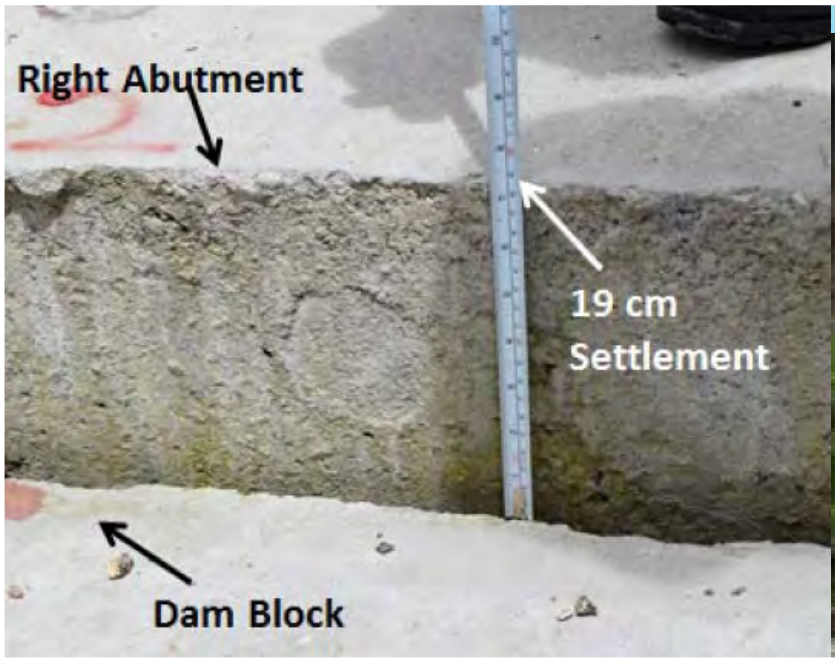
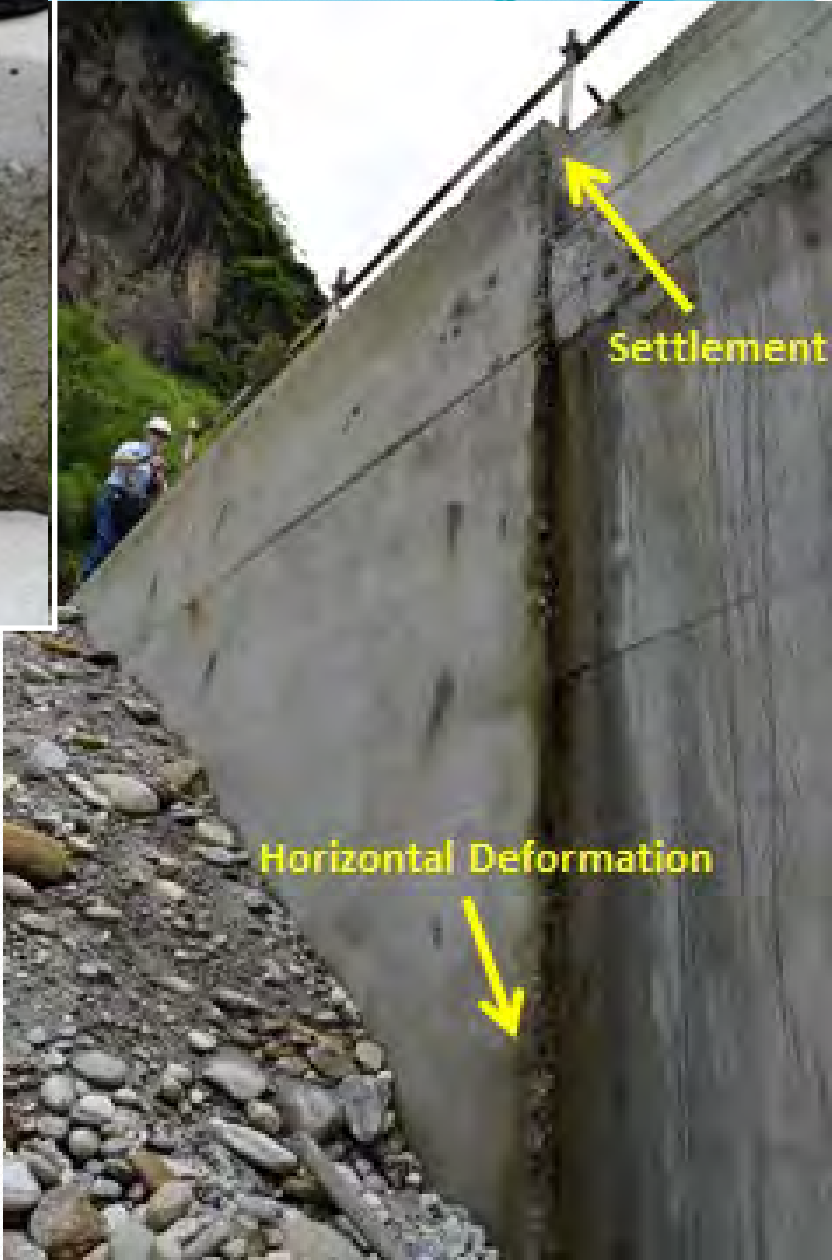
Headworks Movements

- Liquefaction
 - Volumetric strain $\sim 1\%$ - limited depth of liquefiable soil
- Volumetric compression (densification)
 - Volumetric strain $\sim 0.15\%$
- Tectonic movements
 - Possible strike-slip movement on fault in valley
 - Evidence not supportive
- Panel conclusion - densification was likely cause
- How would you have designed the dam?

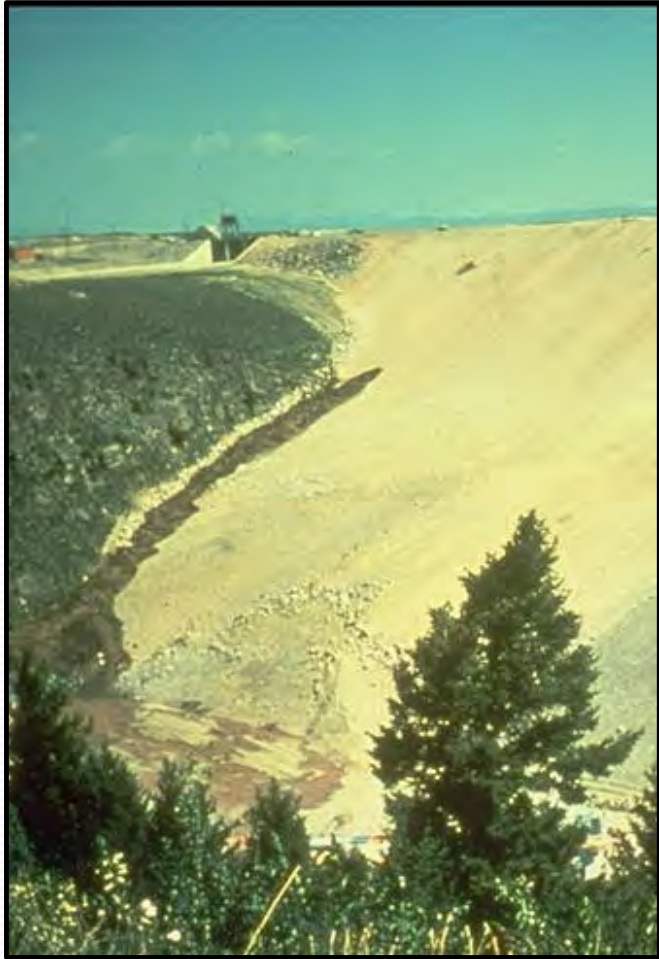
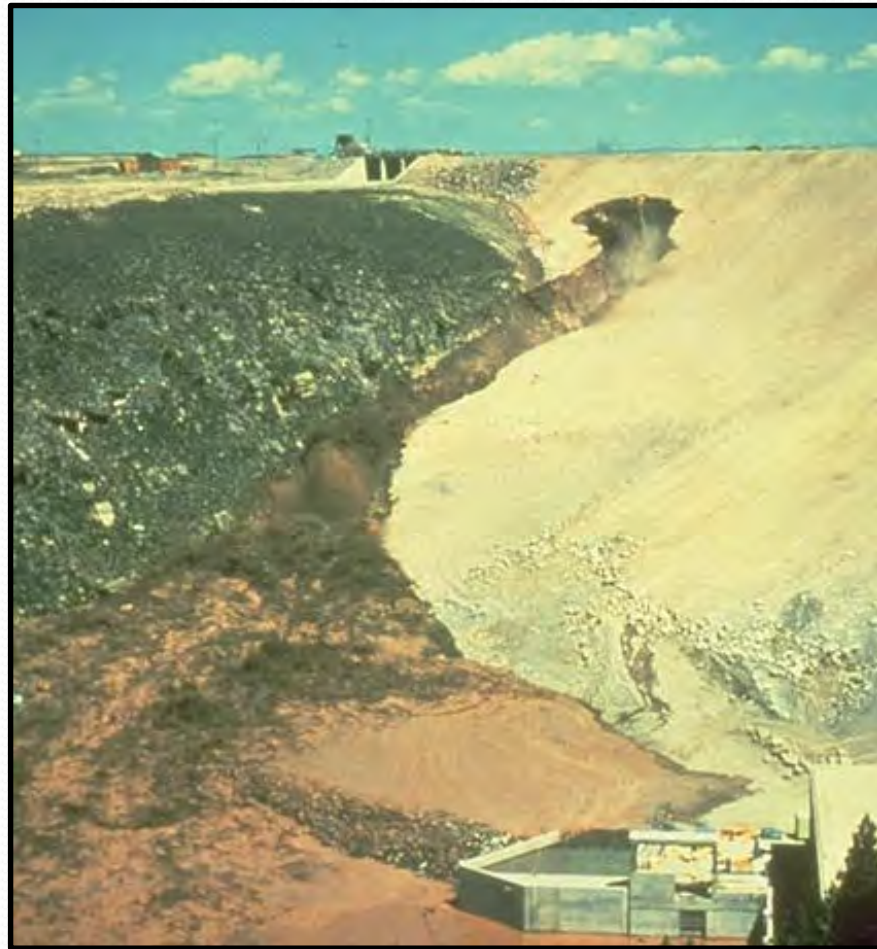
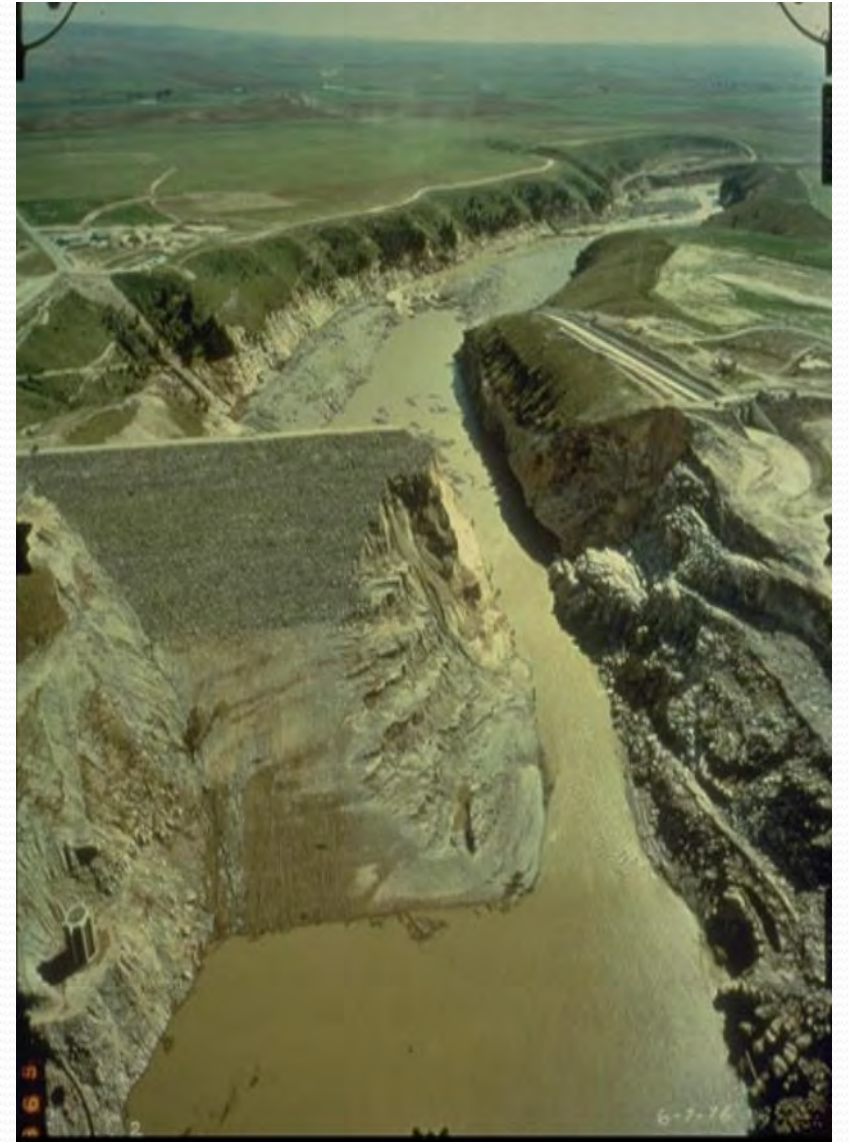
Teton Dam Piping Failure – 1976 -14 Deaths

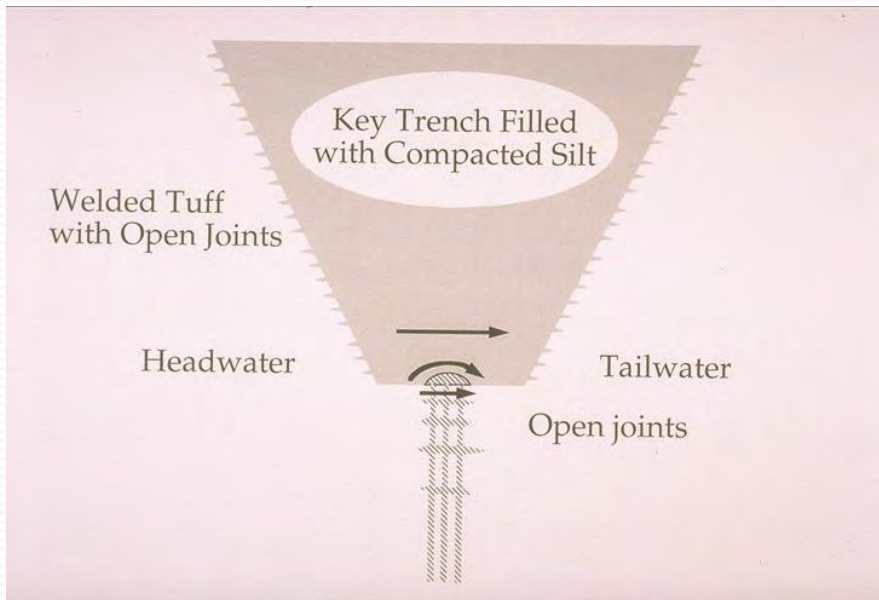
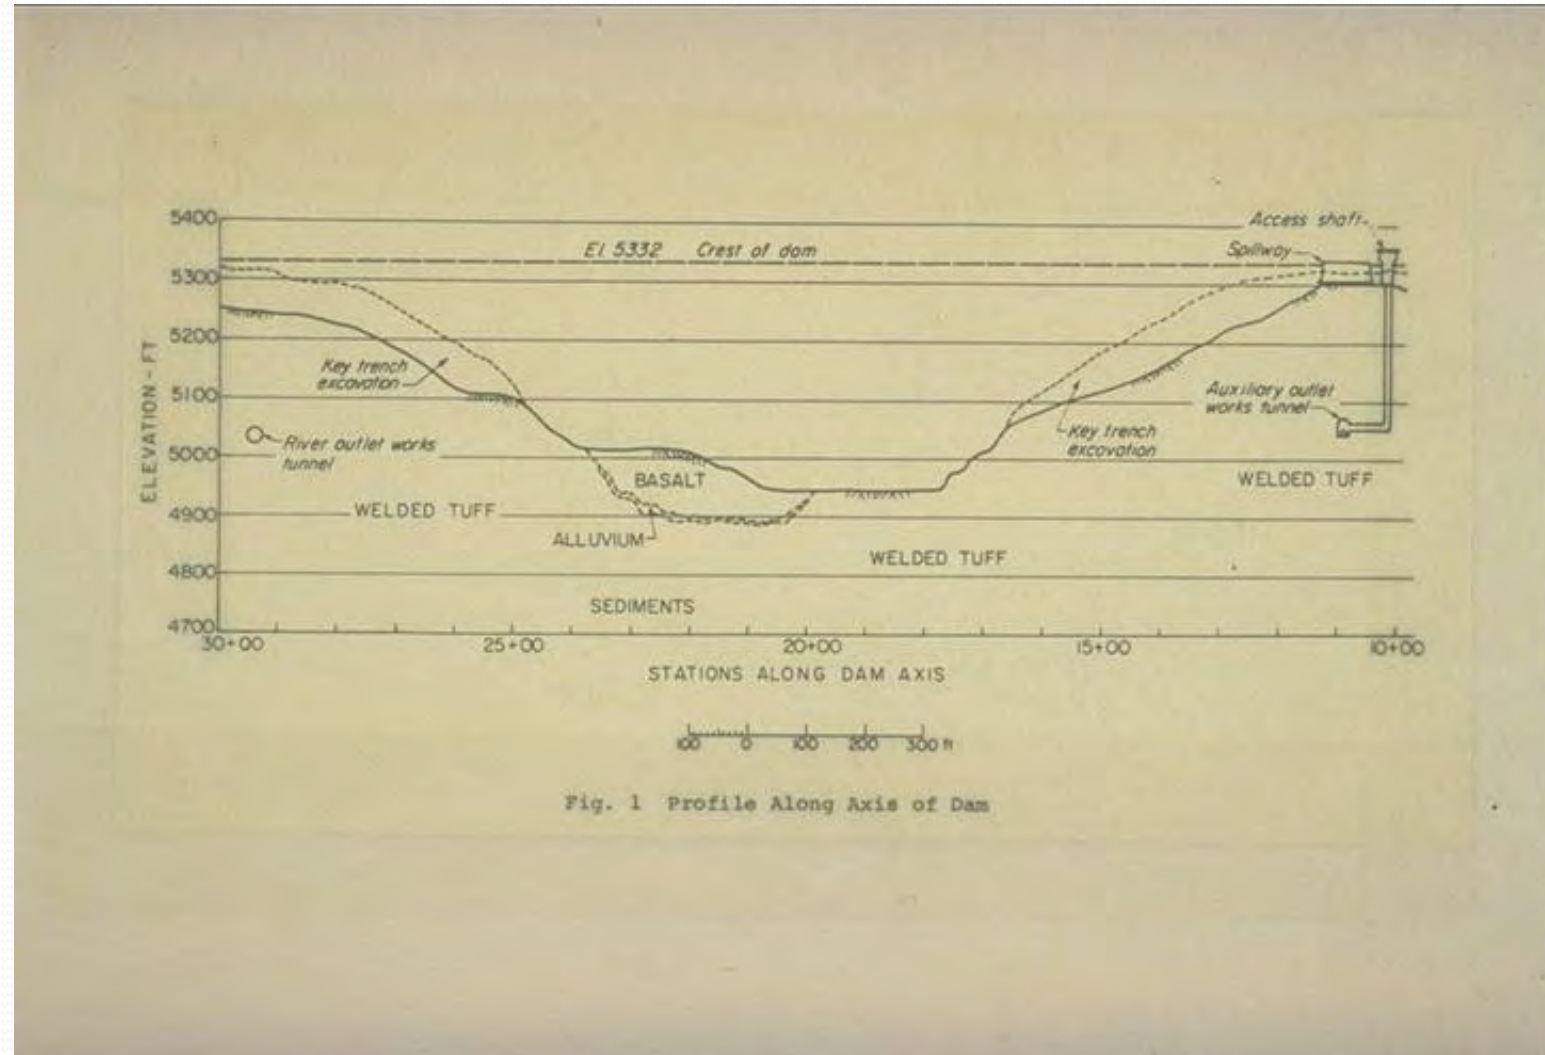
Cross Section Looking Down Stream

- Fractured rock excavated in upper portion of Core Trench
- How erodible is silt?

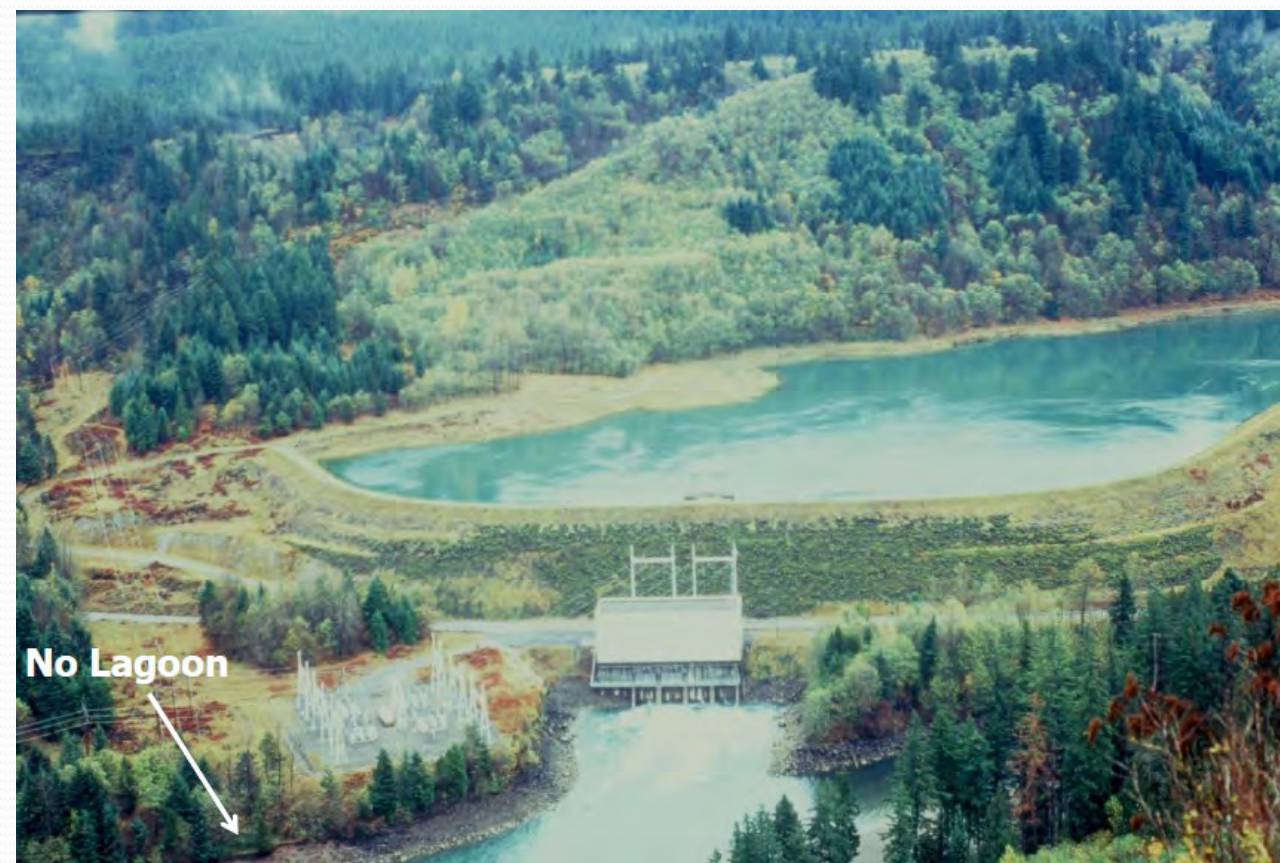
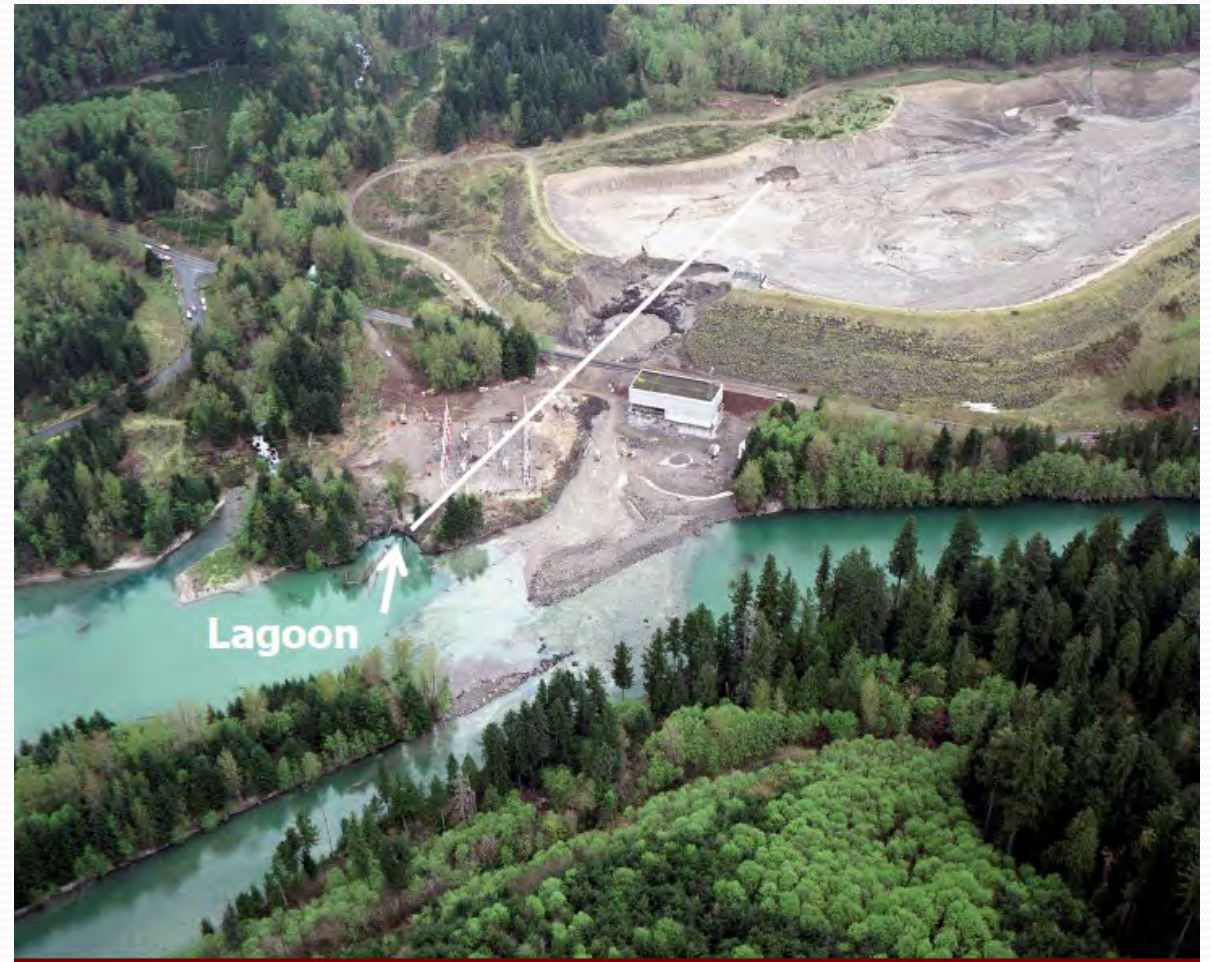
Post Construction View/Post Failure View

April 21, 2002 Failure

- Blowout occurred at toe of embankment at about 3:00 AM
- Orifice expanded upstream causing breach of the embankment at about 5:20 AM
- Flooding destroyed downstream facilities
- Sinkholes discovered in forebay
- Discharge contained in downstream reservoir

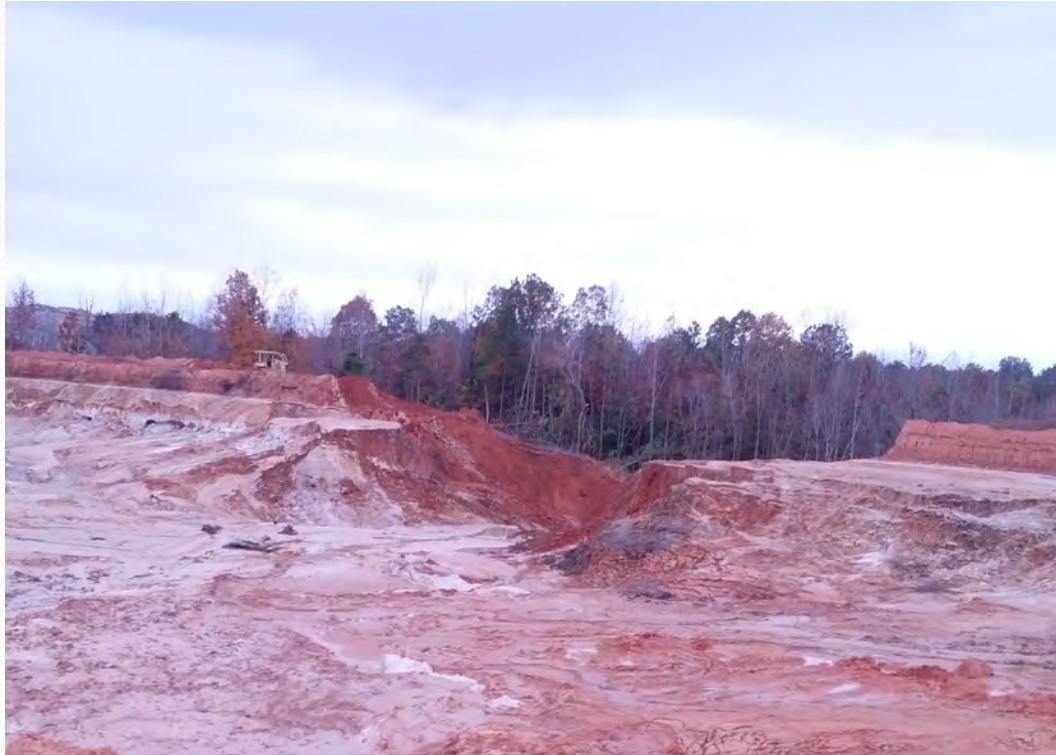
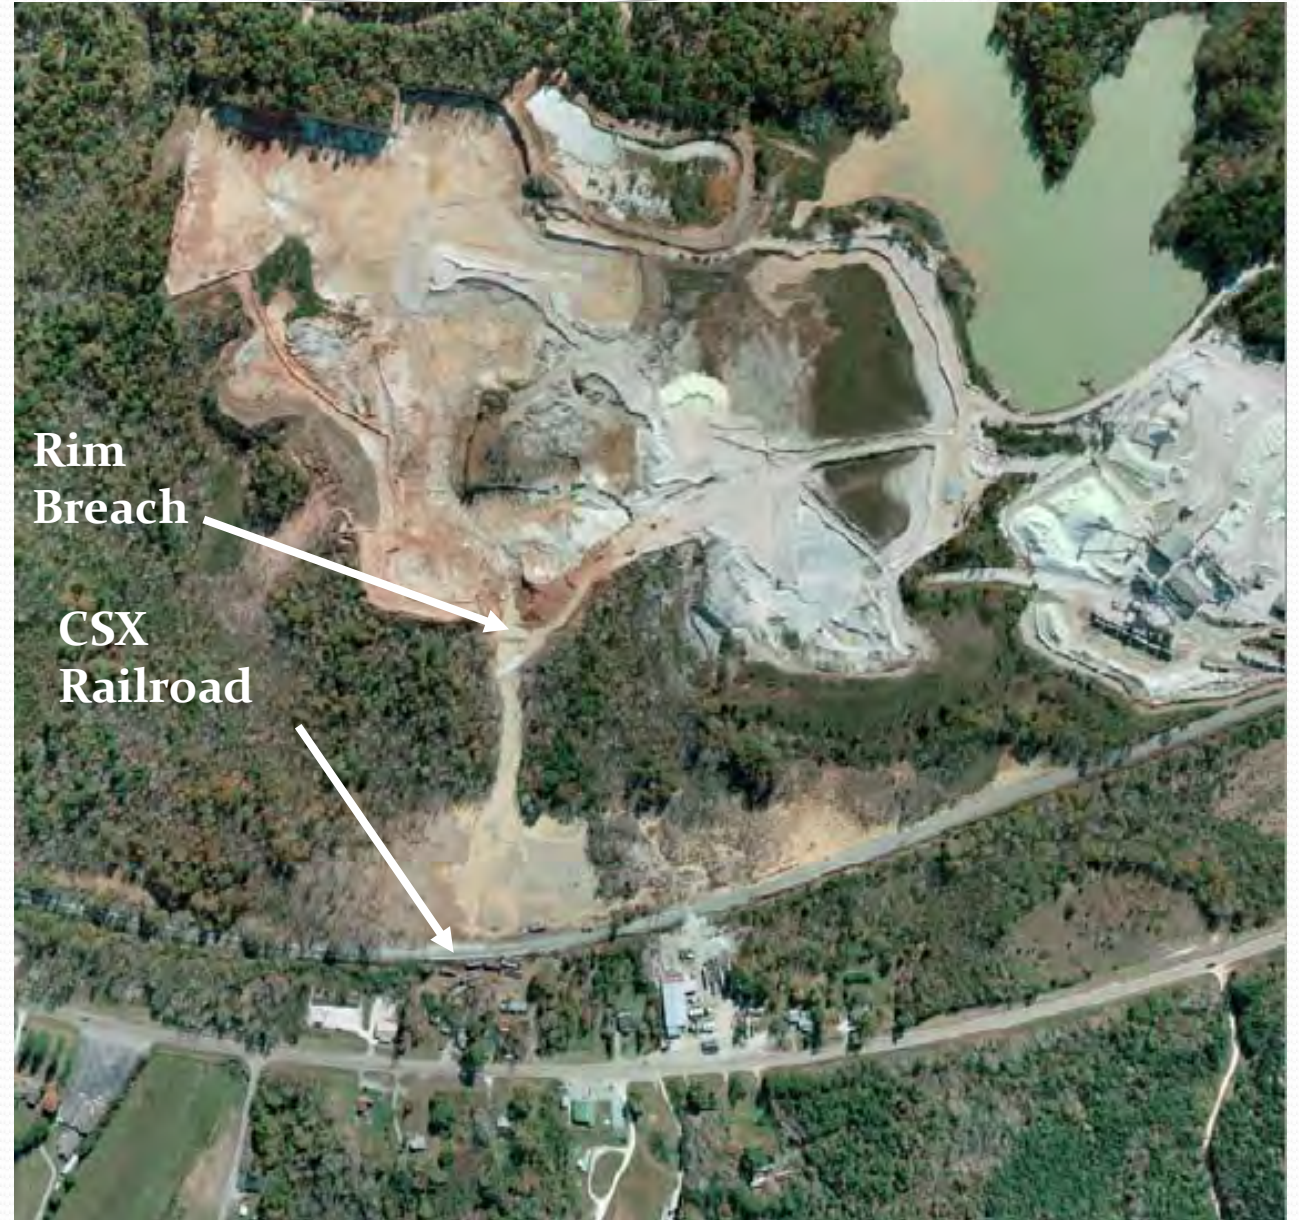
Tailings Pond Rim Piping Failure

Failure on October 26, 2014

- A 911 call at 9:51PM from home north of CSX track – “flooding”
- A CSX Railroad train derailed at about 10PM
- The Pond contained about 79.6 million gallons of water at failure
- In use for about one year

- A - Fill – for access road
- B – Clayey sand
- C - Upper McNairy fine sand
- D - Lower McNairy cemented sand/silt/clay
- Note head cut blocky area in cemented soil
- Water depth at rim – 25.7 ft

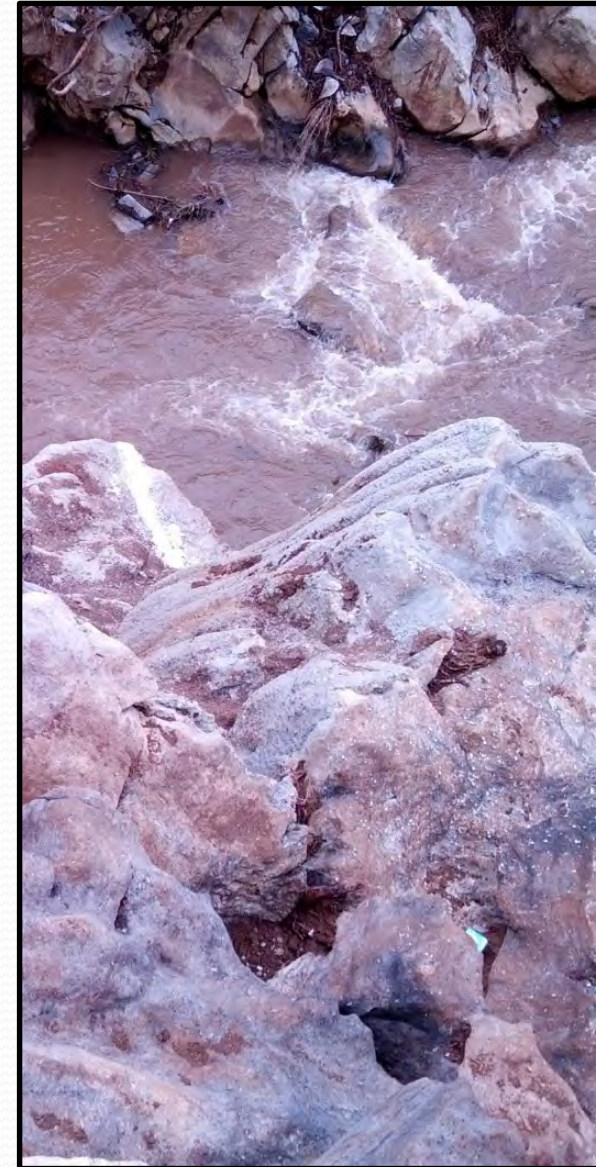
- Gray limestone, contains minor interbedded red shale
 - Rock is of very good quality
 - Concave rock structures generated by dissolution
 - Discontinuous small cavities observed along fractures
- “Neither karstic sinkholes nor visible infiltration that could affect the water reservoir were observed.”

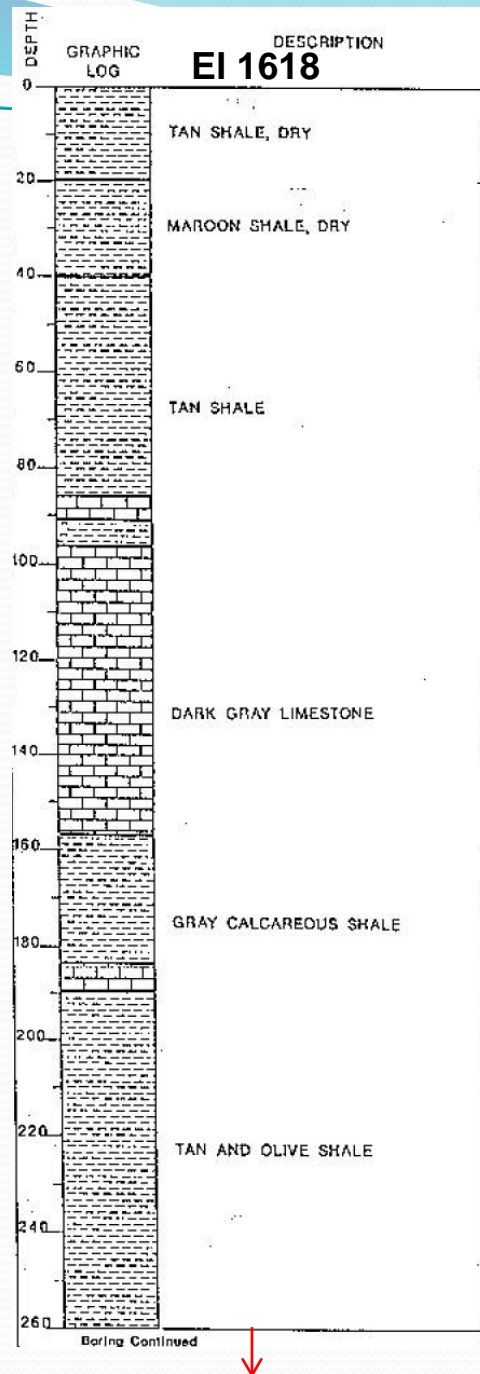
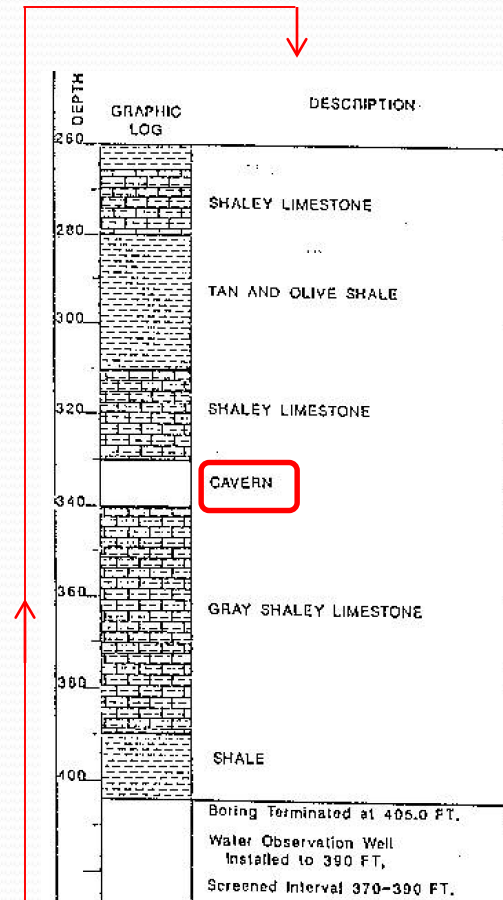
Drilling Program

- Borings drilled along ridge lines on both sides above Spring Hollow
- Voids and caverns located along both sides of Spring Hollow at valley level
- Geomorphology sequence confirmed

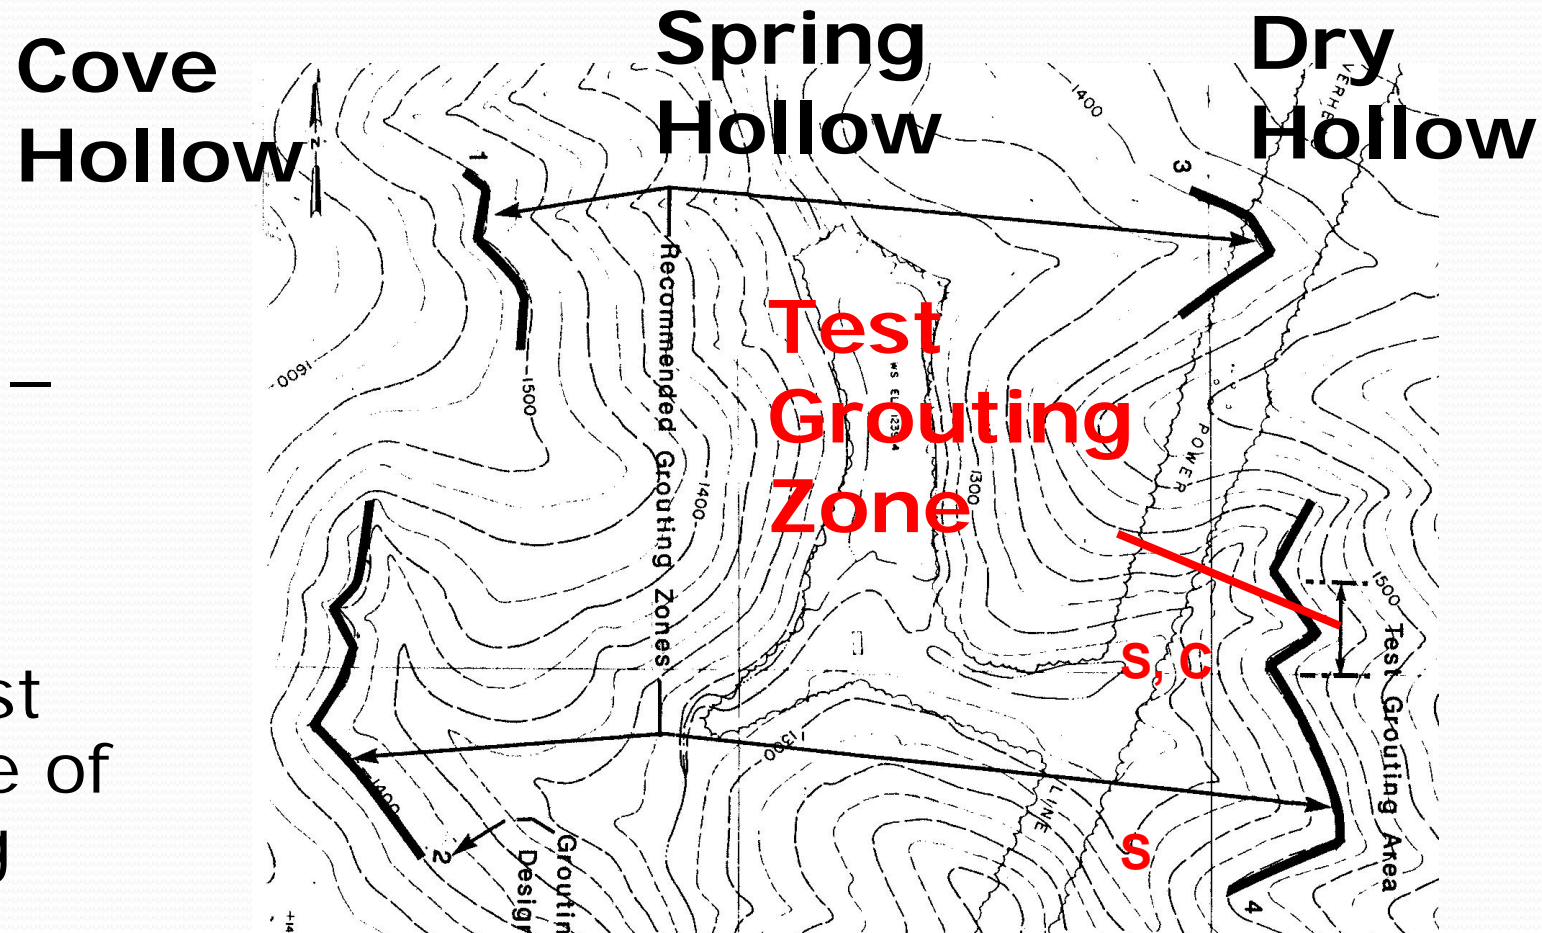
Test Grouting/Production Grouting Program

- Results of test grouting program
 - Spring flows not modified significantly – test section too short
 - Grout takes indicated production grouting costs acceptable if test section representative of remainder of grouting area

- Production grouting completed
 - Cost higher than estimated
- Reservoir holds water
