REHABILITATION OF THE CENTRAL MACHU PICCHU HYDROELECTRIC PLANT

**CONSTRUCTION OF GALLERIES
CONNECTING THE POWERHOUSE TO THE
TAILRACE TUNNEL**

OCTOBER 1, 2013

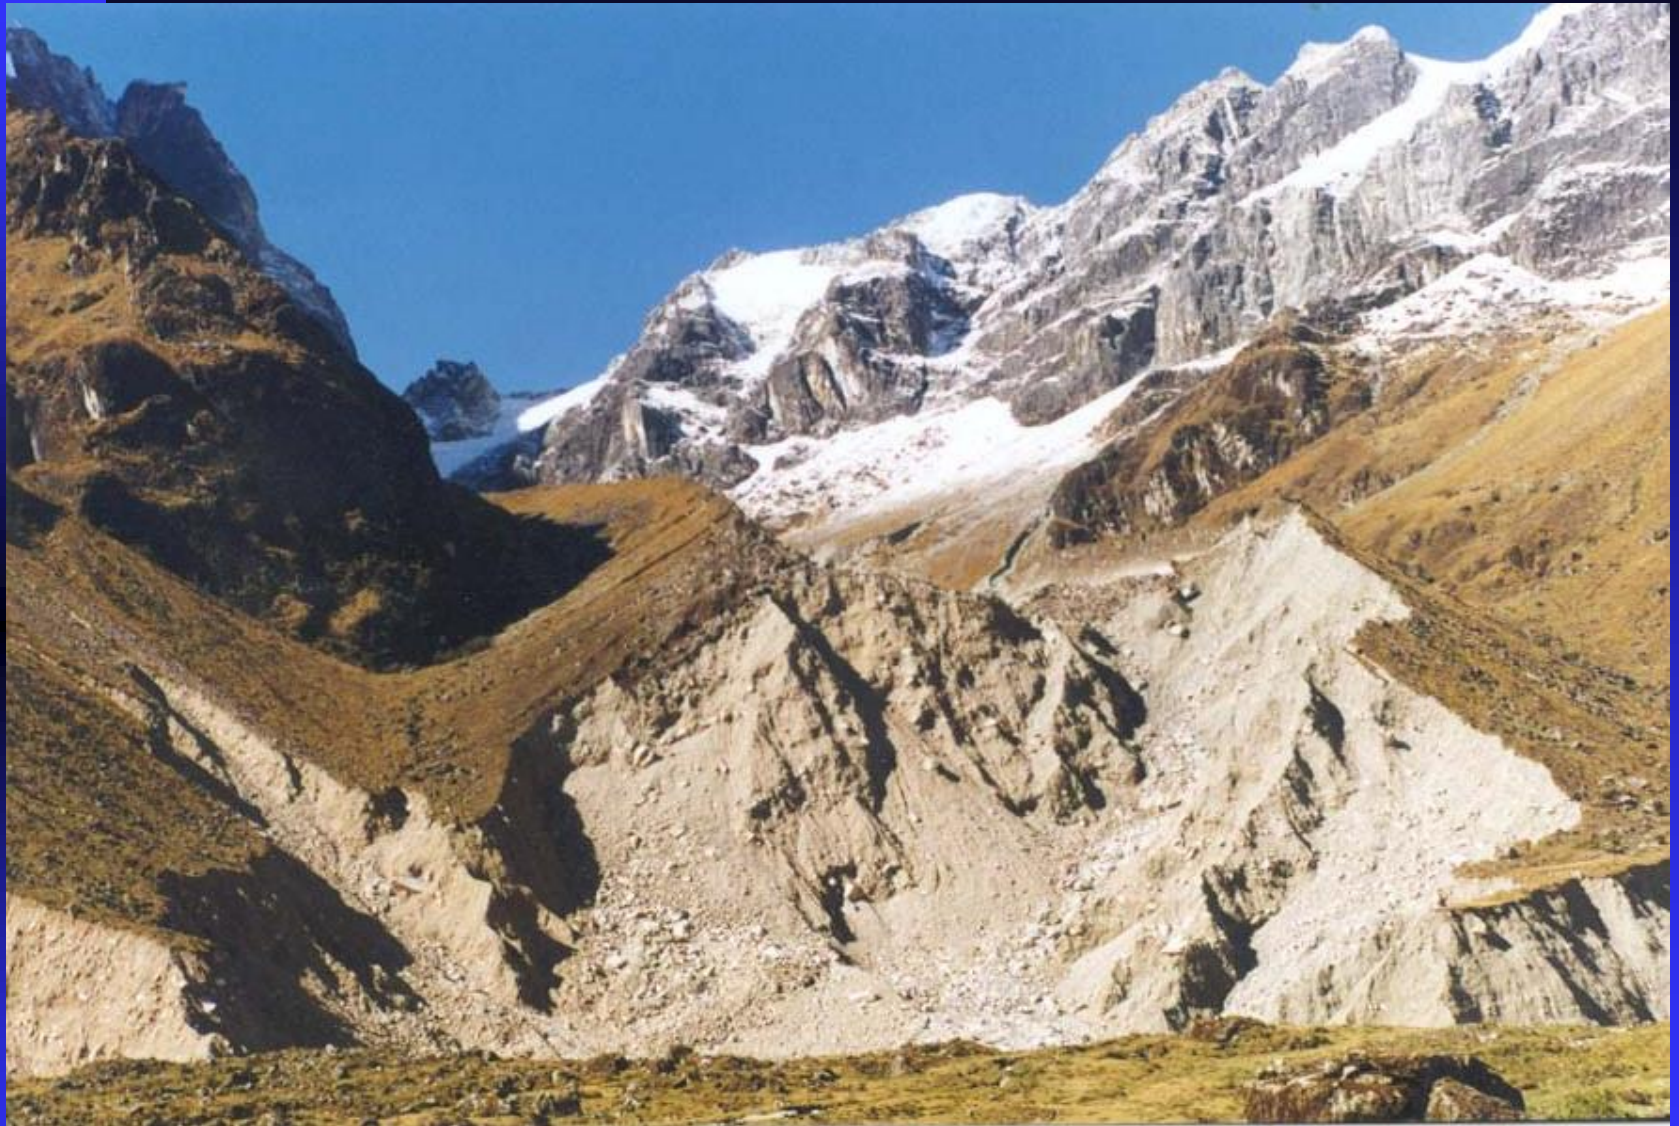
VIEW OF THE STARTING POINT OF THE SLIDE

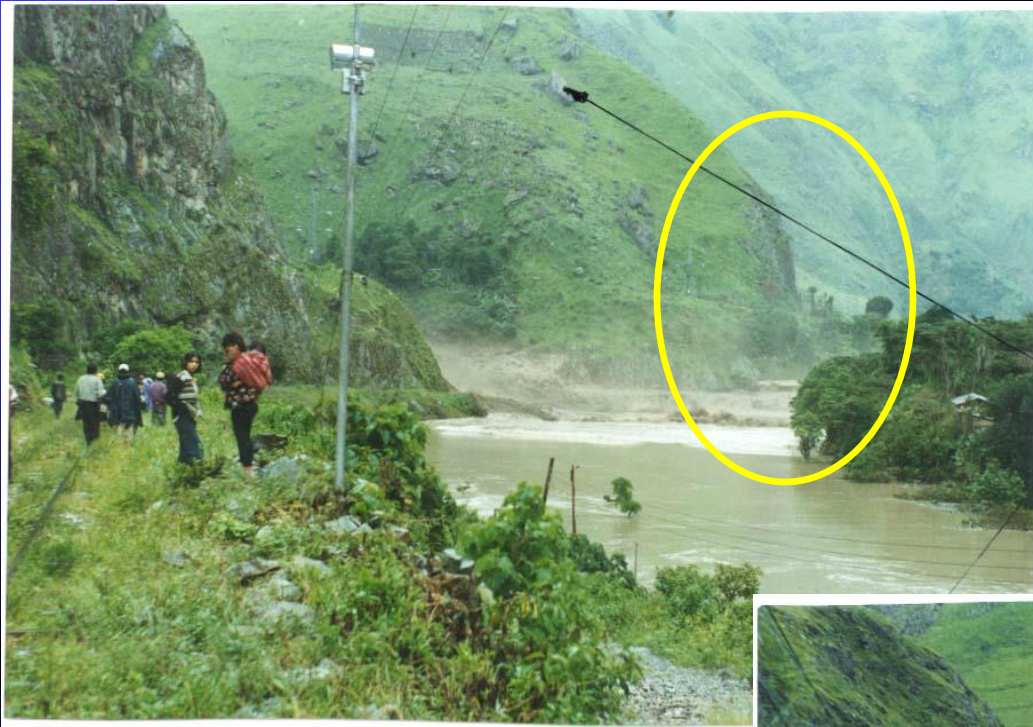
PROCESS OF DAMMING THE VILCANOTA RIVER

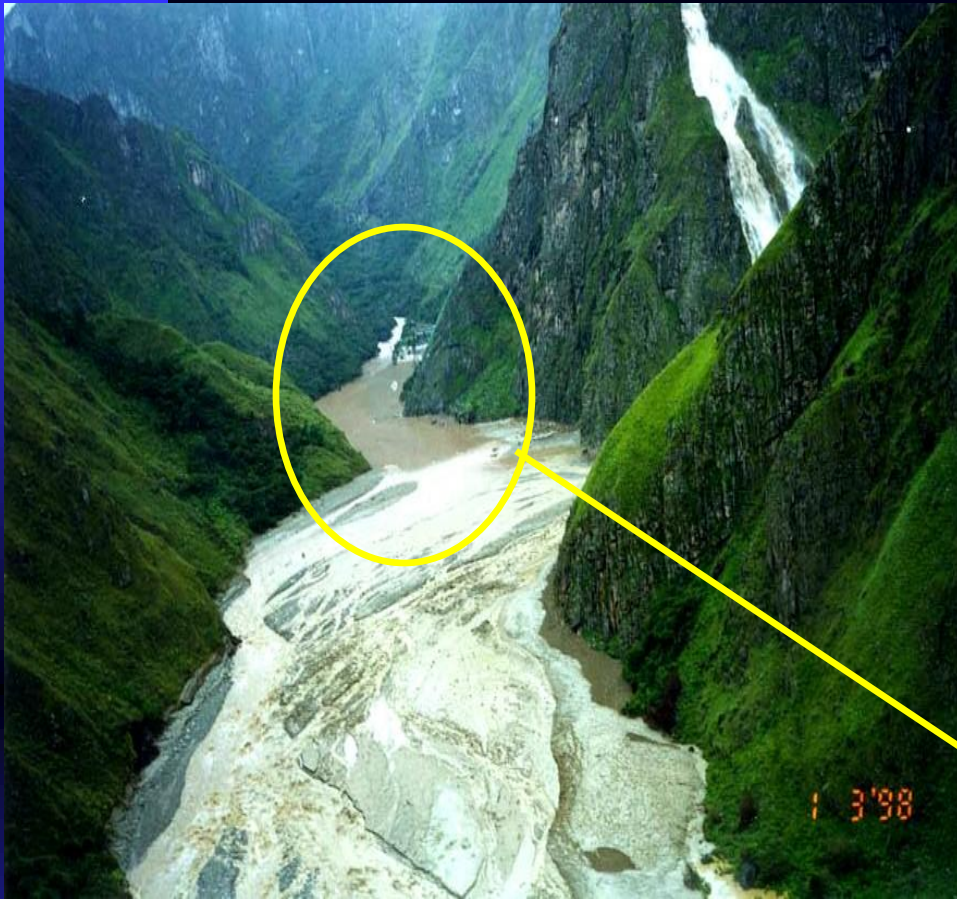
DAMMED AREA AND NATURAL RESERVOIR

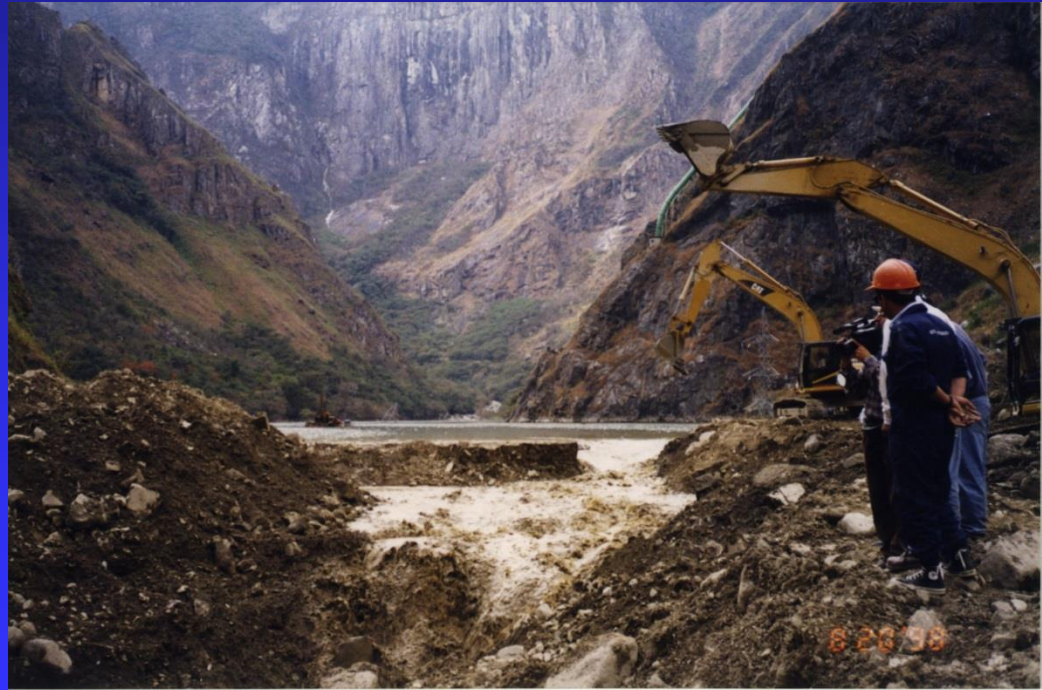
OPENING OF A DISCHARGE CHANNEL TO FACILITATE DRAINAGE

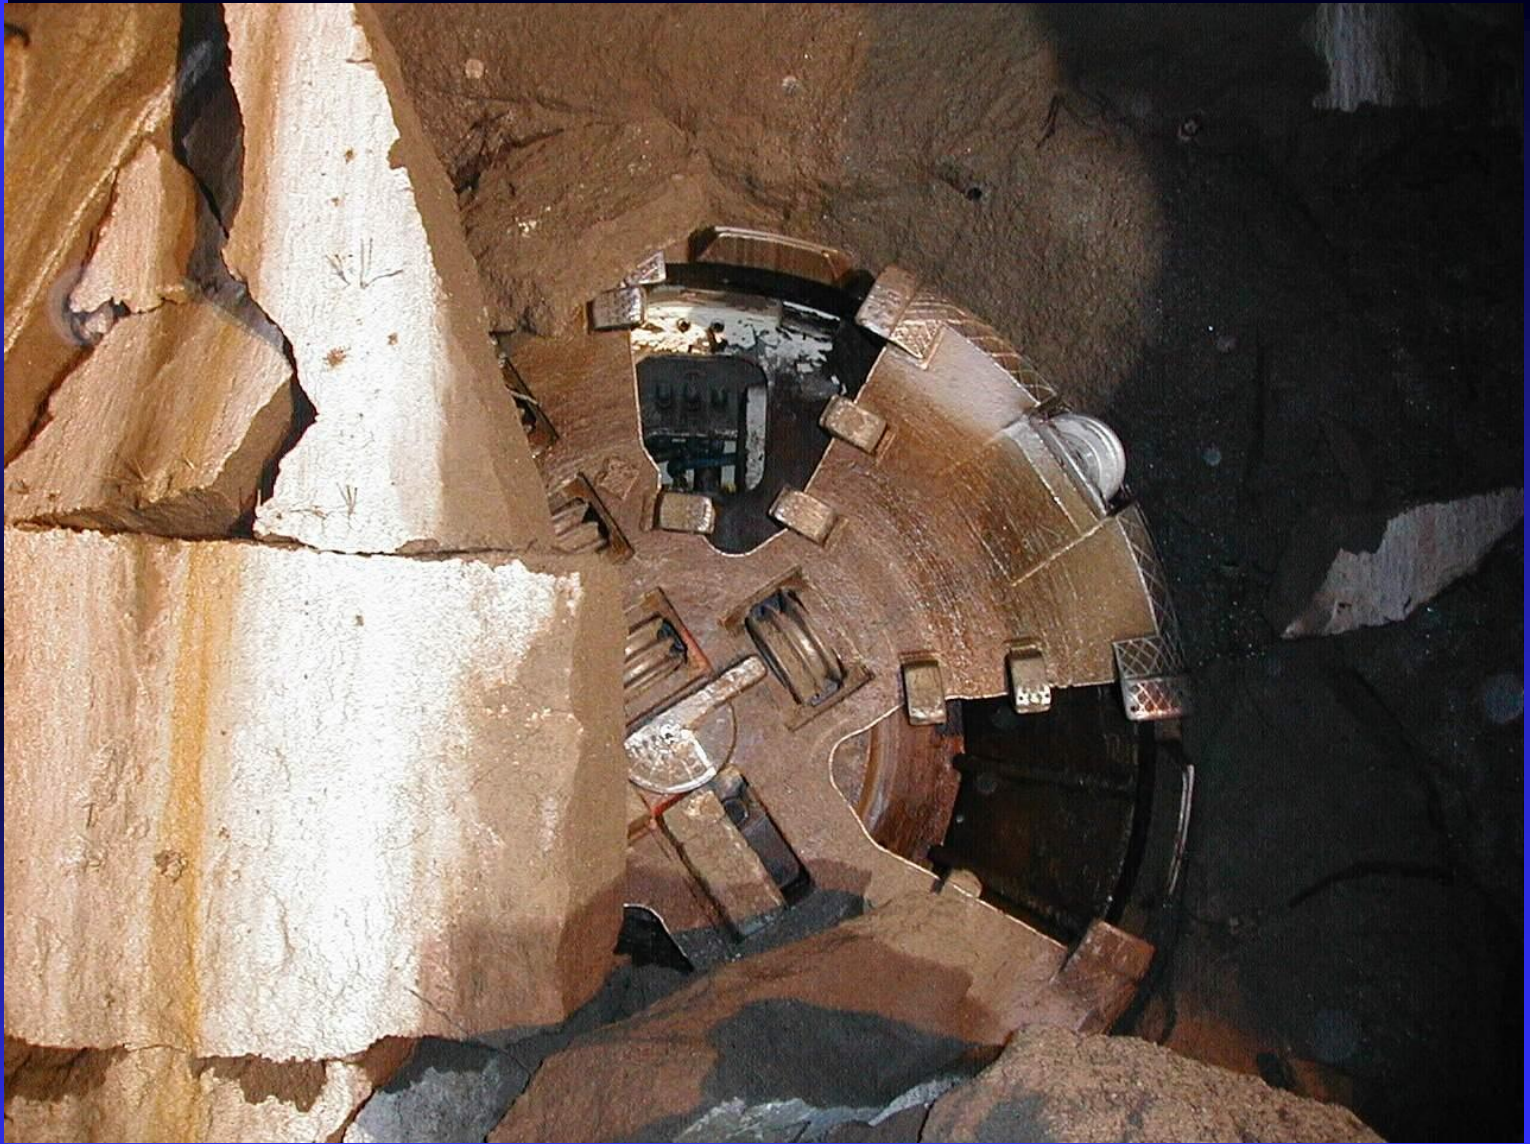
THE MACHINE-GALLERY # 1

- **The advance in Tunnel #1 suddenly stopped after approx. 60 meters from the cavern on the right bank.**
- **The blockage was limited to 5 pipes behind the machine, between the inter-jack and the machine.**
- **Blocking lasted over 60 days, all efforts by using the normal means available on the site could not move the section of the pipe and the trapped machine.**

- **Findings from the exploratory program include:**
 - ◆ **The soil mass consists of fine, flowing and unstable glacial sediments.**
 - ◆ **The material behaves as a liquified sand as the shield advanced, flowing like a dense, viscos fluid.**
 - ◆ **The mass adheres very strongly on the porous surface of the concrete.**
 - ◆ **The friction force of this material exceeded the total available thrust force.**

- The combined efforts of improvement of the bentonite slurry (Mr. Lyon), and the assistance of Mr. Abbott's Jason Co., helped release the machine.
- The tunnel was finally completed on 17 November, having been started in late August.

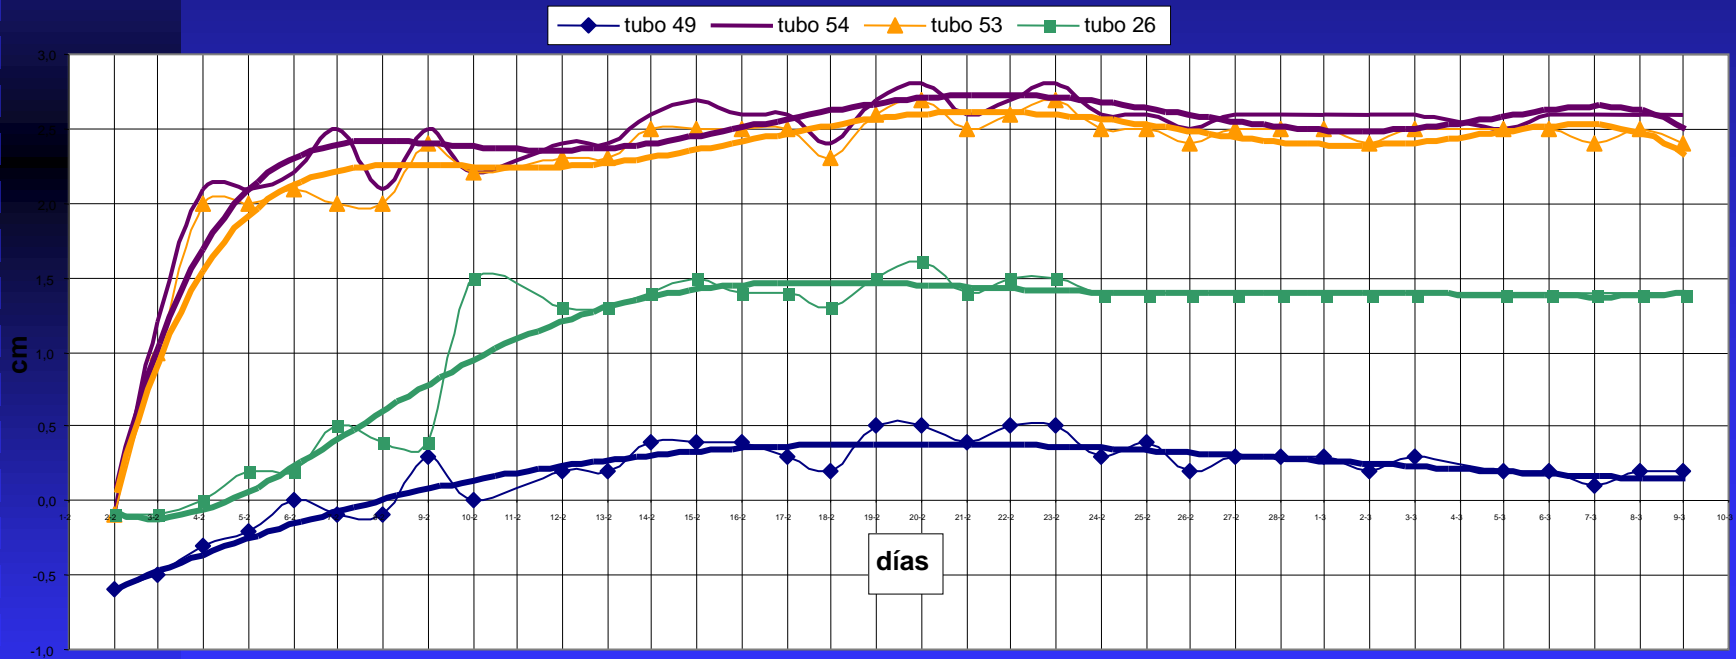
MONITORING OF THE ALIGNMENT OF THE PIPES - TUNNEL 2

GALERIA N°2
medición asientos a partir del 1/02/01
con líneas de tendencia poli nómicas
