# **Geosynthetic Reinforced MSE Wall Failures and Their Remediation**

**Bob and George Koerner  
Geosynthetic Institute**

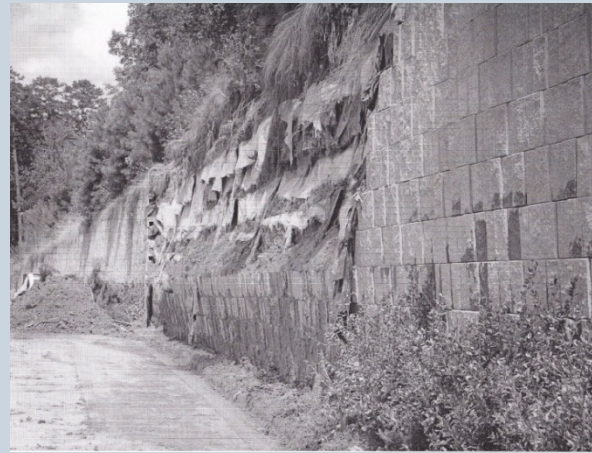
Wide Spacing (0.76 m)

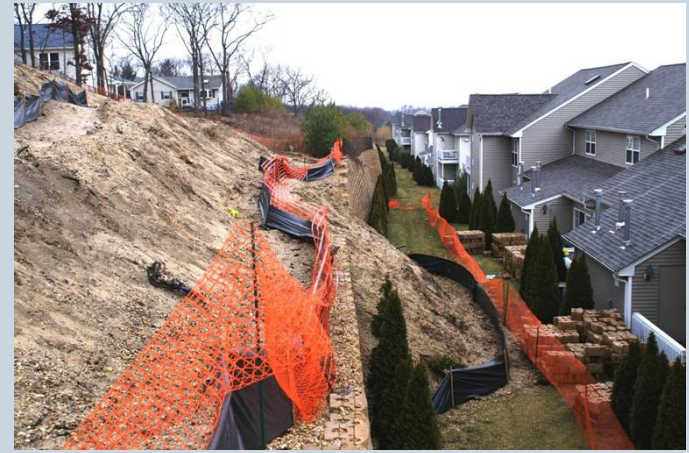
Wider Spacing ( $\approx 1.0$  m)

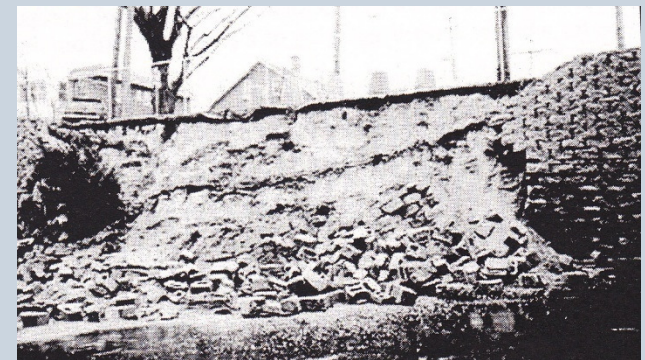
$L/H = 0.20 (!)$

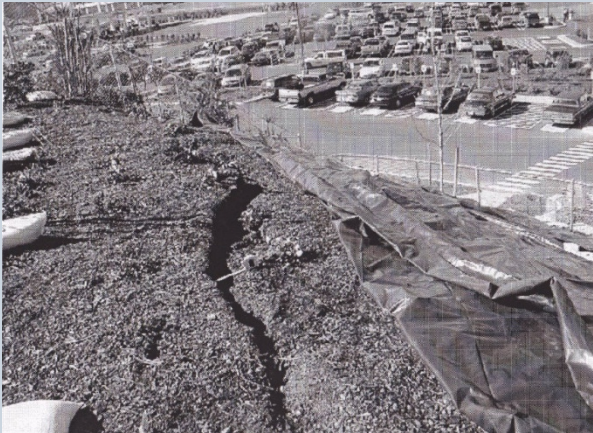
Seismic - Nisqually

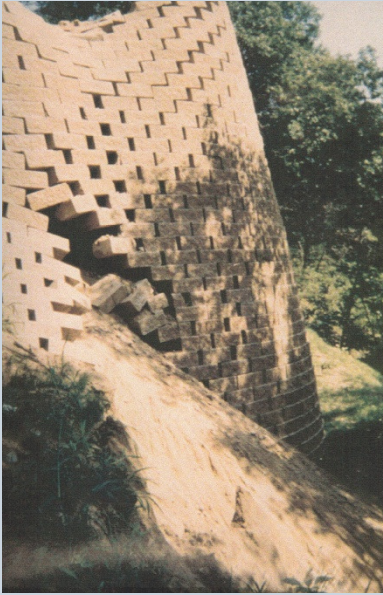
Saturated Backfill

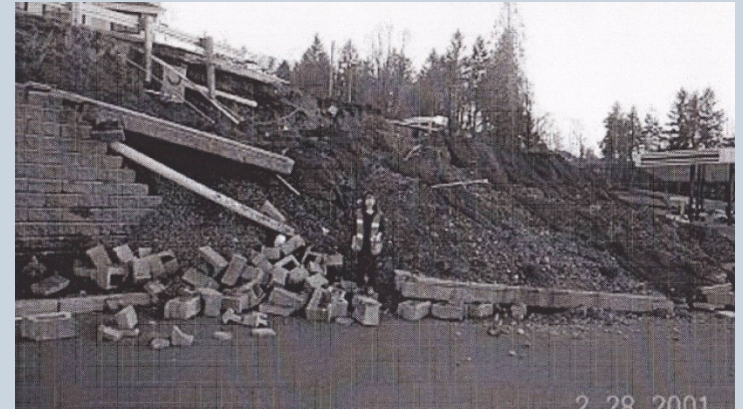
Internal Plumbing

- 16 of 51 (31%) of internal water failures
- catch basins and manholes simply don't belong in the reinforced soil zone!
- nor does the associated transmission piping!!
- backfill soil settles and these walls deform
- this causes leakage or breakage of these heavy, hard and brittle drainage systems!!!

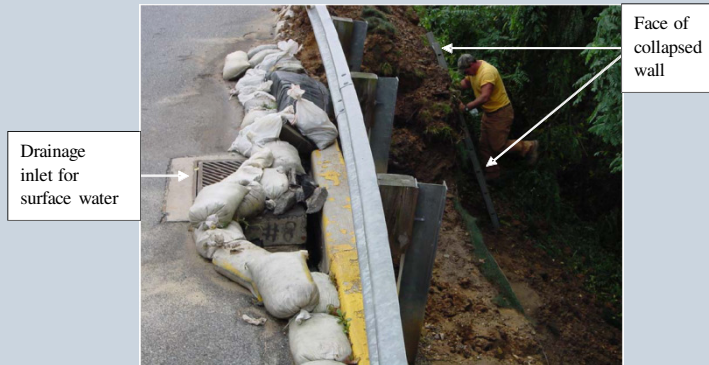
Internal Plumbing

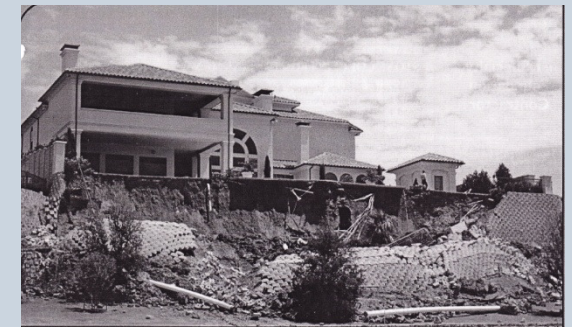
Internal Plumbing

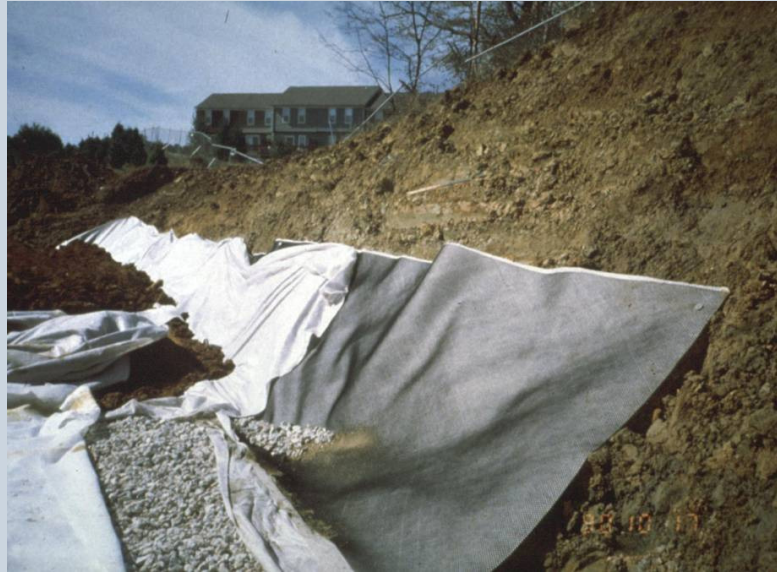
- use of on-site soil is compelling
- cost savings (vs. imported) is 40-70%
- appears incapable of being stopped
- so, use it, but circumvent the poor drainage by external routing as follows...

Use of continuous and intermittent geocomposite back drains when using fine grained soils in the reinforced soil zone (compl., TenCate Geosynthetics, Inc.)

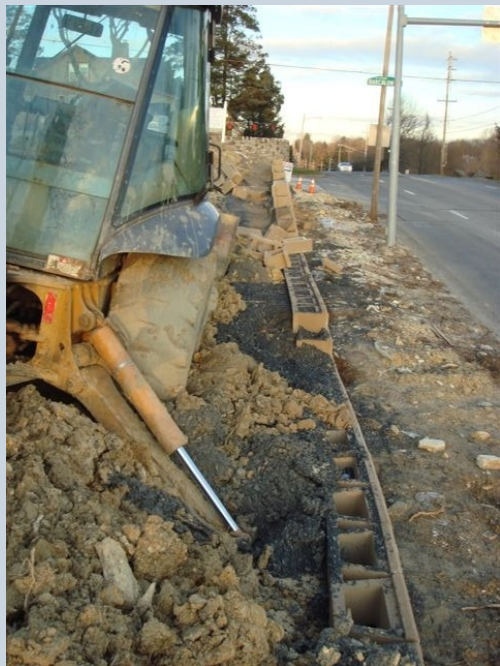
If no one watches, this is what you get; Photos by A. Filshill

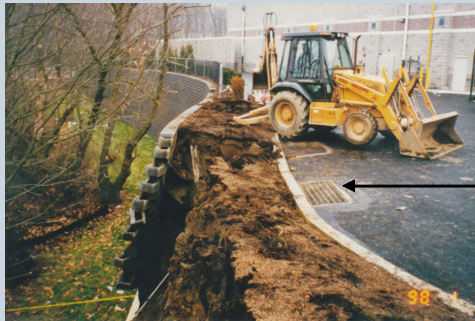
Surface water drainage inlet

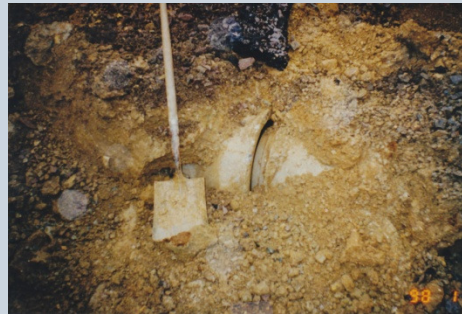
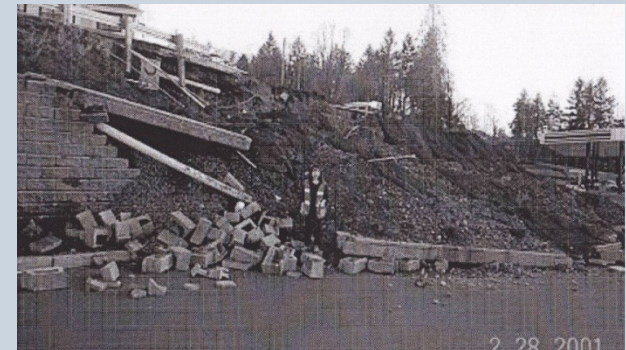
## Various Internal Drainage Failures

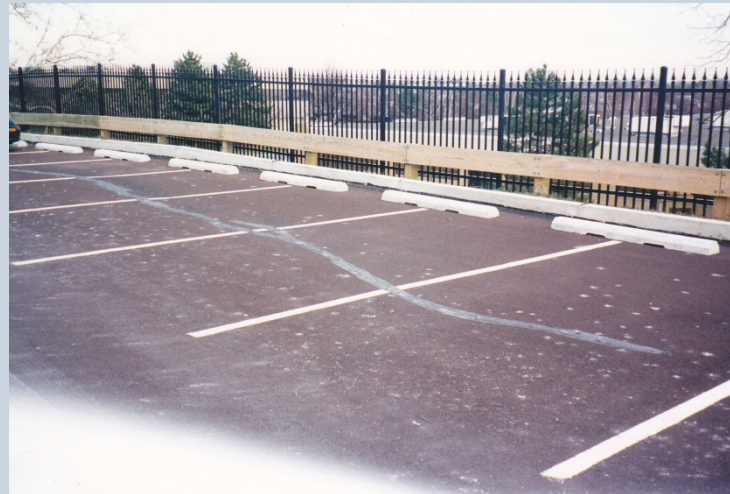
Wall is immediately in back of this fence

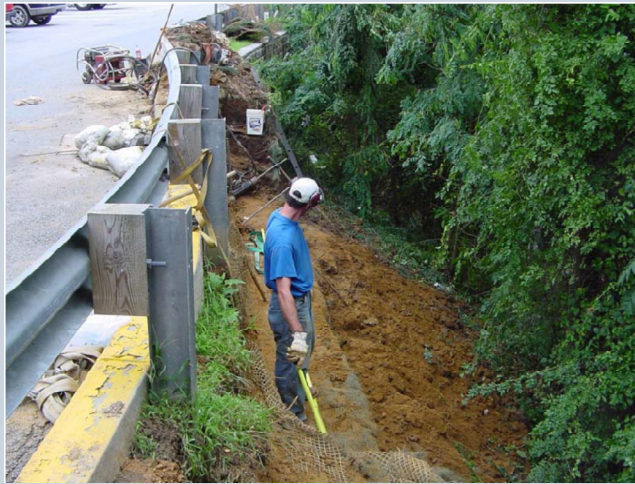
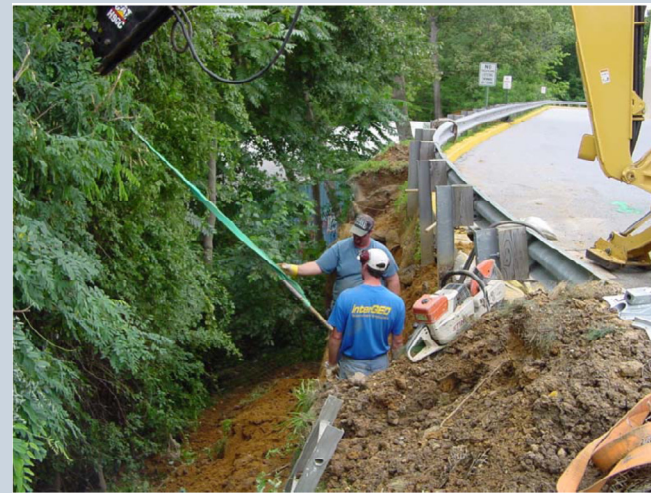
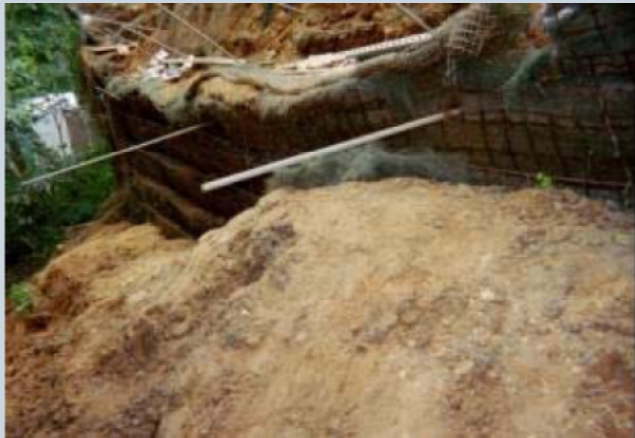
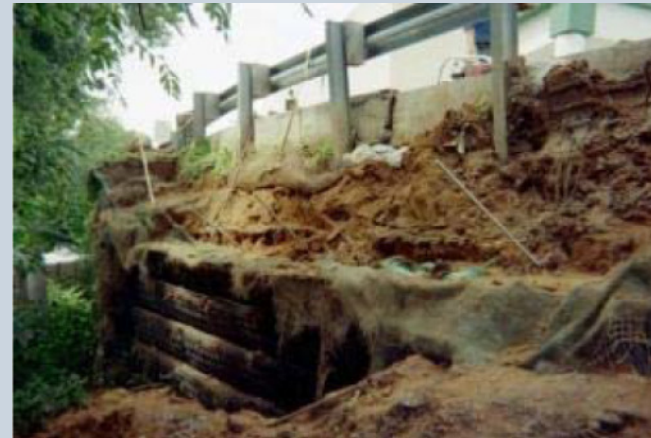
# Remediation to the Collapsed Wall (A. Filshill)

- 4.6 m high masonry block wall
- partial collapse after eight years
- ML-CL backfill soil; poorly compacted
- internal water from leaking catch basins
- remediated using gabions with duckbill anchors at end of driven tendons
